**Inspection Photo
Federal RMF 533-19
API # 045-09964
Inspection # 689301572**

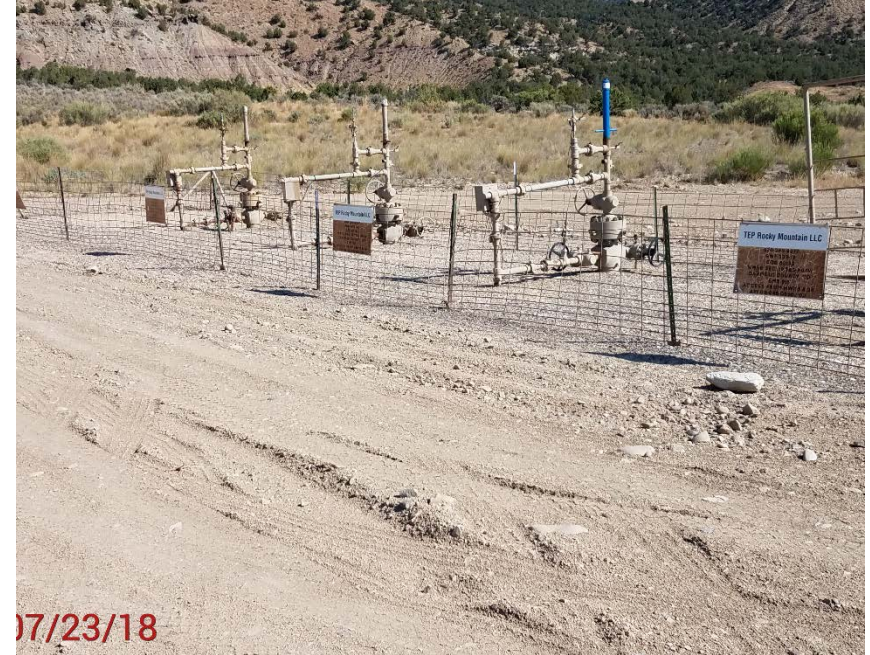
Location Photo #2, 4-non legible wellhead sign.
