Inspection Photo
Federal RMF 534-19
API # 045-10237
Inspection # 689301574

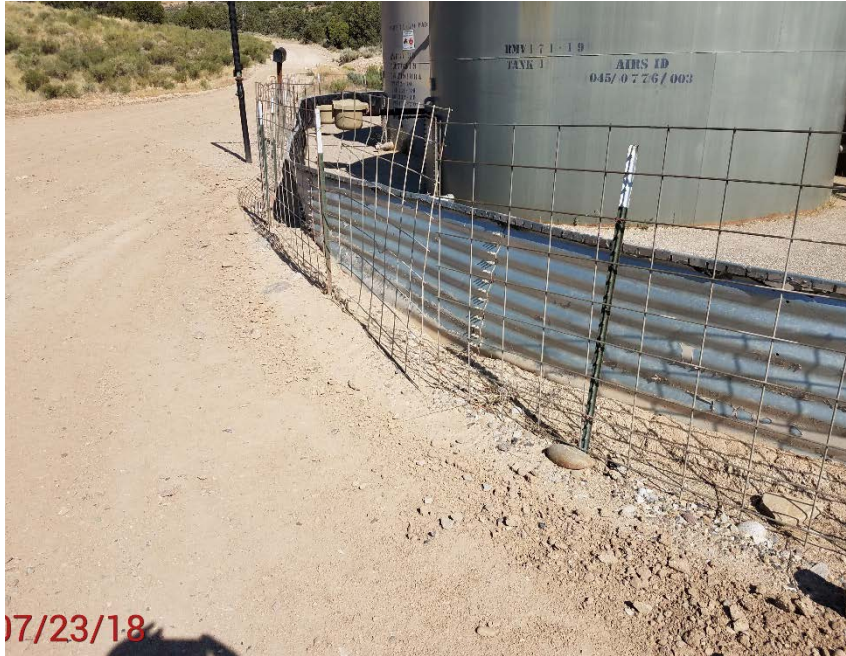
Location Photo #3, Containment maintenance

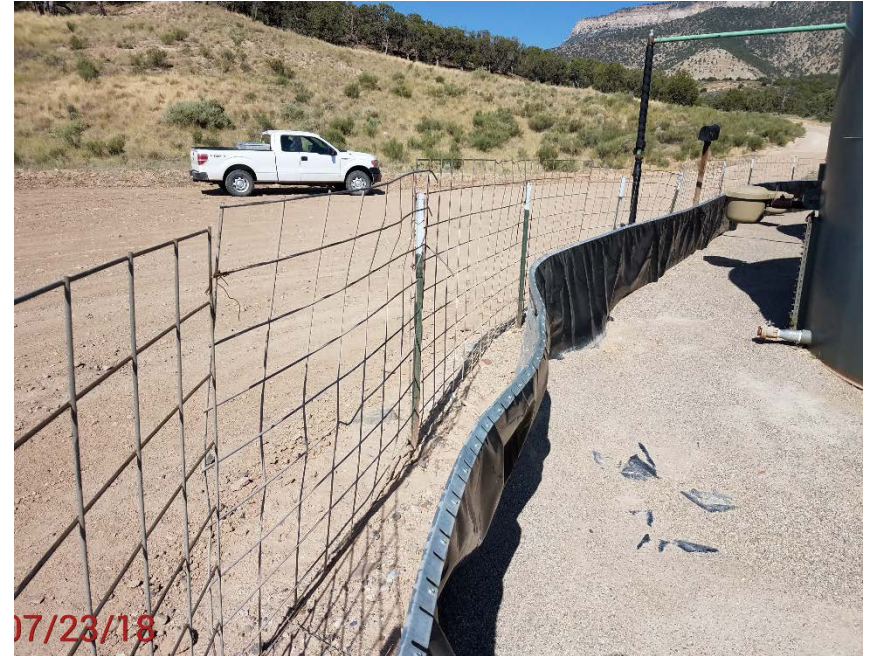
Location Photo #4, Containment maintenance

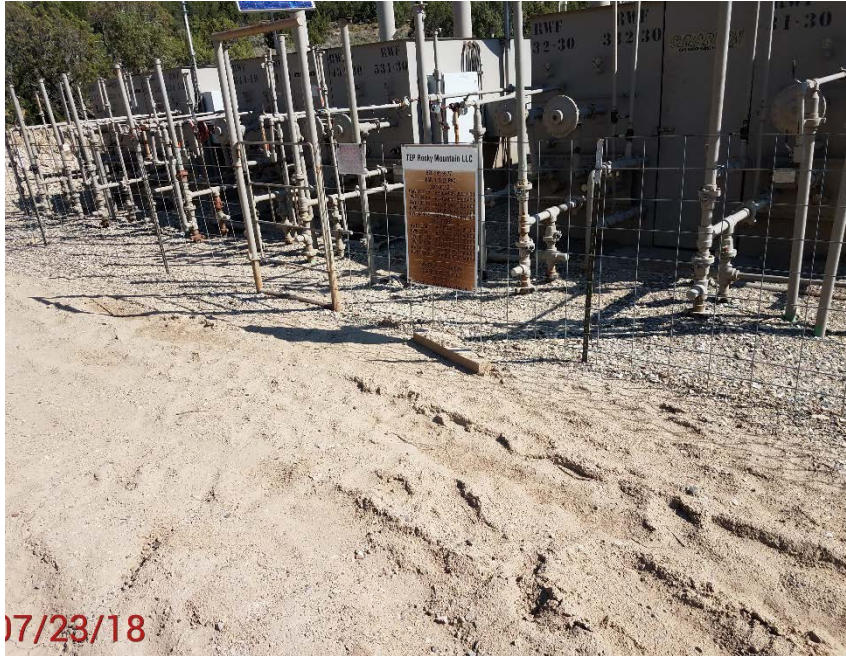
Location Photo #5, non legible battery sign

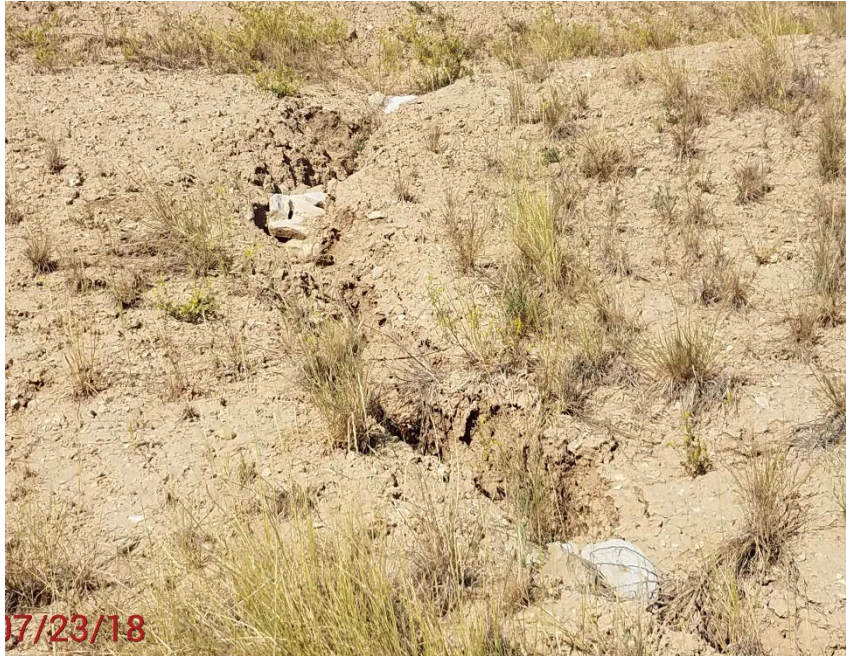
Location Photo #6, slope erosion in SW corner, midslope

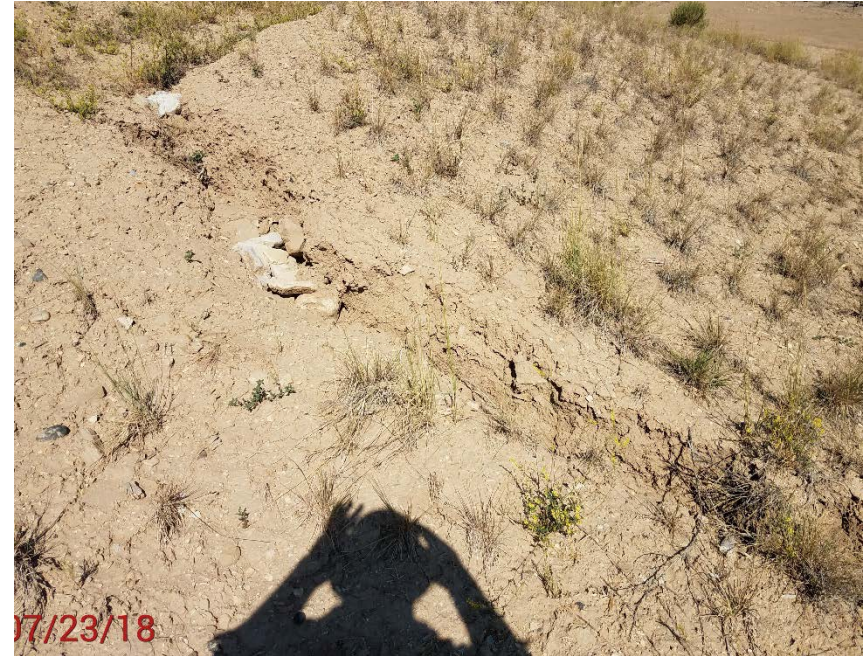
Location Photo #7, slope erosion in SW corner, midslope
