Inspection Photos
Location Name: USA Shaw 19
API: 05-081-60020

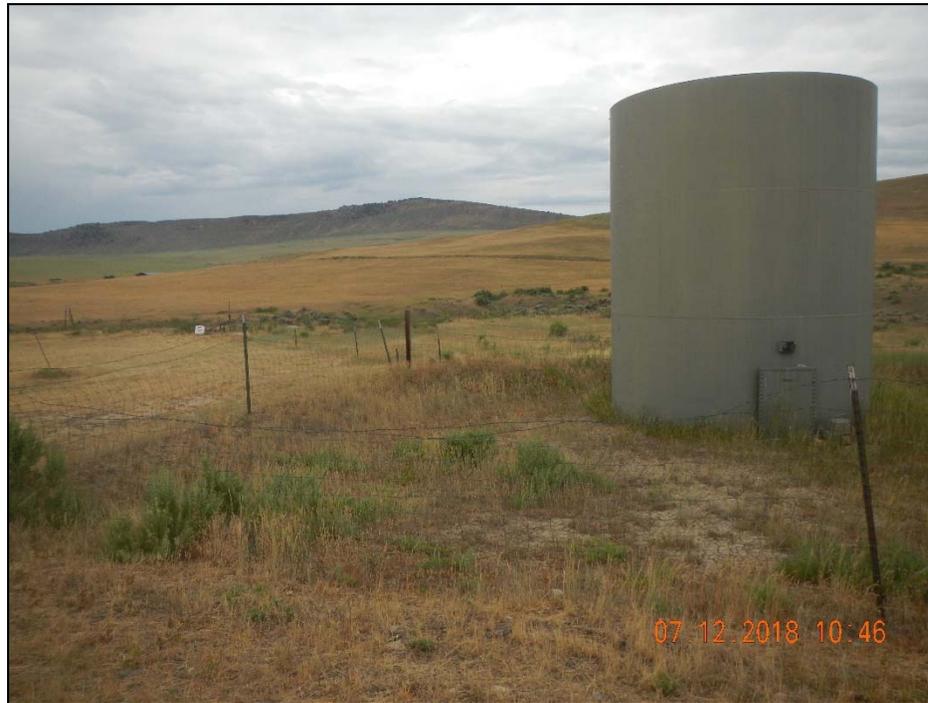
Photo 1. Overview of location taken at entrance facing southwest.

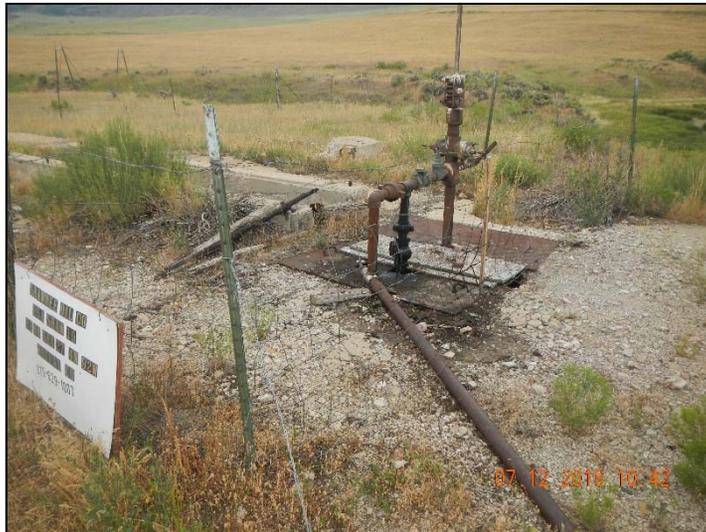
Photo 2. Wellhead. Oily bucket visible to left of wellhead.

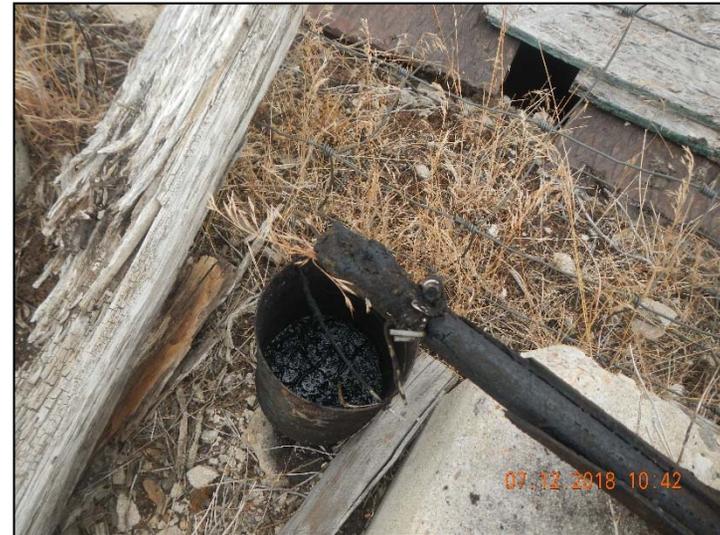
Photo 3. Close-up of oily bucket at wellhead.

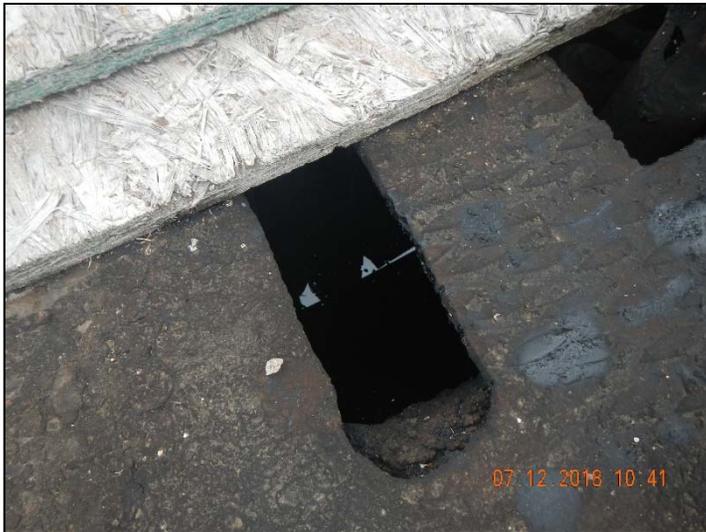
Photo 4. Fluid in cellar.

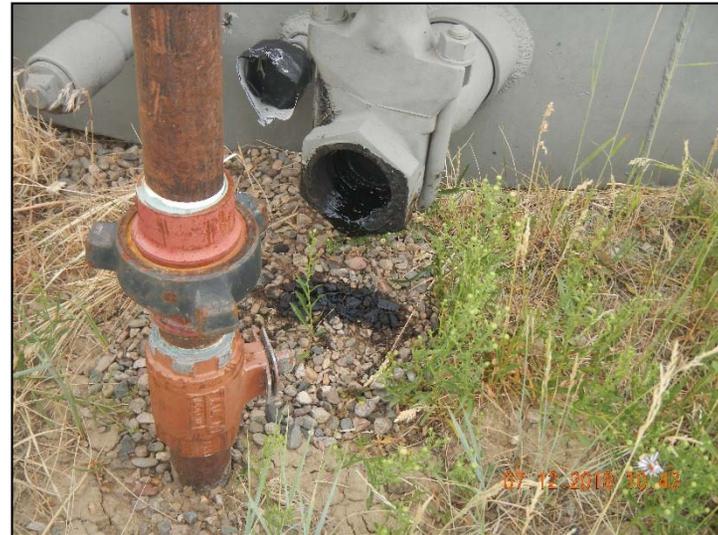
Photo 5. Stained gravel at loadout.
