Inspection Photos
Location Name: Dill Gulch 1-17
API: 05-107-06019

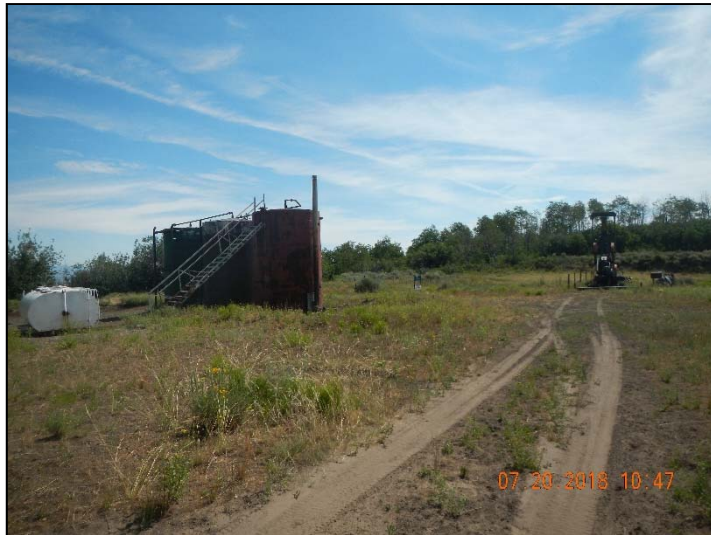
Photo 1. Overview of location taken at entrance facing northeast.

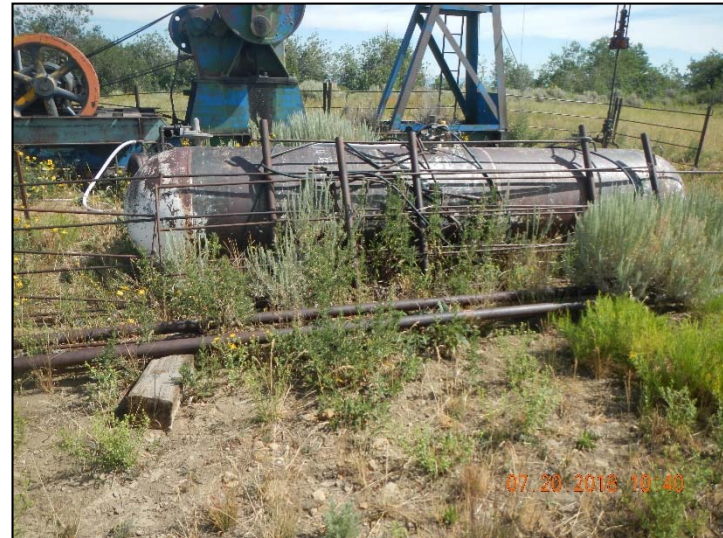
Photo 2. Tubing stored on location.

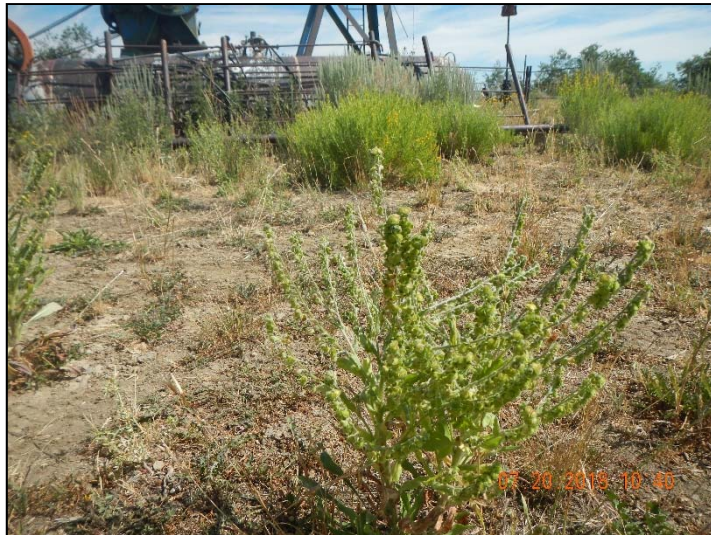
Photo 3. Noxious weeds on location.

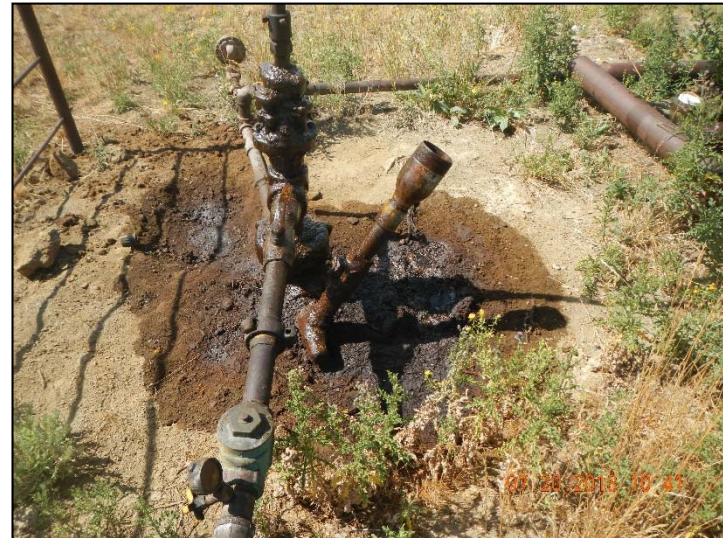
Photo 4. Stained soil at wellhead.

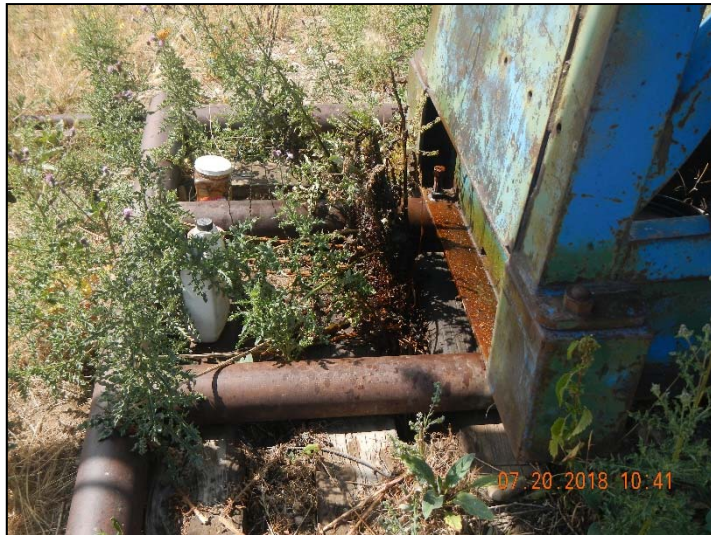
Photo 5. Stained soil at pumpjack base.

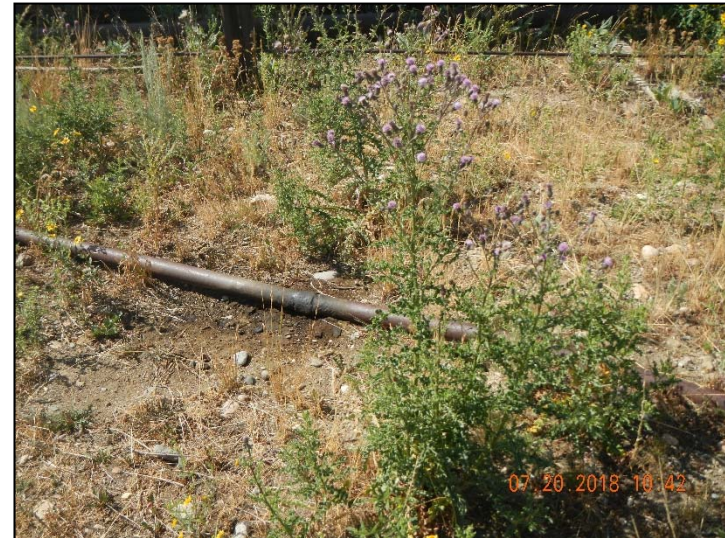
Photo 6. Stained soil and noxious weeds at flowline connection.

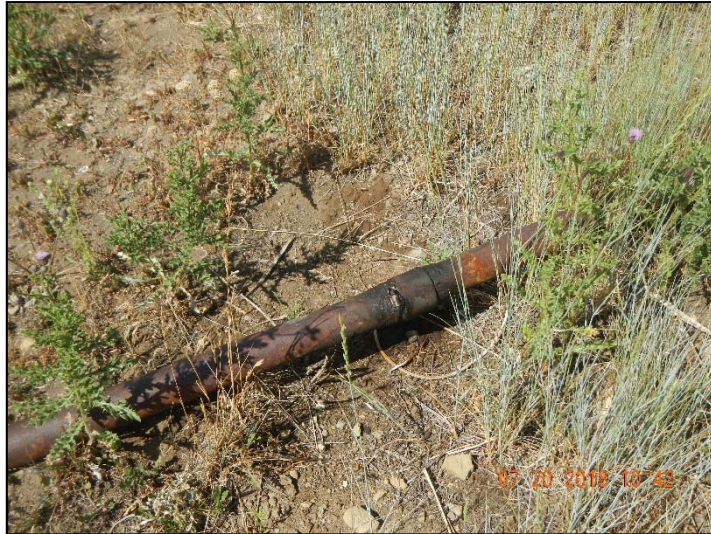
Photo 7. Stained soil and noxious weeds at flowline fitting.

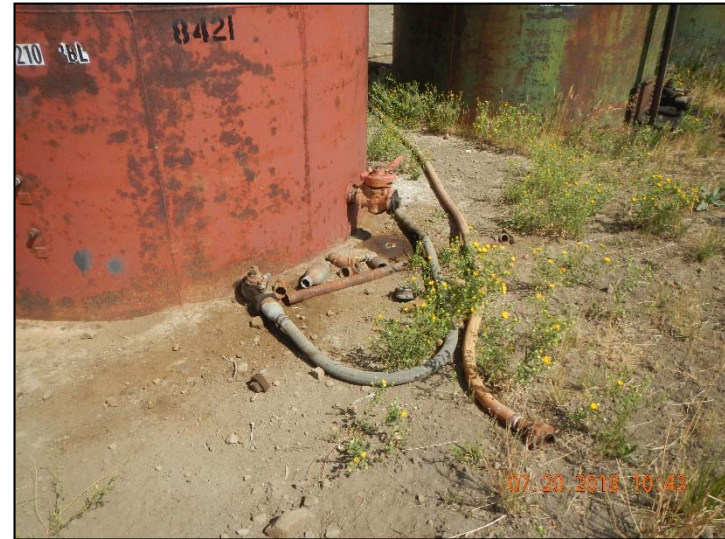
Photo 8. Stained soil at tank base.

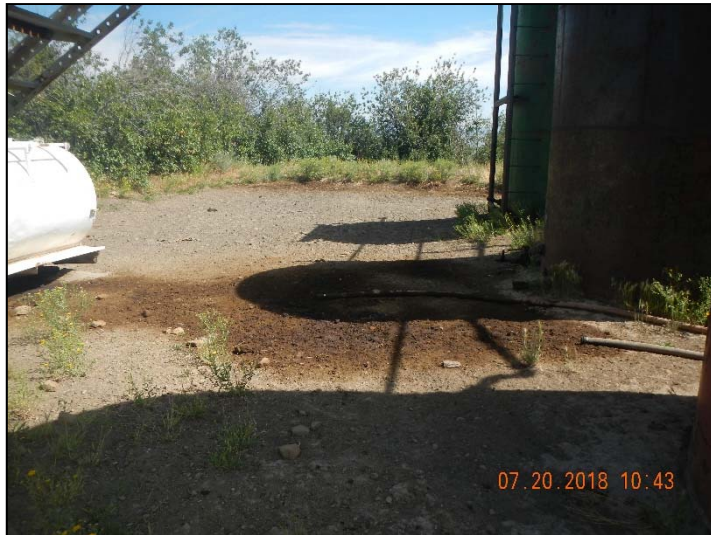
Photo 9. Stained soil in tank berm.

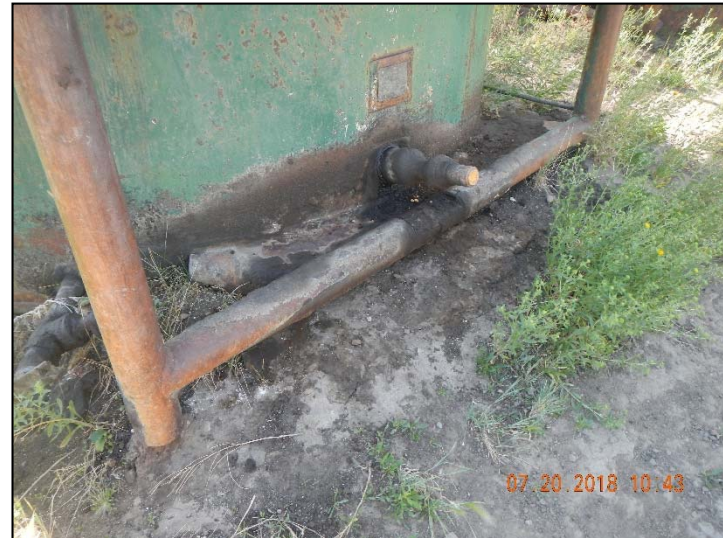
Photo 10. Stained soil at tank base.

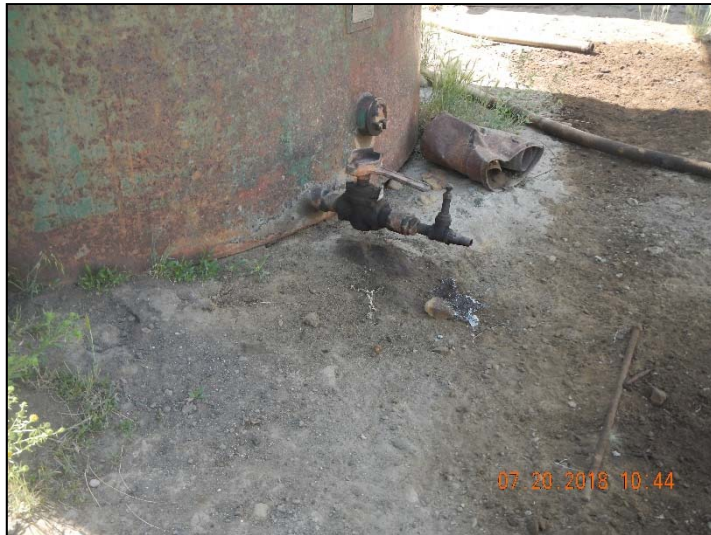
Photo 11. Stained soil at tank base.

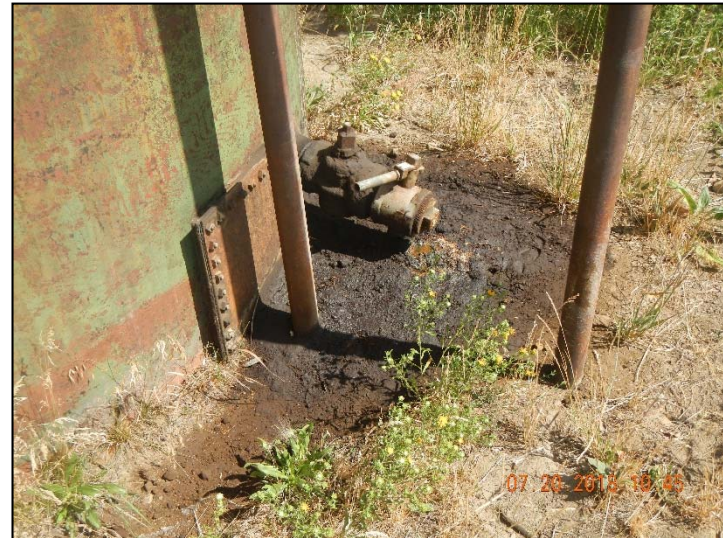
Photo 12. Stained soil at tank base.

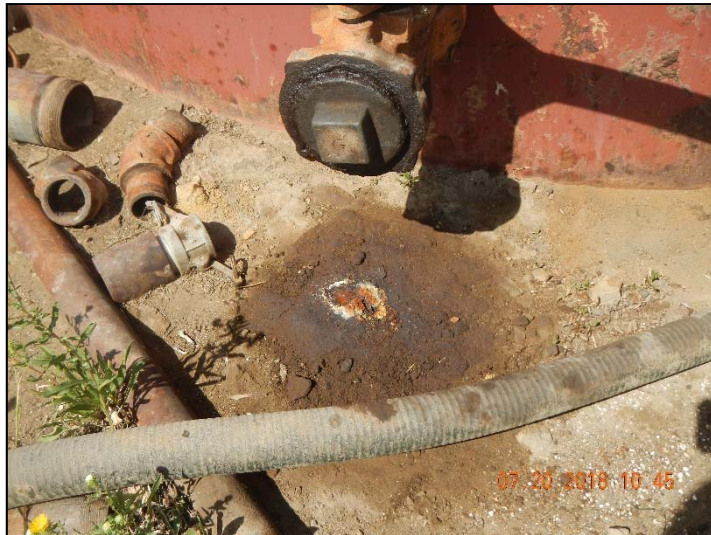
Photo 13. Stained soil at tank base.

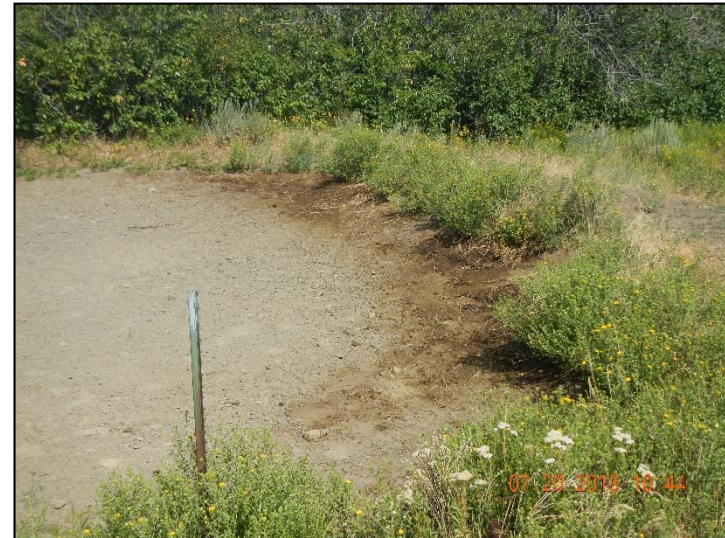
Photo 14. Stained soil on tank berm perimeter.
