TR 513-26-597
API# 05-045-18339
Inspection# 689701671

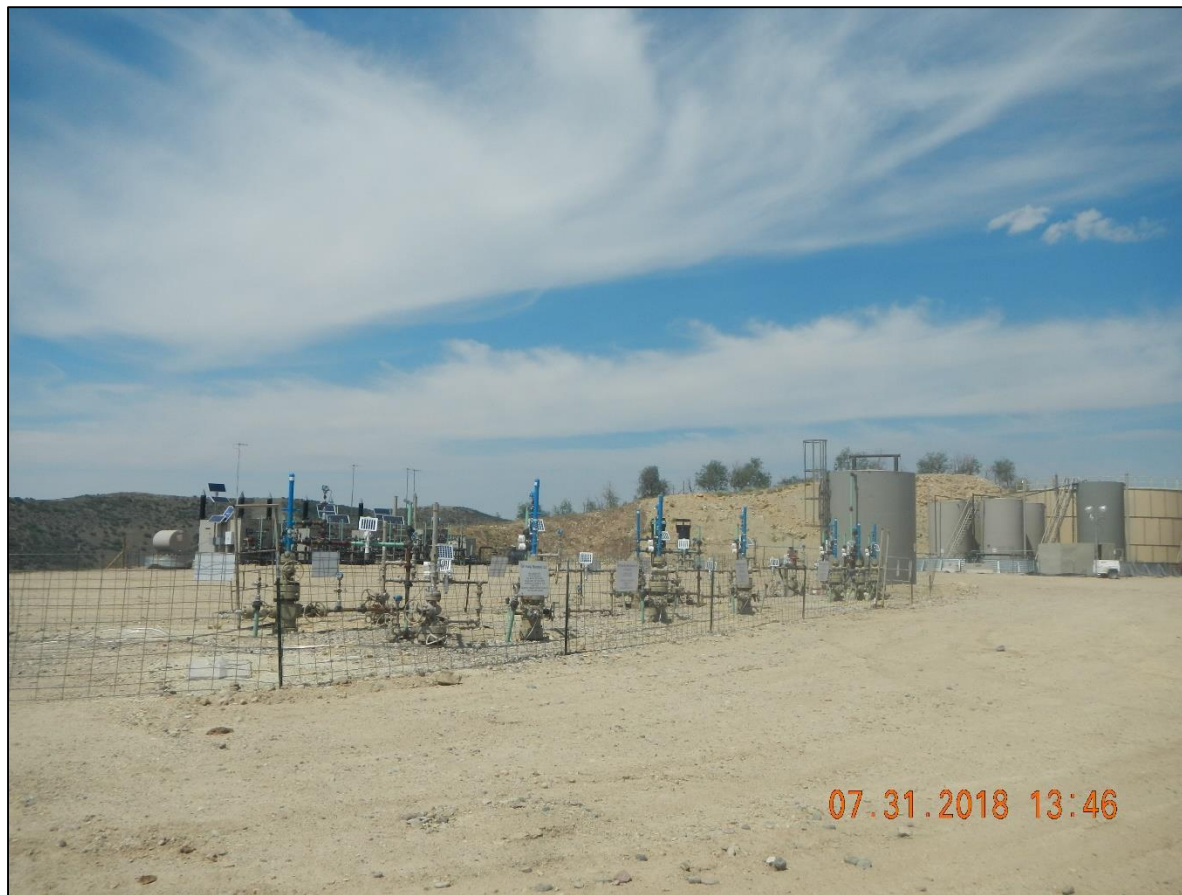
Location photo.

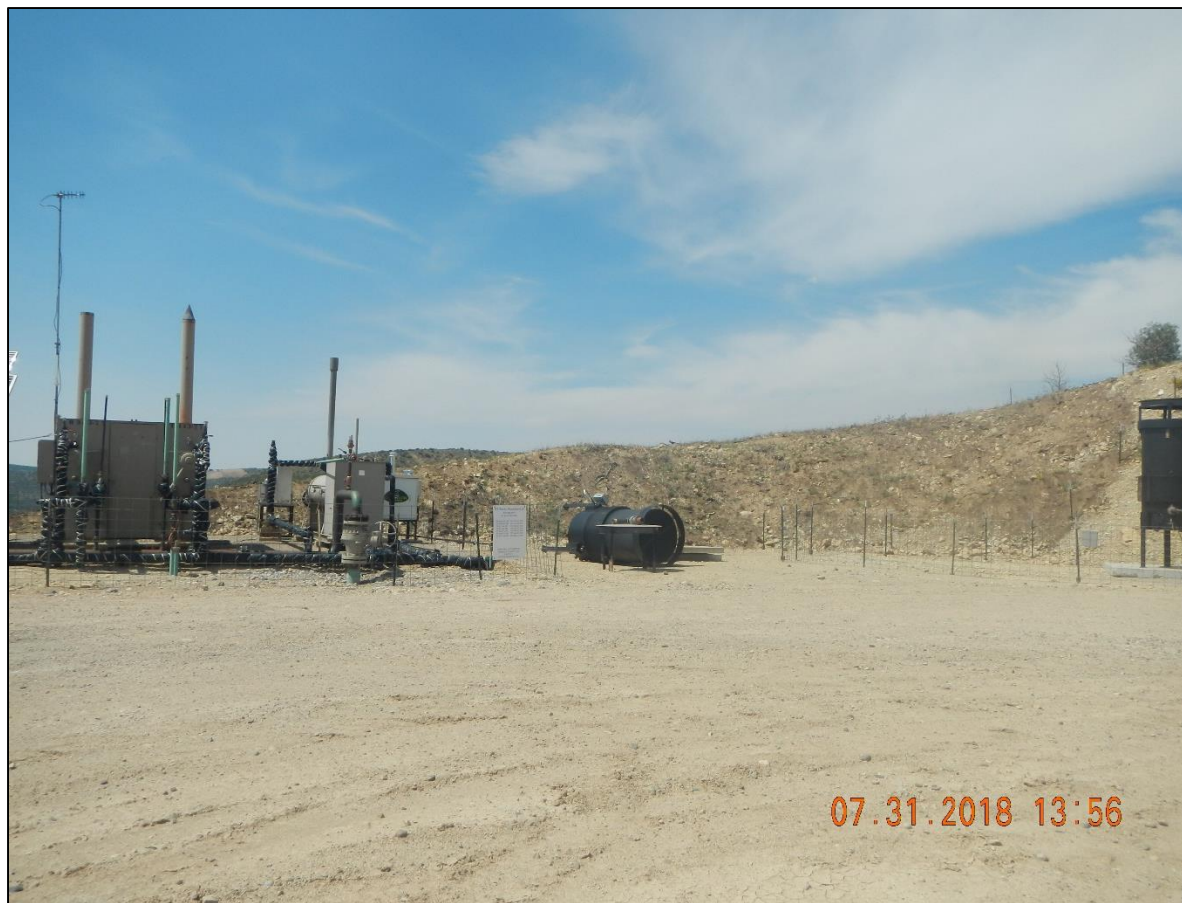
Unused equipment.

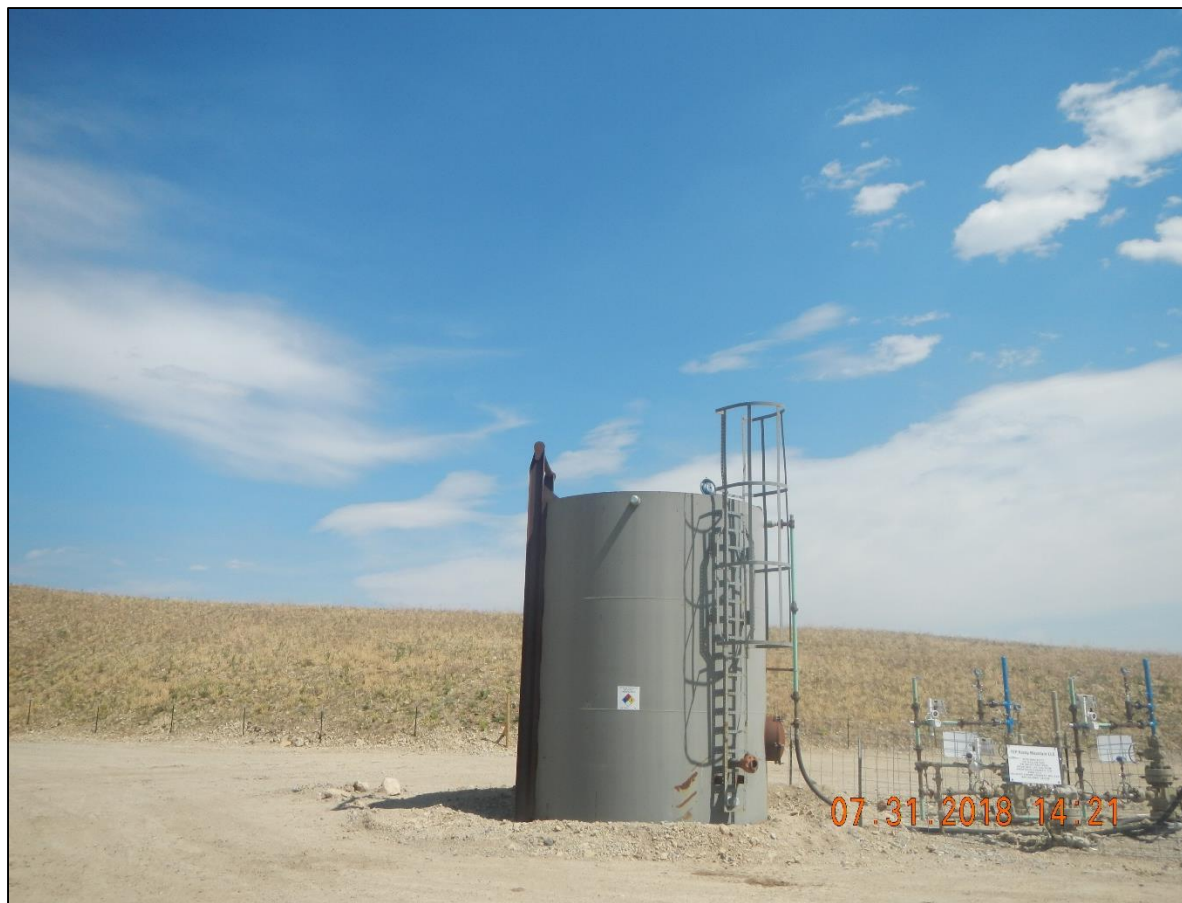
Tank thief hatch is open. Berm has been knocked down.

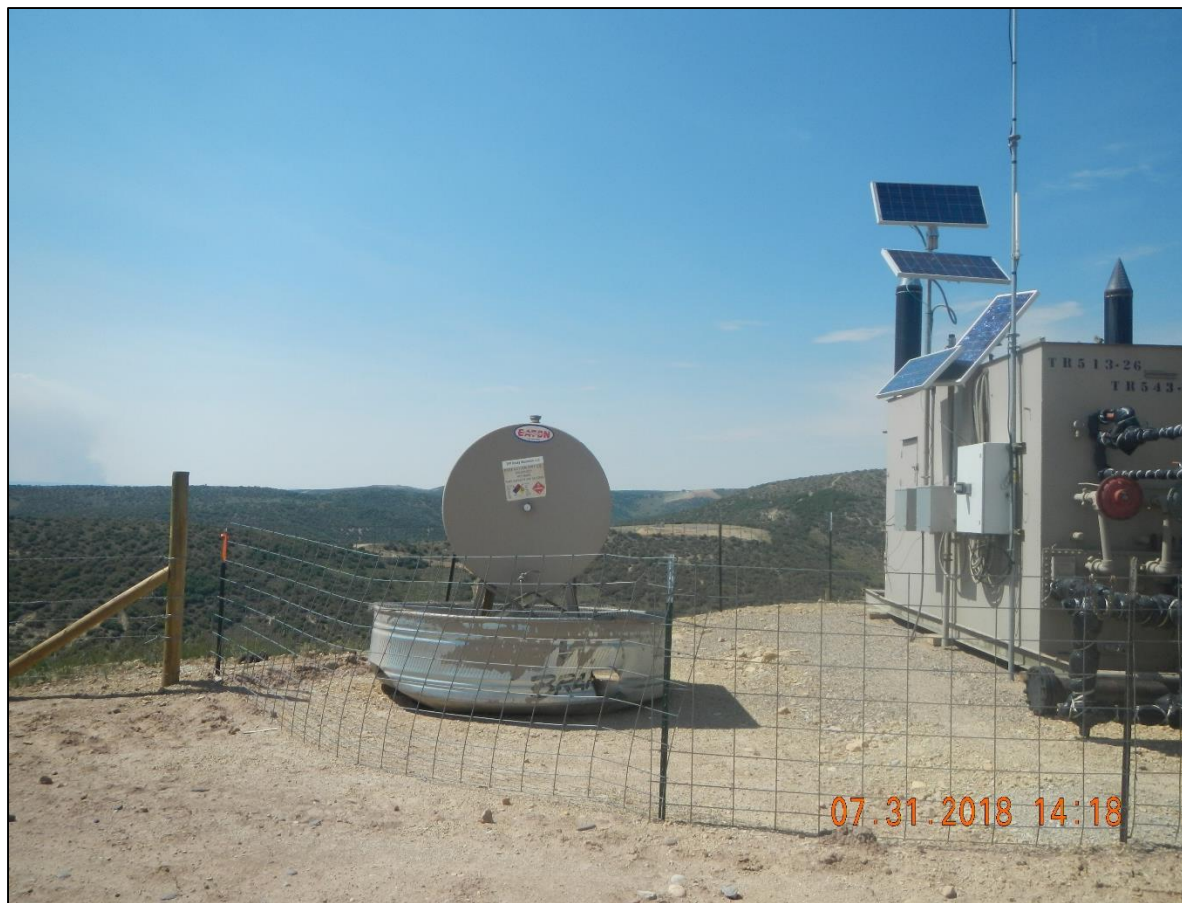
Metal secondary containment is damaged.

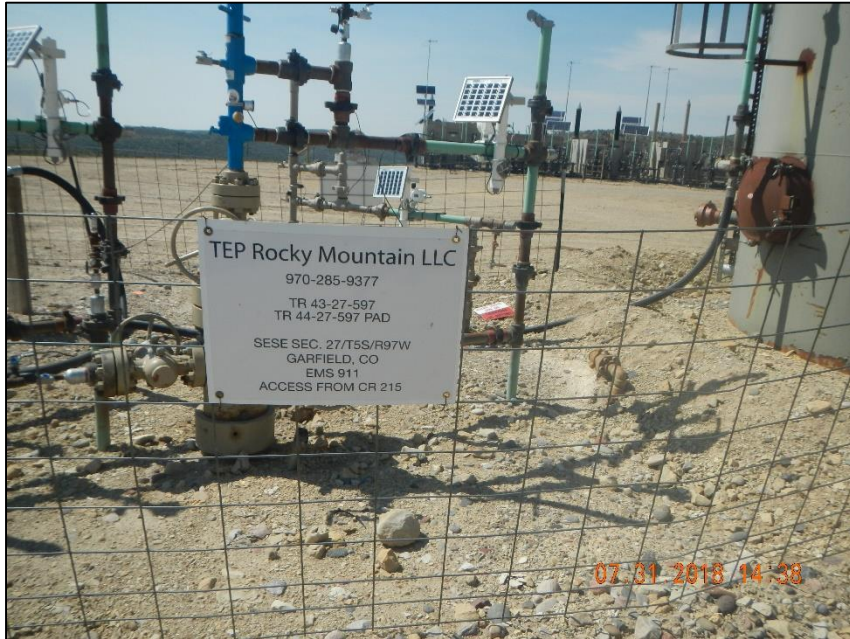
Unused 2" riser at TR 43-27-597

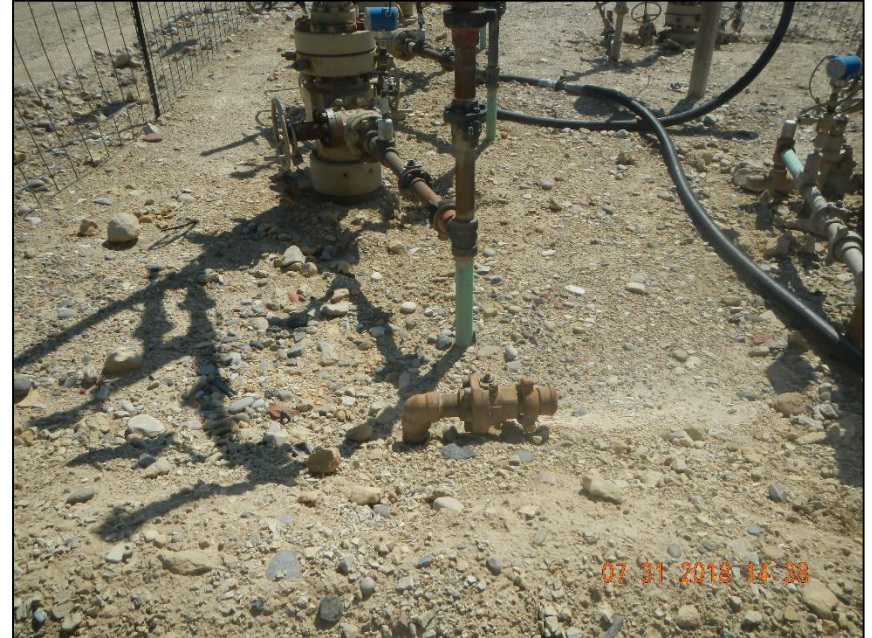
Unused 2" riser.
