Inspection Photos

07/31/2018

Operator: WESTERN OPERATING COMPANY -
95620

Inspection Doc. Number: 682503670
Logan County, CO

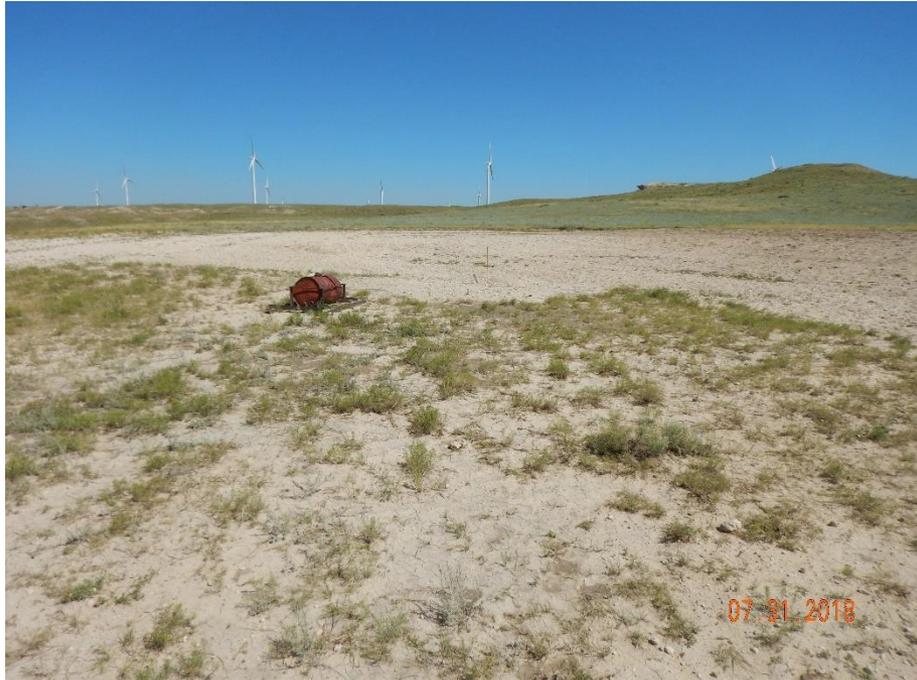
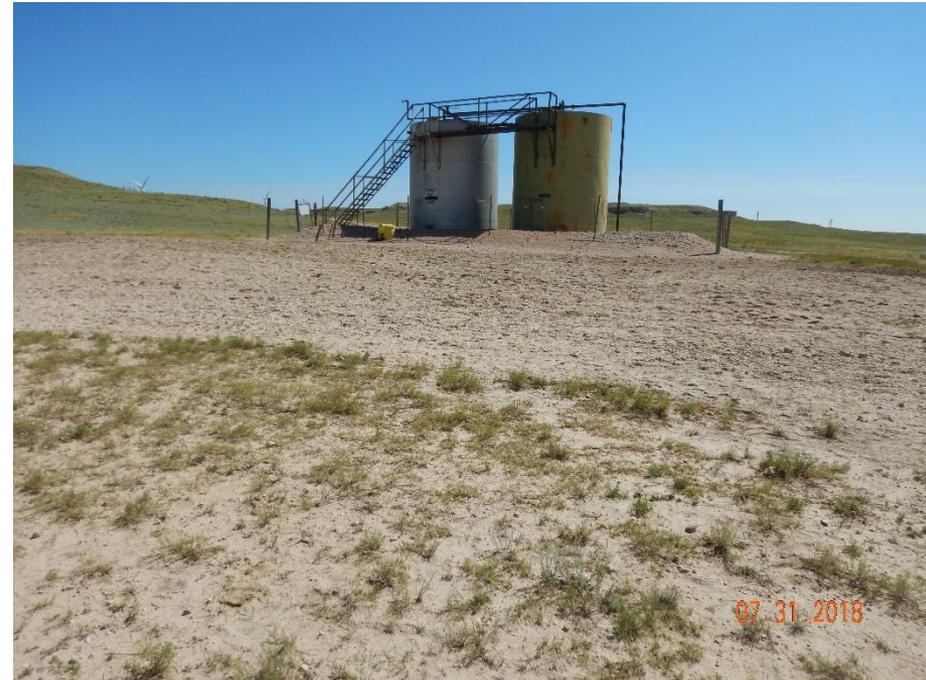
Photo 1: Photos 1-2 taken from the northeast end of the pumpjack, facing northeast to east. Photos show interim areas of the location have been regraded and appears to have been reseeded. However, no stabilization or stormwater and erosion control BMPs have been installed per the corrective actions.

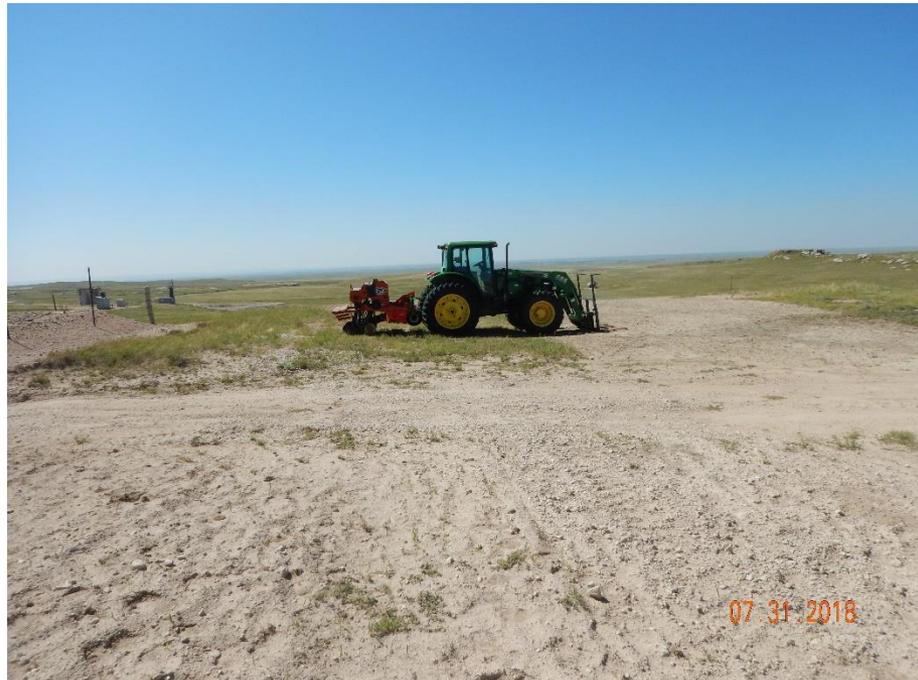
Photo 3: Photo taken from the central area of the location facing south. Photo shows tractor and seeding equipment on location.

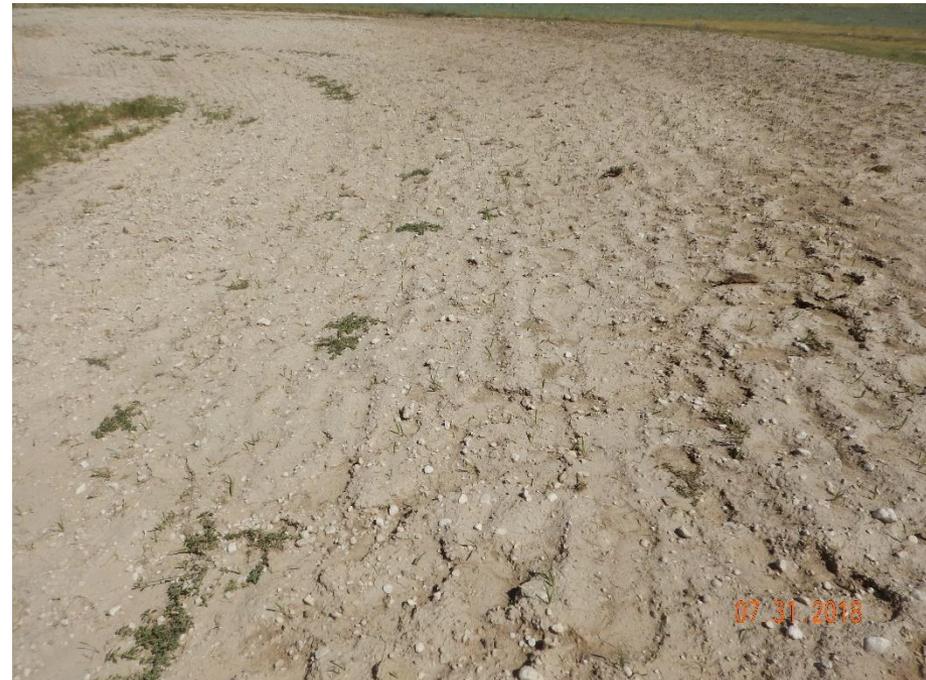
Photo 4: Photo taken from the central interim areas of the location (see photos 1-2). Photos show interim areas of the location have been regraded and appears to have been reseeded. However, no stabilization or stormwater and erosion control BMPs have been installed per the corrective actions.

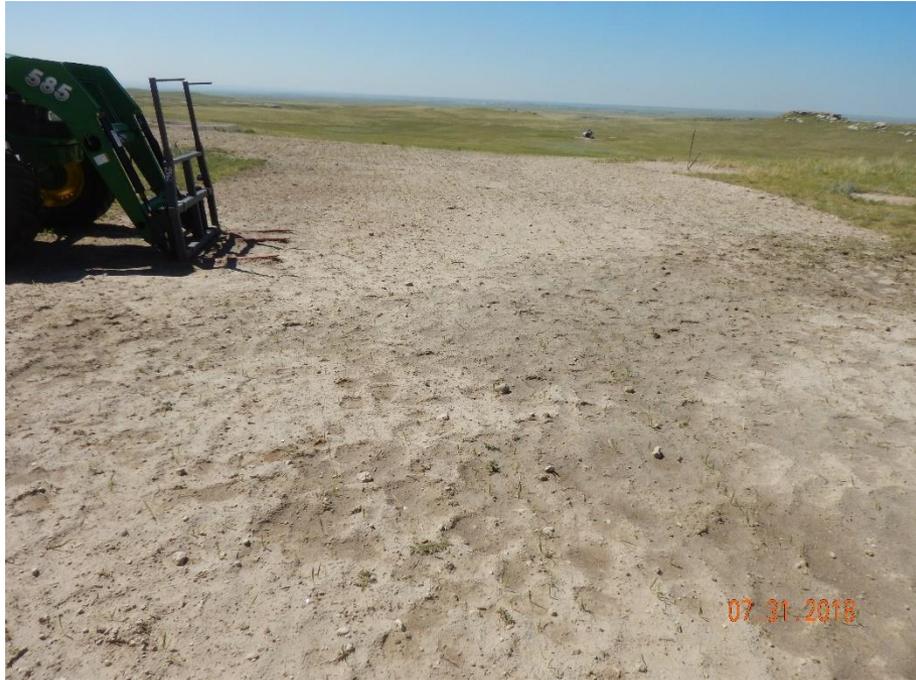
Photo 5: Photo taken from the south end of the location, facing south. Photos show interim areas of the location have been regraded and appears to have been reseeded. However, no stabilization or stormwater and erosion control BMPs have been installed per the corrective actions.

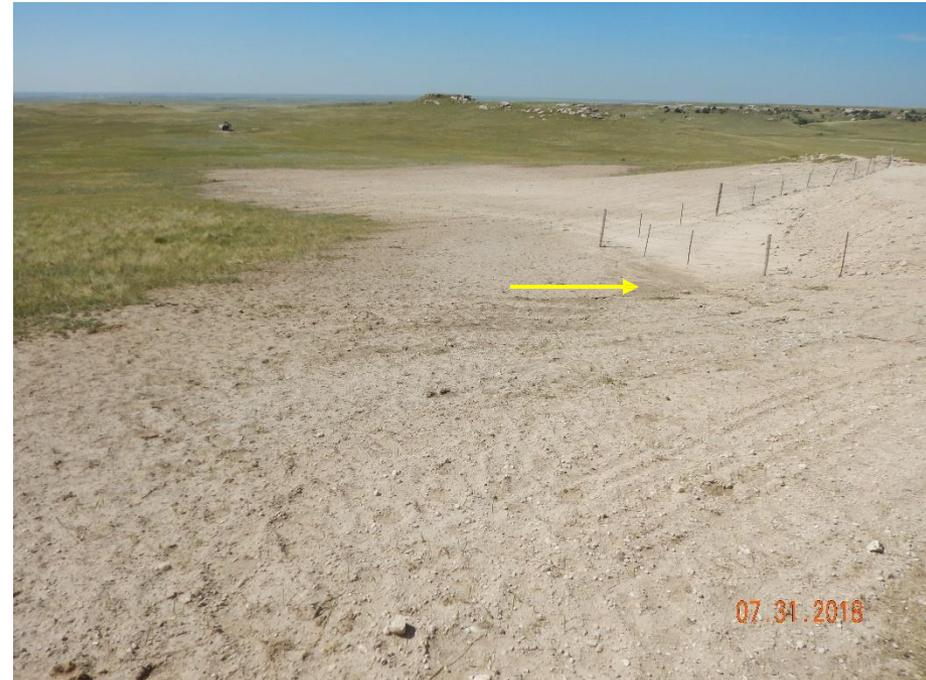
Photo 6: Photo taken from the south end of the location, facing southwest. Photos show interim areas of the south and east of the pit have been regraded and appears to have been reseeded. However, no stabilization or stormwater and erosion control BMPs have been installed per the corrective actions. Photos show erosion degradation has been allowed to continue on the slope.

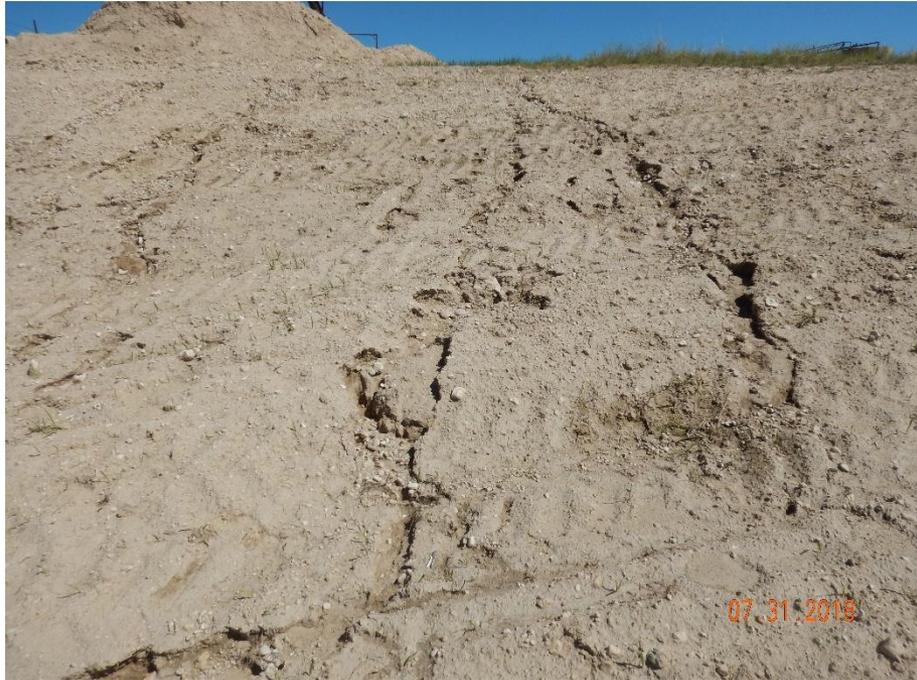
Photo 7: Continued from photo 6. Photo taken from the slopes east of the pit, facing south. Photo shows operator appears to have regraded and reseeded the disturbance areas. However, no stabilization or stormwater and erosion control BMPs have been installed per the corrective actions. Photos show erosion degradation has been allowed to continue on the slope.

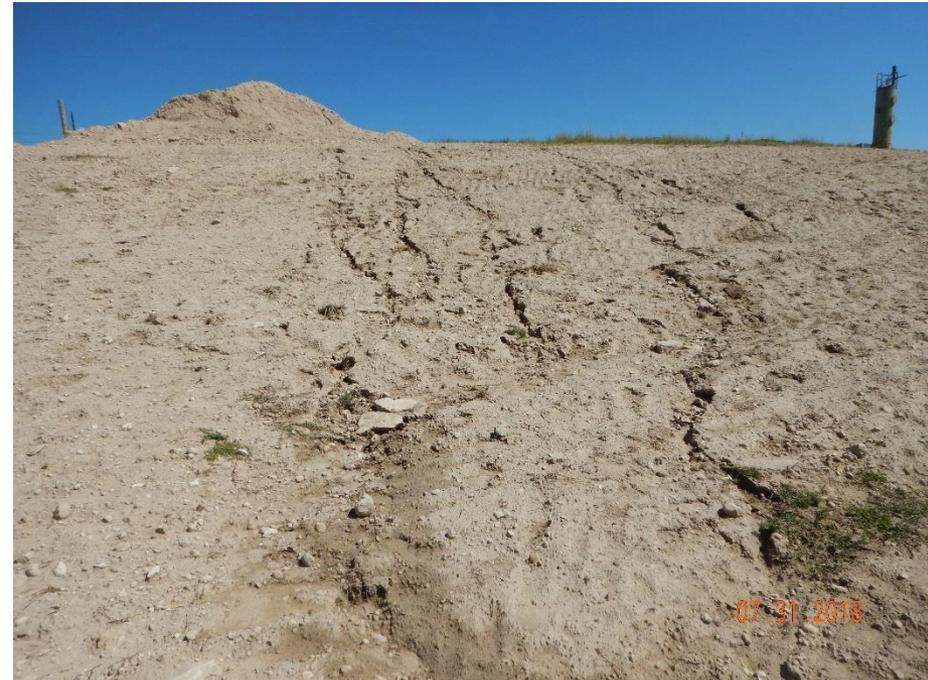
Photo 8: See comments under photo 7.

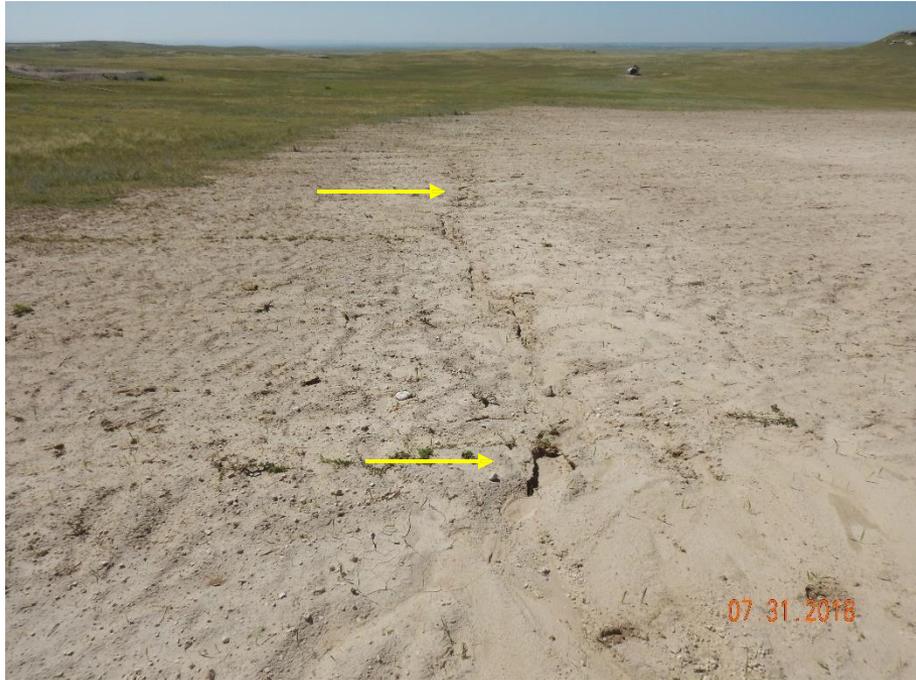
Photo 9: Photo taken from the southeast corner of the pit, facing south. See comments under photo 7.

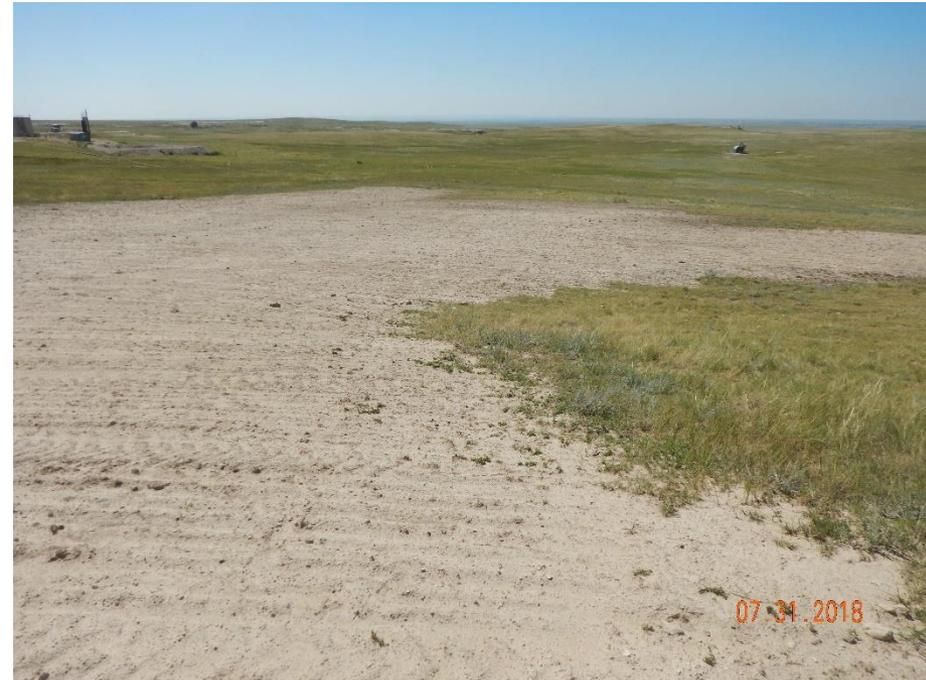
Photo 10: Photo taken from the southwest corner of the pit, facing south. Photos show interim areas of the south and east of the pit have been regraded and appears to have been reseeded. However, no stabilization or stormwater and erosion control BMPs have been installed per the corrective actions

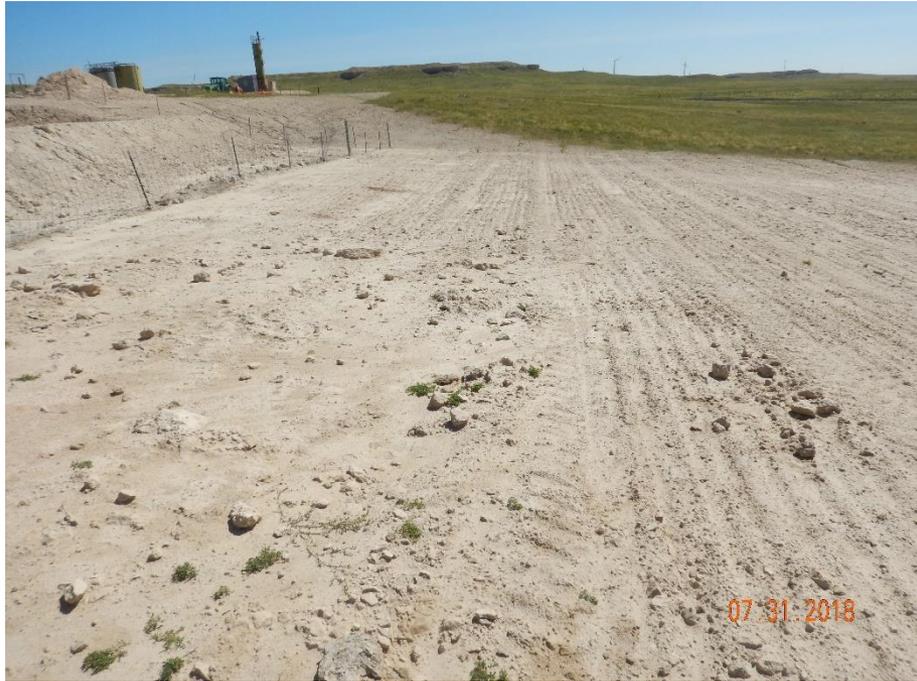
Photo 11: Photo taken from the southwest corner of the pit, facing south. Photos show interim areas of the south and east of the pit have been regraded and appears to have been reseeded. However, no stabilization or stormwater and erosion control BMPs have been installed per the corrective actions

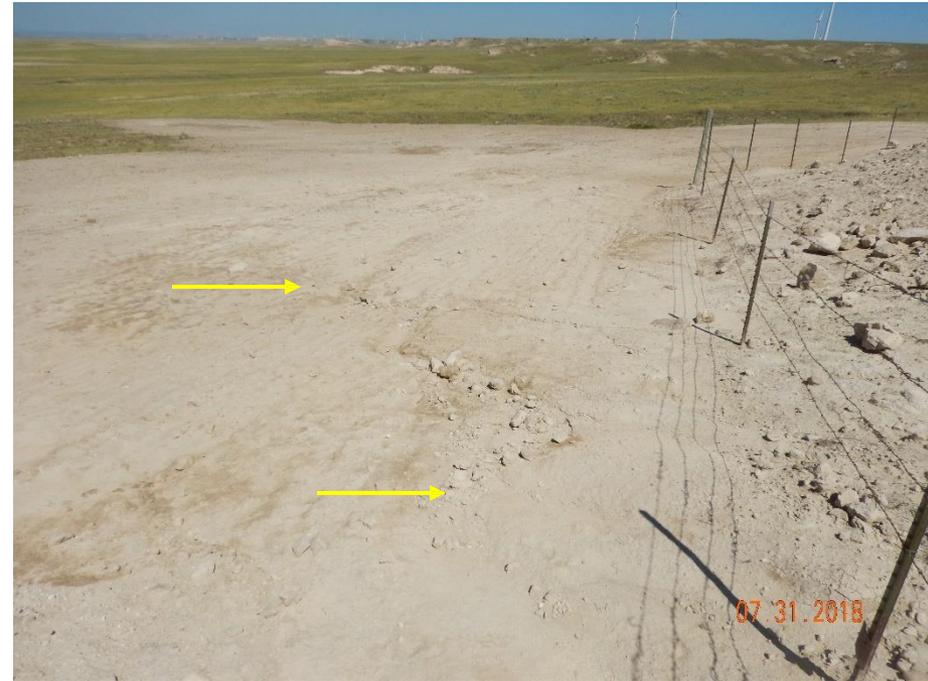
Photo 12: Photo taken from the southwest corner of the pit, facing north. See comments under photo 7.

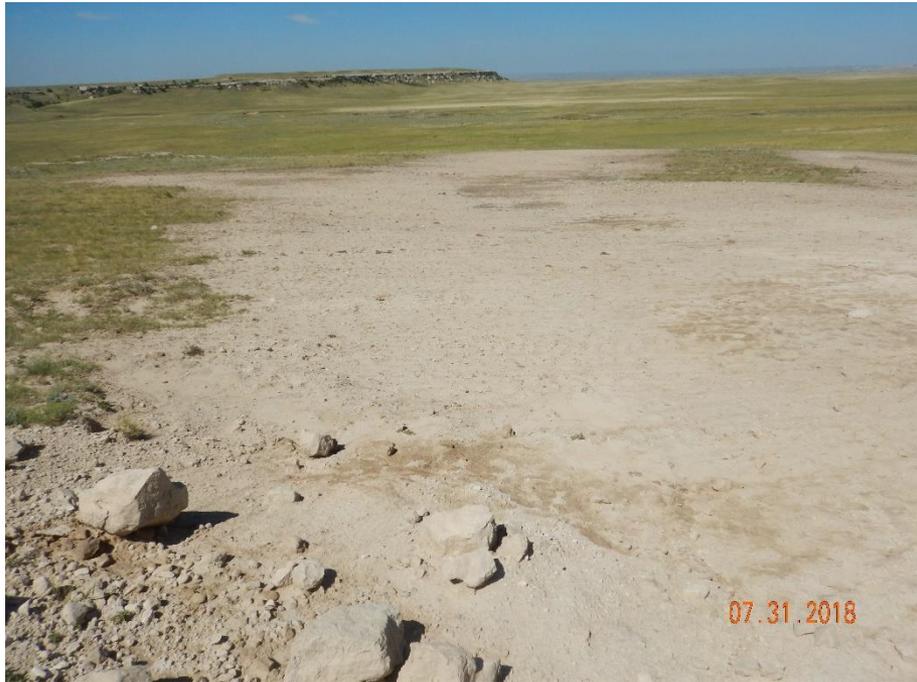
Photo 13: Photo taken from the southwest corner of the pit, facing west. Photos show interim areas of the south and east of the pit have been regraded and appears to have been reseeded. However, no stabilization or stormwater and erosion control BMPs have been installed per the corrective actions

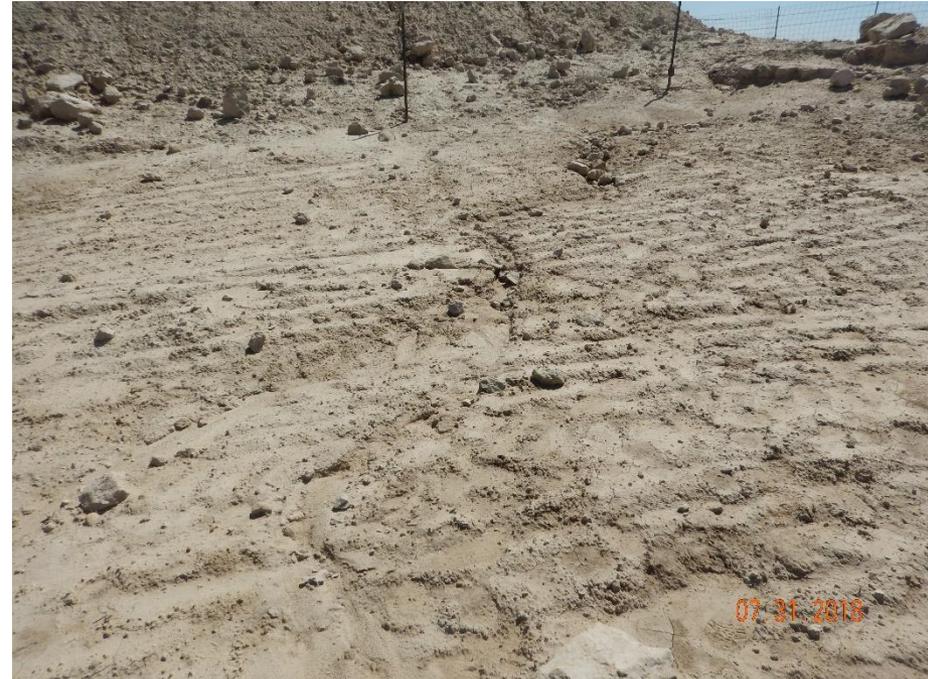
Photo 14: Photo shows operator appears to have regraded and reseeded the disturbance areas. However, no stabilization or stormwater and erosion control BMPs have been installed per the corrective actions. Photos show erosion degradation has been allowed to re-occur on the slope.

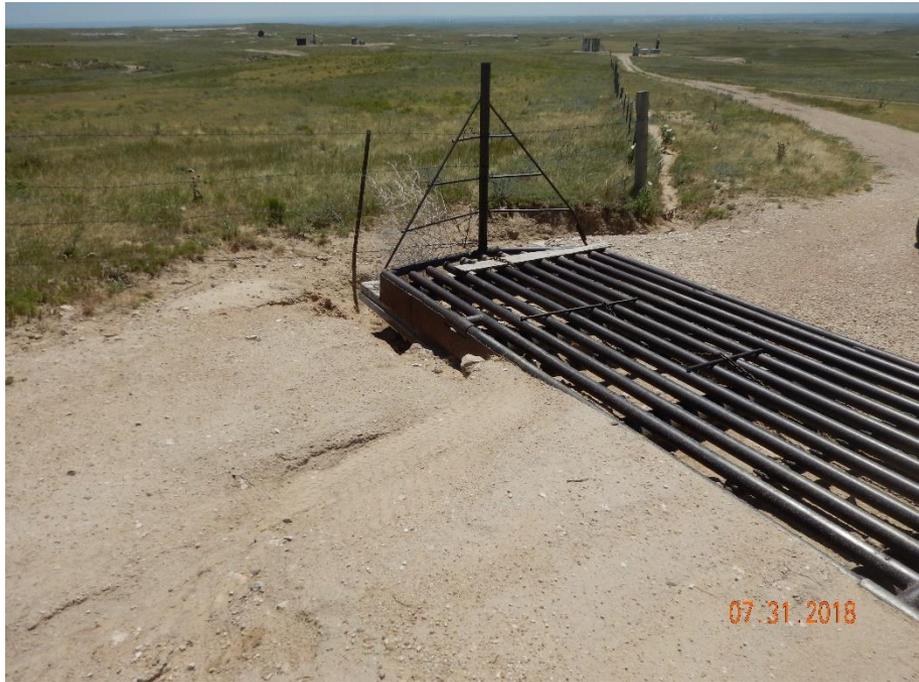
Photo 15: Photo taken from the access road gate, north of the location facing south. Photo shows stormwater erosion has cut underneath the cattle guard. This needs to be repaired and stabilized.

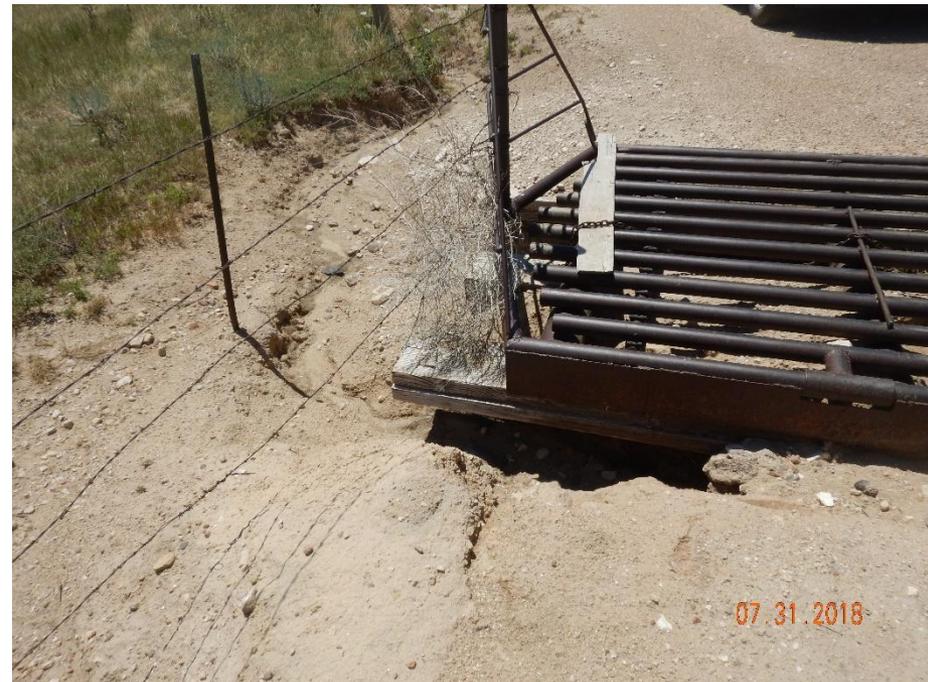
Photo 16: Photo taken from the access road gate, north of the location facing south. Photo shows stormwater erosion has cut underneath the cattle guard. This needs to be repaired and stabilized.
