# Inspection Photos

Operator: WESTERN OPERATING COMPANY -  
95620

Location ID: 312291

Inspection Doc. Number: 682503672  
Logan County, CO

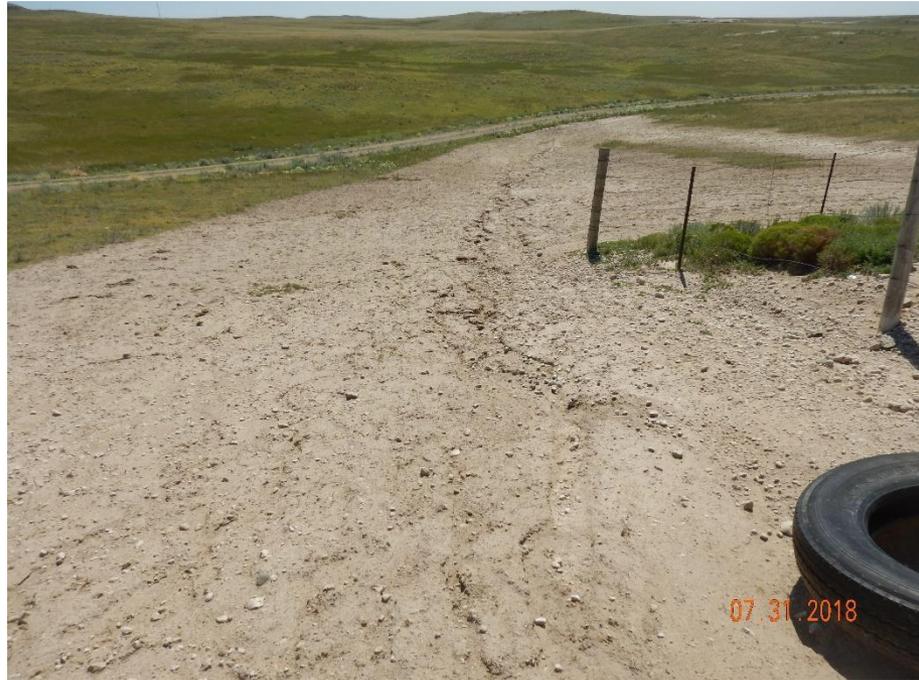
**Photo 1:** Photos 1-2 taken from the northeast end of the pit, facing east. Photos show interim areas of the location have been regraded and appears to have been reseeded. However, no stabilization, or stormwater and erosion control BMPs have been installed per the corrective actions. Photos show erosion degradation has been allowed to continue on the slope.

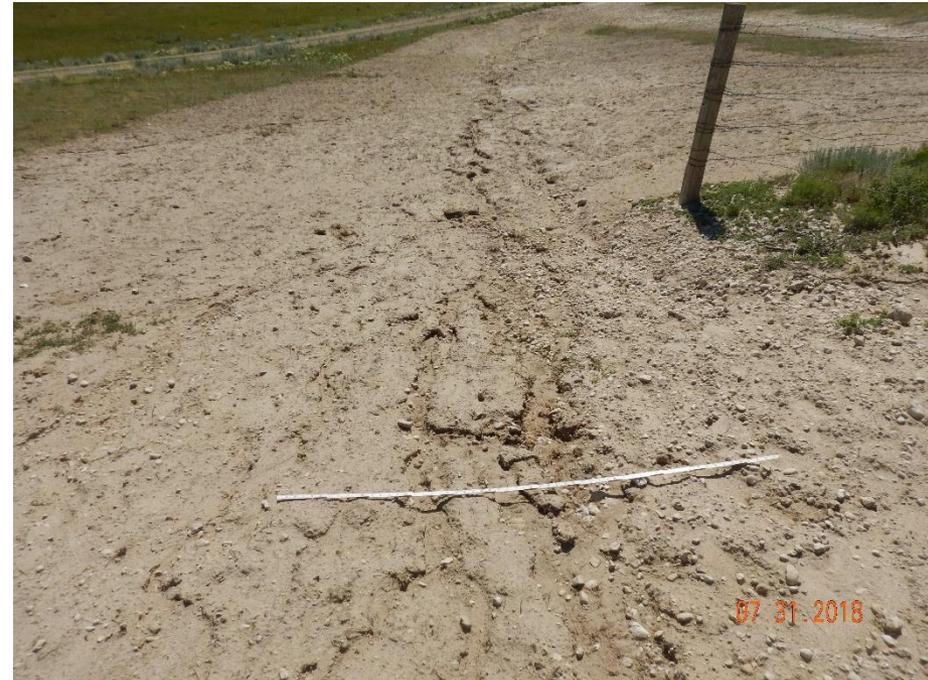
**Photo 2:** 6 foot measuring stick for reference.

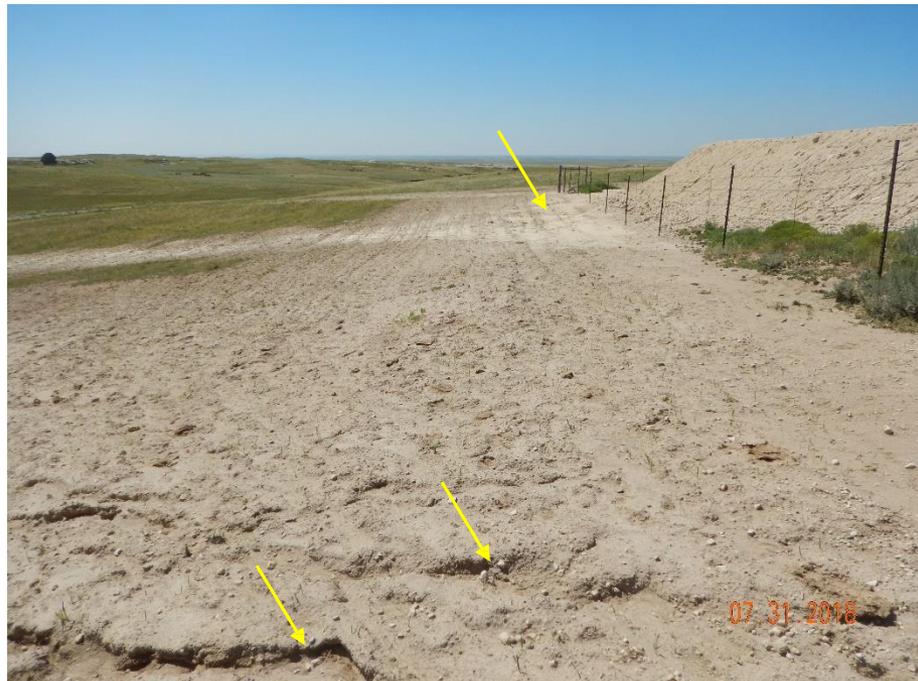
**Photo 3:** Photo taken from the northeast corner of the pit, facing south. Photos show interim areas of the location have been regraded and appears to have been reseeded. However, no stabilization, or stormwater and erosion control BMPs have been installed per the corrective actions. Photos show erosion degradation has been allowed to continue on the slope.

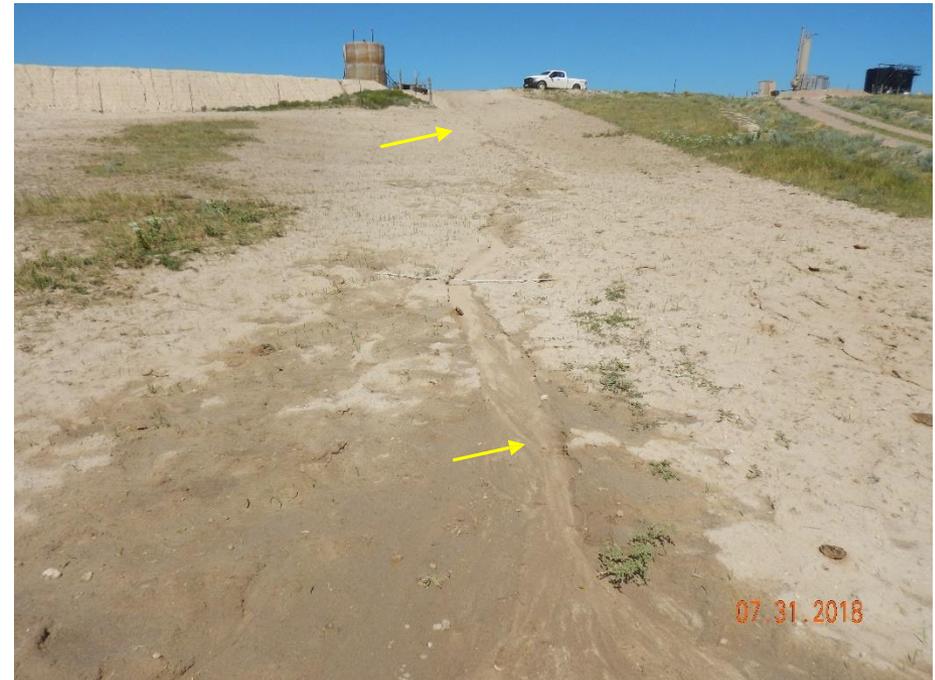
**Photo 4:** Photo taken from east of the pit, facing northwest. See comments under photo 3.

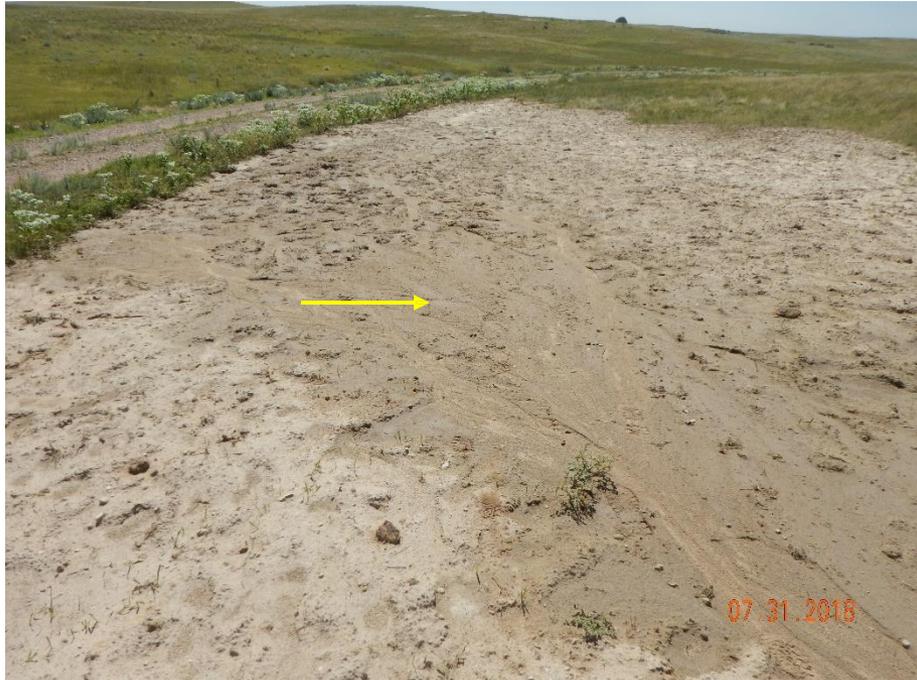
**Photo 5:** Continued from photo 4. Photo shows sediment deposition caused by stormwater erosion from the slopes.

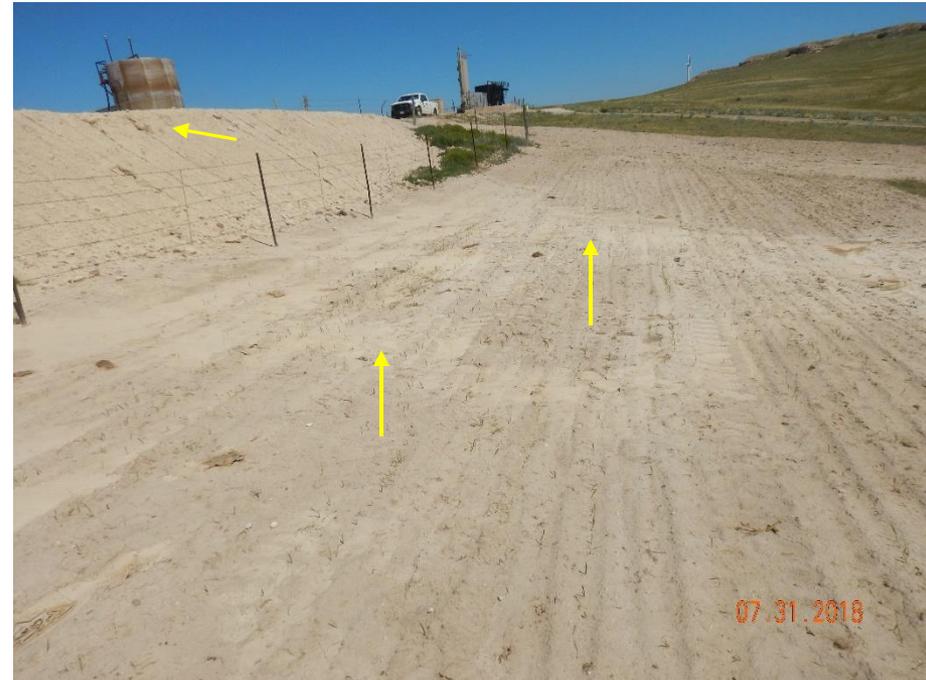
**Photo 6:** Photo taken from the east end of the pit, facing north. See comments under photo 3.

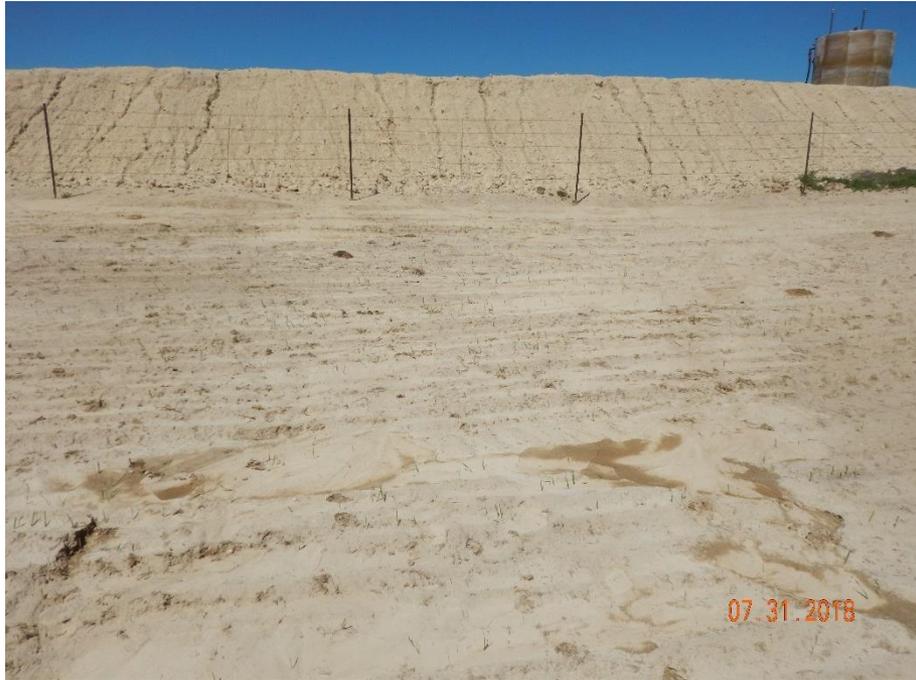
**Photo 7:** Photo taken from the east end of the pit, facing west. See comments under photo 3.

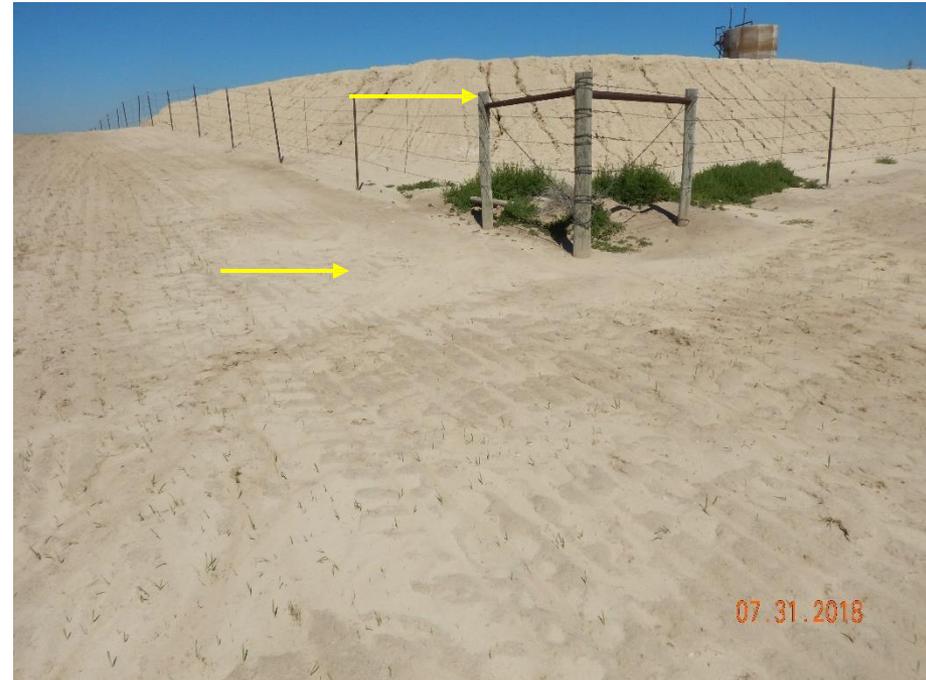
**Photo 8:** Photo taken from the southeast end of the pit, facing north west. Photo shows erosion degradation has continued from the pit with sediment being transported off location and onto the interim areas. Additionally, interim areas of the location have been regraded and appears to have been reseeded. However, no stabilization, or stormwater and erosion control BMPs have been installed per the corrective actions. Photos show erosion degradation has been allowed to continue on the slopes.

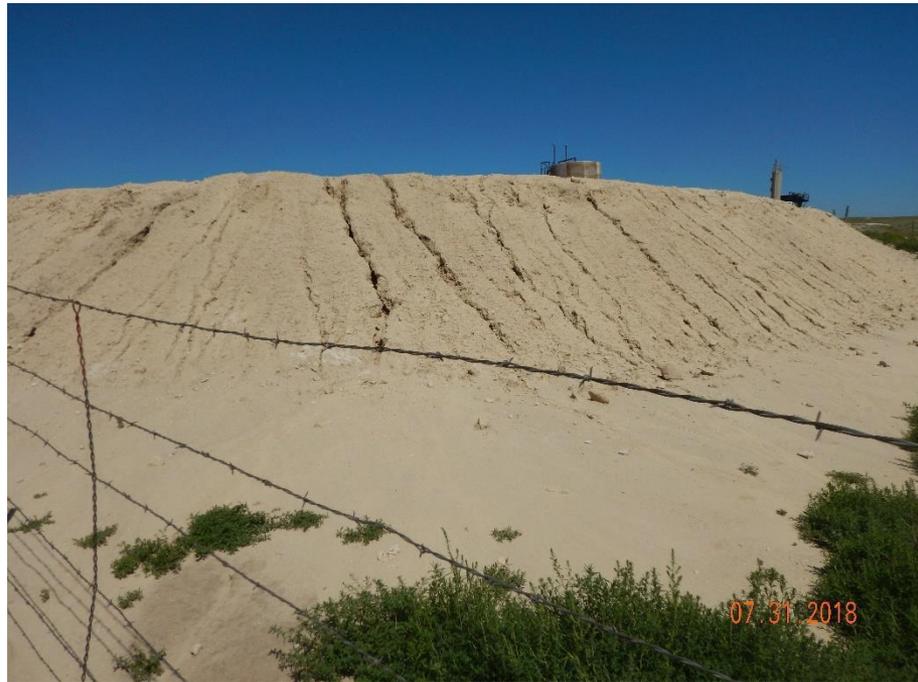
**Photo 9:** See photo 8.

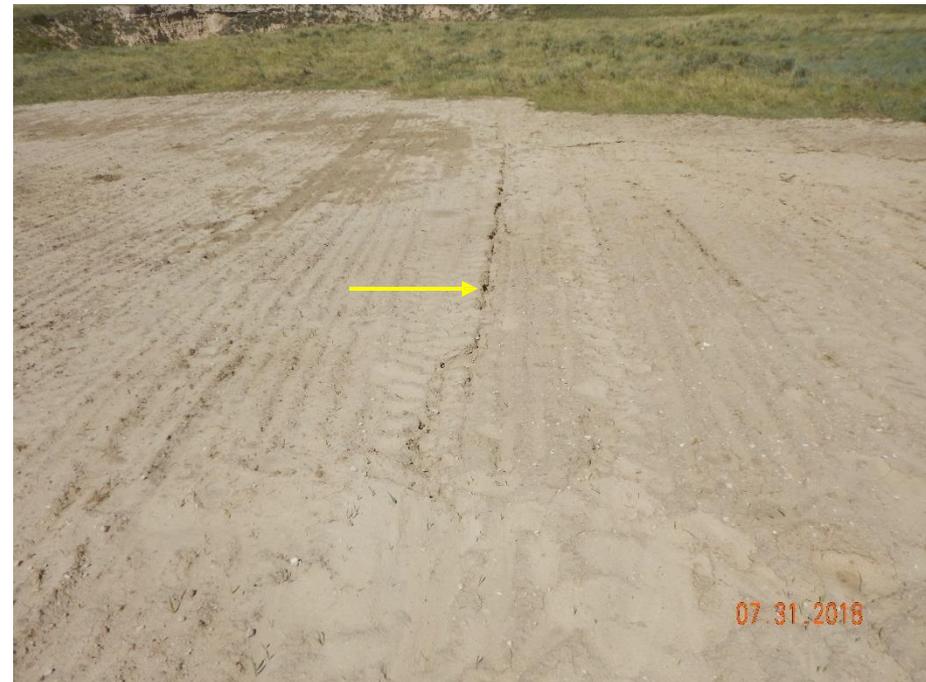
**Photo 10:** Photo taken from the southwest corner of the pit, facing west. Photo show interim areas of the location have been regraded and appears to have been reseeded. However, no stabilization, or stormwater and erosion control BMPs have been installed per the corrective actions. Photo show erosion degradation has been allowed to continue on the slope.

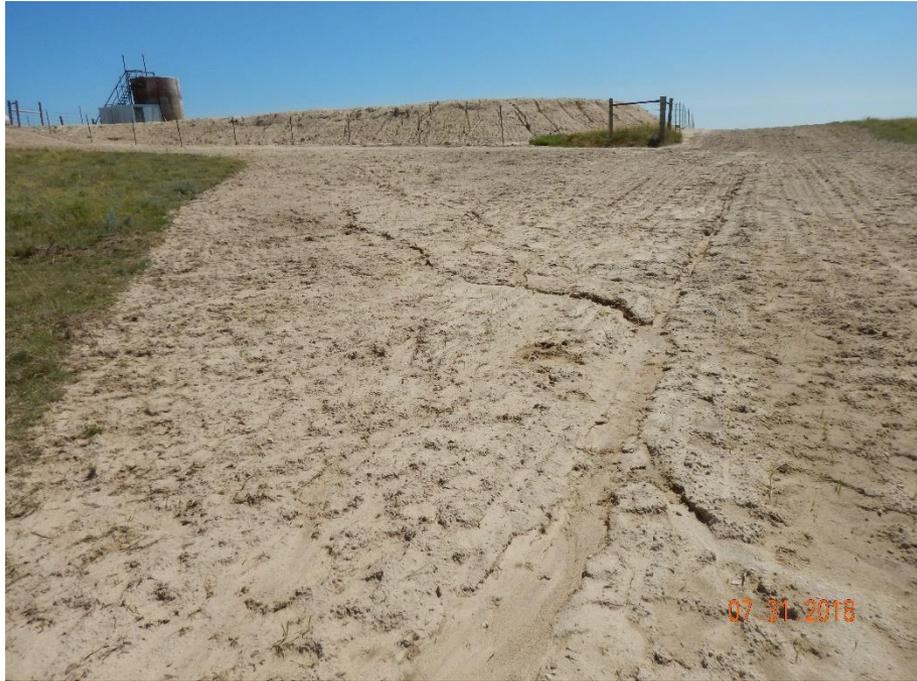
**Photo 11:** Photo taken from the southwest of the pit, facing northeast. See comments under photo 10.

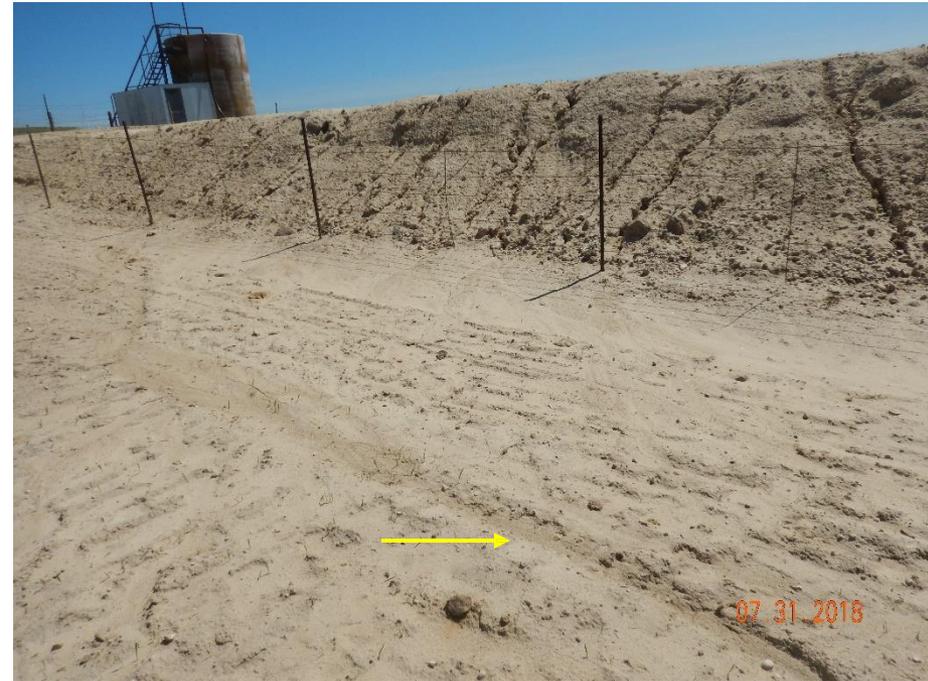
**Photo 12:** Photo taken from the west end of the pit, facing northeast. See comments under photo 10.

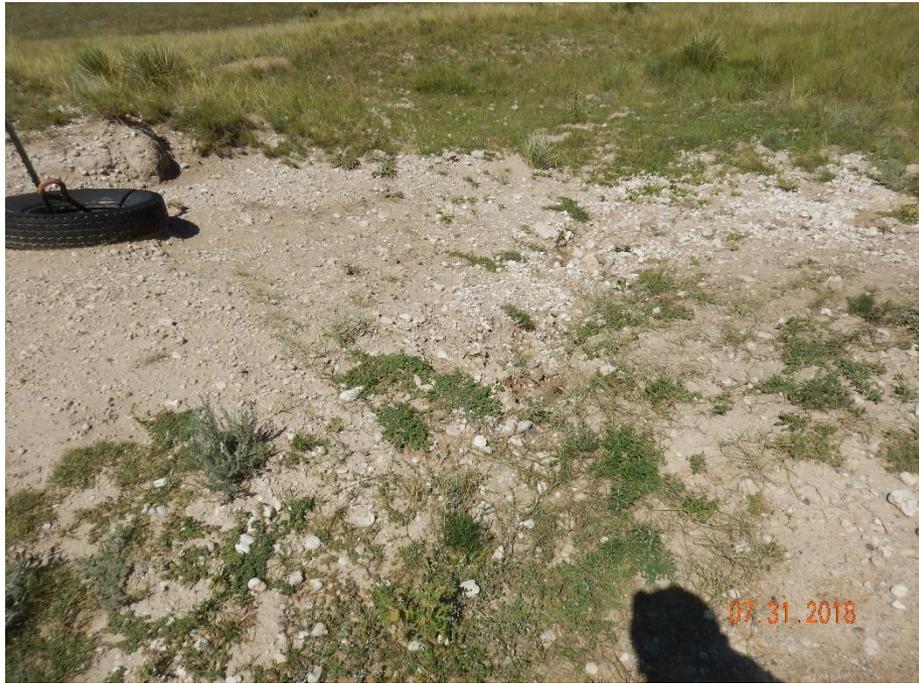
**Photo 13:** Photo taken from the west end of the location. Photo work appears to have been conducted to repair gulley erosion, however no stabilization controls have been implemented and erosion degradation has been allowed to continue.

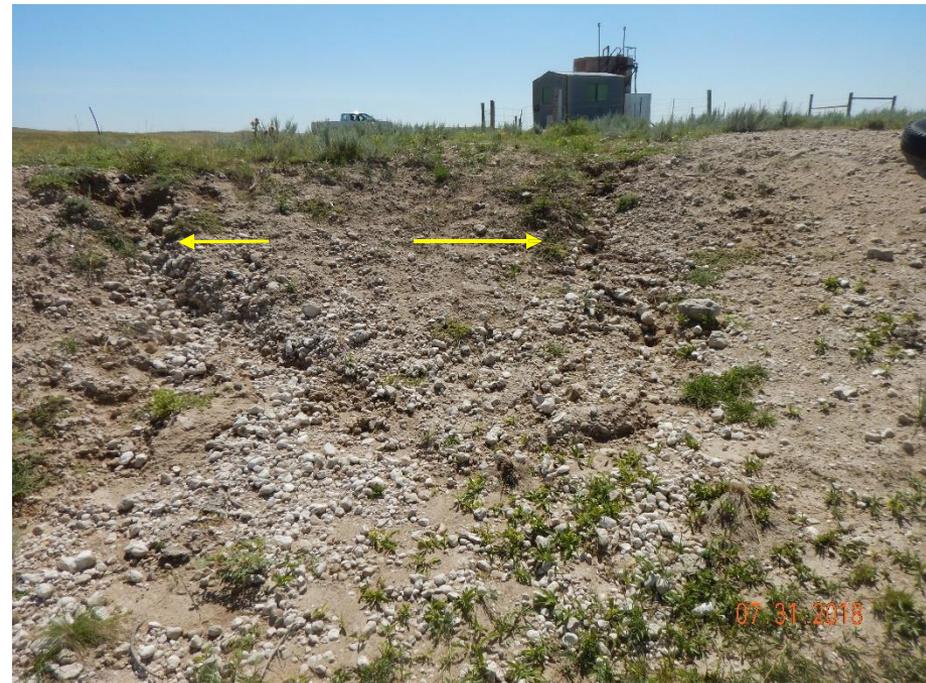
**Photo 14:** Photo taken from the west end of the location, facing east. See comments under photo 13.

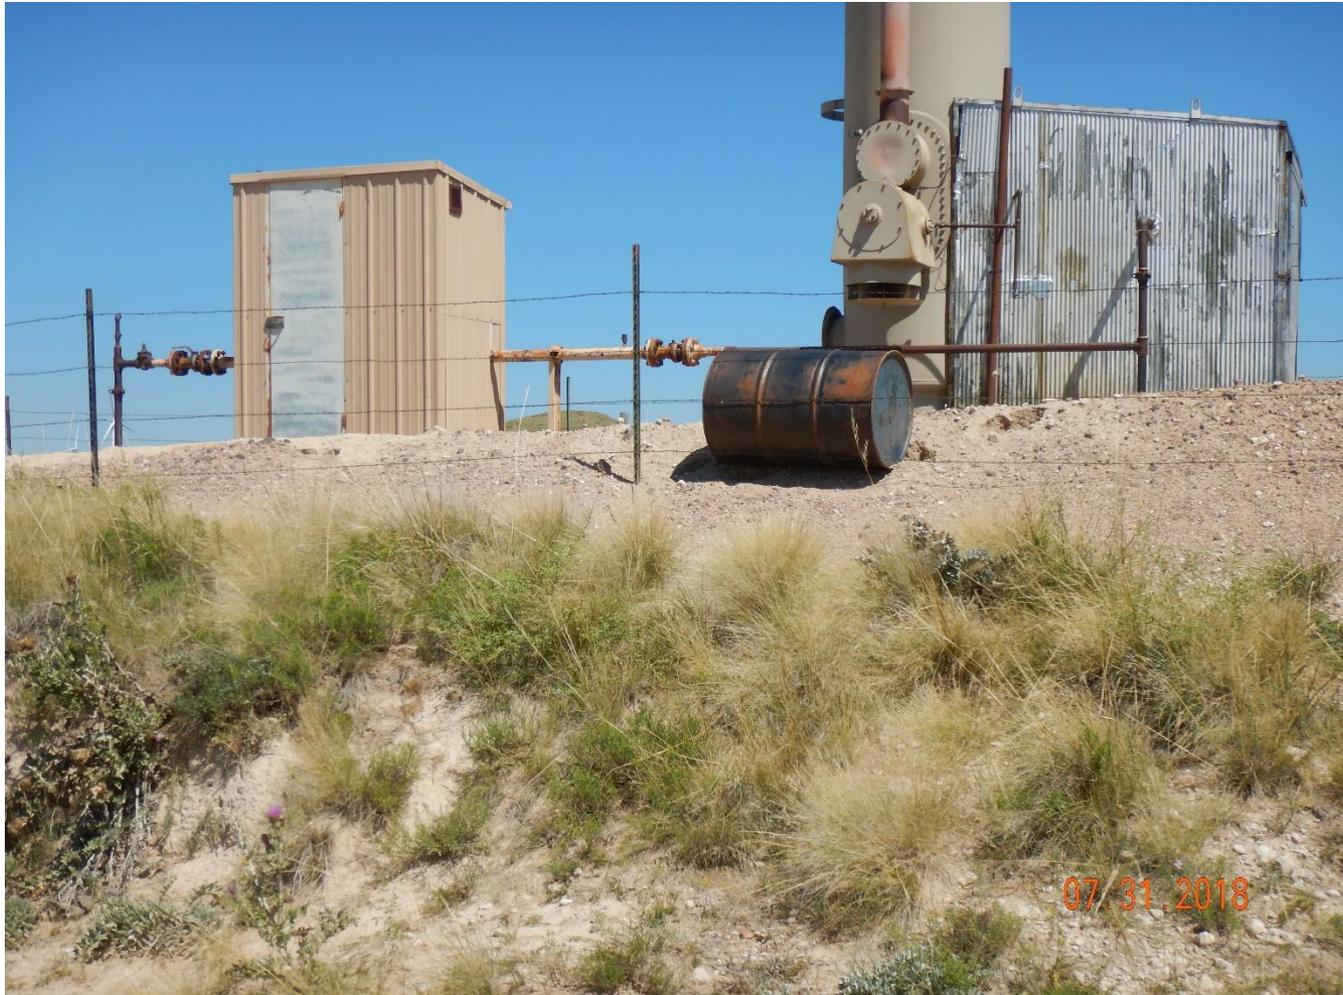
**Photo 15:** Photo taken from the south end of the facilities, facing north. Photo shows barrel laying along fence. This is improper materials management, barrel needs to be placed in secondary containment, or removed and properly stored.
