Inspection Photos
Location Name: Federal Sandwash 2-1
API: 05-081-06792

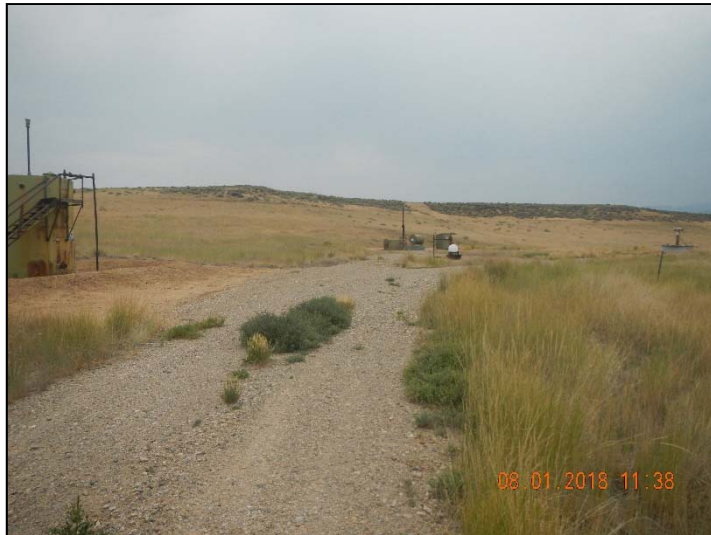
Photo 1. Overview of location taken at entrance facing east.

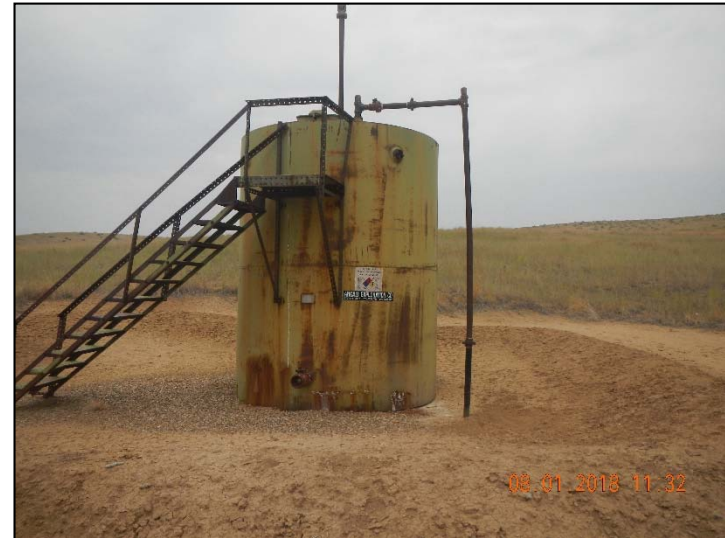
Photo 2. Corrosion along tank bottom.

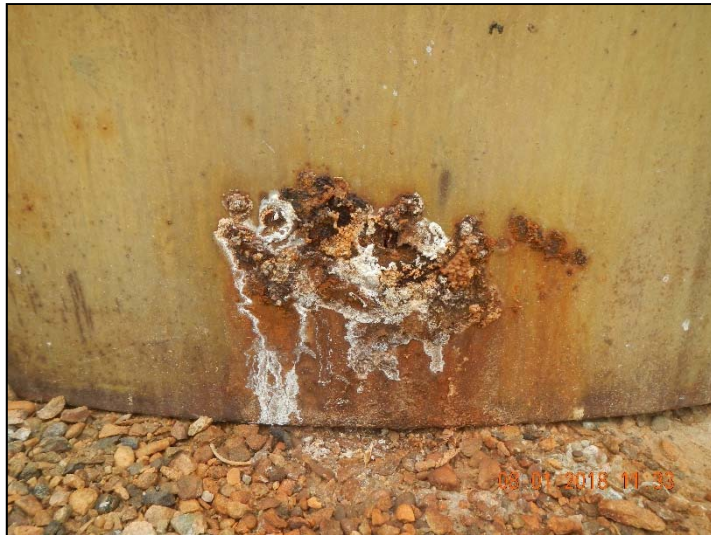
Photo 3. Close-up of corrosion with holes formed.

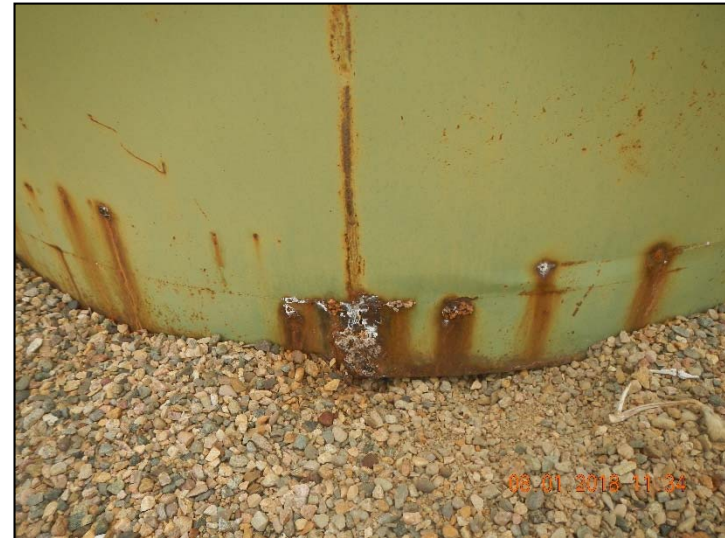
Photo 4. Close-up of corrosion.
