Inspection Photos
Location Name: Okes 5-6
API: 05-081-06798

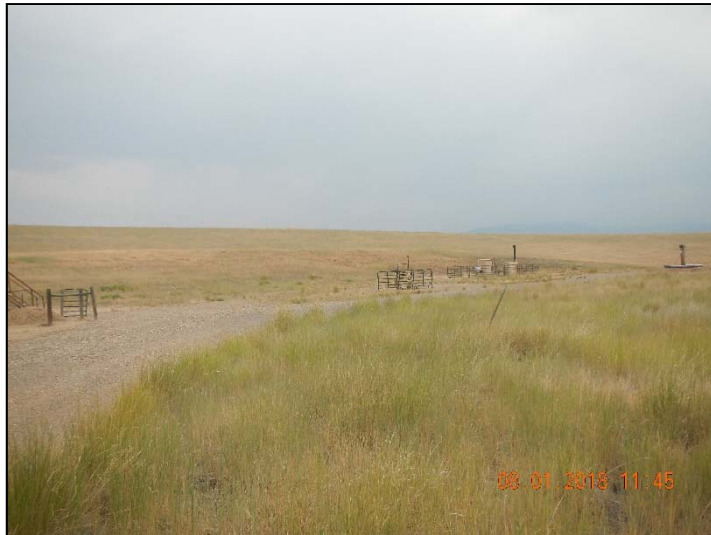
Photo 1. Overview of location taken at entrance facing east.

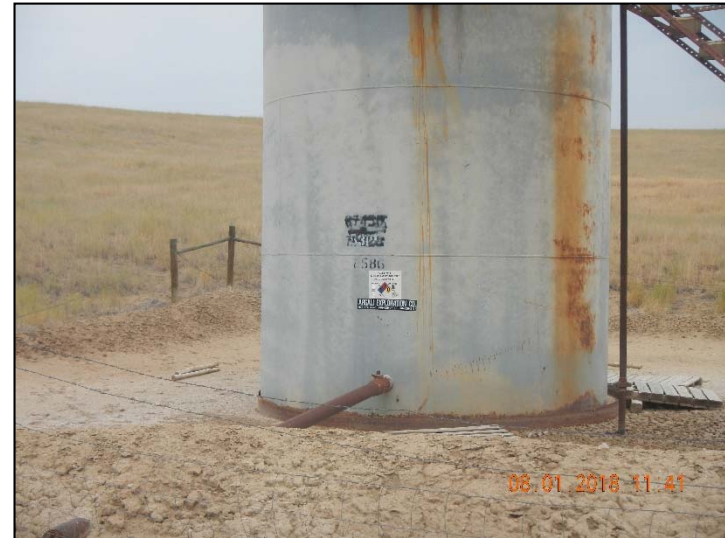
Photo 2. Incorrect emergency contact information on location signs.

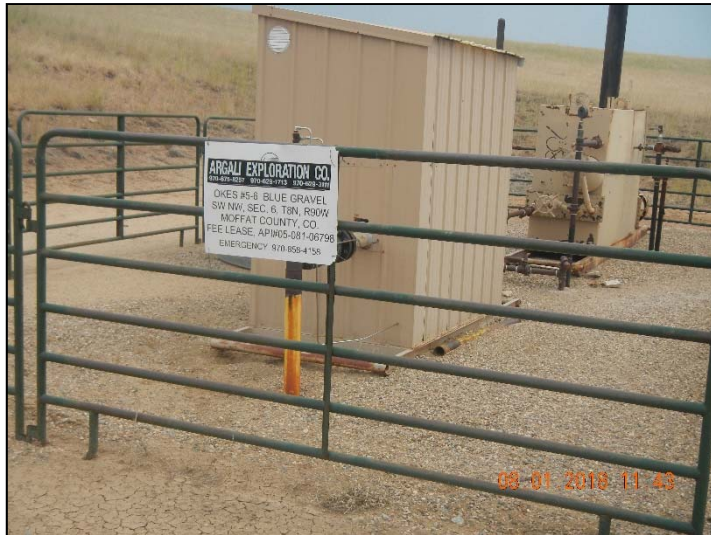
Photo 3. Incorrect emergency contact information on location signs.

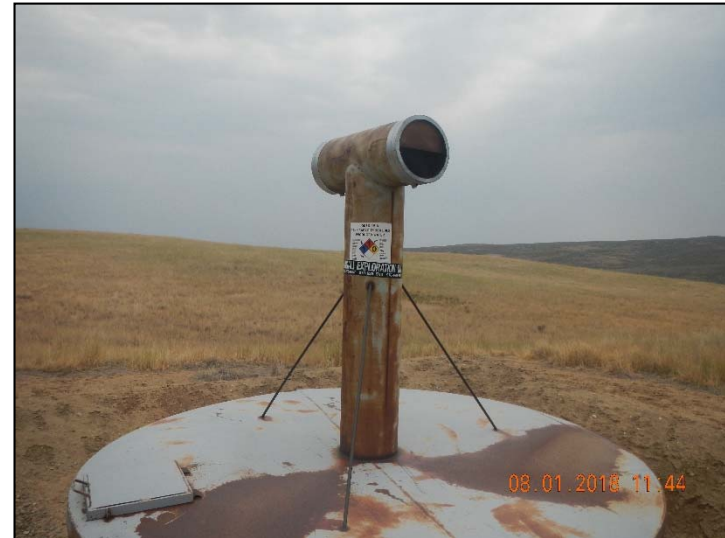
Photo 4. Incorrect emergency contact information on location signs.

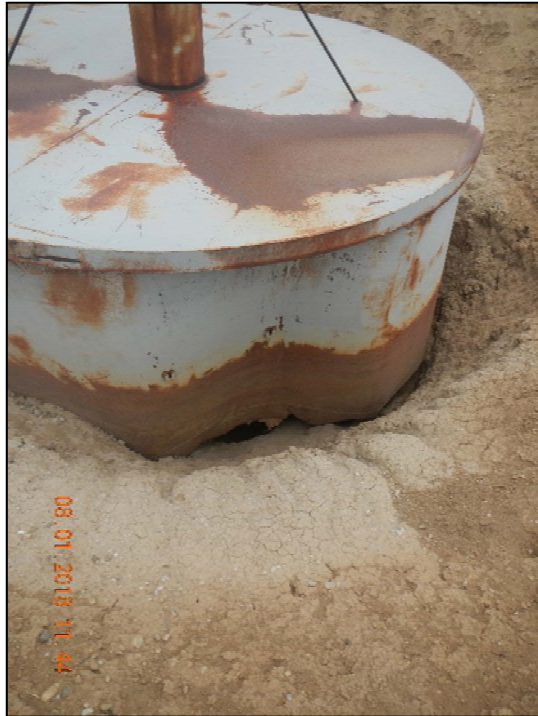
Photo 5. Hole in tank bottom.

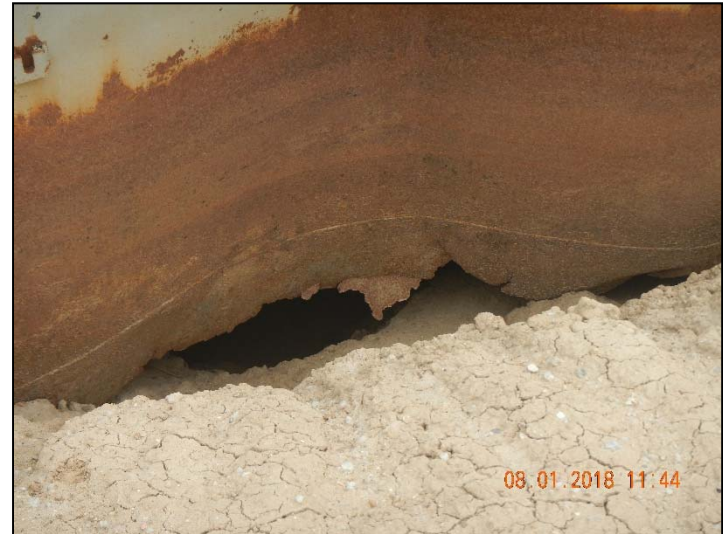
Photo 6. Close-up of hole in tank bottom.
