Inspection Photos

Operator: OILFIELD SALVAGE & SERVICE CO -
65550

Location ID: 311709

Inspection Doc. Number: 682503696
Adams County, CO

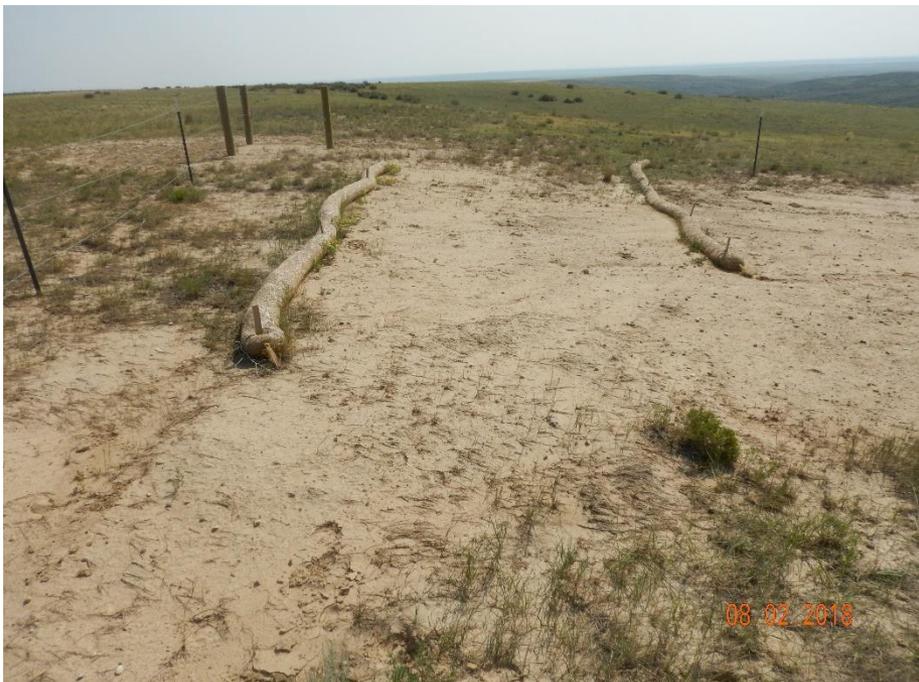
Photo 1: Photo taken from the northwest end of the fenced spill area facing east. Previous inspections required operator to perform reclamation and stormwater management (properly select and install site specific stormwater and sediment control BMPs). Reclamation activities were previously conducted, however it was documented that no controls to stabilize the seeded soil were implemented per the corrective action, and that the seeded soil was at risk to wind and stormwater erosion. Photo shows that straw wattles improperly installed and insufficient, and that stormwater erosion has been allowed to continue. Additionally, photo also shows that vegetation has failed to germinate and establish on the location.

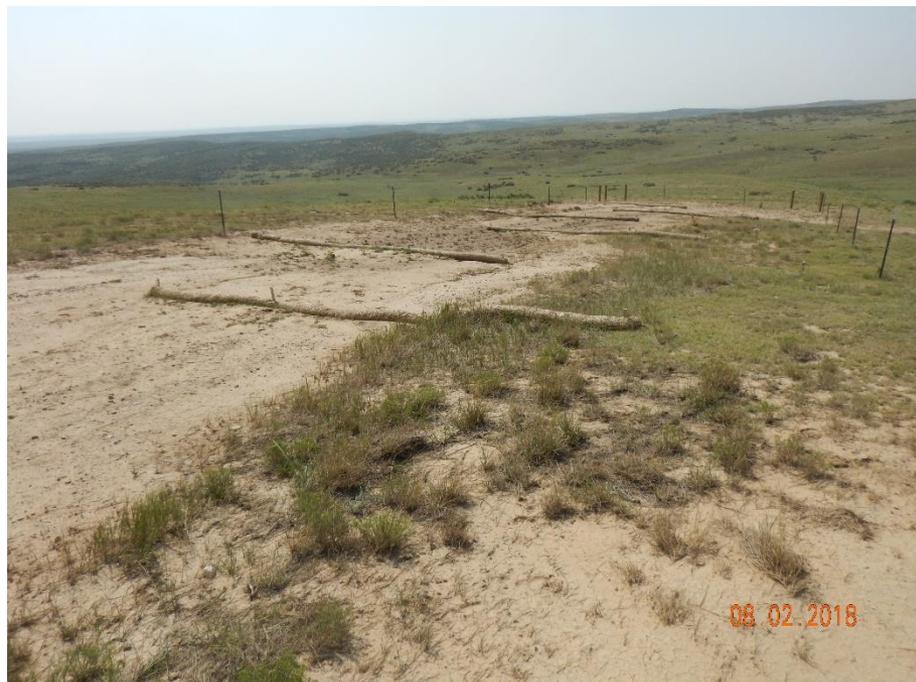
Photo 2: Photo taken from the northwest end of the fenced spill area facing southeast. See comments under photo 1.

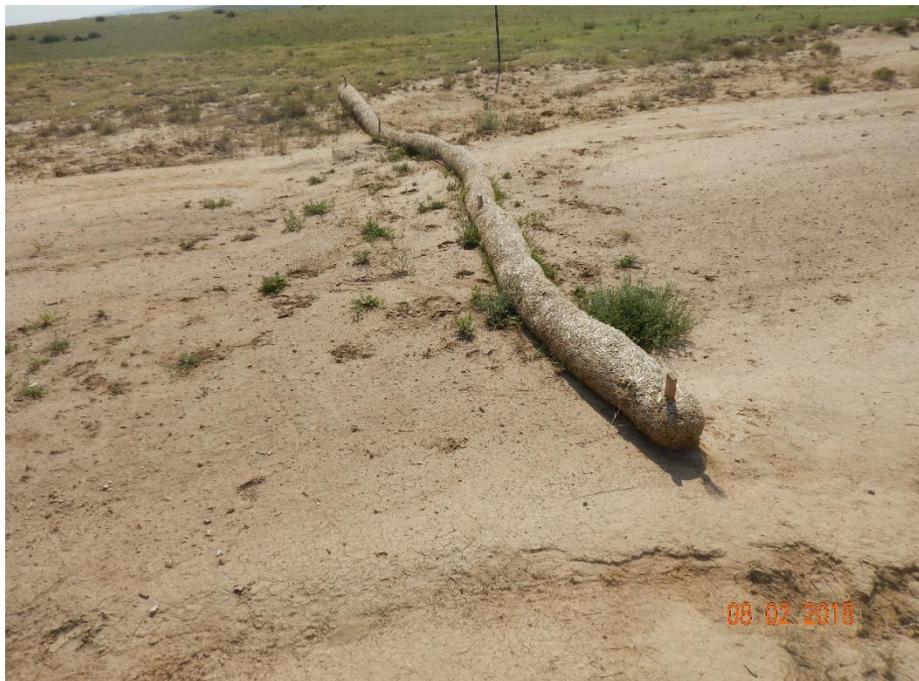
Photo 3: Photo taken from the location. Photo shows that straw wattles improperly installed and insufficient, and that stormwater erosion has been allowed to continue. See comments under photo 1.

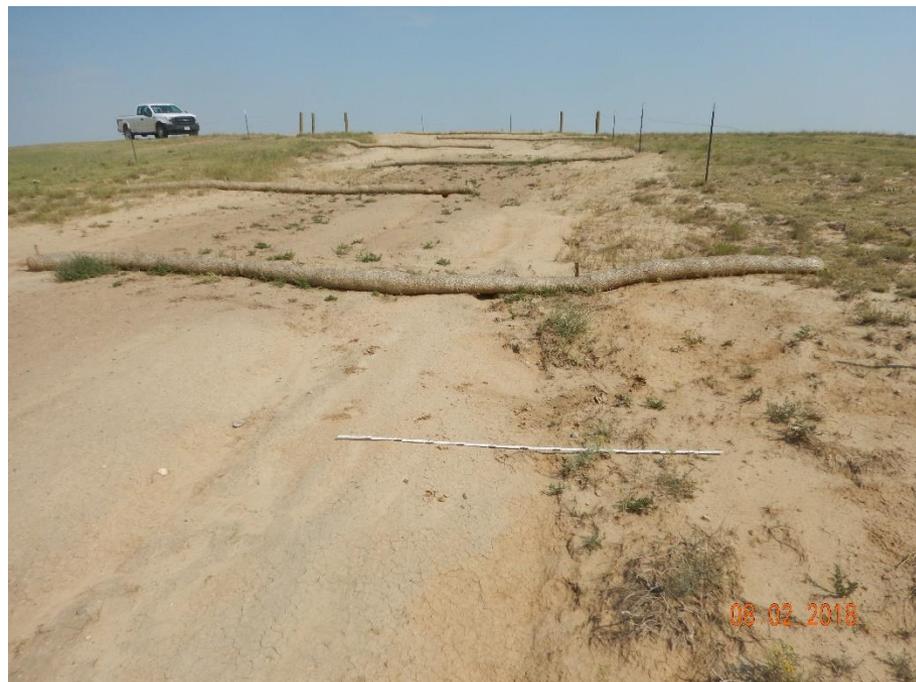
Photo 4: Photo taken from the location, facing north. Photo shows that straw wattles improperly installed and insufficient, and that stormwater erosion has been allowed to continue. See comments under photo 1. Six (6) foot measuring stick for reference.

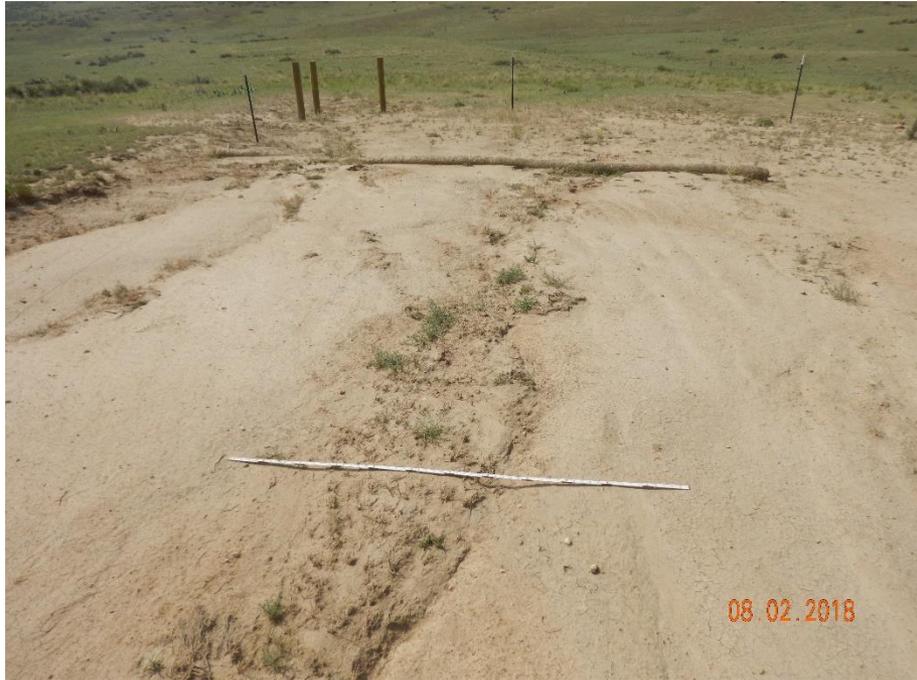
Photo 5: Photo taken from the location, facing south. Photo shows that straw wattles improperly installed and insufficient, and that stormwater erosion has been allowed to continue. See comments under photo 1. Six (6) foot measuring stick for reference.

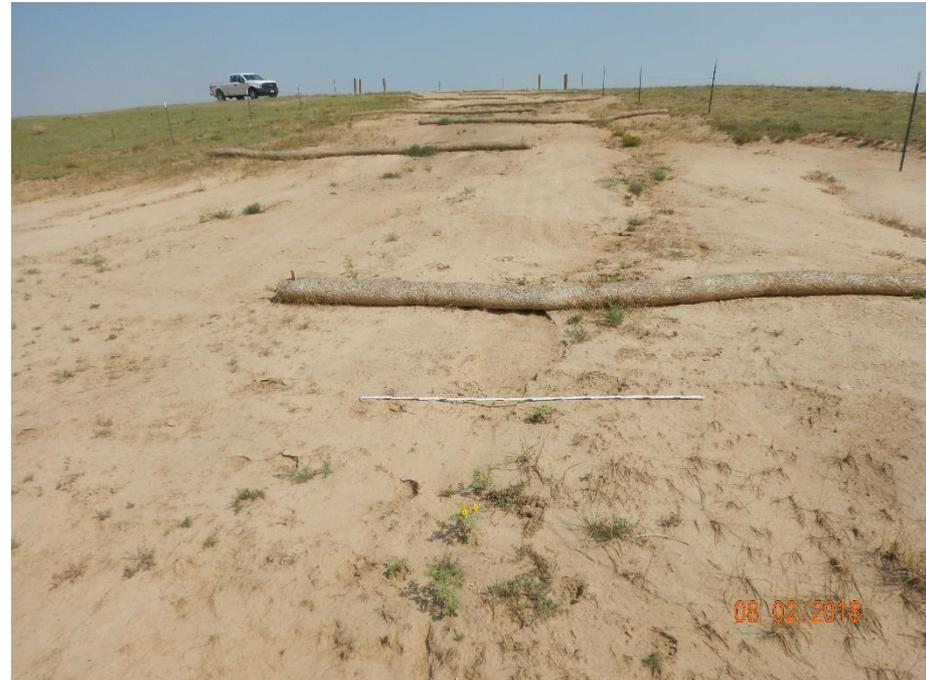
Photo 6: Photo taken from the location, facing north. Photo shows that straw wattles improperly installed and insufficient, and that stormwater erosion has been allowed to continue. See comments under photo 1. Six (6) foot measuring stick for reference.

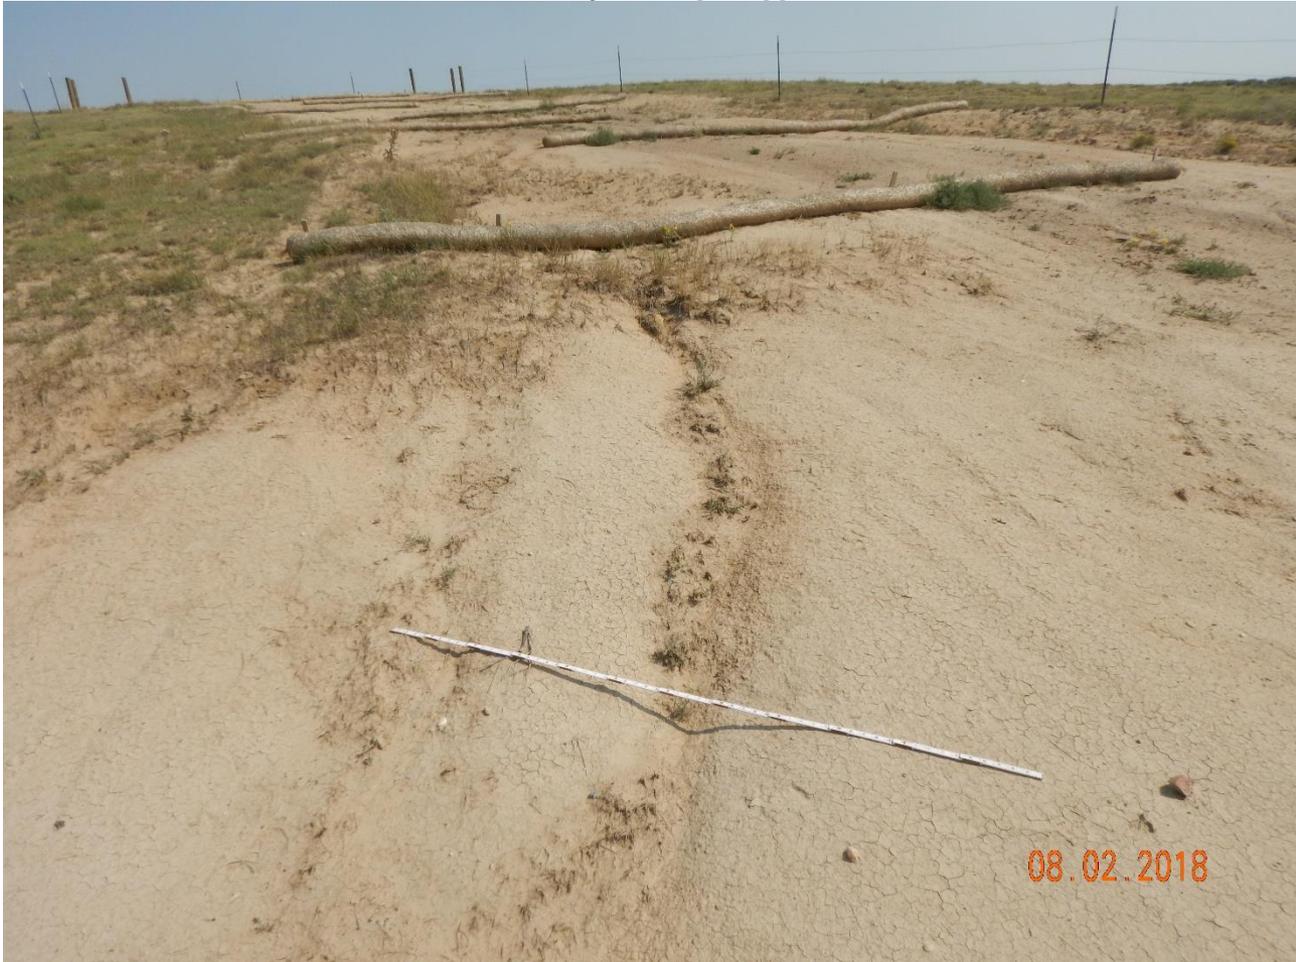
Photo 5: Photo taken from the location, facing north. Photo shows that straw wattles improperly installed and insufficient, and that stormwater erosion has been allowed to continue. See comments under photo 1. Six (6) foot measuring stick for reference.
