Inspection Photos

Operator: WESTERN OPERATING COMPANY -
95620

Location ID: 319767

Inspection Doc. Number: 682503700
Adams County, CO

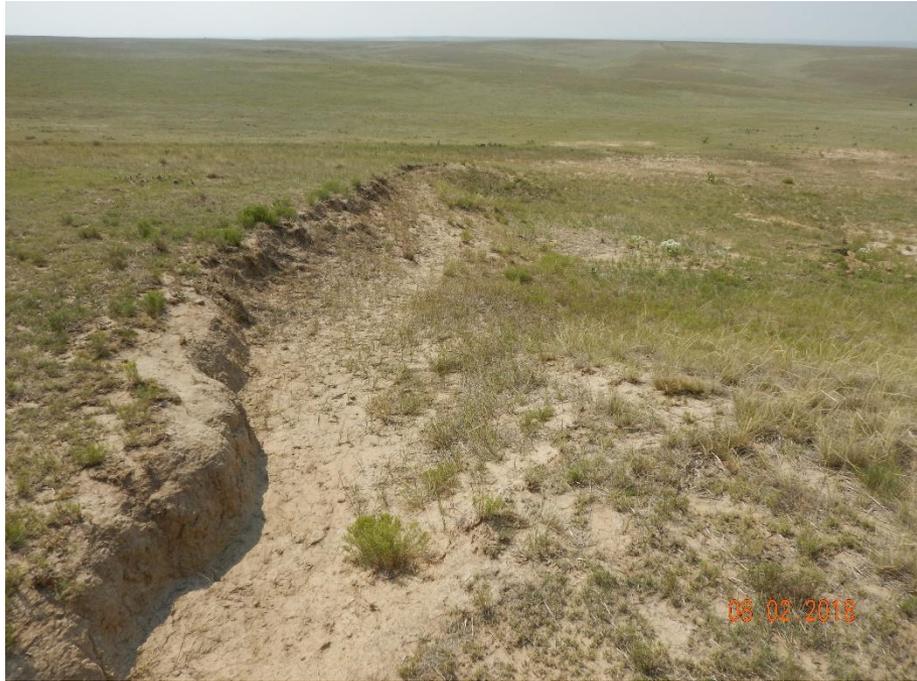
Photo 1: Photo taken from the northeast corner of the location, facing south. Photo shows erosion degradation on the location. Photo also shows the location has not be recontoured/regraded in accordance to 1004.a

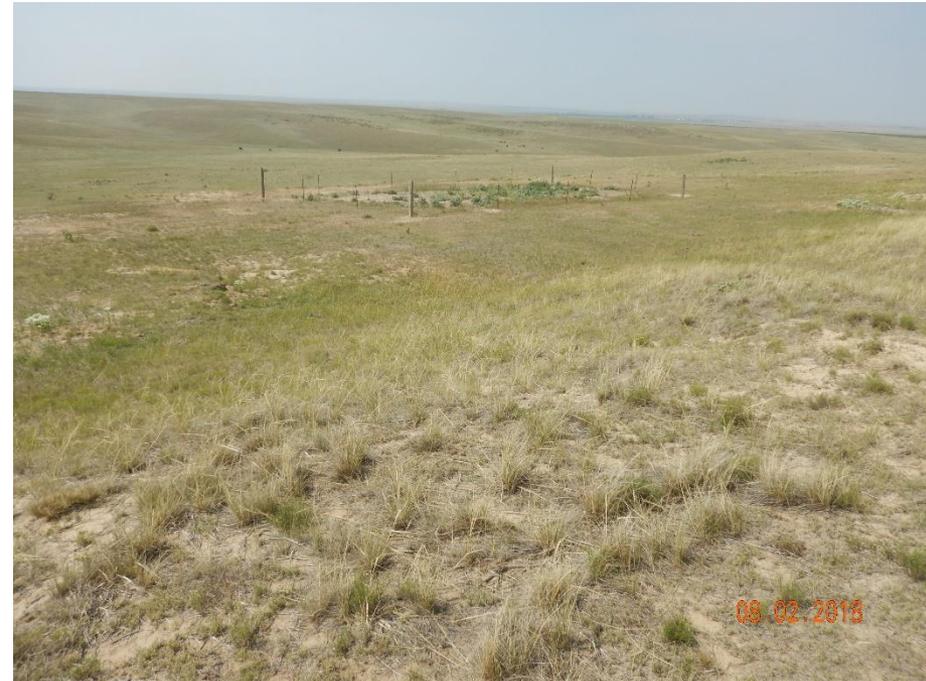
Photo 2: Photo taken from the northeast corner of the location, facing southwest. See comments under photo 1.

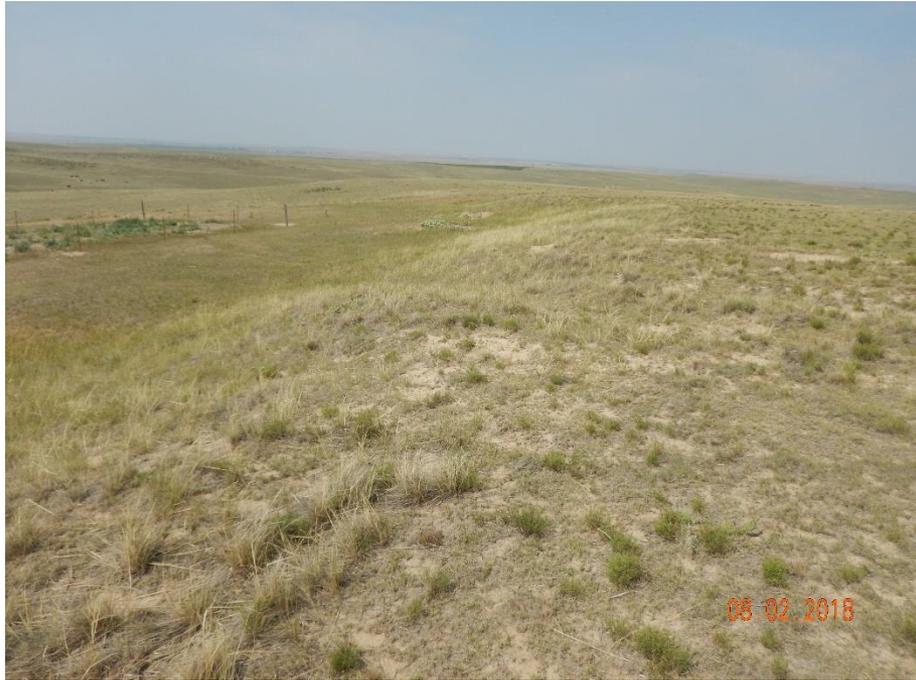
Photo 3: Photo taken from the northeast corner of the location, facing west. See comments under photo 1.

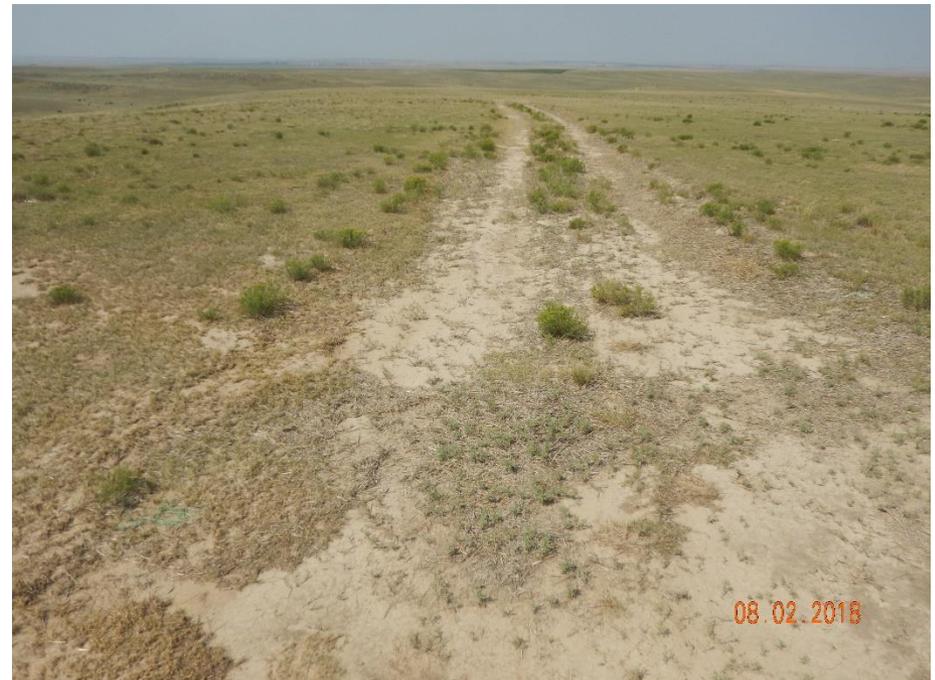
Photo 4: Photo taken from the west end of the location, facing southwest. Photo shows no reclamation activities, including compaction alleviation, recontouring/regrading and revegetation appear to have been conducted on the access road.

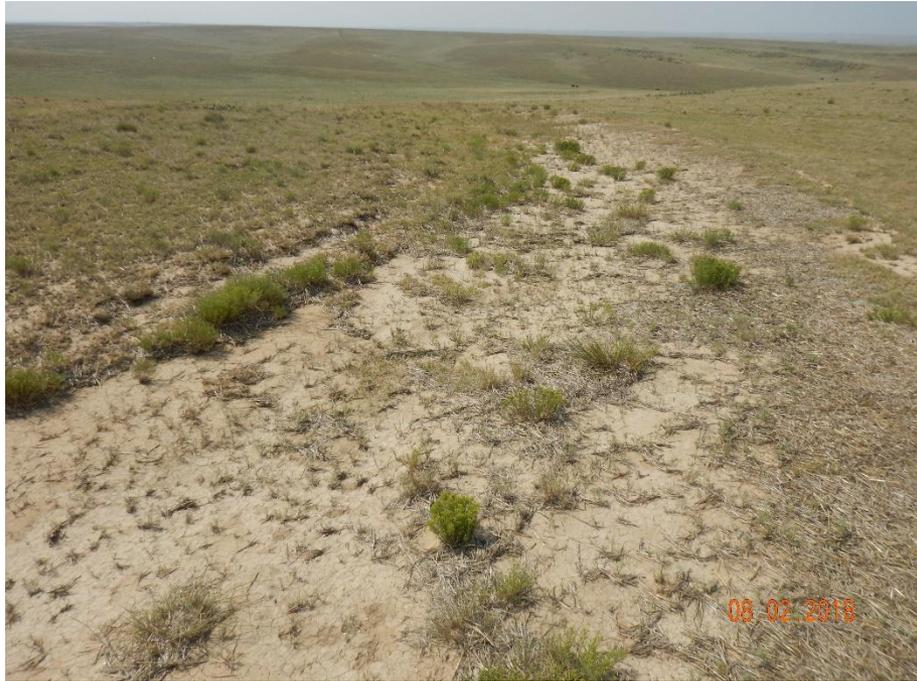
Photo 5: Photo taken from the west end of the location, facing southwest. Photo shows no reclamation activities, including compaction alleviation, recontouring/regrading and revegetation appear to have been conducted on the access road.

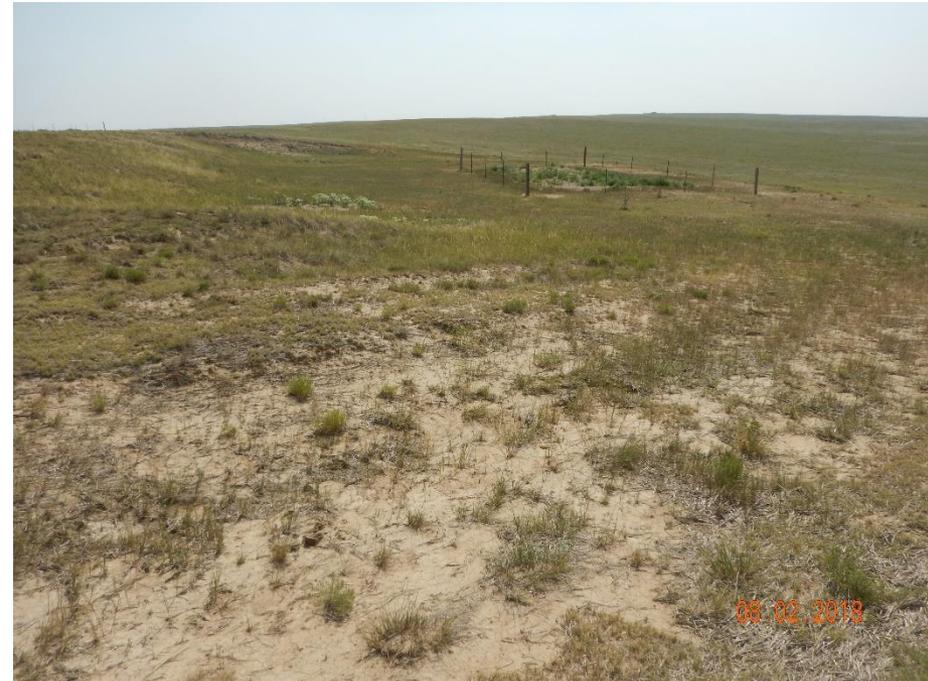
Photo 6: Photo taken from the west end of the location, facing southeast. Photo shows no reclamation activities, including compaction alleviation, recontouring/regrading and revegetation appear to have been conducted on the access road.

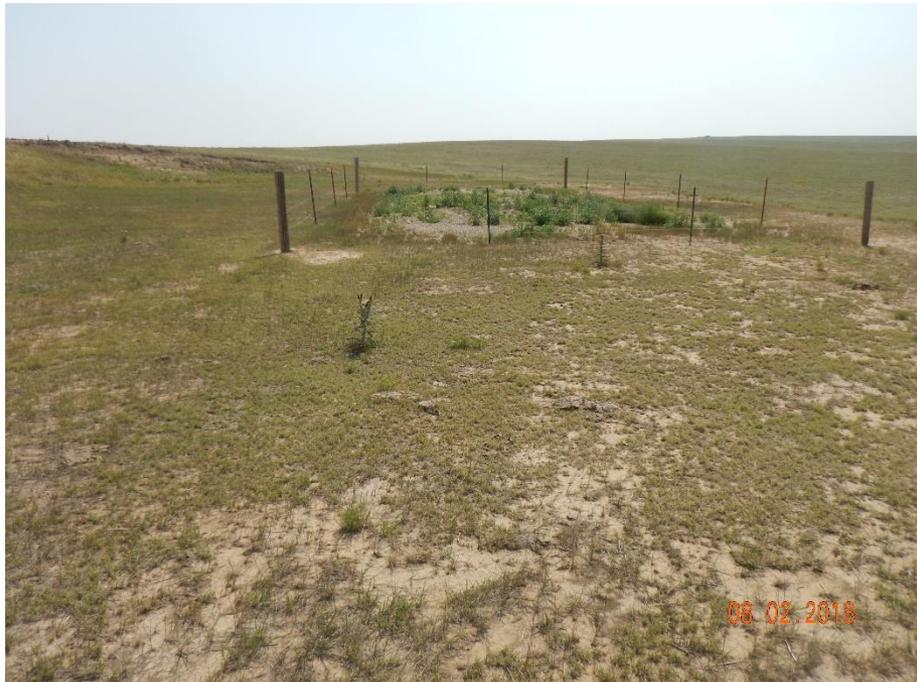
Photo 9: Photo taken from the west end of where the well was location. Photo shows reclamation activities only appear to have been conducted in the immediate areas of the well (fenced area).

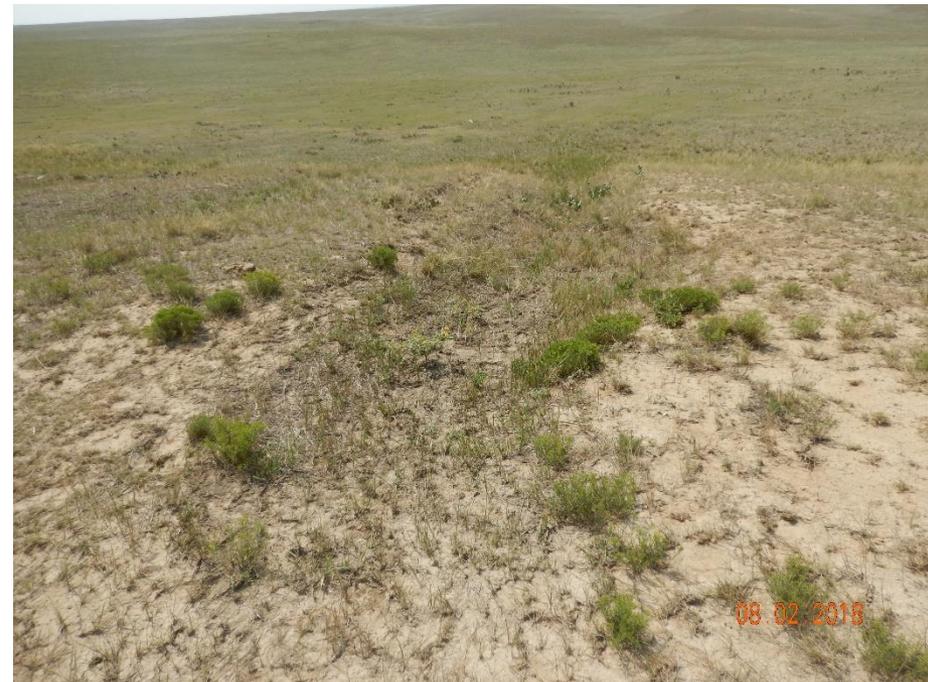
Photo 10: Photo taken from the south end of the location, facing south. Photo shows a shallow gully that has formed from stormwater runoff on the slopes of the location.

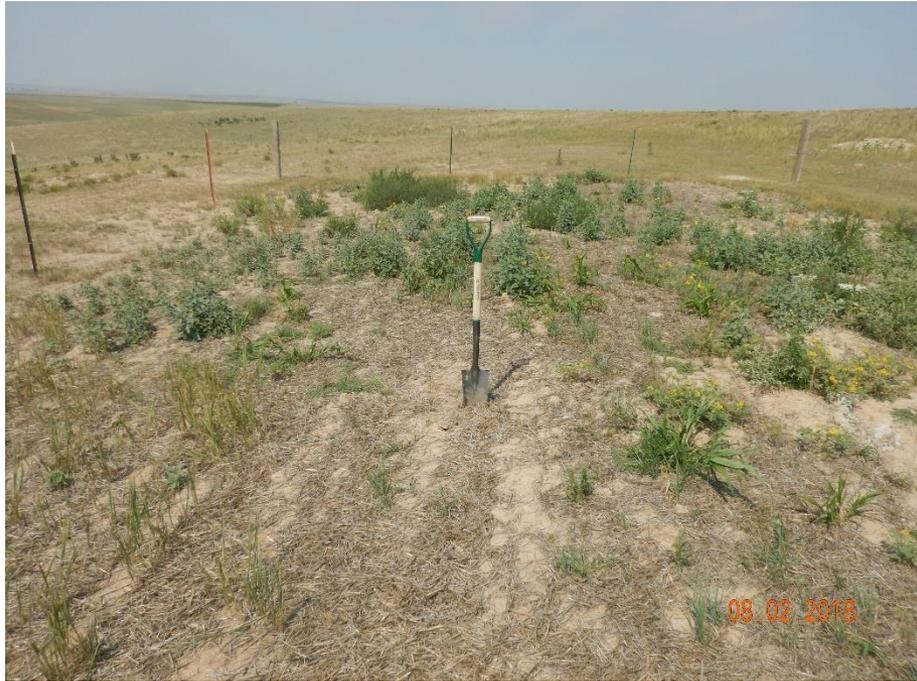
Photo 11: Photo taken from the fenced area of the well, facing west. Photo shows compaction alleviation and revegetation activities appear to have been conducted in the area of the well. Inspector was able to easily penetrate the top 8-10 inches of the soil with a shovel.

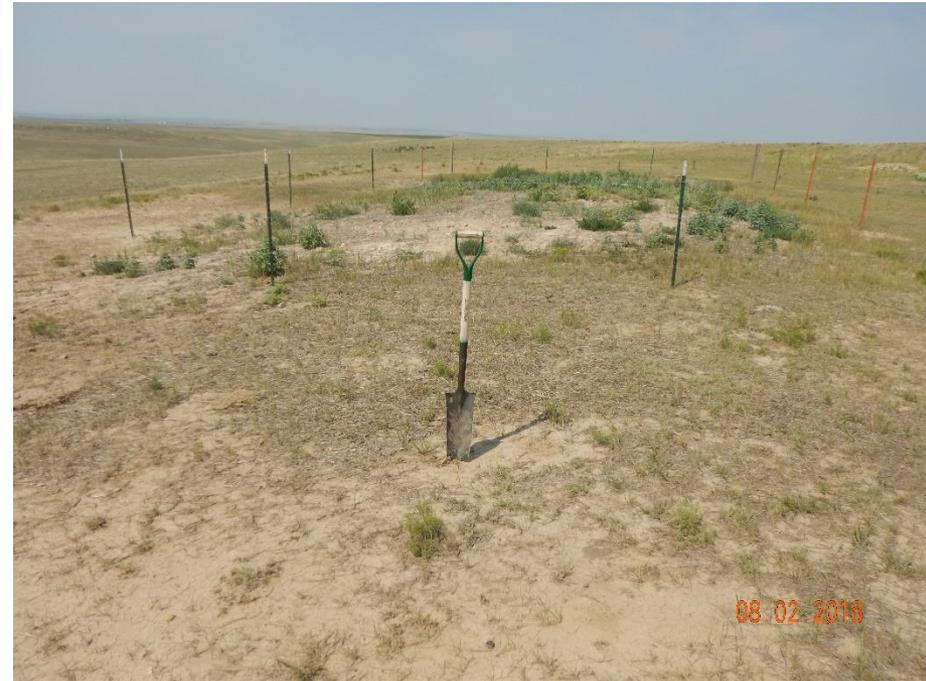
Photo 12: Photo taken from outside of the fenced area of the well, facing west. Photo shows compaction alleviation and revegetation activities DO NOT appear to have been conducted in the remaining location. Inspector was able to penetrate the top couple of inches of the soil with a shovel; compaction concerns evident.

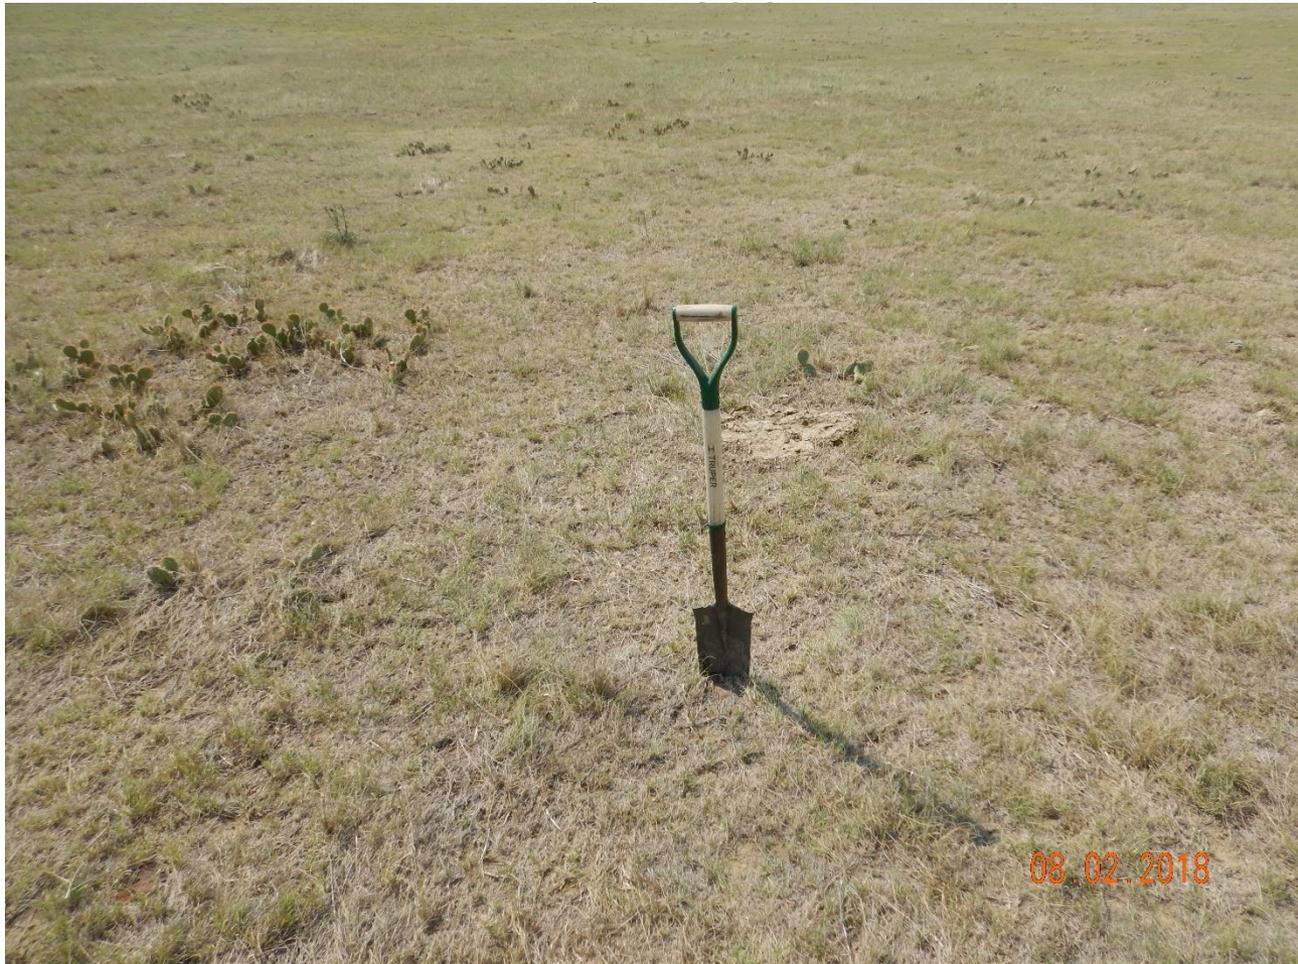
Photo 13: Photo taken from the adjacent reference area. Photo shows inspector tested the soils in the reference area for compaction to compare to the disturbed areas of the location. Inspector was able to easily penetrate the top 8-10 inches of the soil with a shovel.

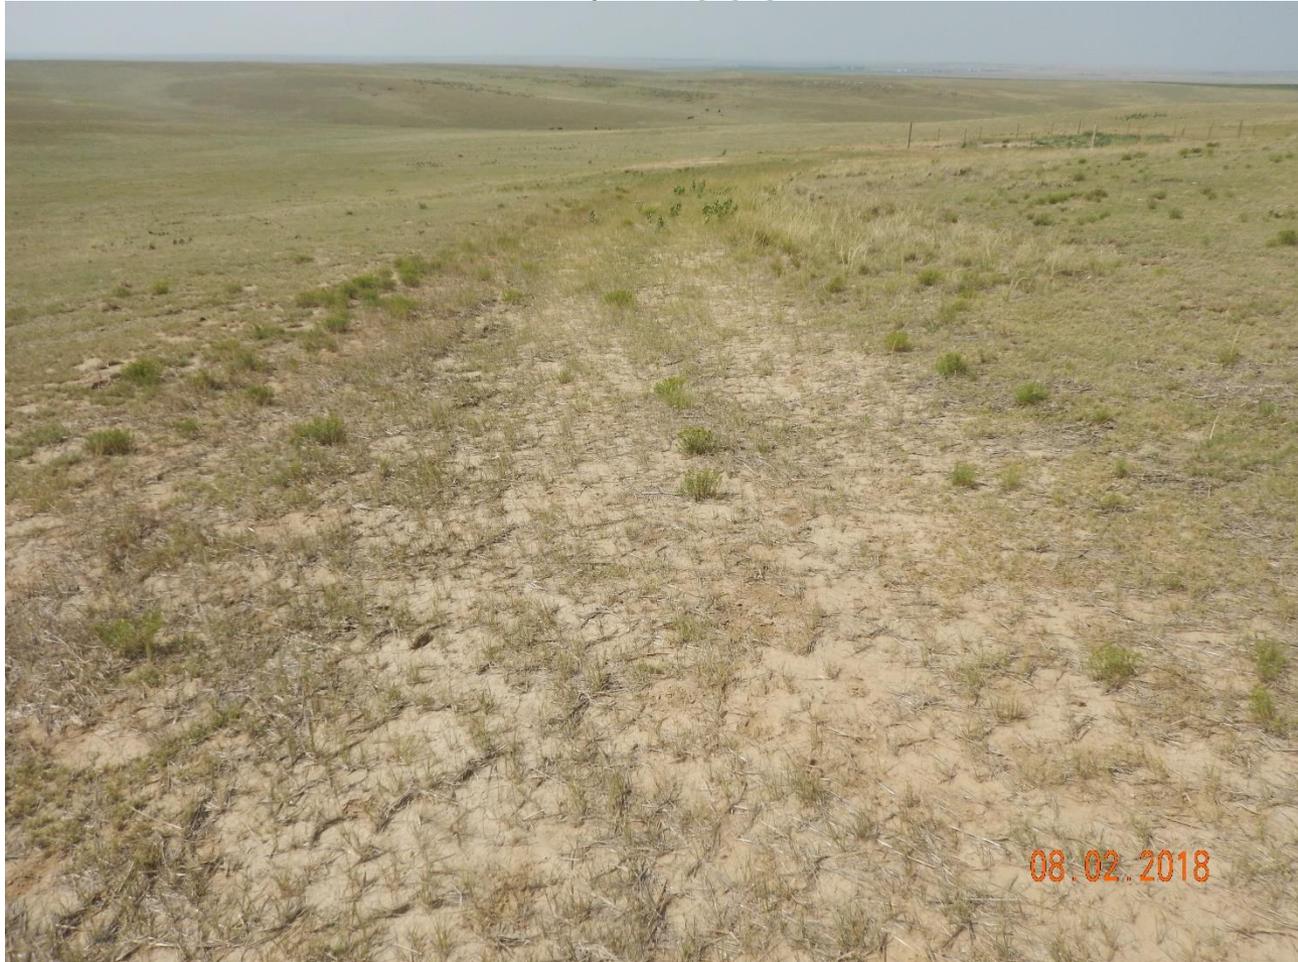
Photo 5: Photo taken from the east end of the location, facing southwest. Photo shows no reclamation activities, including compaction alleviation, recontouring/regrading and revegetation appear to have been conducted on the access road.
