**Inspection Photo
COX 33-1 (B33NE)
API # 045-13388
Inspection # 689301681**

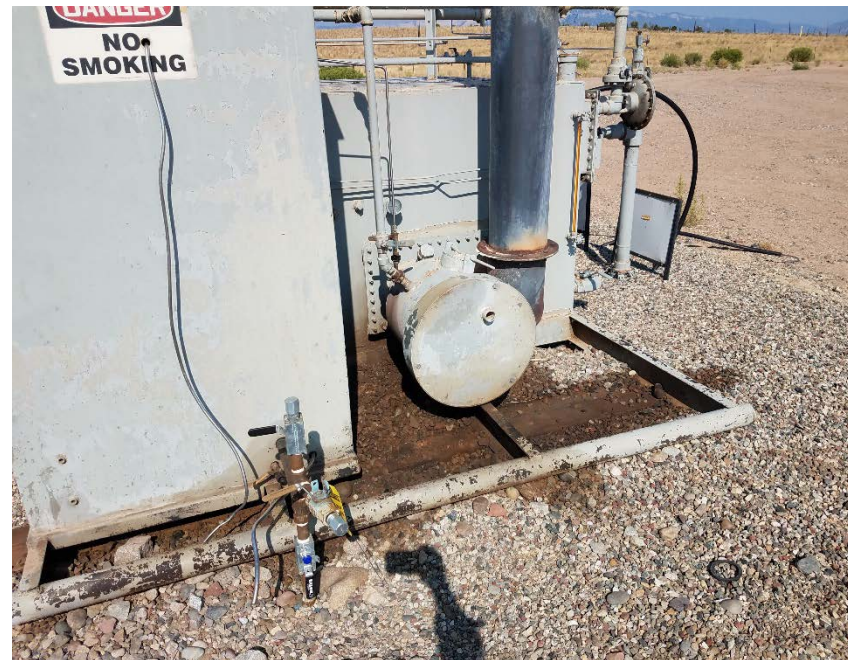
Location Photo #2, Oil stained rock near separators.

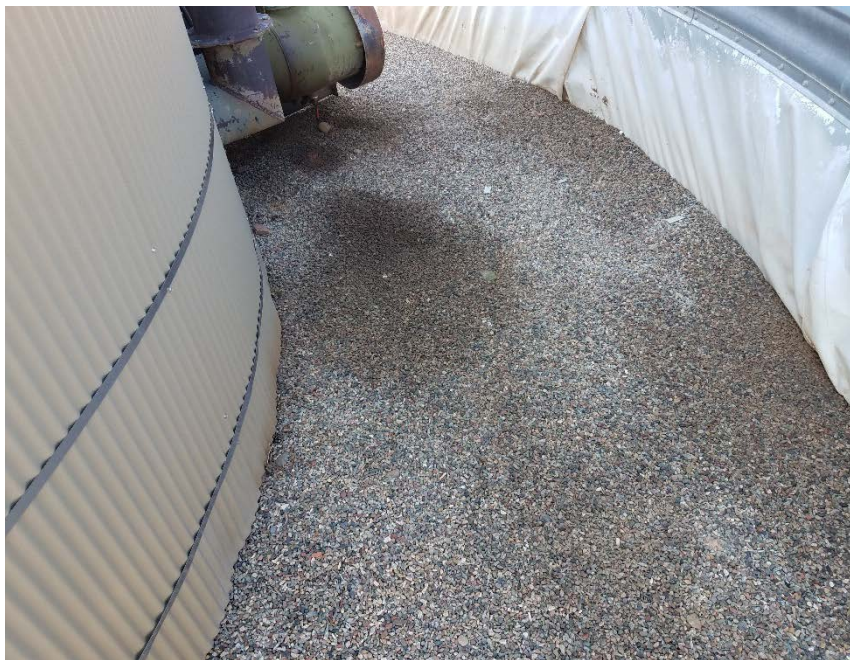
Location Photo #3, Stained rock in tank containment.

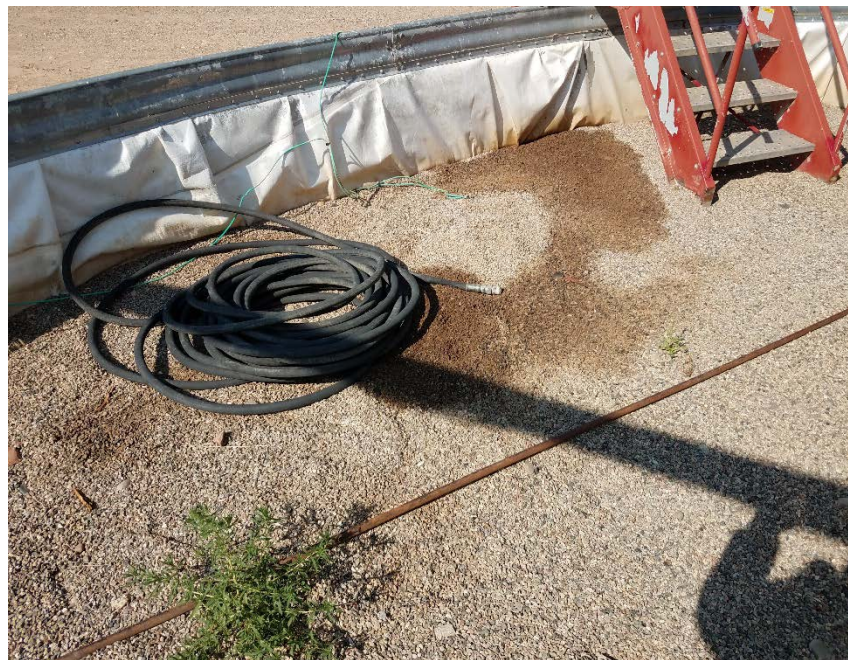
Location Photo #4, Stained rock in tank containment.

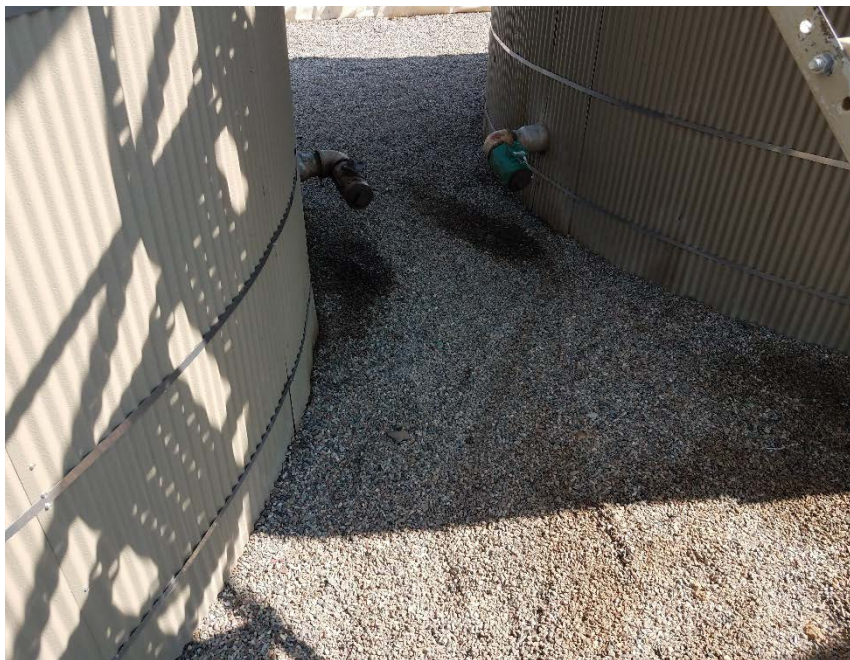
Location Photo #5, Stained rock in tank containment.

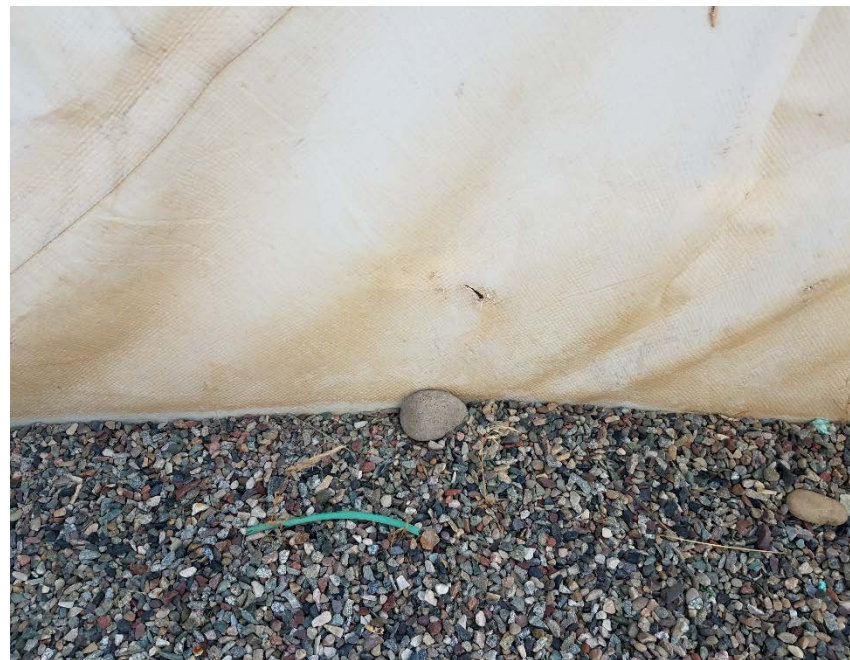
Location Photo #6, Hole in secondary containment.
