Inspection Photos

Location Name: Lake Fox Water Storage Facility

Facility ID: #149016

Inspection Date: August 1, 2018

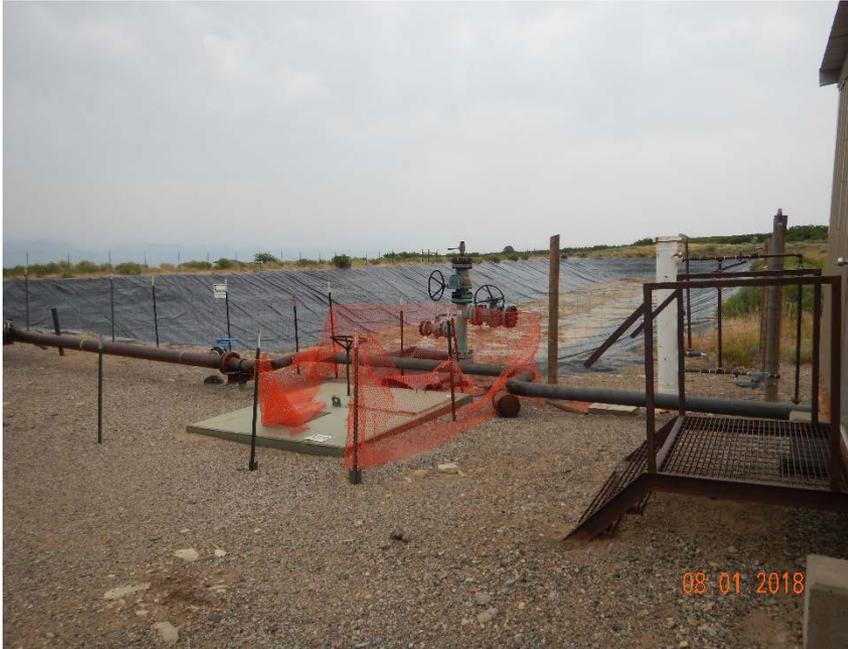
Photo #1 – View of damaged safety fence, flowline manifold, and freshwater pit from SW corner of location.

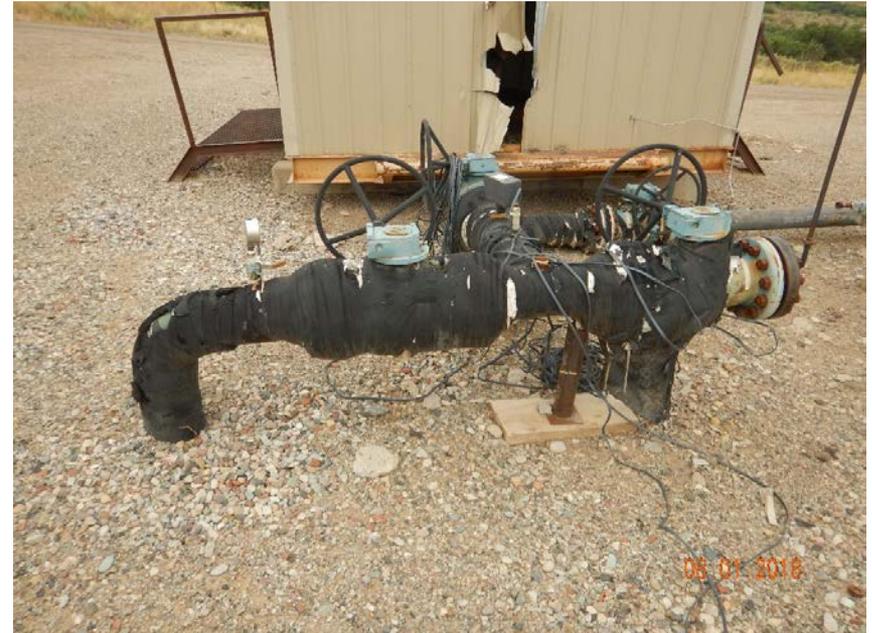
Photo #2 – Damaged shed and insulated flowline manifold located at SW corner of pit. Note tangled wiring draped on top of flowline manifold.

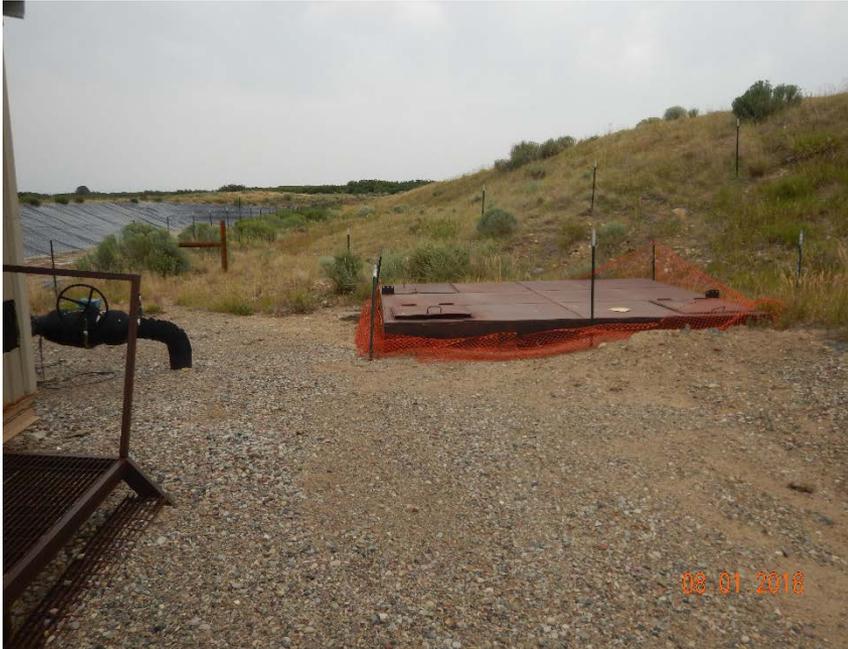
Photo #3 – Damaged safety fence located southwest of pit.

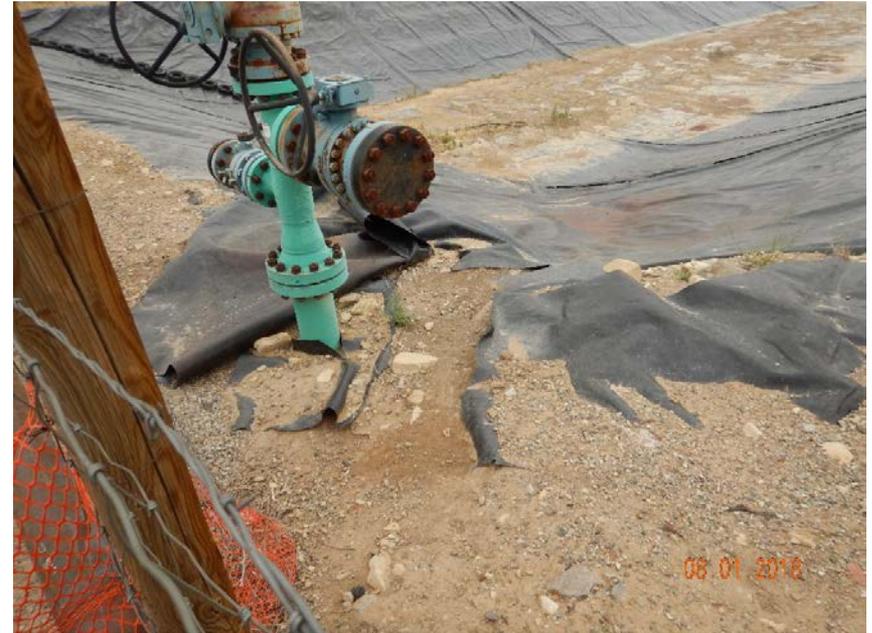
Photo #4 – Damaged pit liner, liner debris, and pipeline riser located at SW corner of pit.

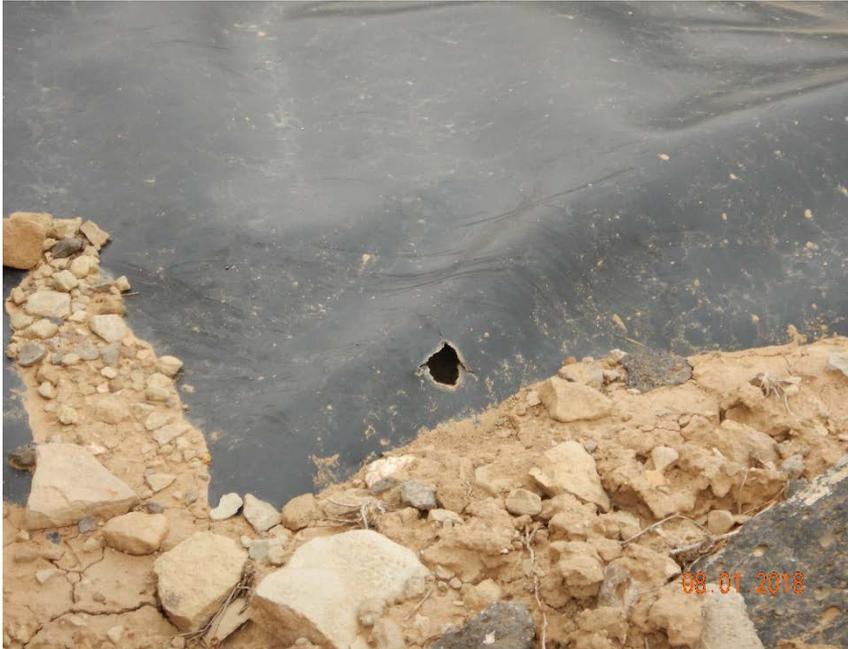
Photo #5 – Holes in pit liner along anchor trench (1).

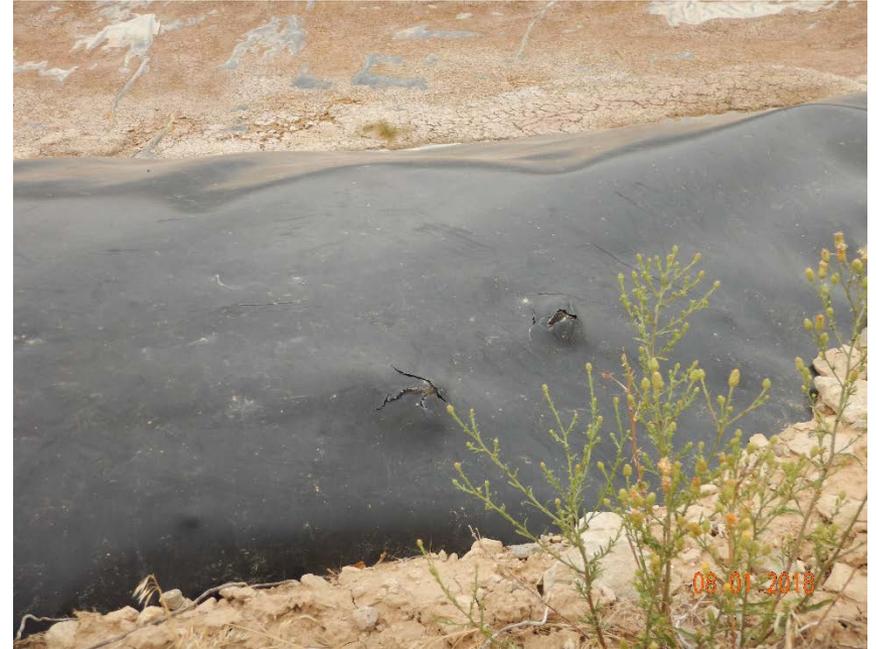
Photo #6 - Holes in pit liner along anchor trench (2).

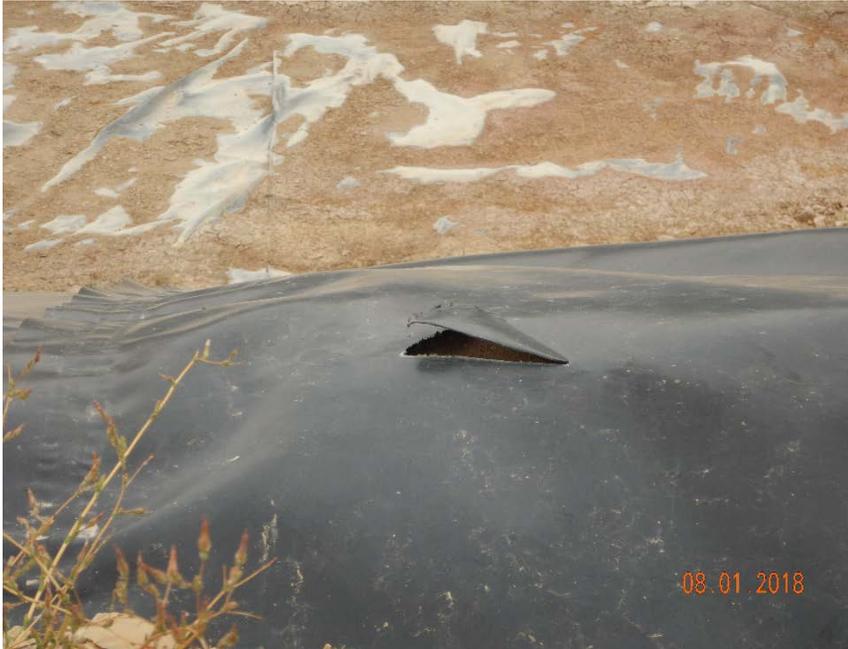
Photo #7 - Holes in pit liner along anchor trench (3).

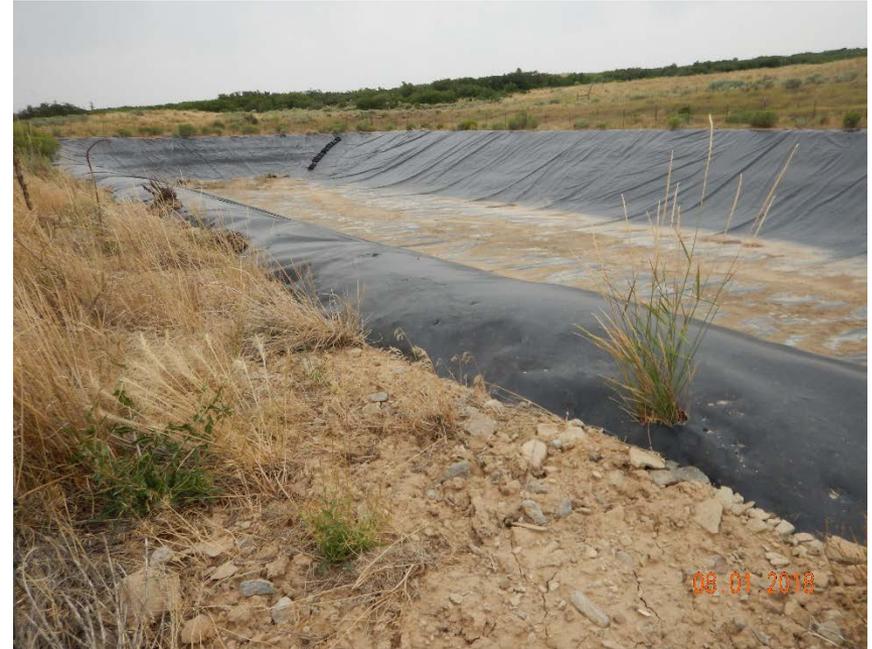
Photo #8 – Holes (and vegetation) in pit liner along anchor trench (4).

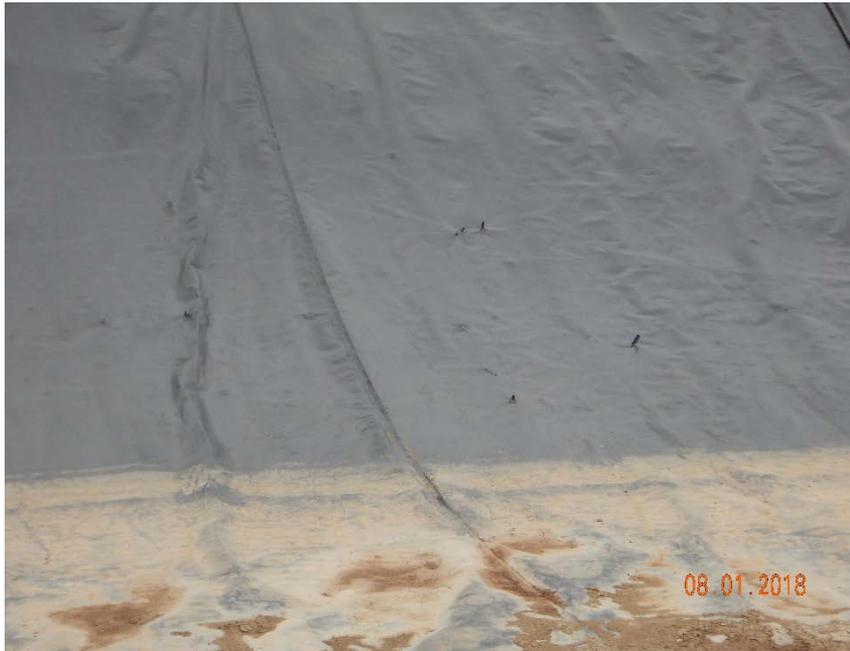
Photo #9 – Holes observed in pit liner along base of pit.

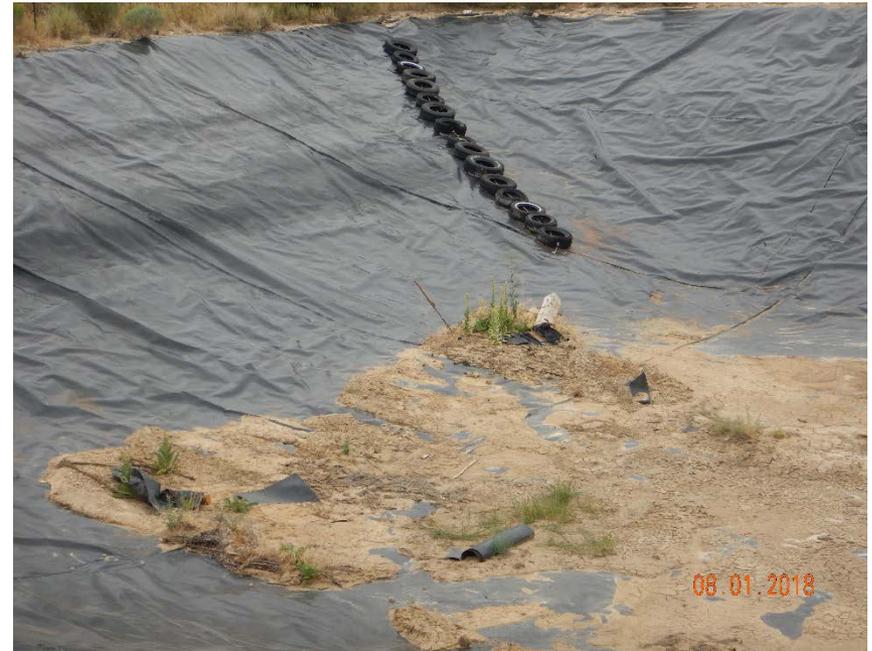
Photo #10 – Wood debris, vegetation, and scraps of liner located inside of pit.
