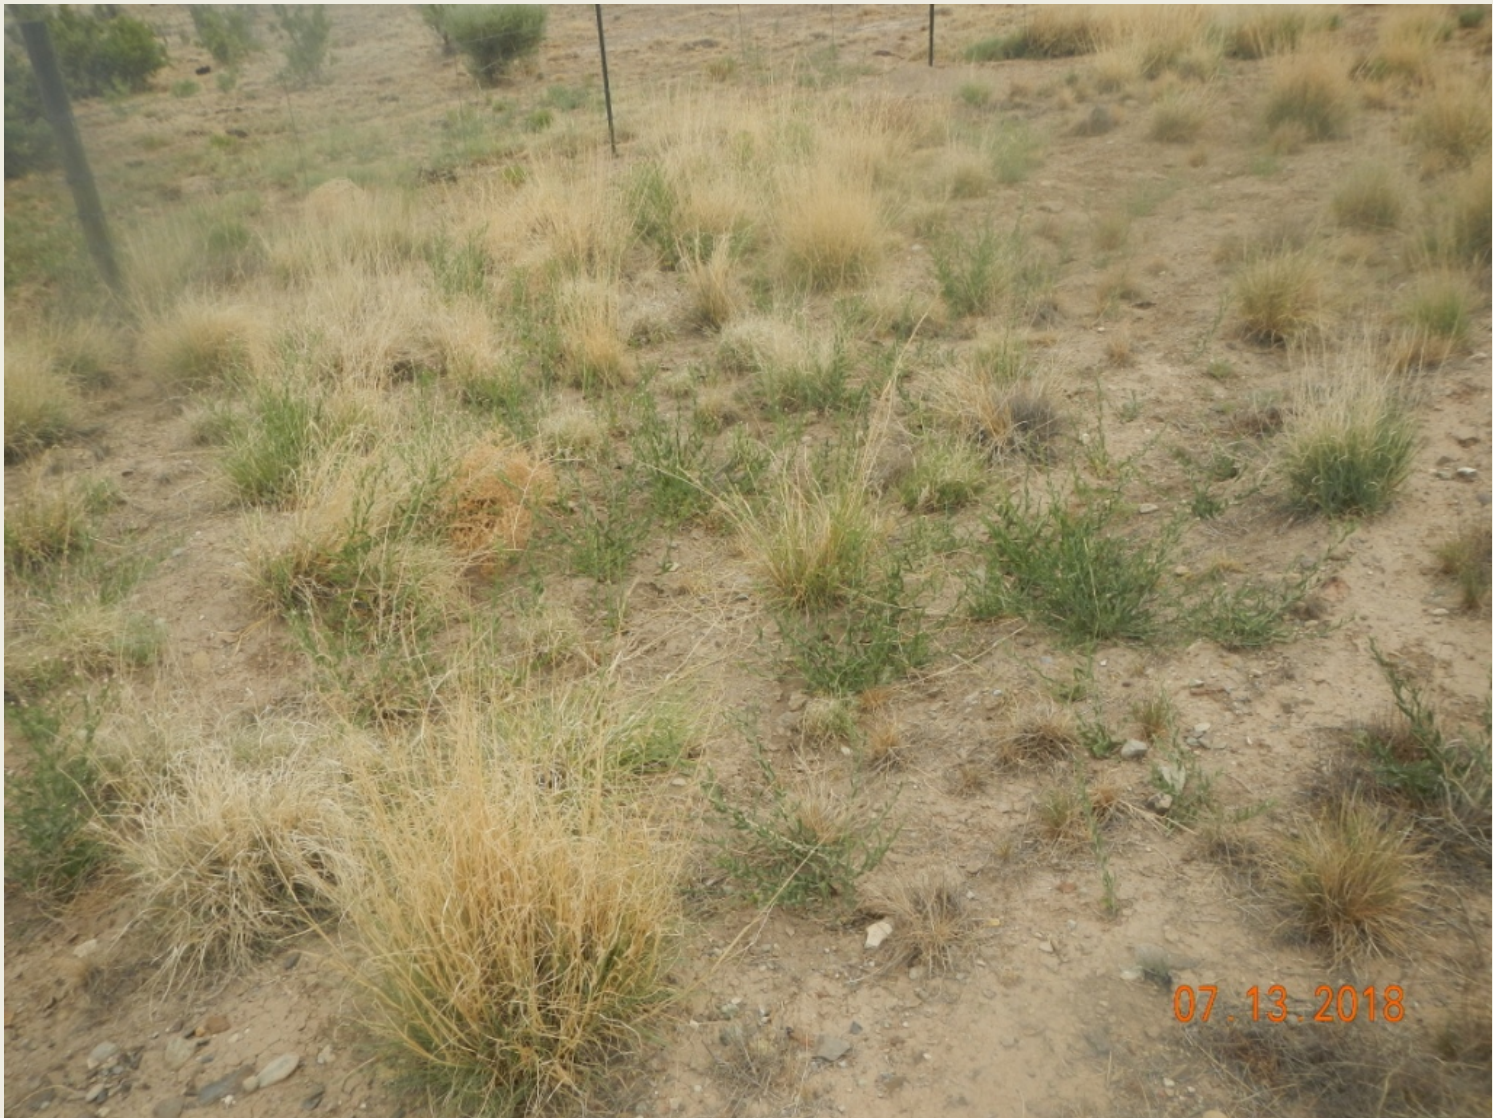
**Photo 3. View of Russian knapweed (*Rhaponticum repens*) in the southeastern portion of the project area. Approximately 100 individuals observed.**

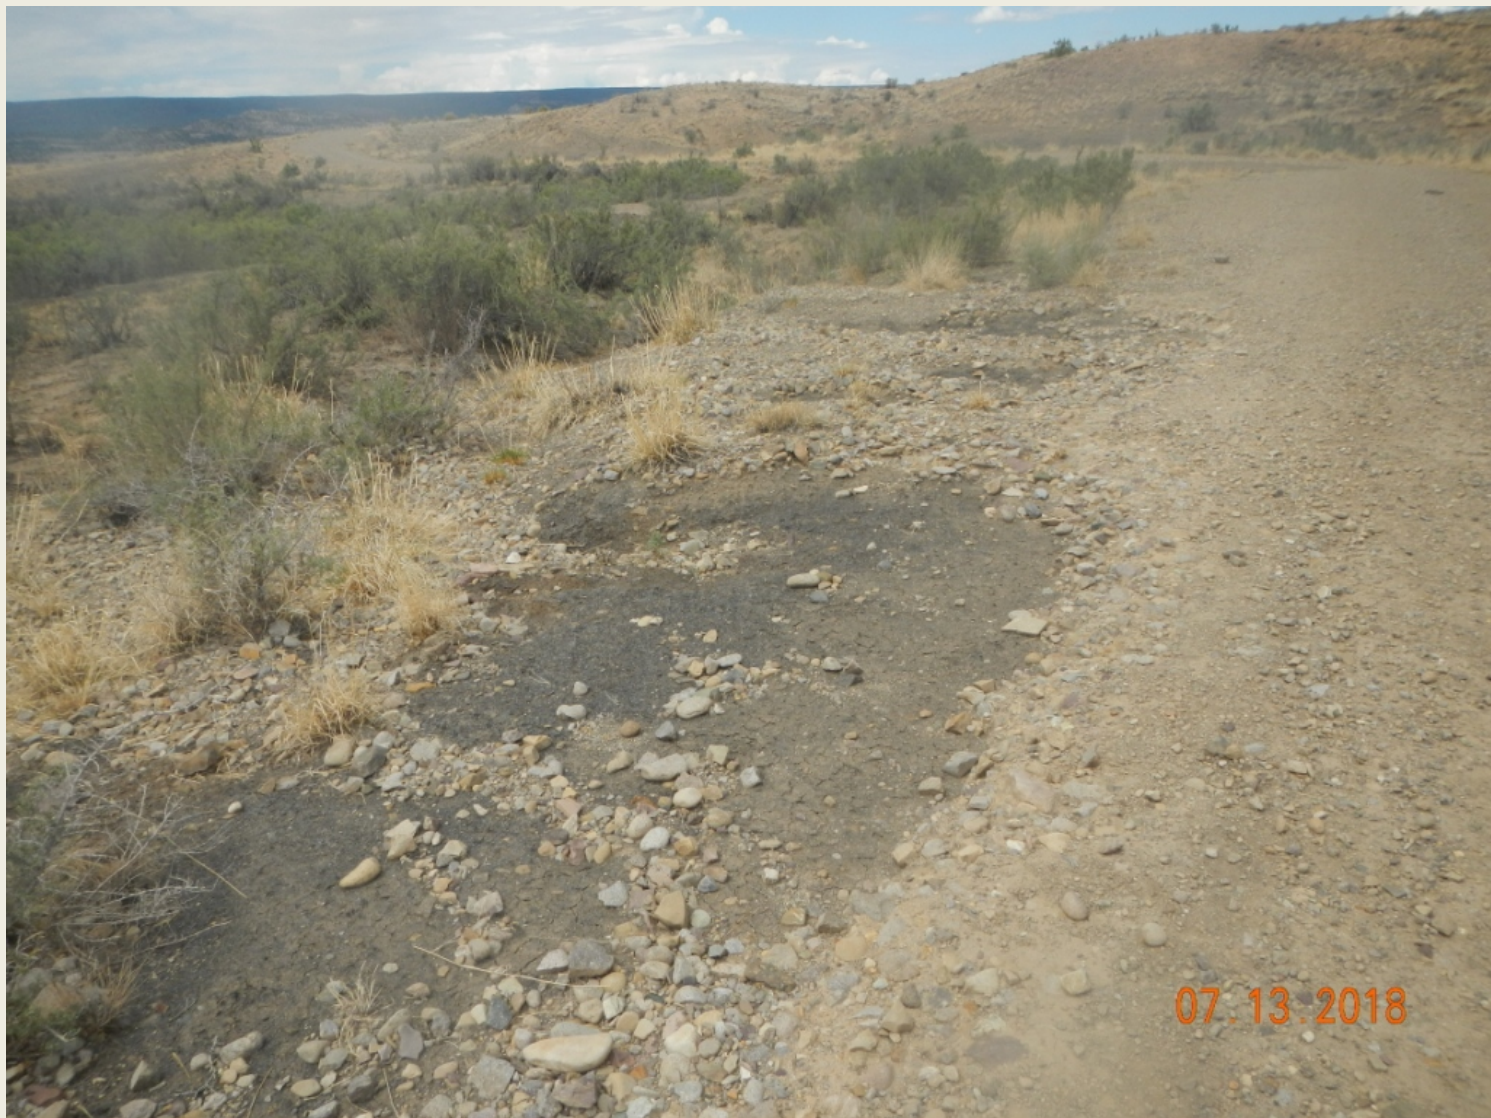
**Photo 4. View of area along the access road where it appears that stormwater flows over the road and erodes the road surface and shoulders, depositing debris downstream.**

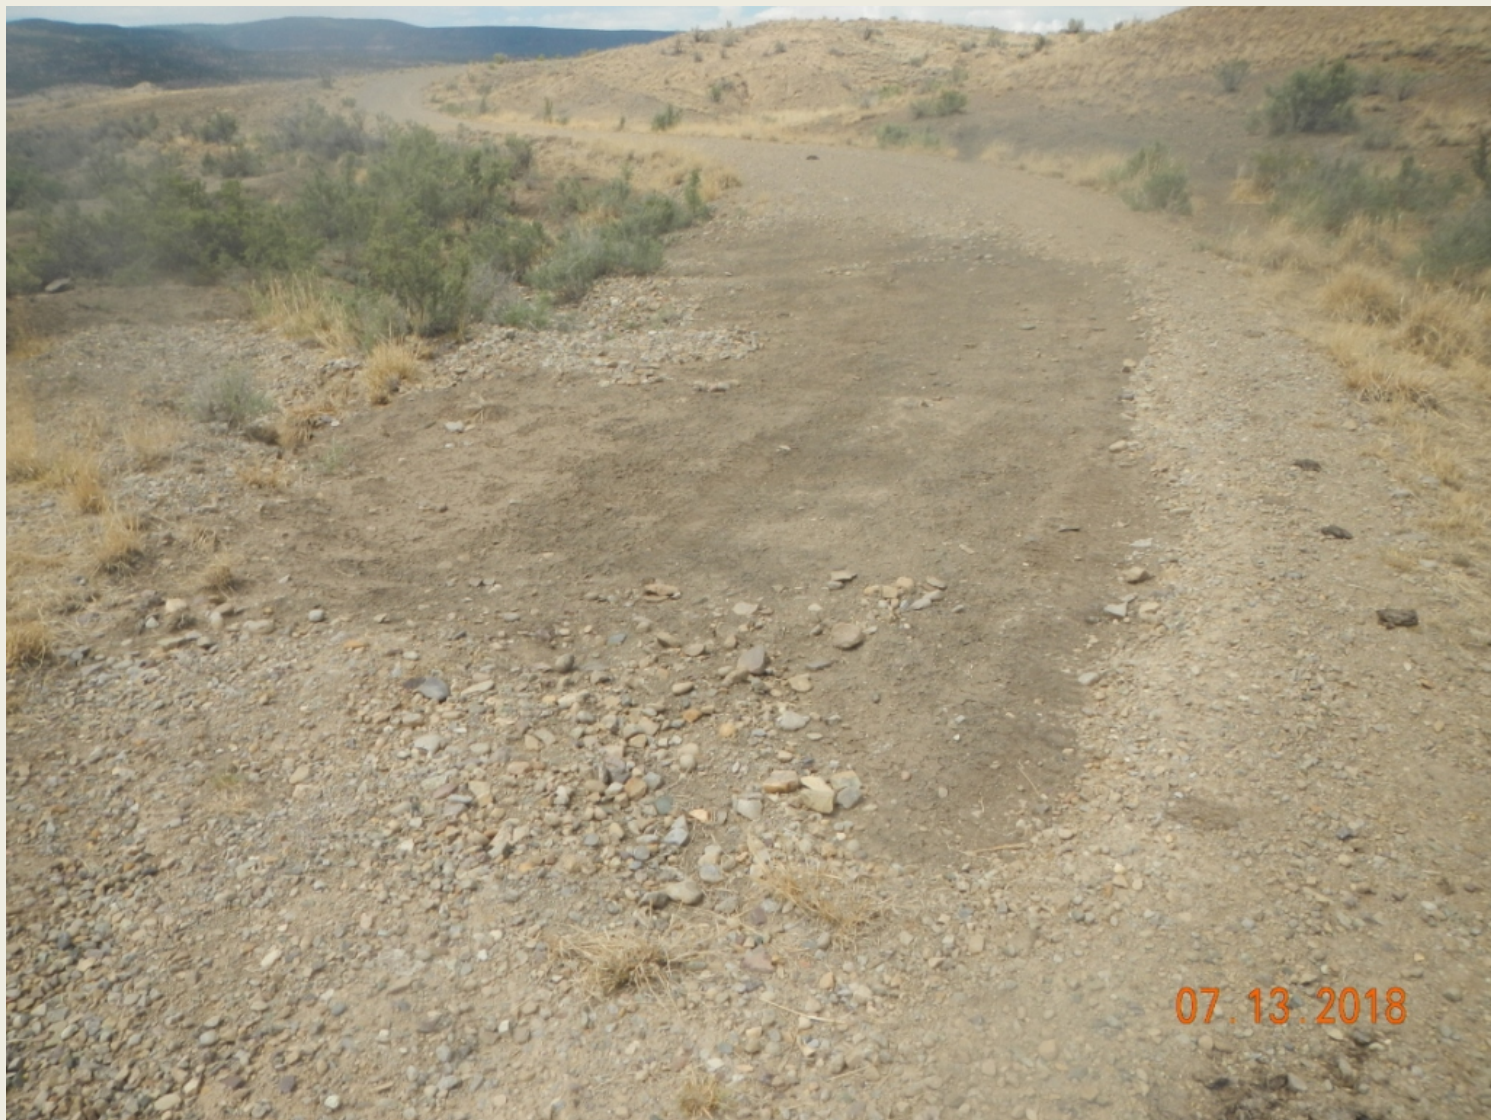
**Photo 5. View of another area along the access road where stormwater flows are eroding the road. Gravel is washed off of the road and deposited downstream.**

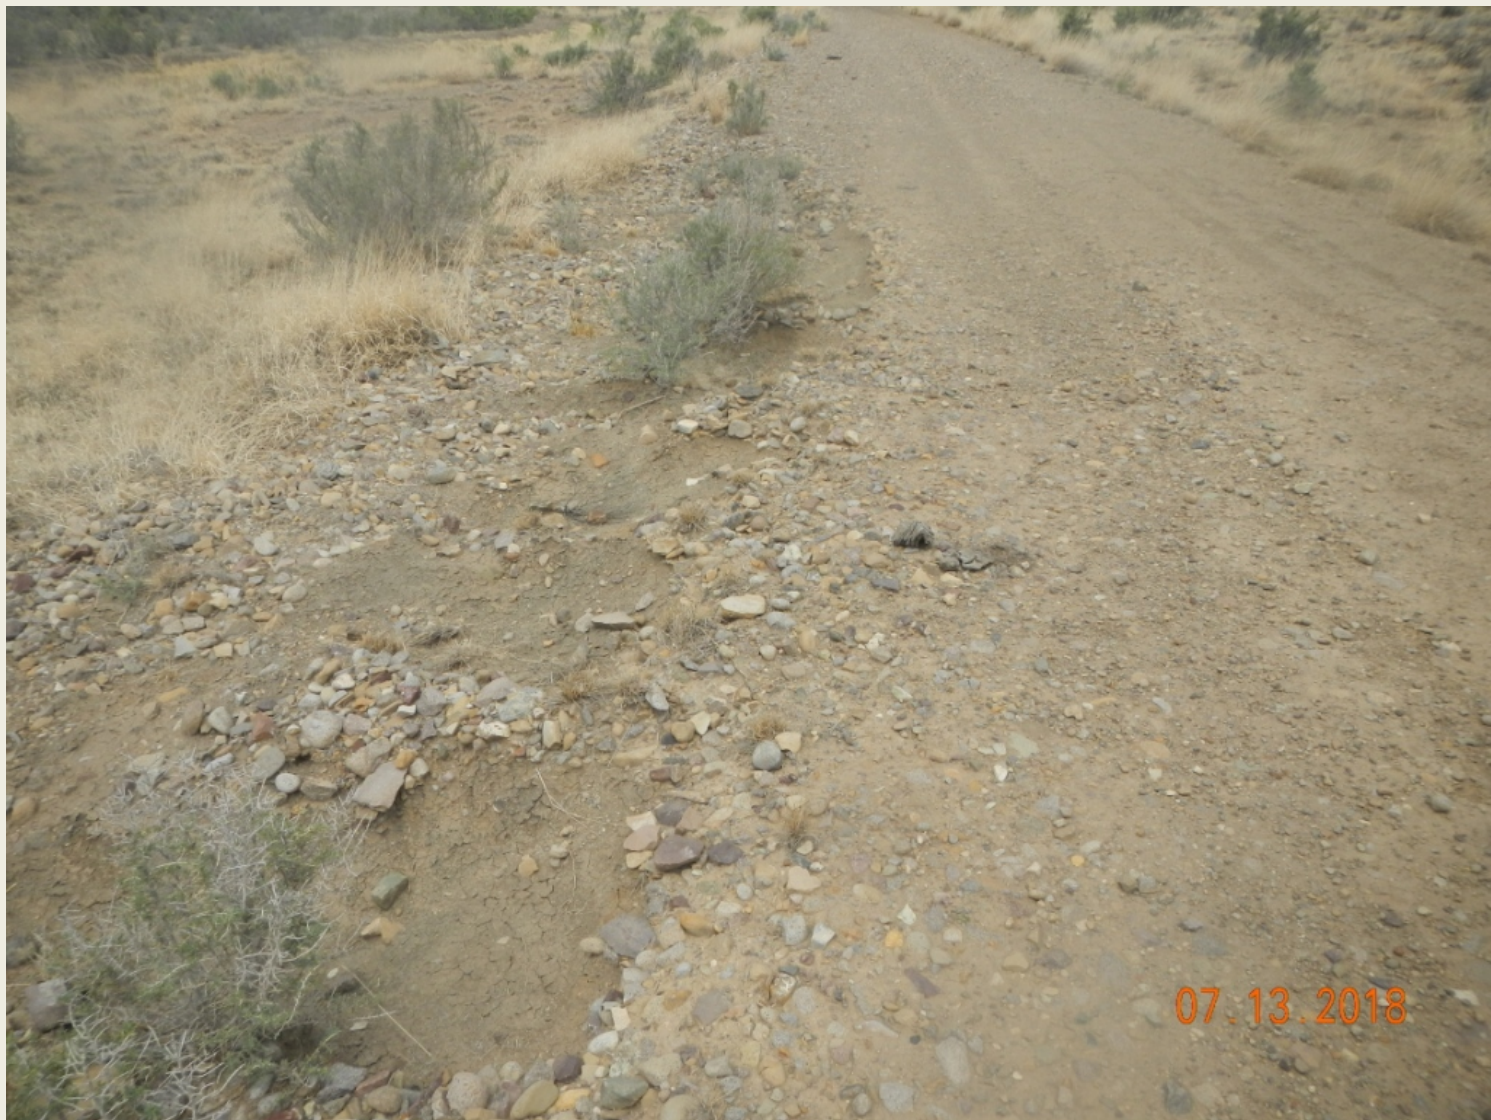
**Photo 6. View of another area along the access road where stormwater is eroding the road surface.**
