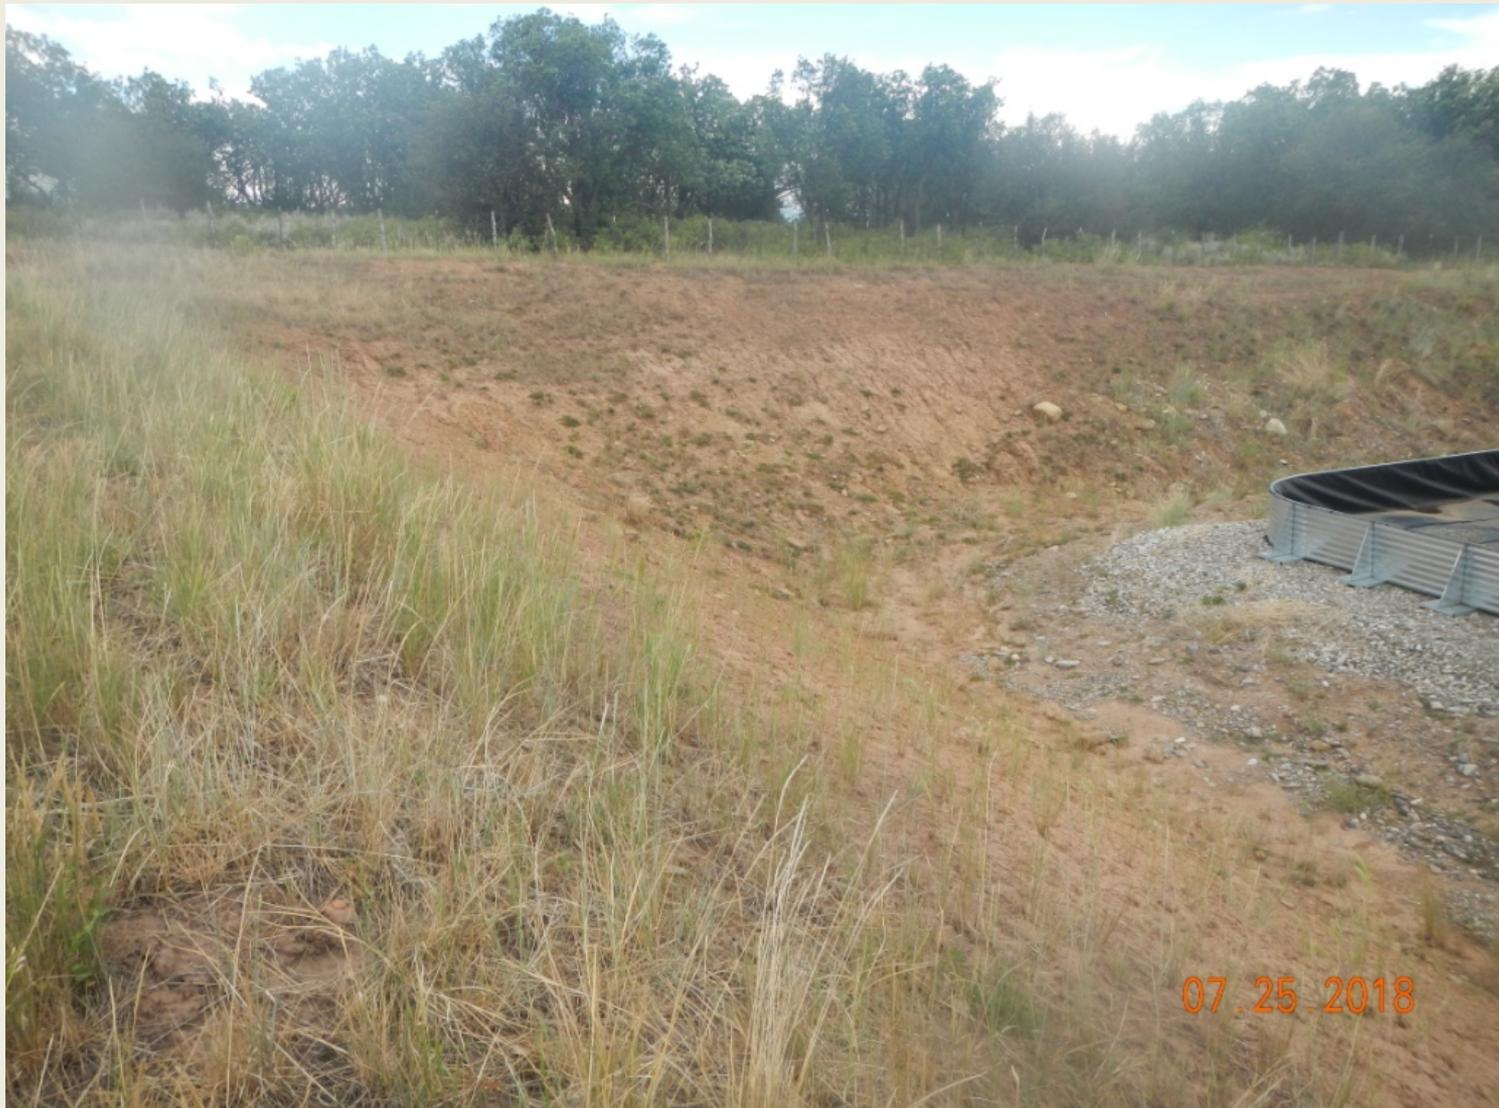
Photo 4. View of the northeastern cut-slope. Vegetation is progressing, but rilling is occurring here.

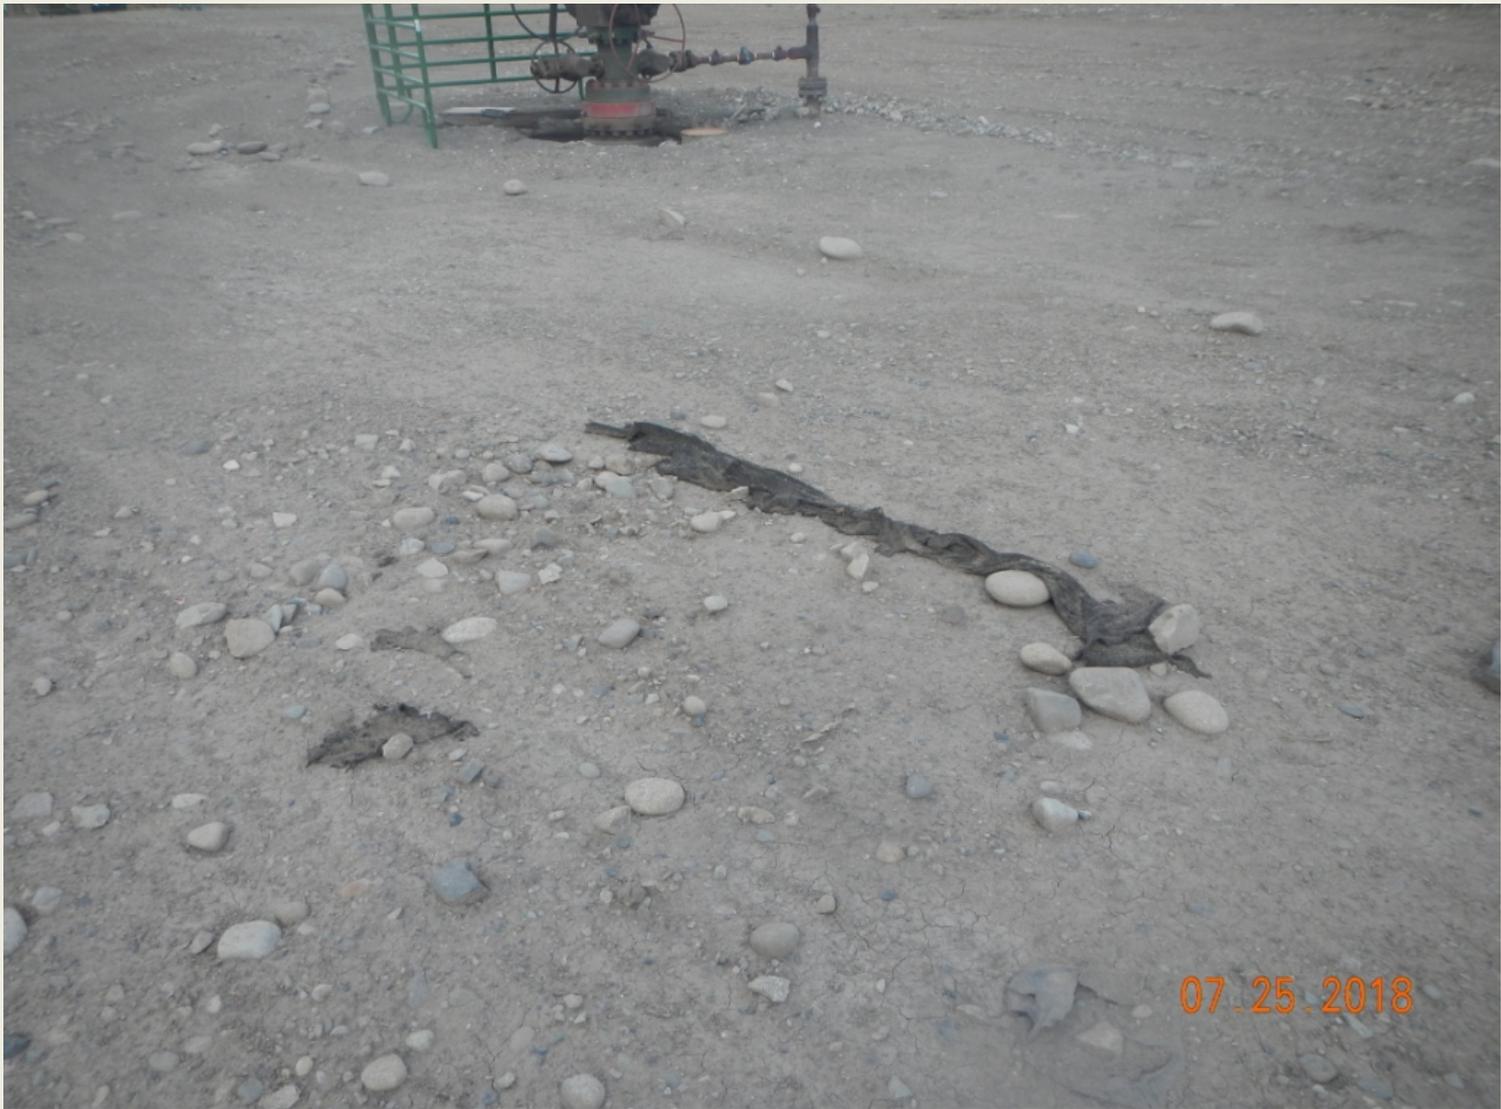
Photo 5. View of trash/debris on the well pad.

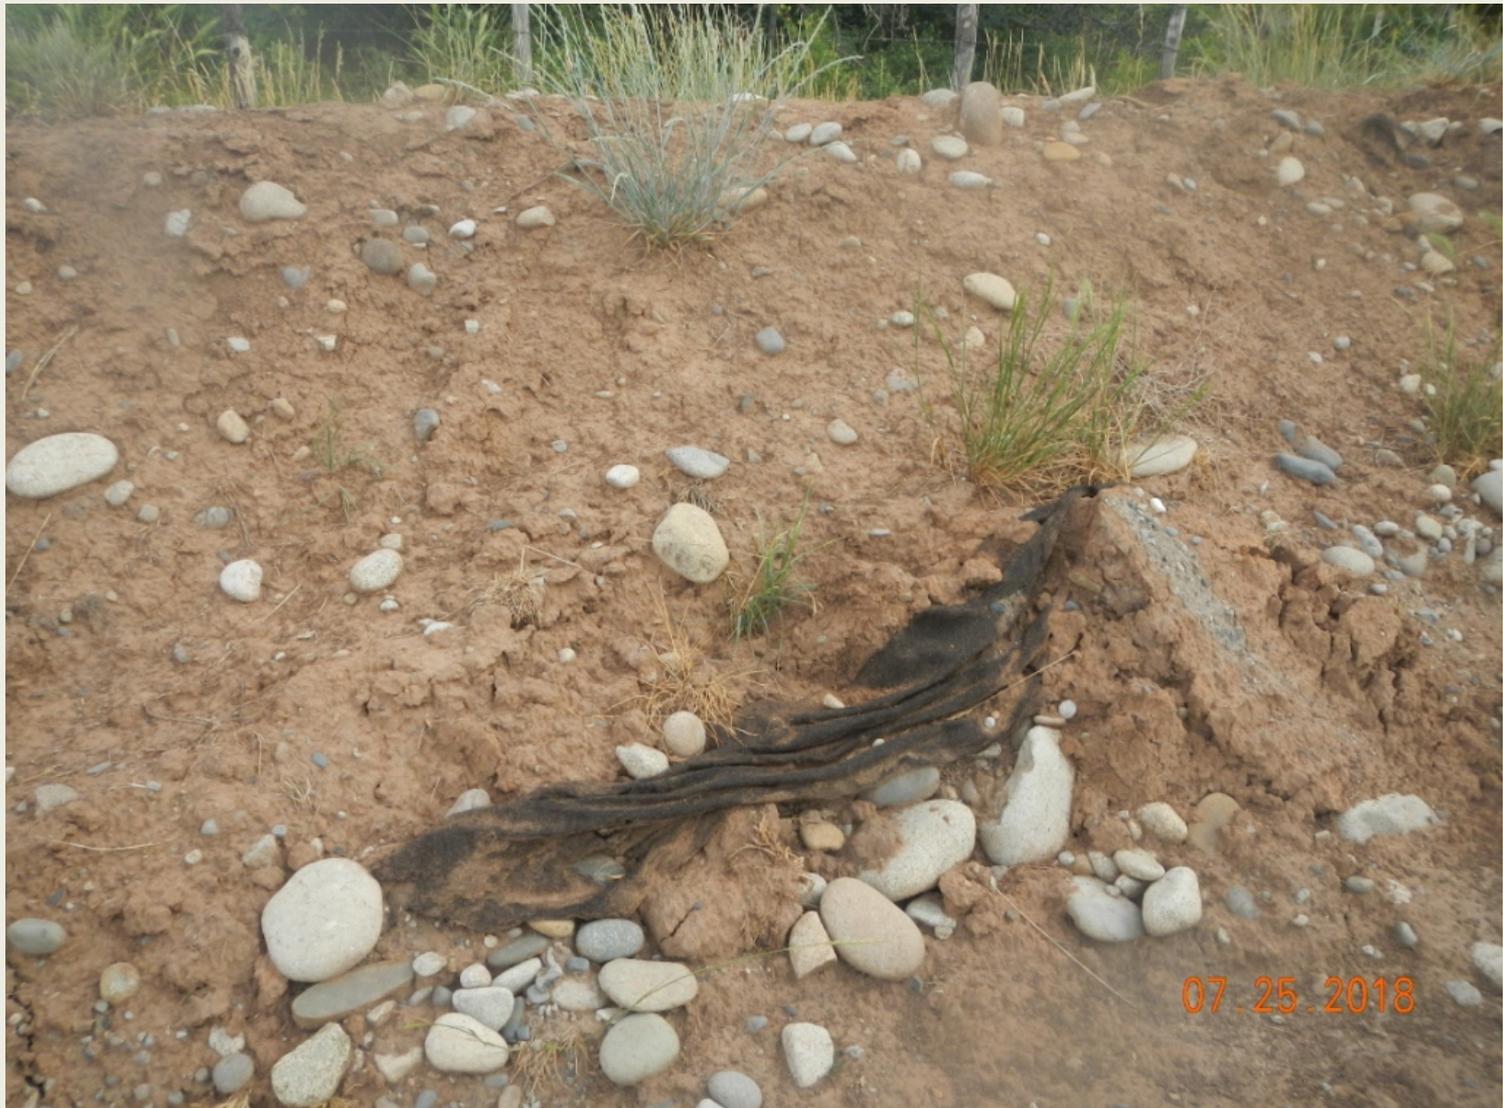
Photo 6. View of more trash/debris in the southeastern cut-slope.

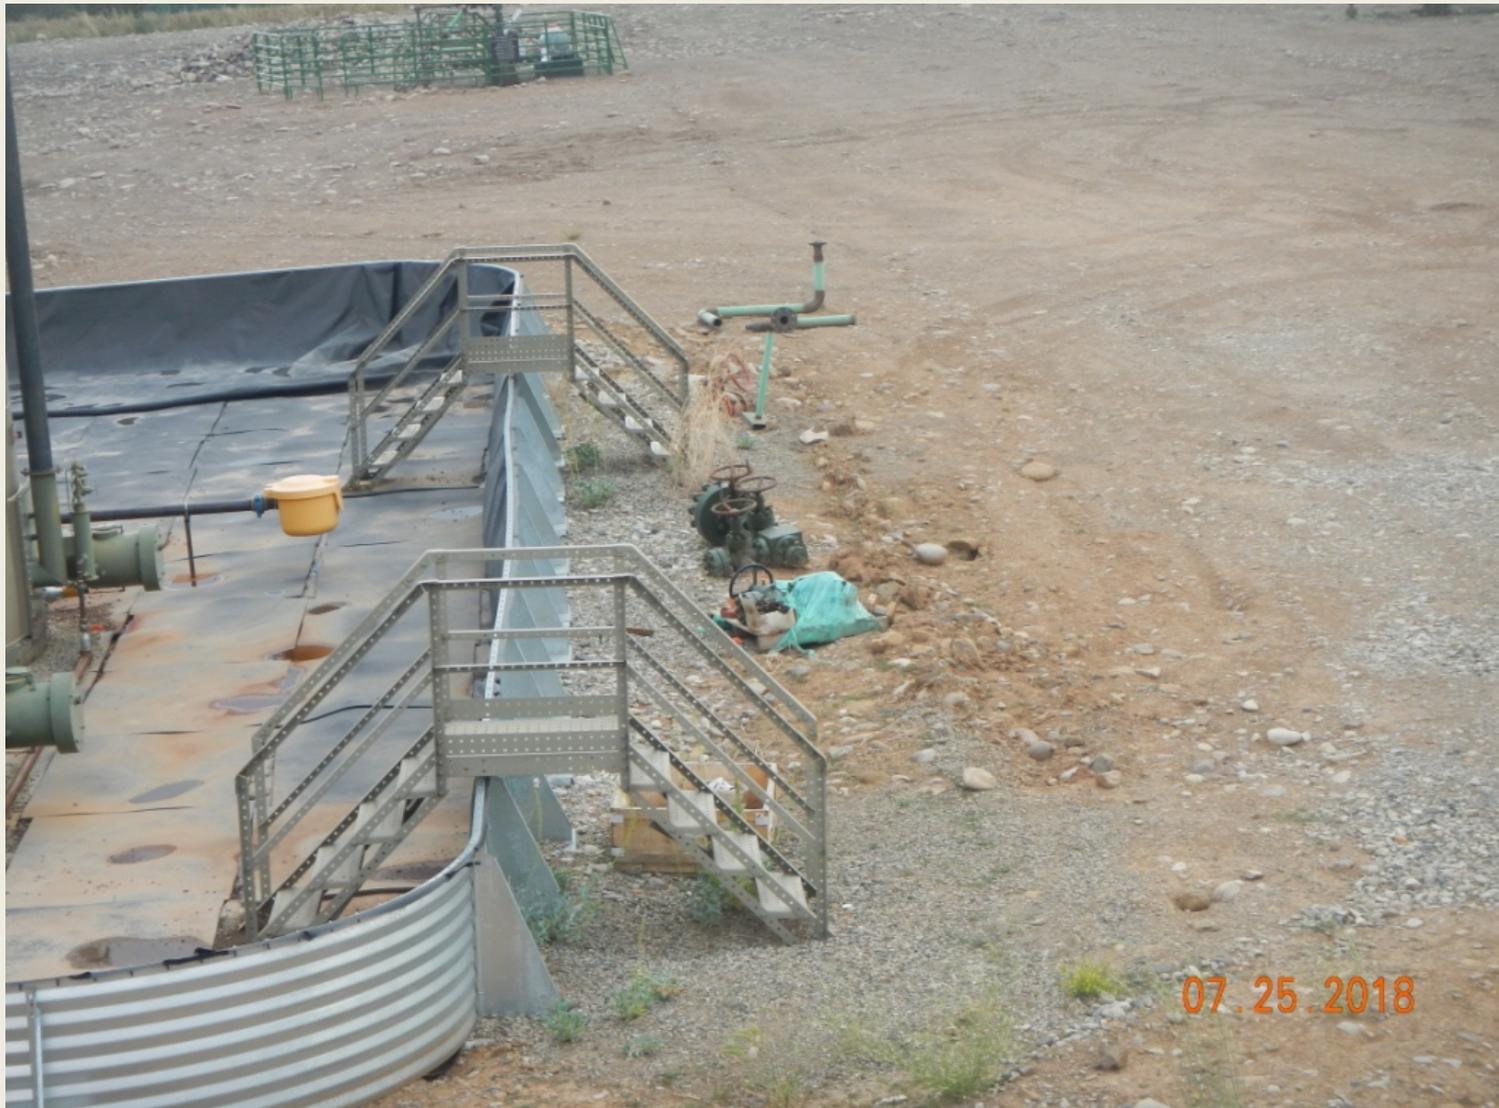
Photo 5. View unused equipment within the project area.
