Interim Reclamation and Stormwater Inspection

Operator: BURLINGTON RESOURCES OIL & GAS LP- #26580

Location ID: 449376

Inspection Photos
Location Name: Aspen 3-65 15-14 /2DH
Location ID: 449376

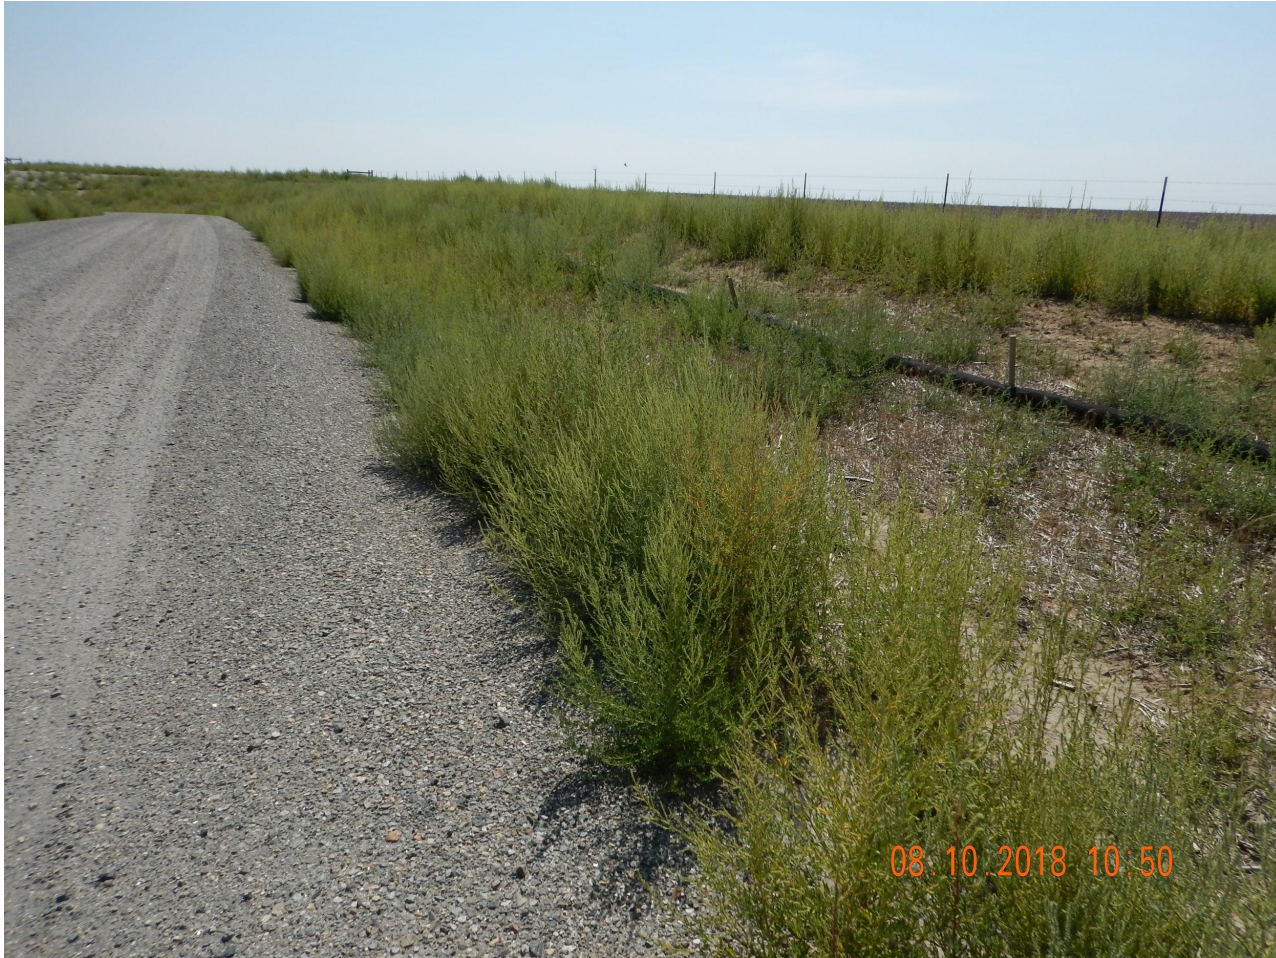
Photo 1. Photo taken from the entrance of the location, facing East. Operator has failed to manage and control Kochia and Russian thistle throughout the entire location, minus the compacted graveled areas. Germination of grass species was observed within the weed growth but an assessment was not made throughout due to the high density of weeds.

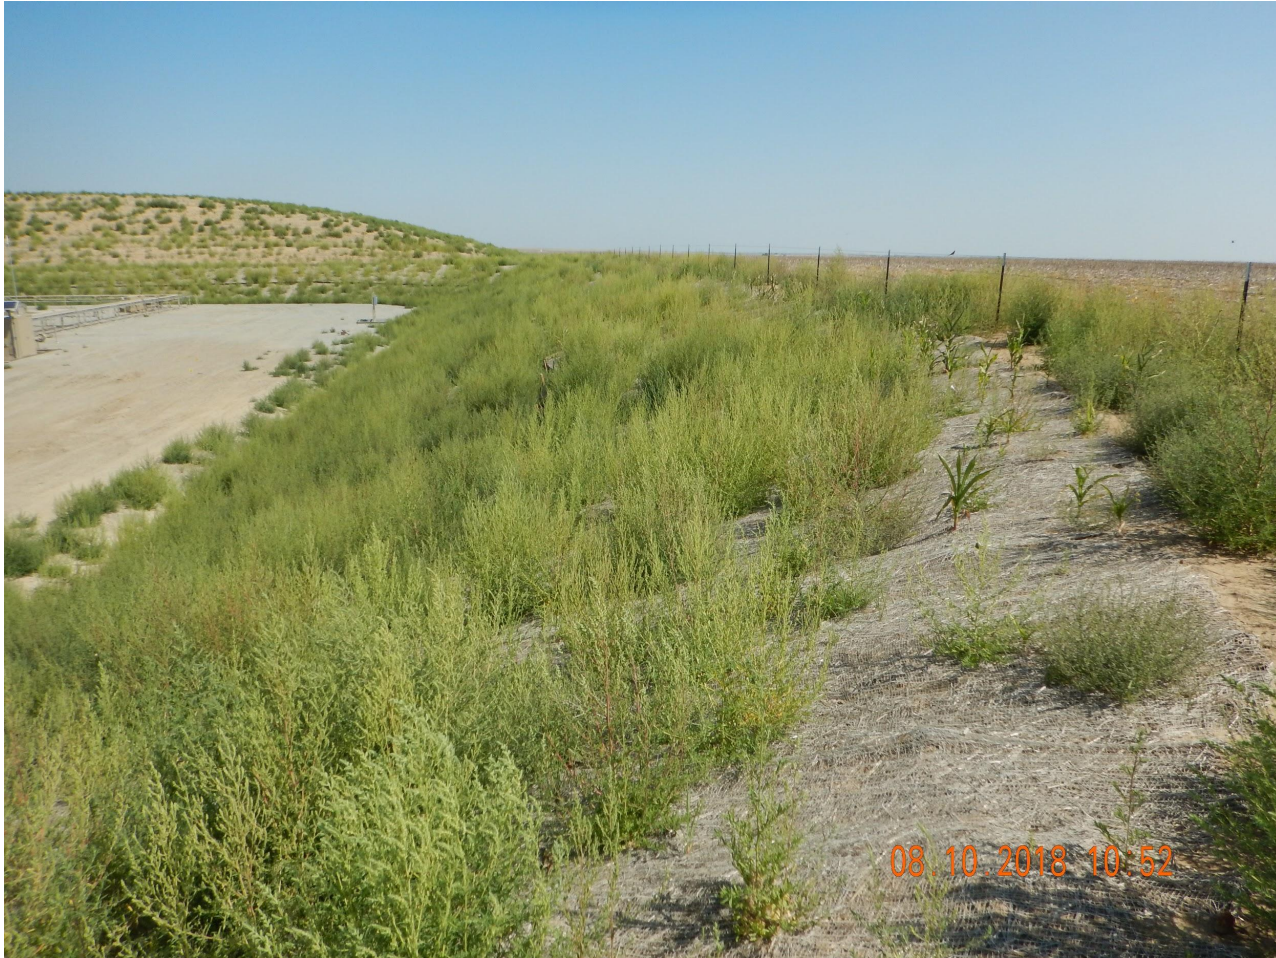
Photo 2. Photo taken from the southeastern perimeter of the location, facing North. See comments under Photo 1. Photo also illustrates erosion control blankets which have been installed along portions of cut slopes.

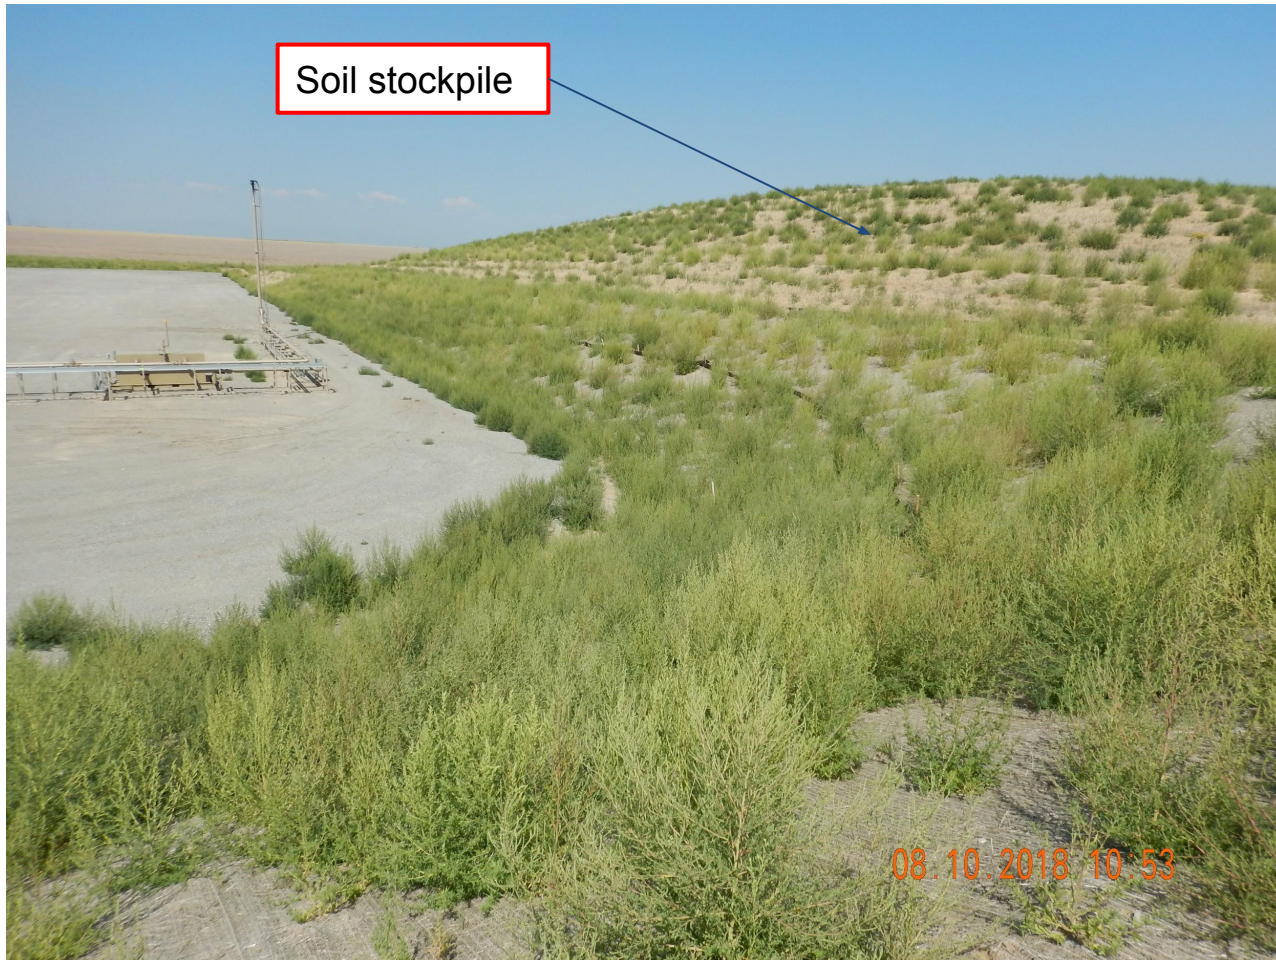
Photo 3. Photo taken from the eastern perimeter of the location, facing West. See comments under Photo 2. Photo also illustrates weed establishment on the soil stockpile which is not in compliance with Rule 1002.c.

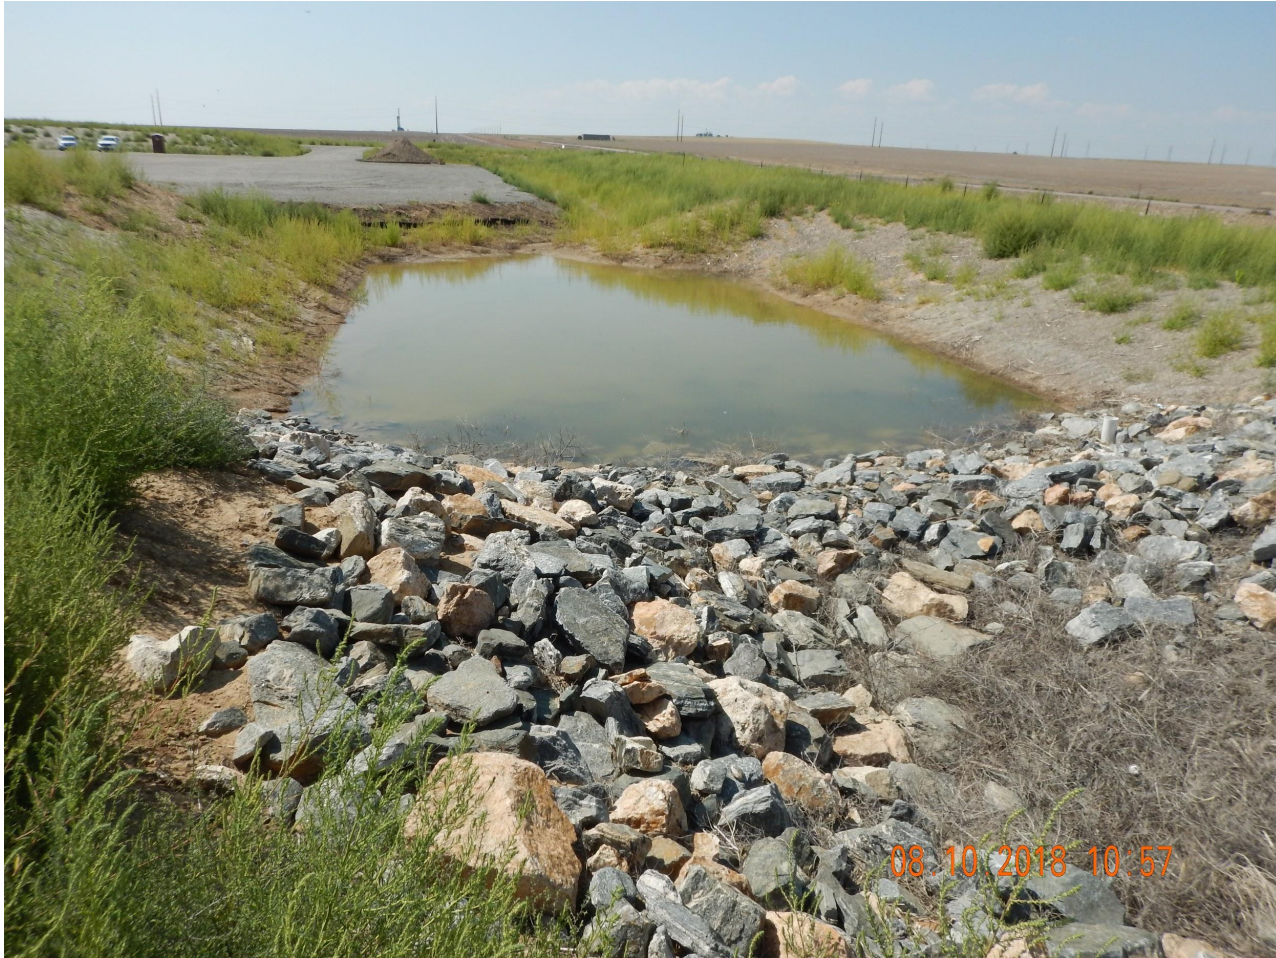
Photo 4. Photo taken from the northwestern location, facing South. Sediment basin appears to be properly functioning. No sediment discharge was observed off location.

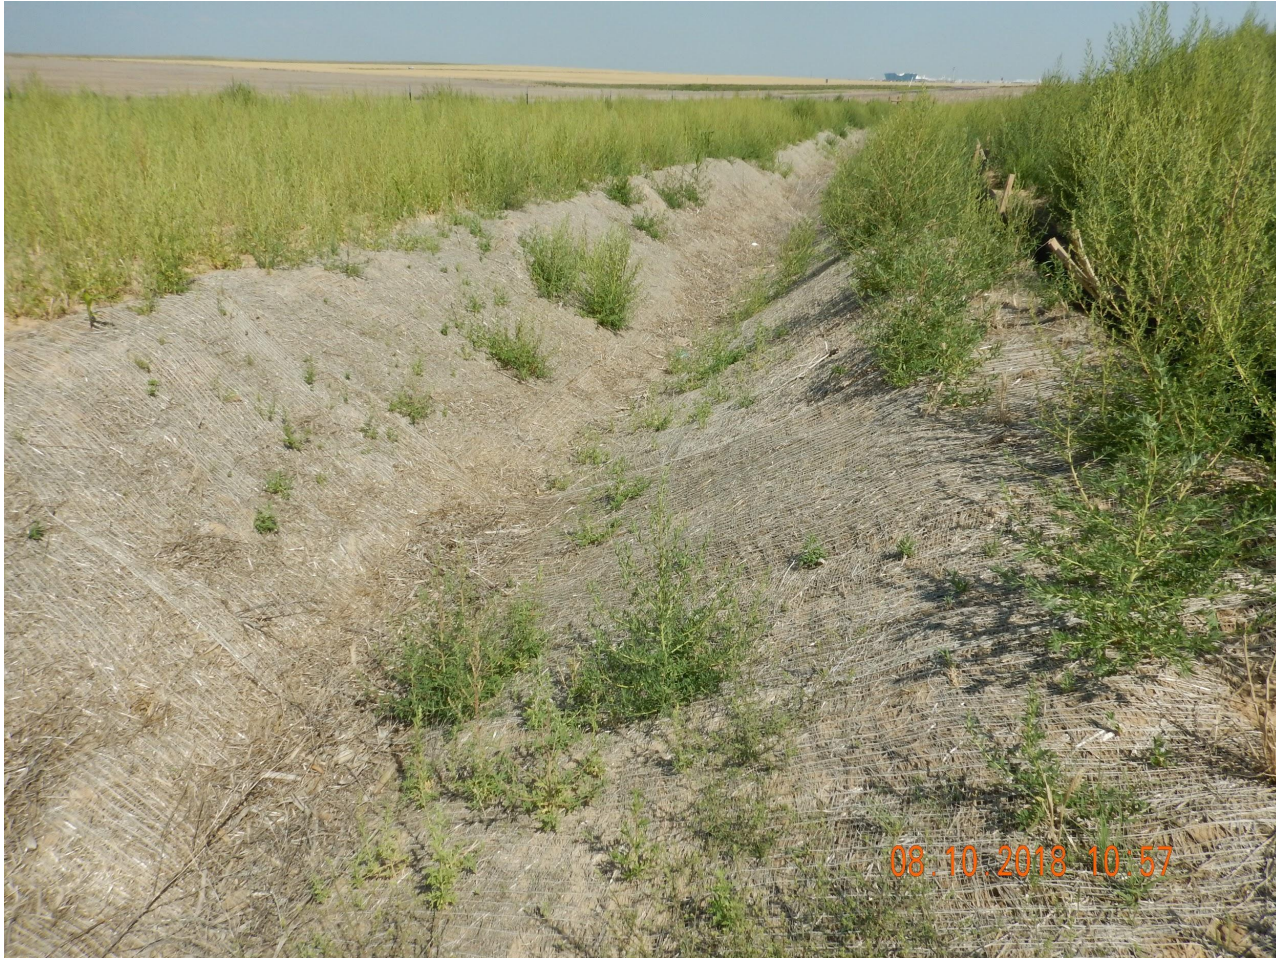
Photo 5. Photo taken from the northwestern location, facing North. Operator has installed a stabilized ditch outlet area from the sediment basin. Photo also illustrates Kochia and Russian thistle weeds.

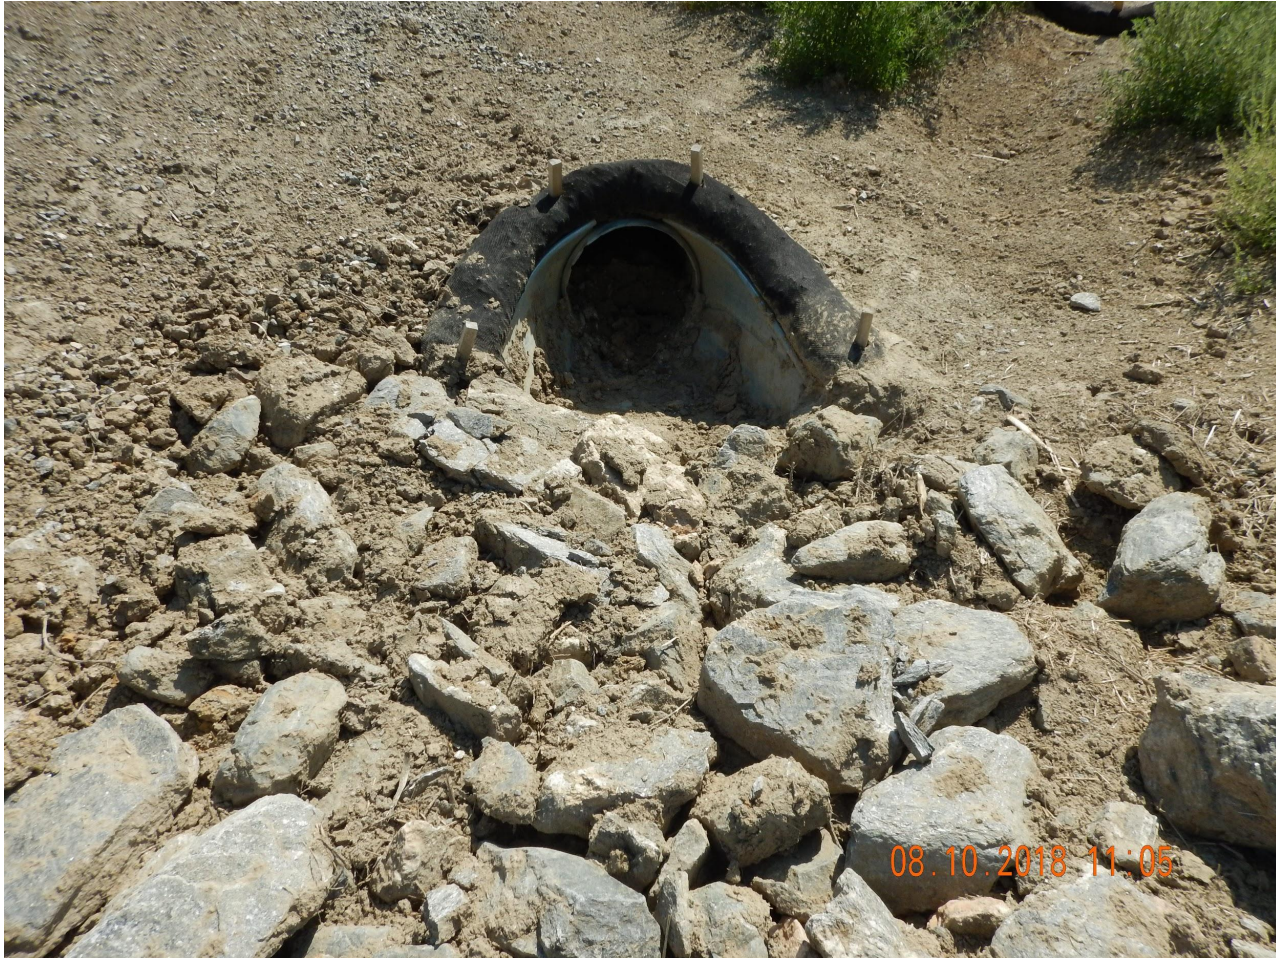
Photo 6. Photo taken from the entrance of the location, facing East. Culvert in need of maintenance, as material appears to have filled in. Riprap outlet material appears to need maintenance.
