Inspection Photos

08/14/2018

Operator: RUNNING FOXES PETROLEUM INC -
10221

Inspection Doc. Number: 682503720
Lincoln County, CO

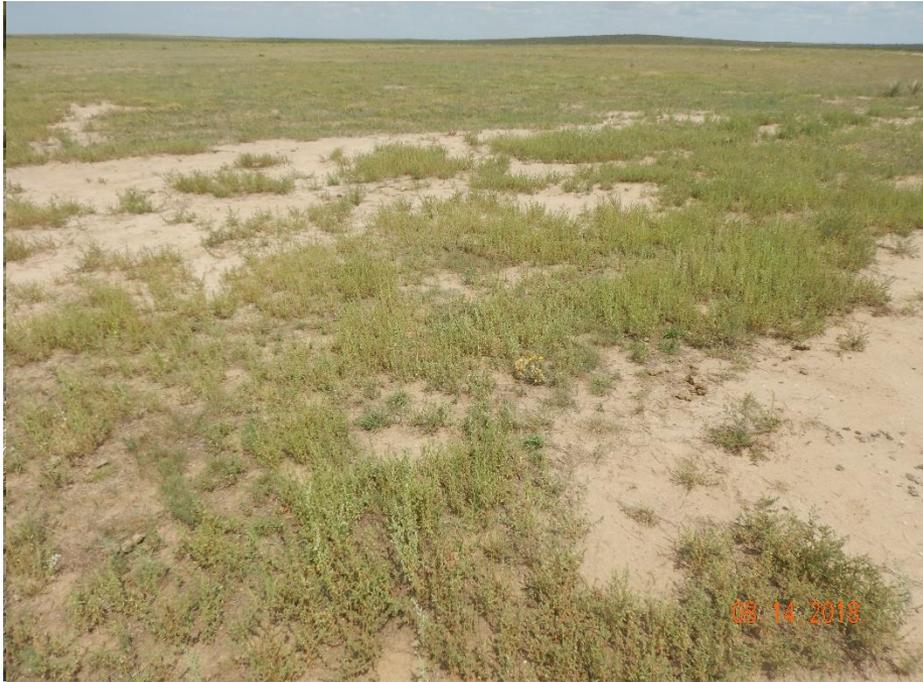
Photo 1: Photo taken from the location, facing north. Photo shows vegetation over the reclamation area.

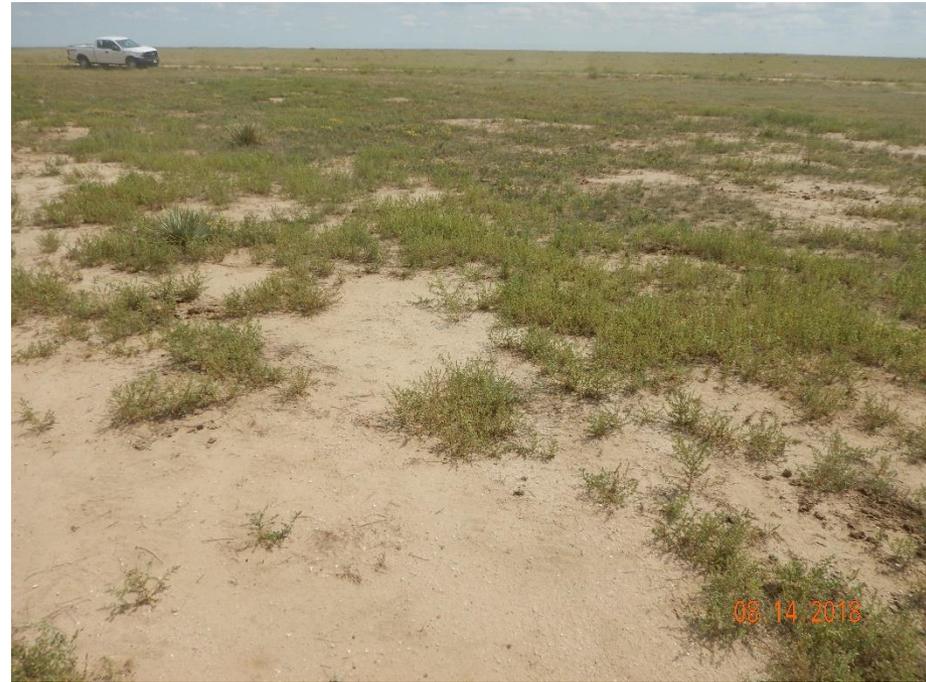
Photo 2: Photo taken from the location, facing east. Photo shows vegetation over the reclamation area.

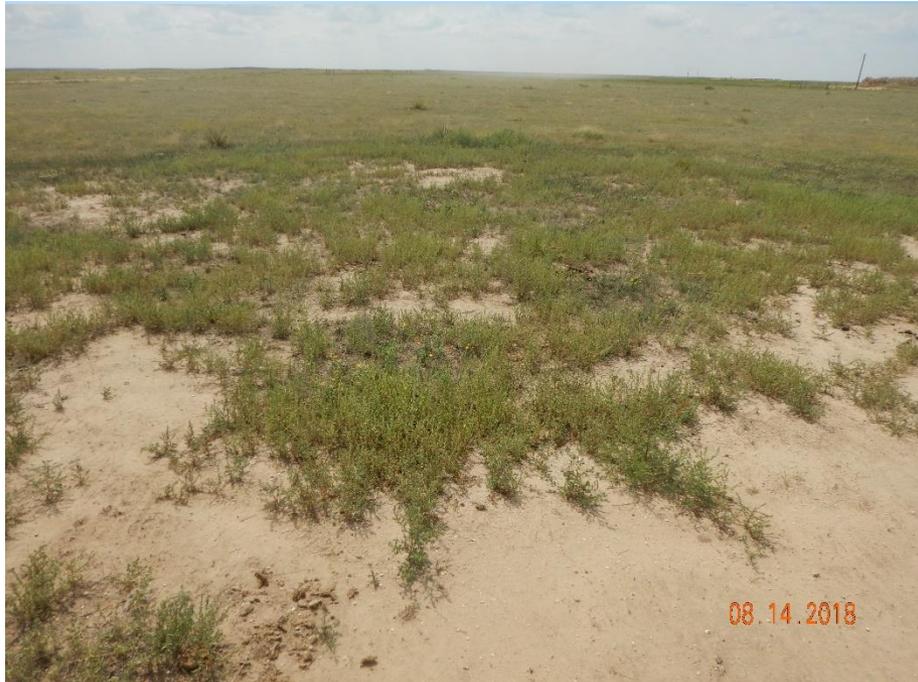
Photo 3: Photo taken from the location, facing south. Photo shows vegetation over the reclamation area.

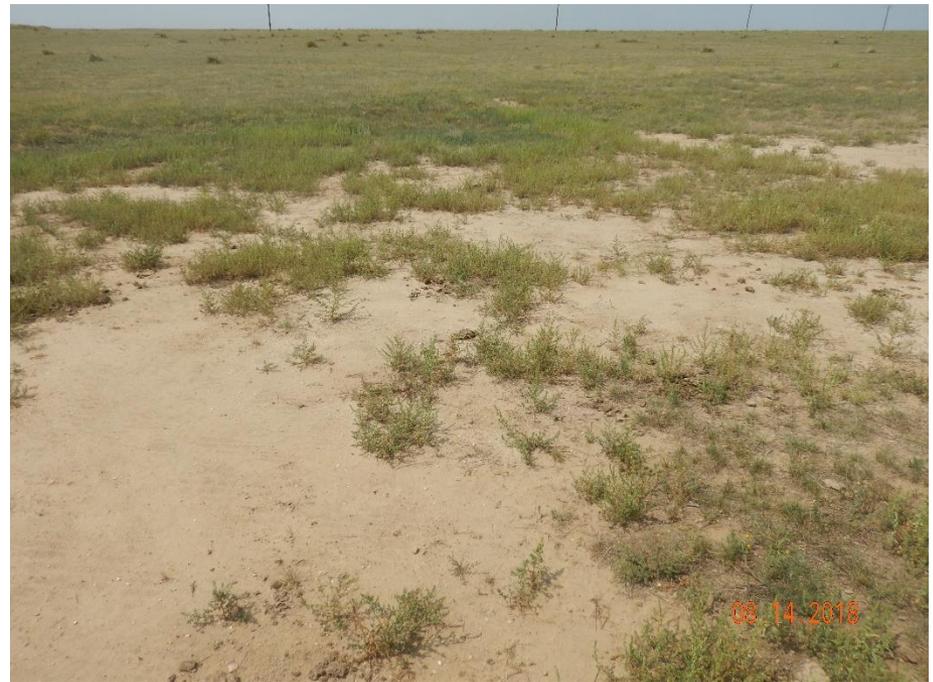
Photo 4: Photo taken from the location, facing west. Photo shows vegetation over the reclamation area.

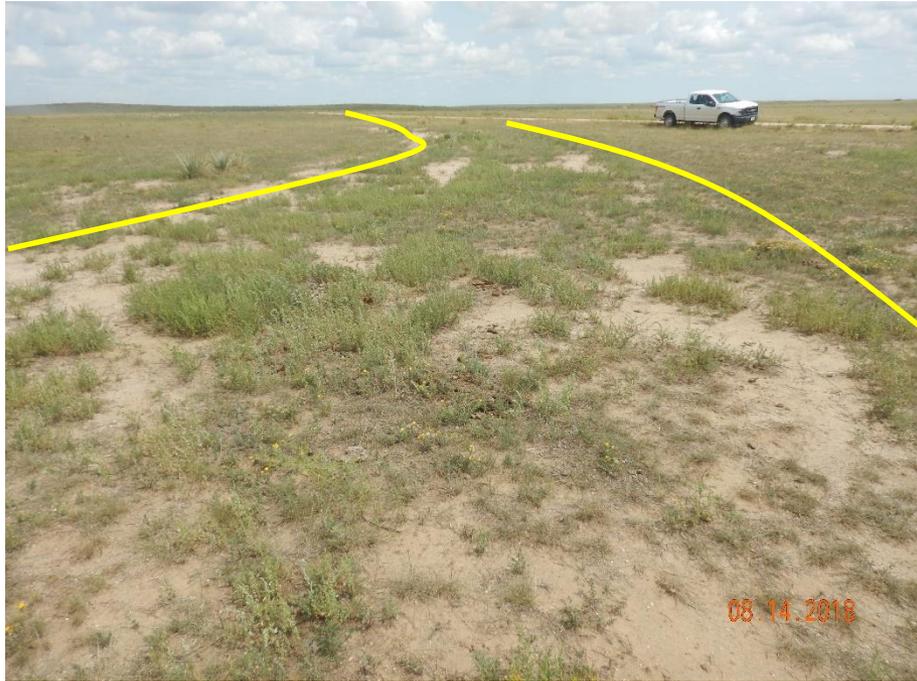
Photo 5: Photo taken from what appears to have been the former access road, facing northeast.

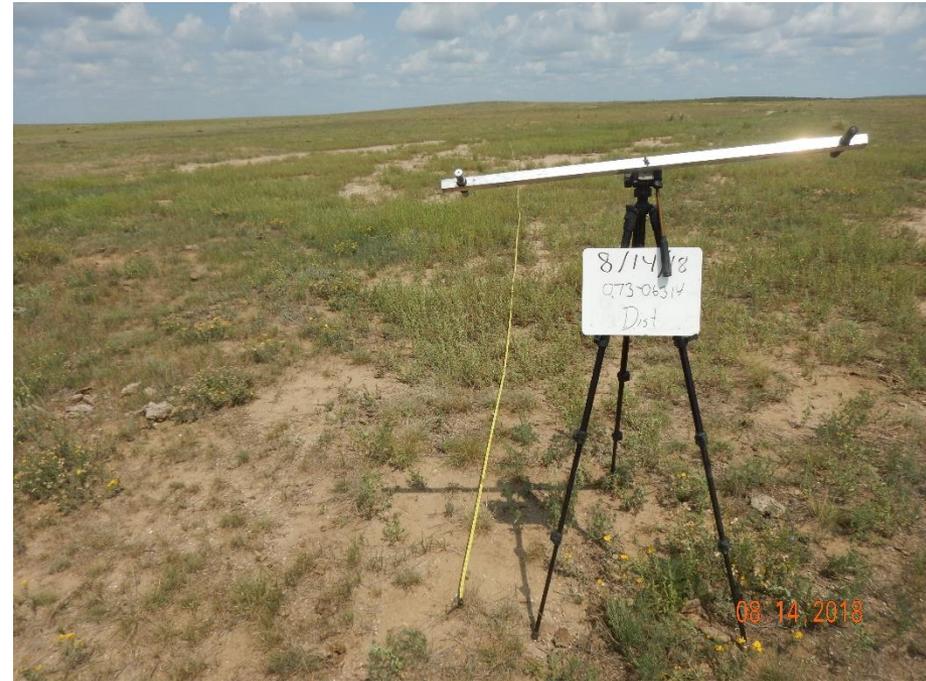
Photo 6: Photo taken from the location, facing north. Photo shows the starting point for the **DISTURBANCE AREA** transect.

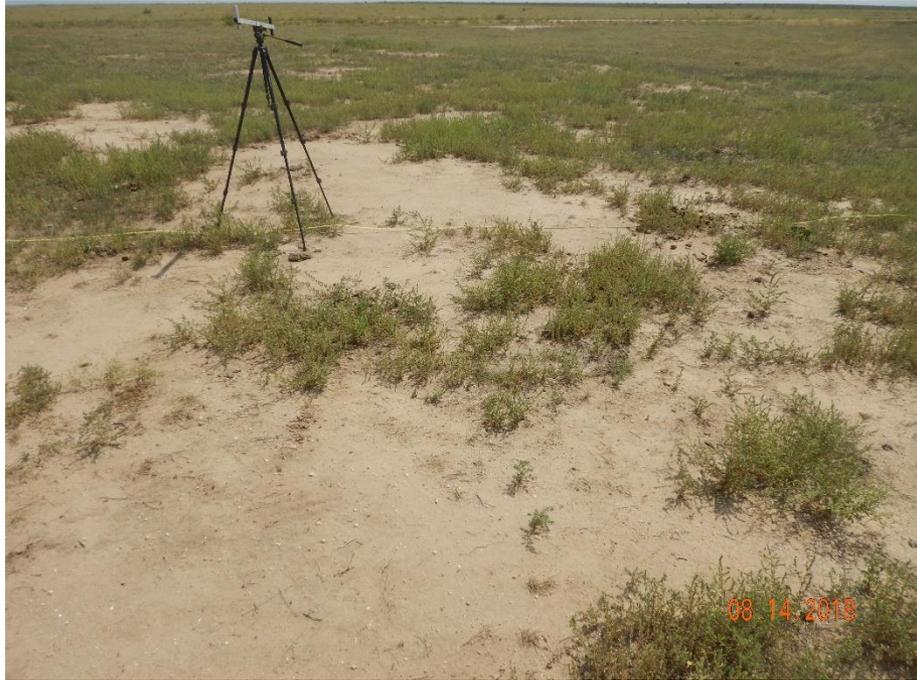
Photo 7: Photo taken from the 50th point of the **DISTURBANCE AREA** transect, facing east.

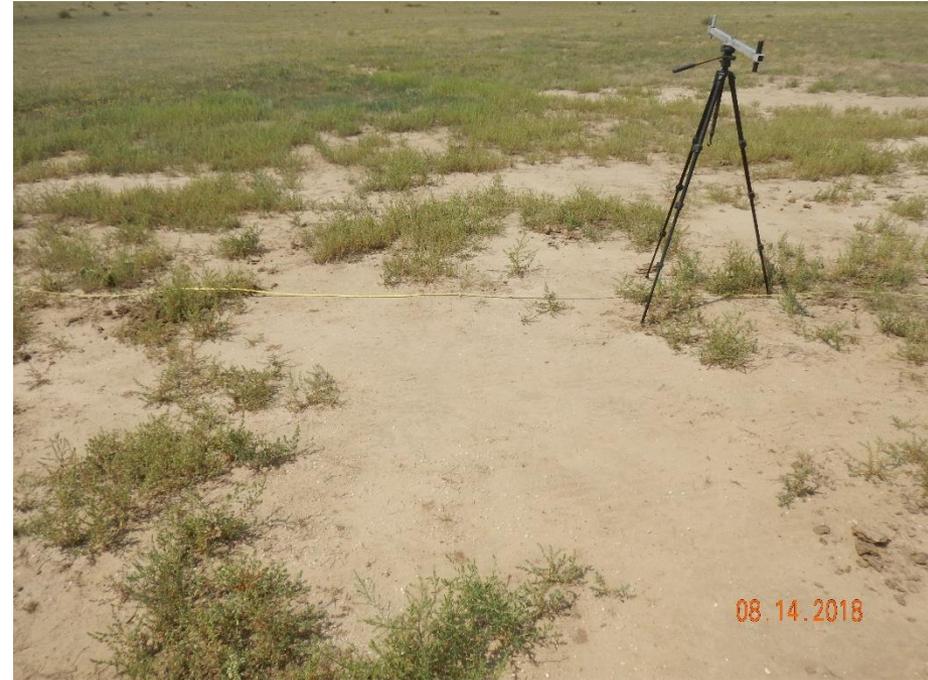
Photo 8: Photo taken from the 50th point of the **DISTURBANCE AREA** transect, facing west.

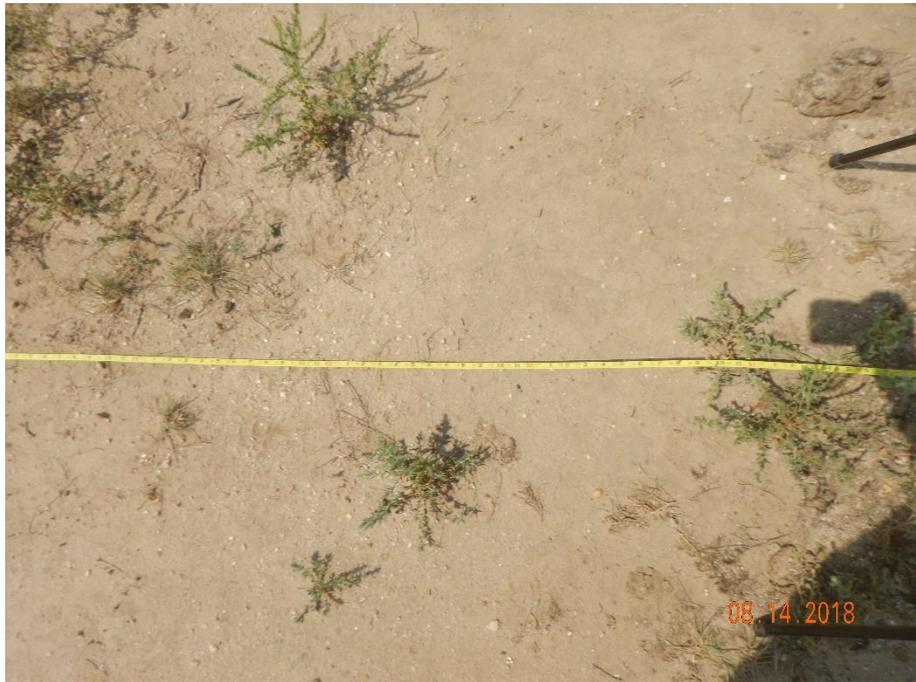
Photo 9: Photo taken from the 50th point of the **DISTURBANCE AREA**.

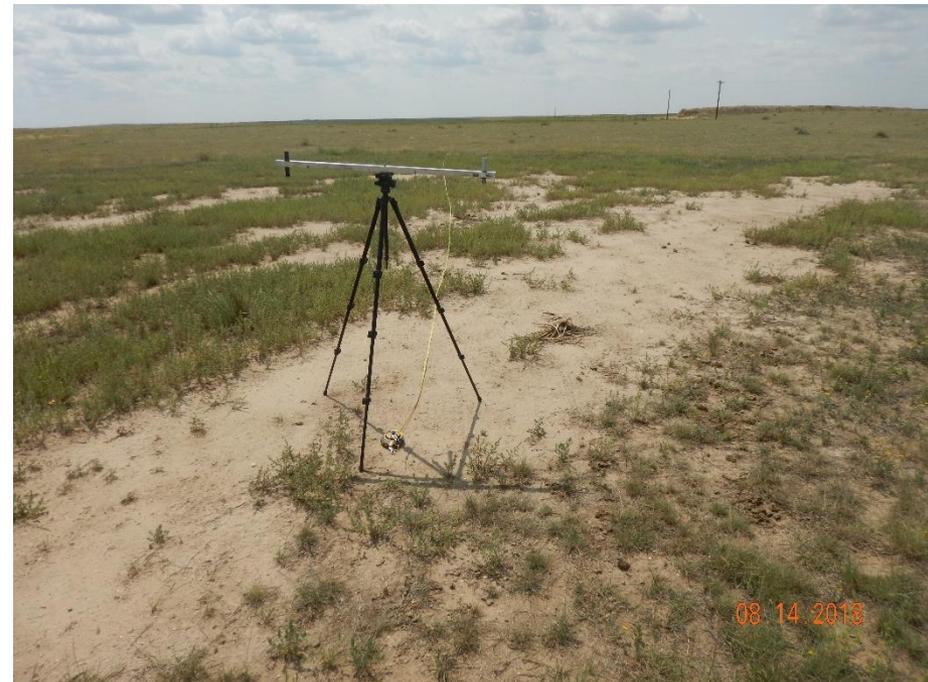
Photo 10: Photo taken from the location, facing south. Photo shows the end point for the **DISTURBANCE AREA** transect.

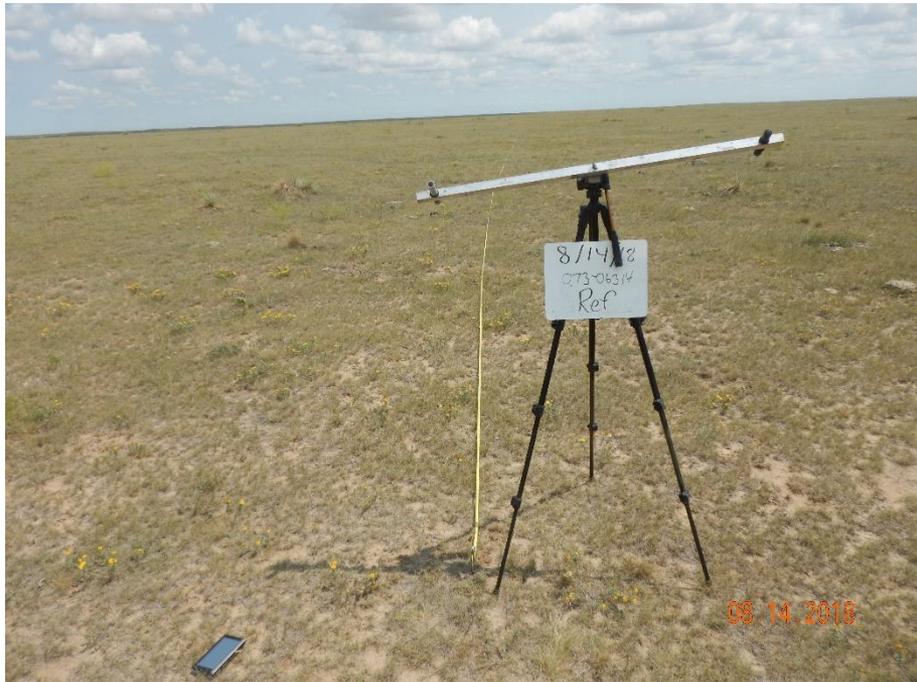
Photo 11: Photo taken from the adjacent reference, facing east. Photo shows the starting point for the **REFERENCE AREA** transect.

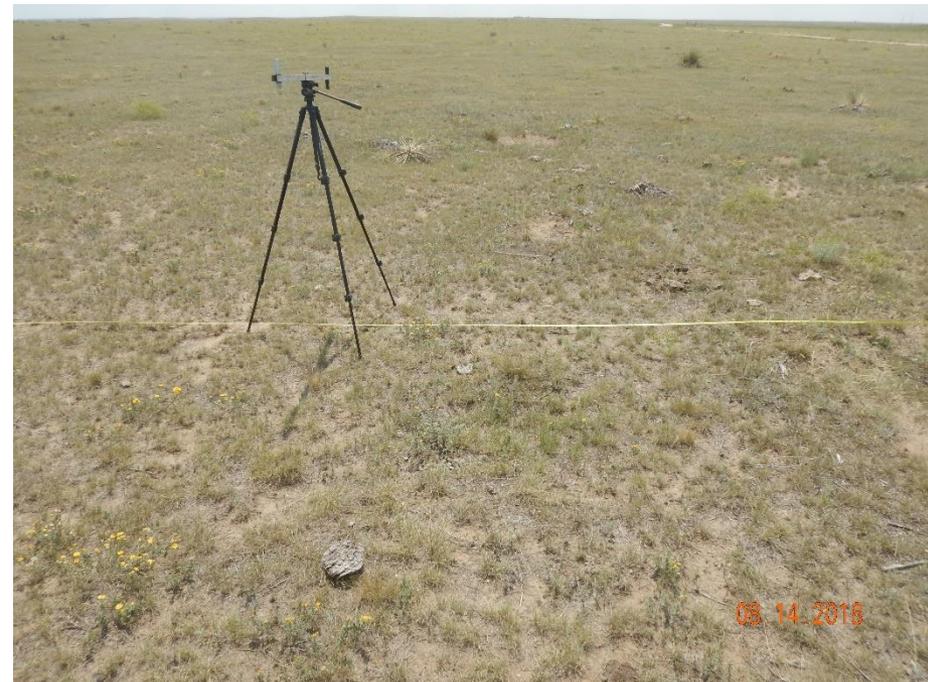
Photo 12: Photo taken from the 50th point of the **REFERENCE AREA** transect, facing South.

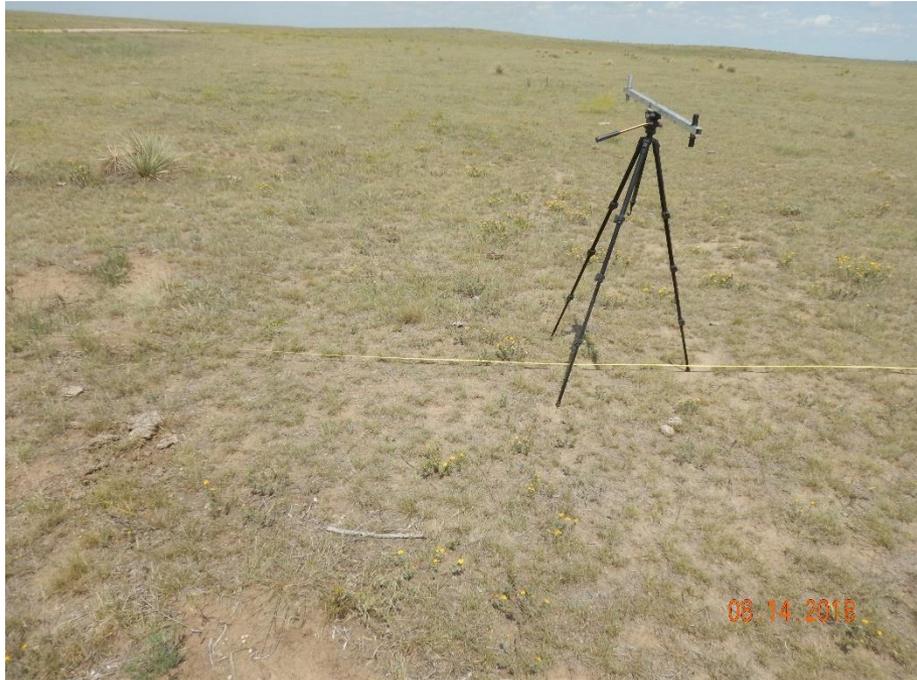
Photo 13: Photo taken from the 50th point of the **REFERENCE AREA** transect, facing North.

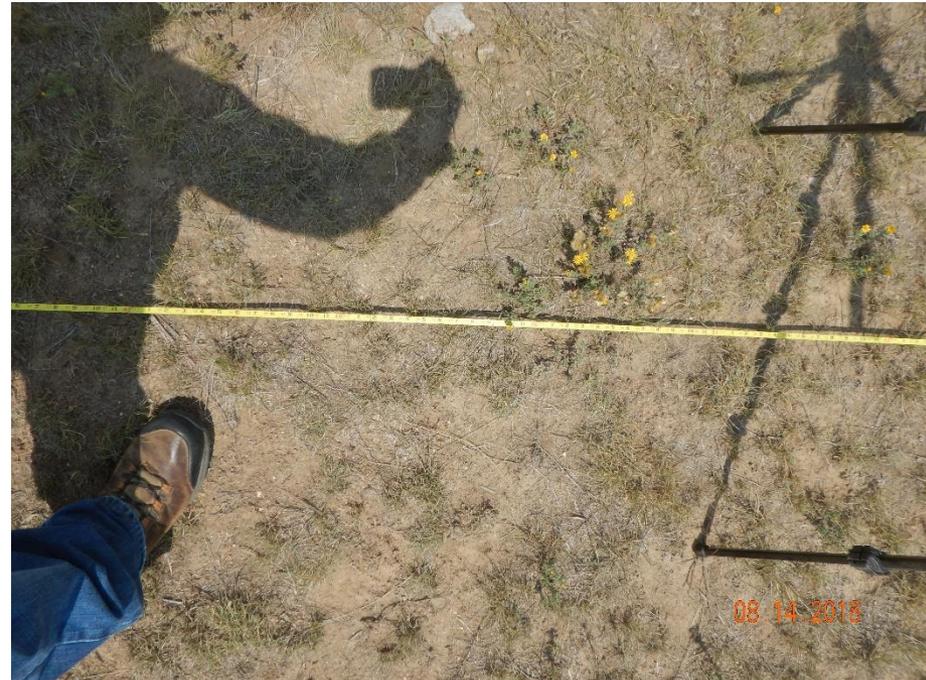
Photo 14: Photo taken from the 50th point of the **REFERENCE AREA** transect.

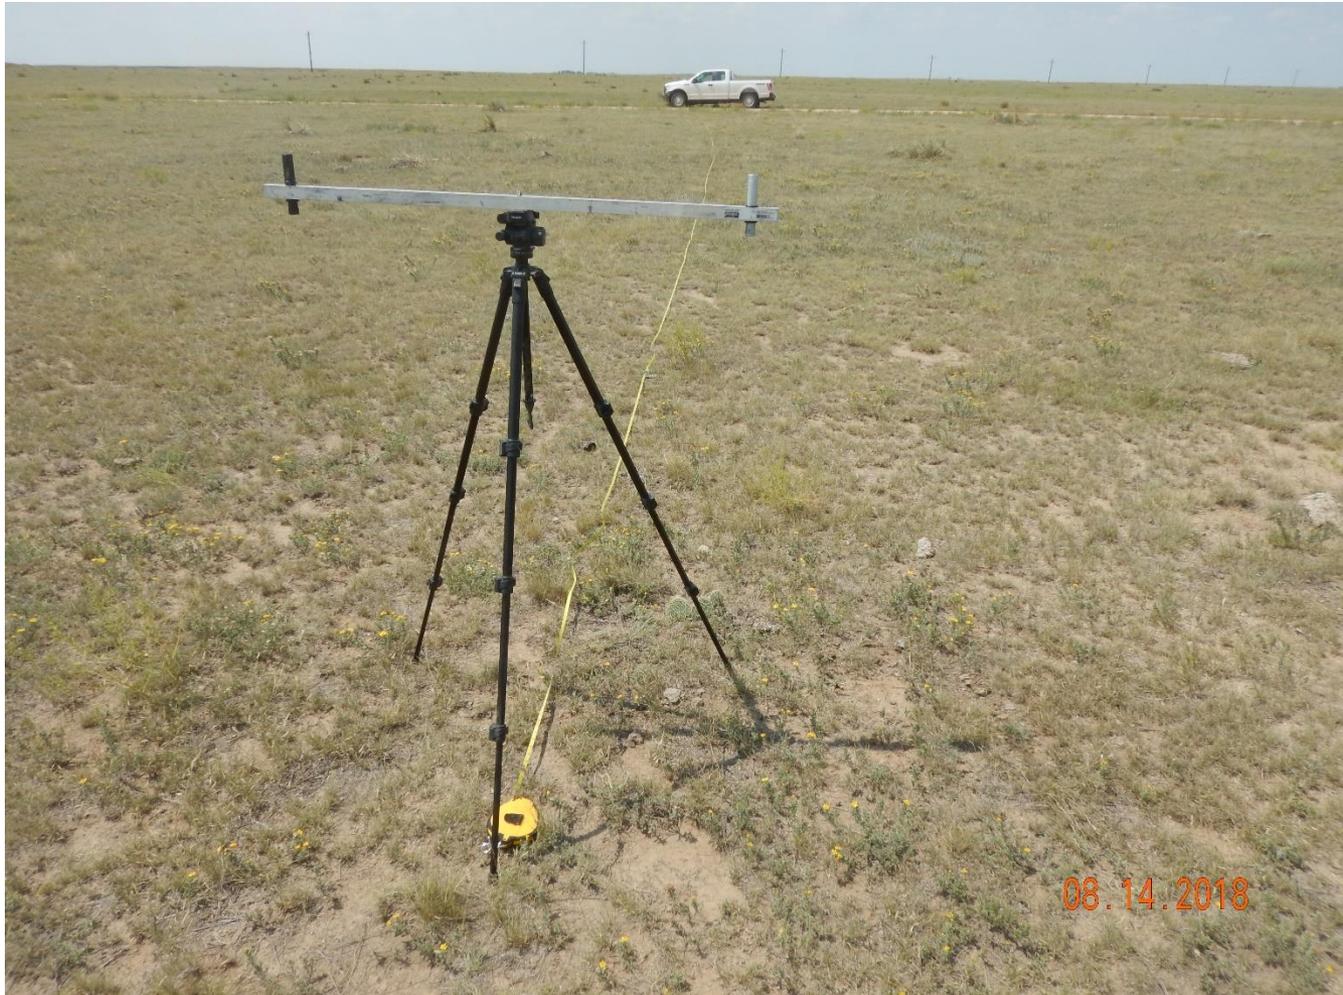
Photo 15: Photo taken from the adjacent reference, facing west. Photo shows the end point for the **REFERENCE AREA** transect.
