Inspection Photos

Operator: SG Interests

API: 05-051-06152

Date: 7/25/2018

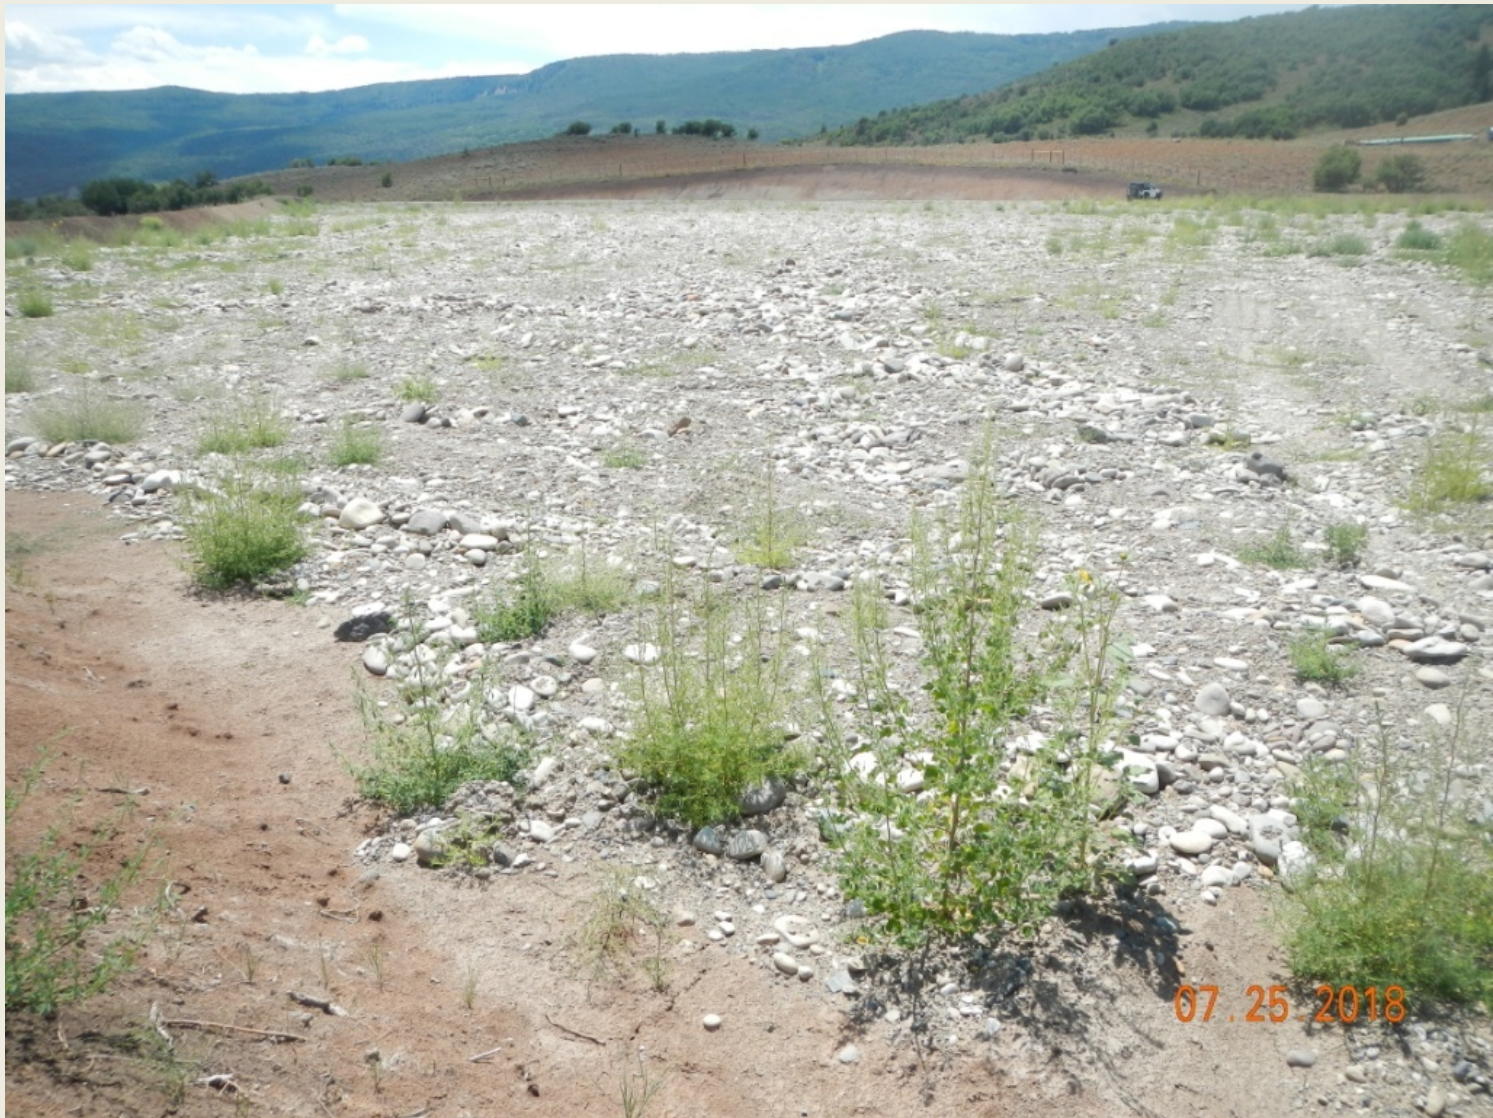
Photo 1. View of the project area from the southeastern corner facing center.

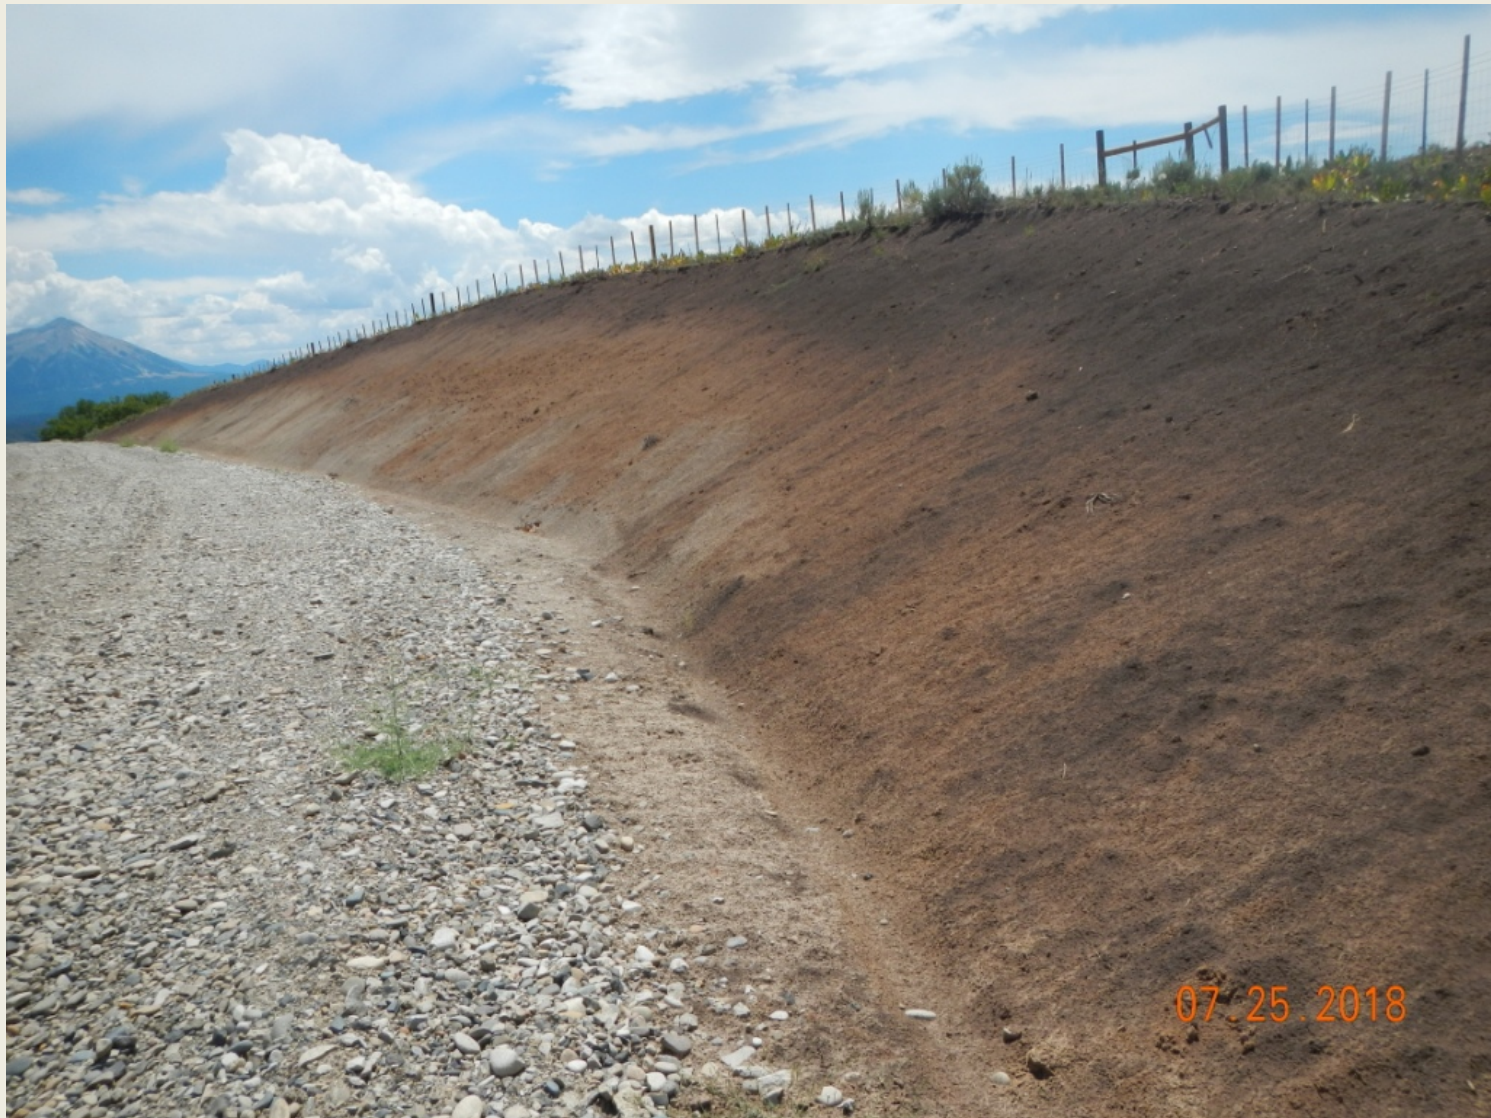
Photo 2. View of the western portion of the project area from the northwestern corner facing southward.

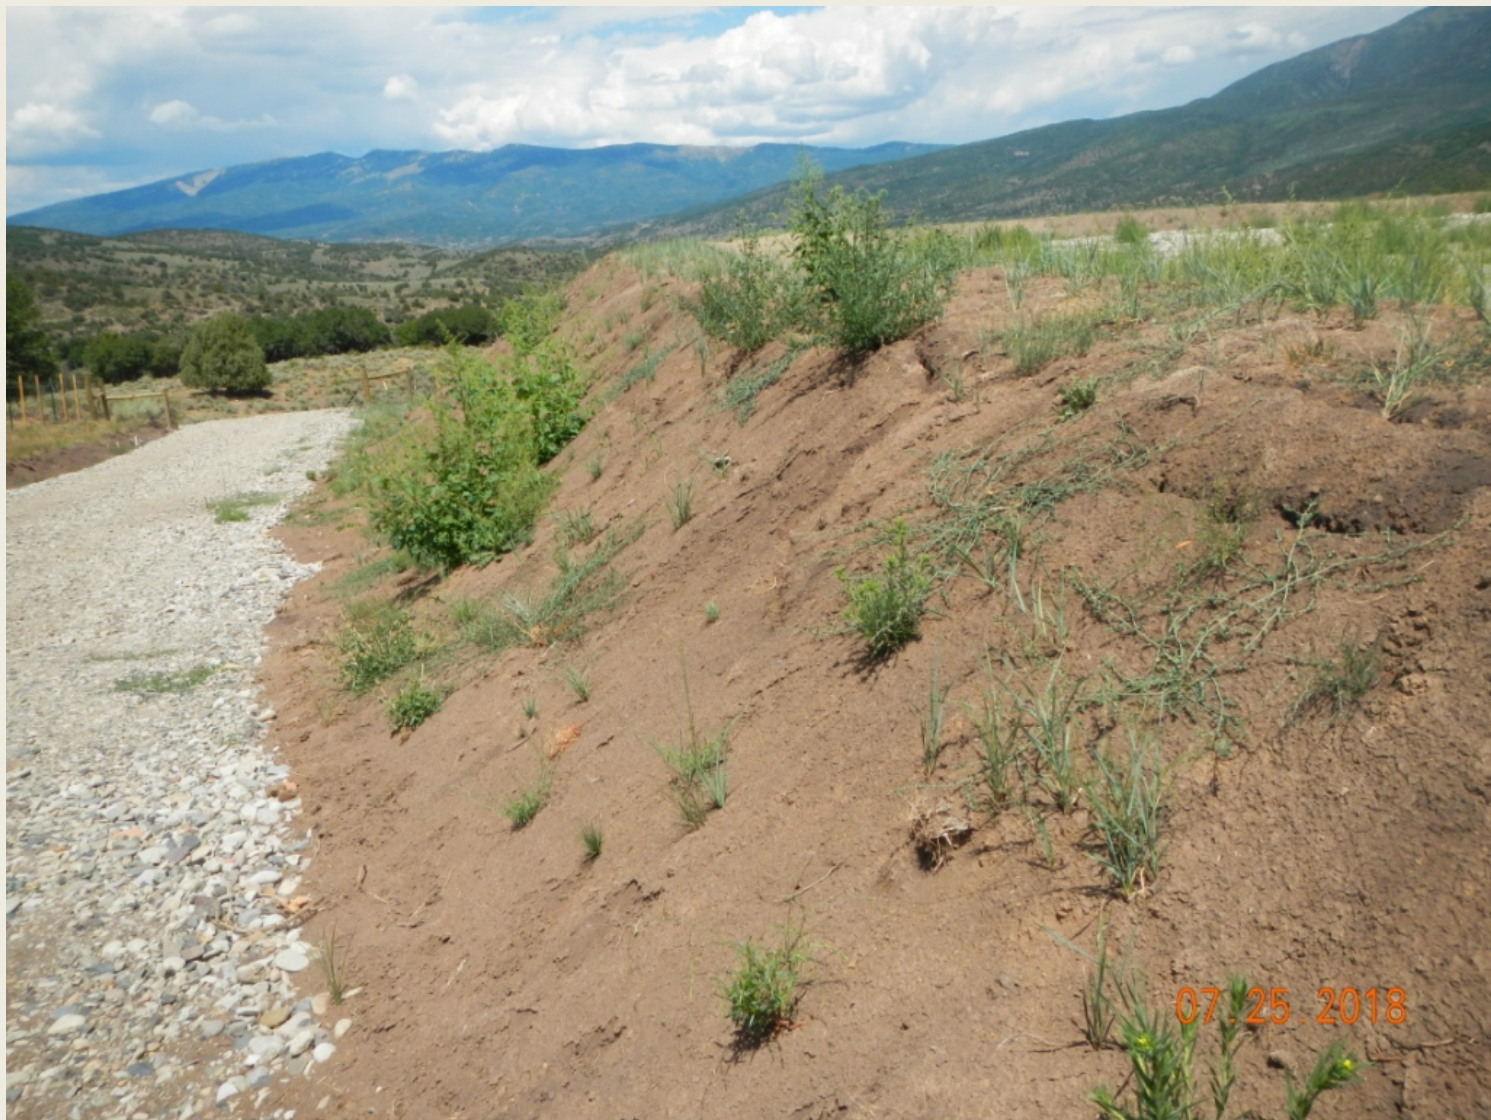
Photo 3. View of exposed soils at the northwester access entrance. This area needs better stabilization and sediment controls.

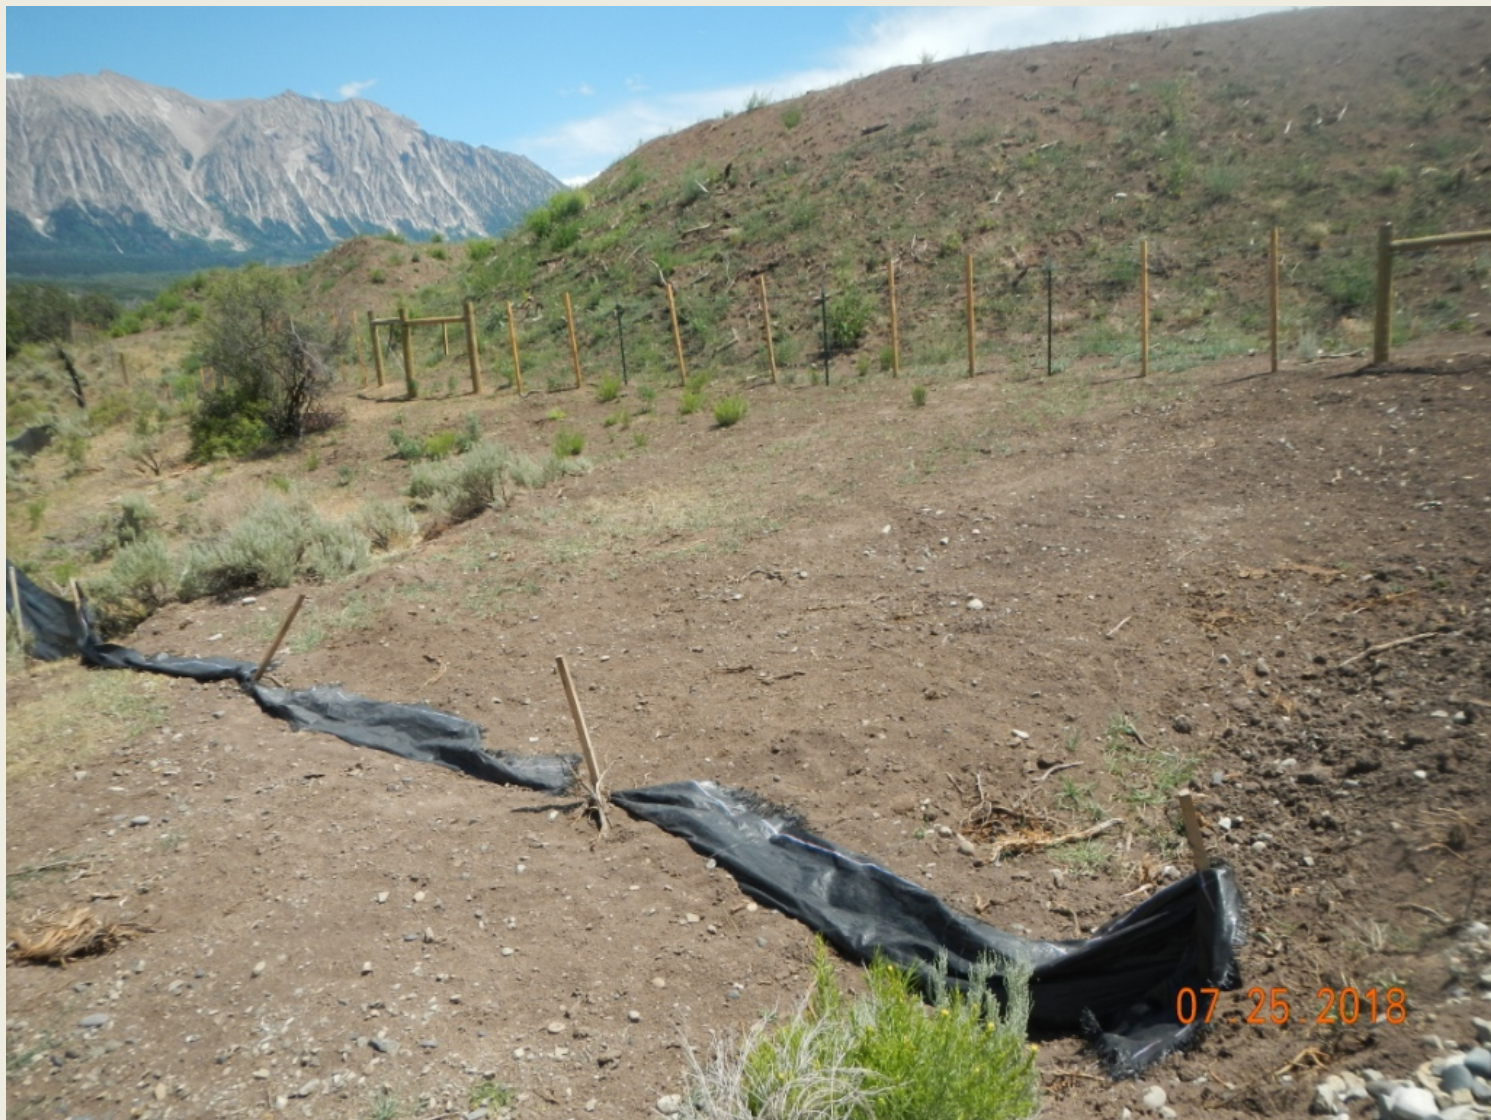
Photo 4. View of damaged silt fence and exposed soils that are not protected (also downslope from silt fence in lower left portion of photo), in the northwestern portion of the project area.

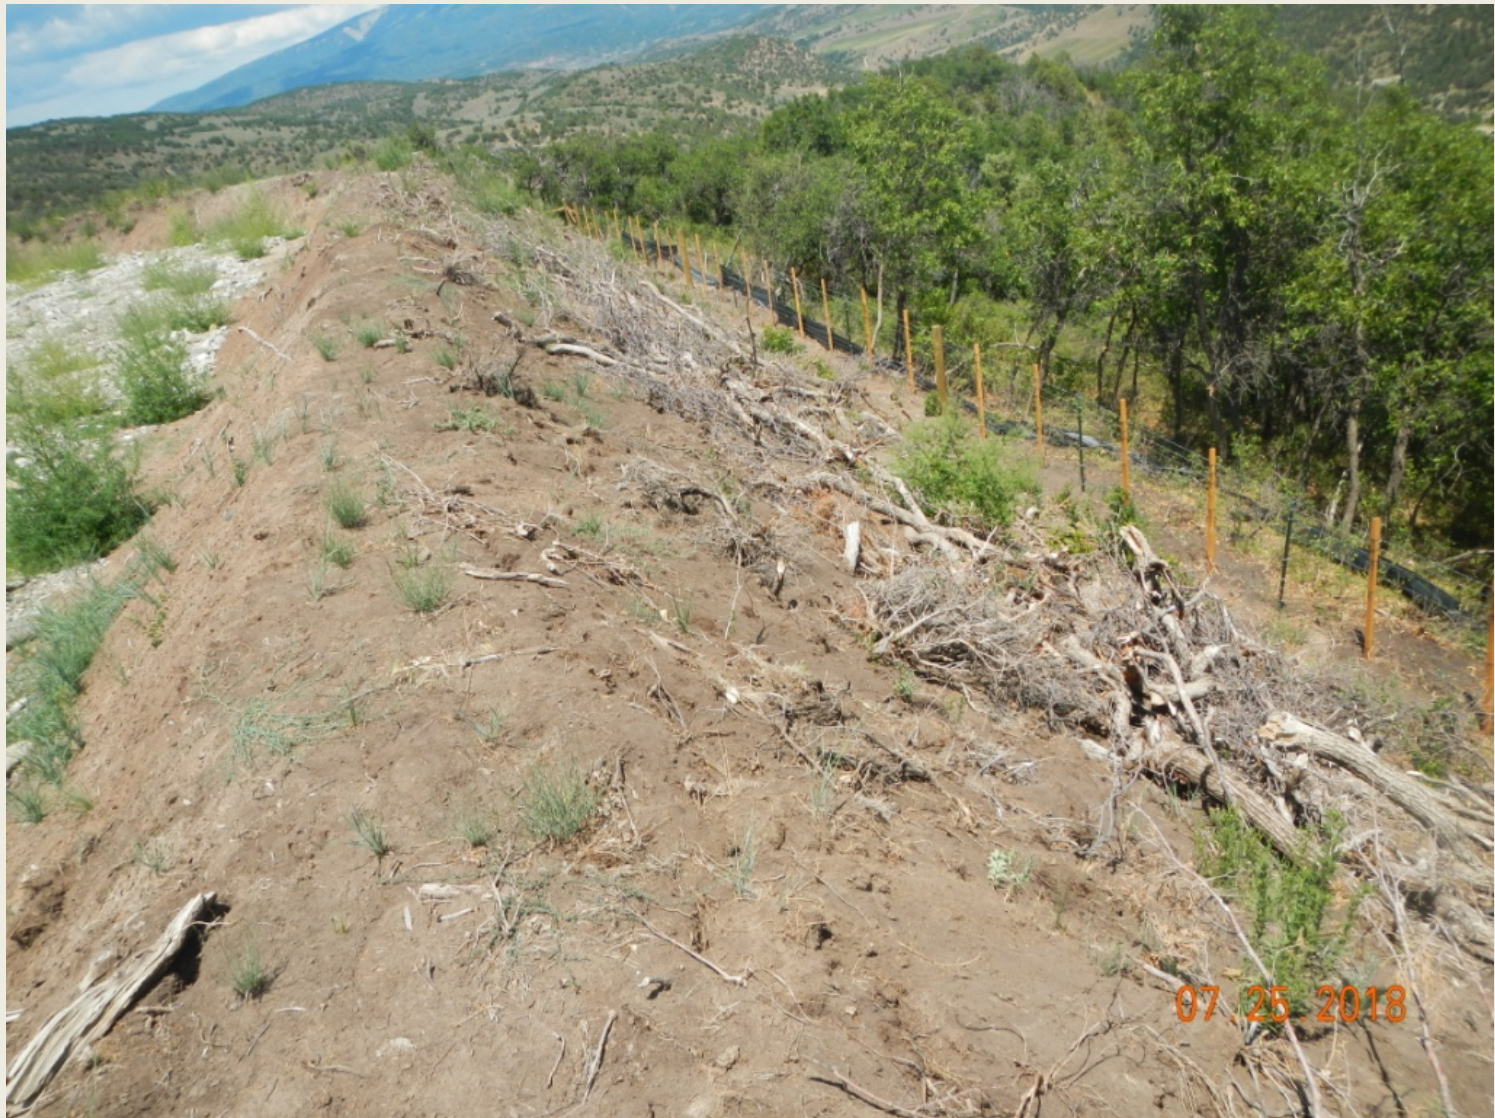
Photo 5. View of the eastern portion of the project area from the southeastern corner facing northward. Silt fence along the perimeter is in disrepair.

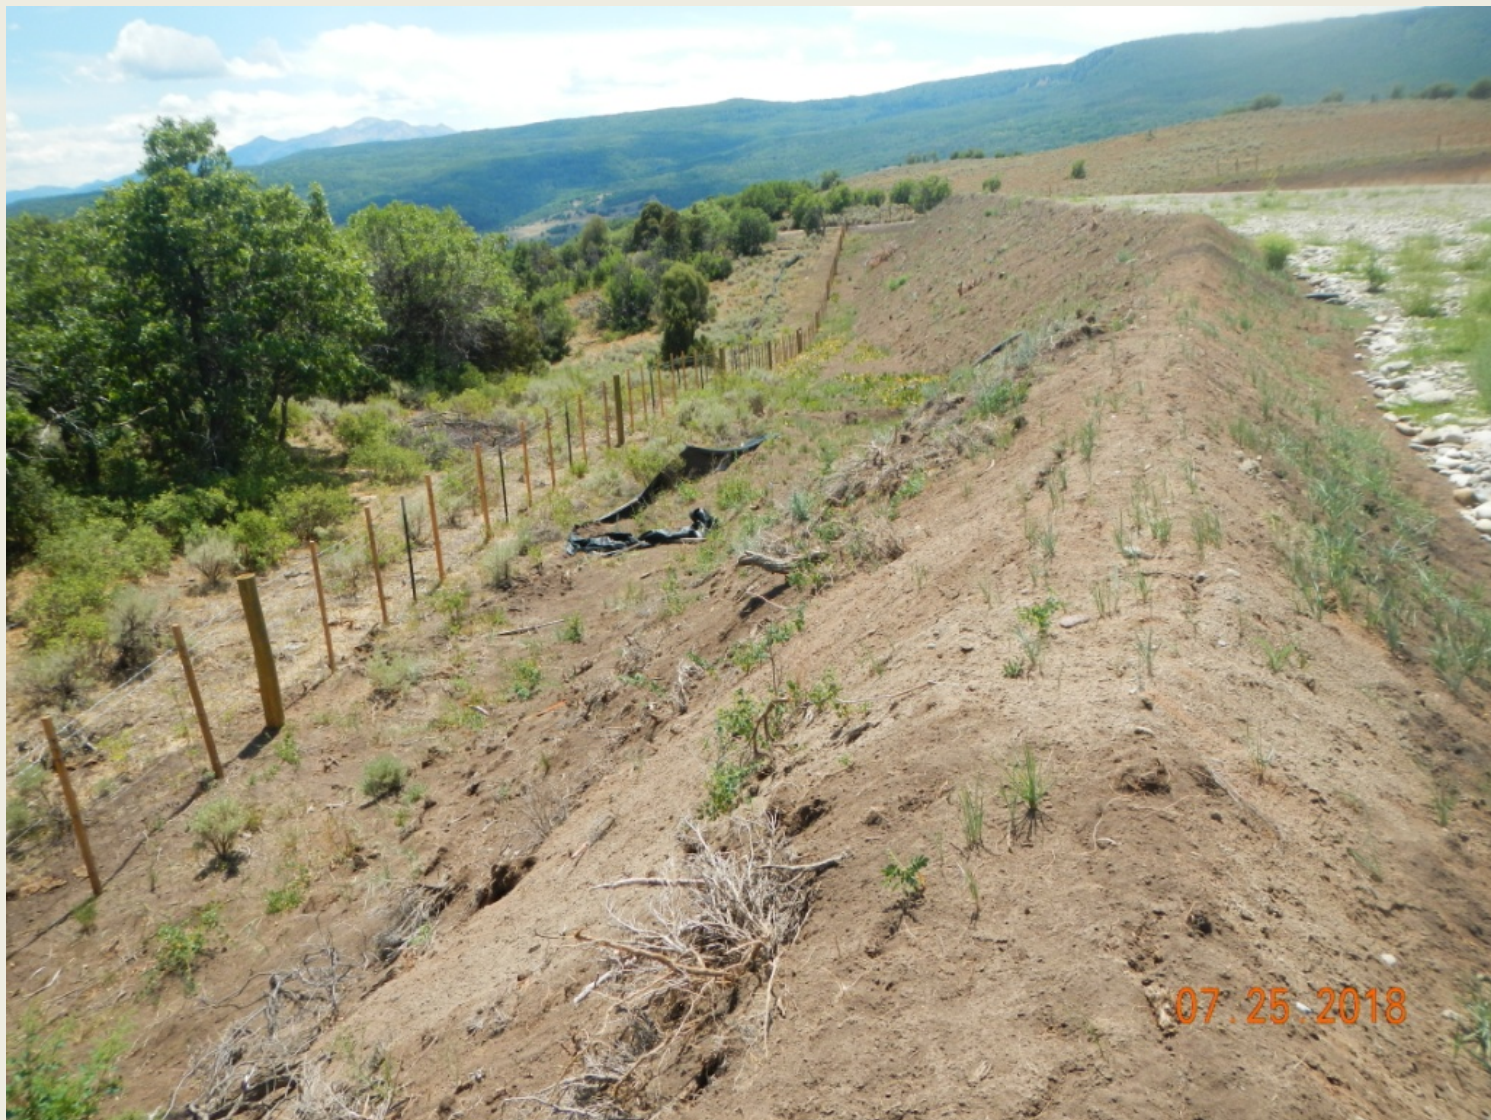
Photo 5. View of the southern portion of the project area from the southeastern corner facing northward. Silt fence is in disrepair.

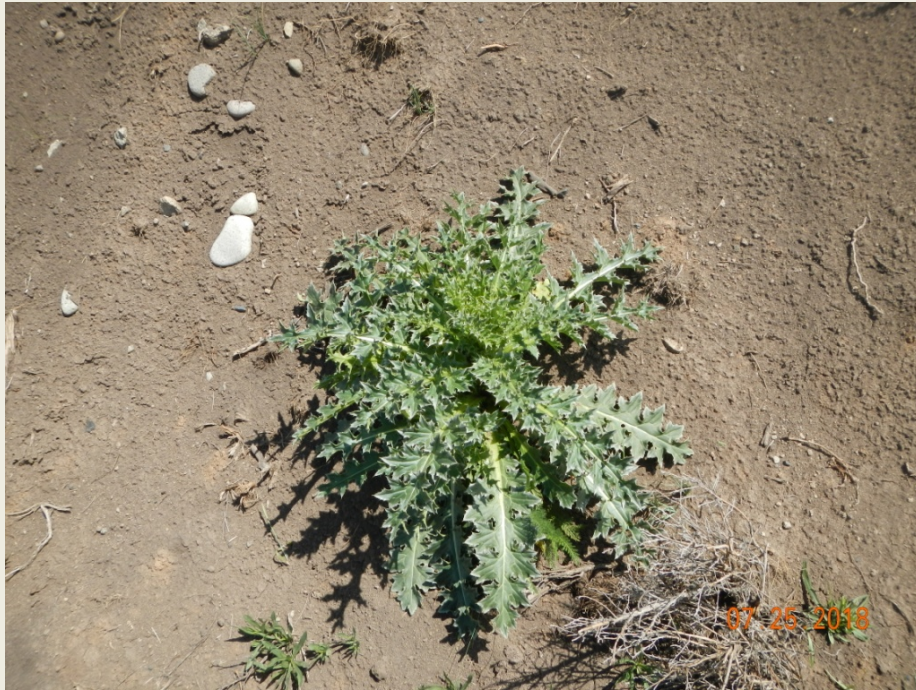
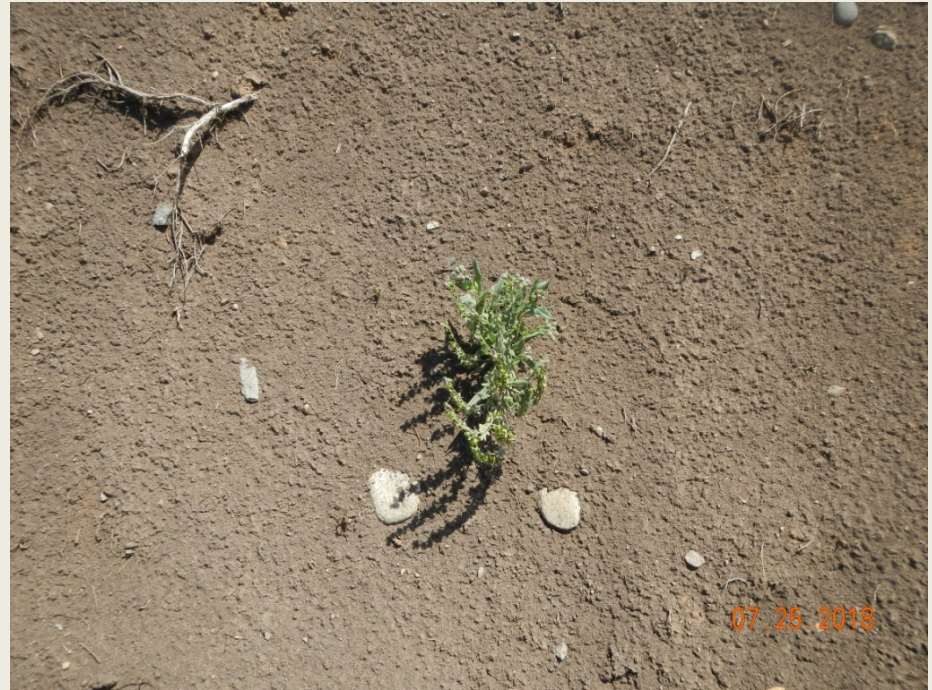
Photo 5. View of musk thistle (*Carduus nutans*) and houndstongue (*Cynoglossum officinale*) within the project area
