## Inspection Photos

Location Name: Dryer - 67N60W /14NWNW

Location #: 306577

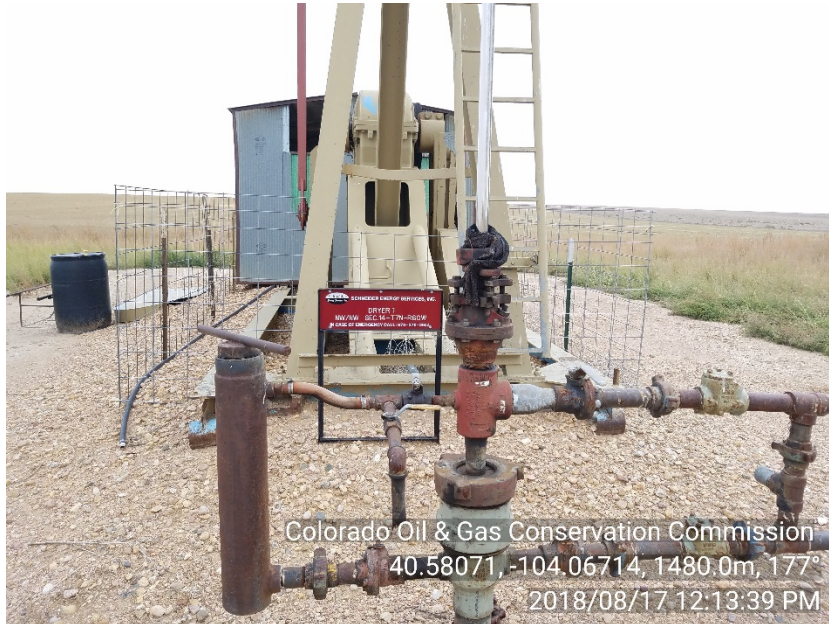
**Photo #1**

**Dryer 1 (API # 05-123-24398) wellhead**

**Wellhead sign w/ emergency contact info has been posted**

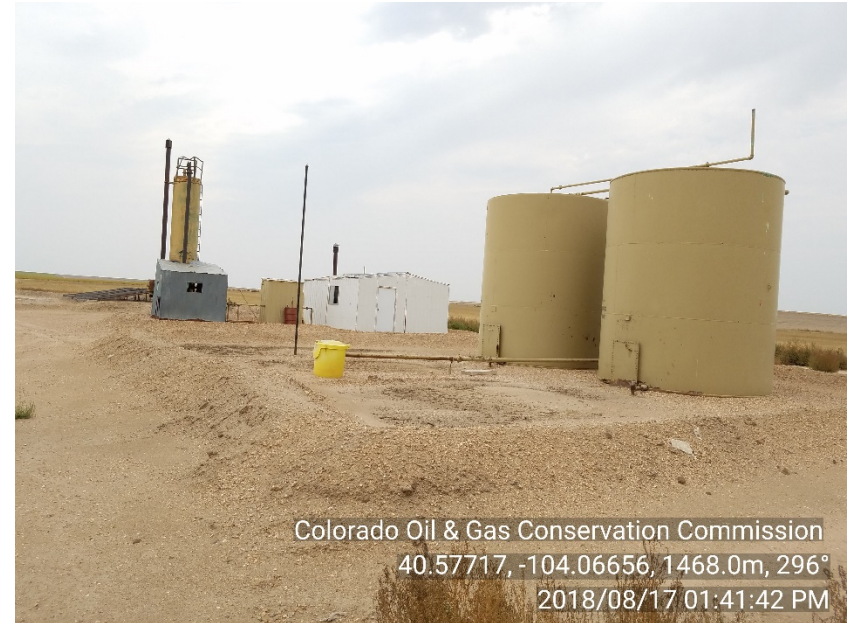
**Photo #2**

**Dryer 1 & April 12-14 Battery**

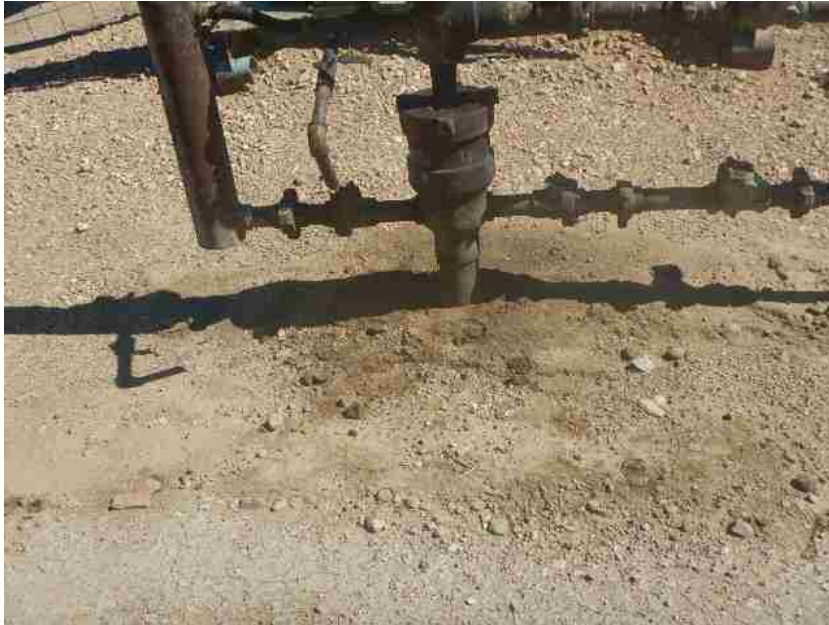
**Photo #3**

**Dryer 1 (API # 05-123-24398) wellhead**

*Previous photo from SEP-2016 FIR showing soil stain*

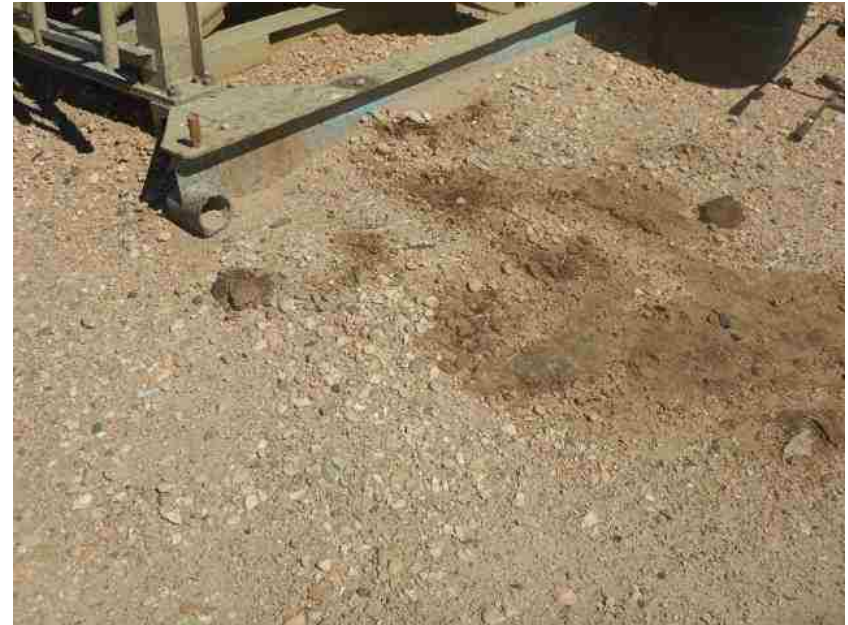
**Photo #4**

**Dryer 1 (API # 05-123-24398) Pumping Unit**

*Previous photo from SEP-2016 FIR showing soil stain*

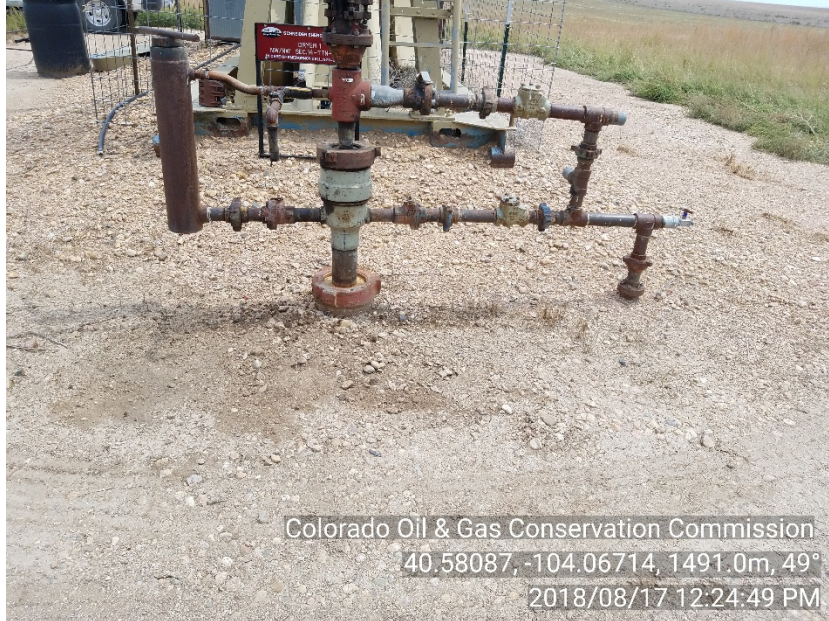
**Photo #5**

Dryer 1 (API # 05-123-24398) wellhead

*Stained soil near wellhead & pumping unit appears to have been addressed*

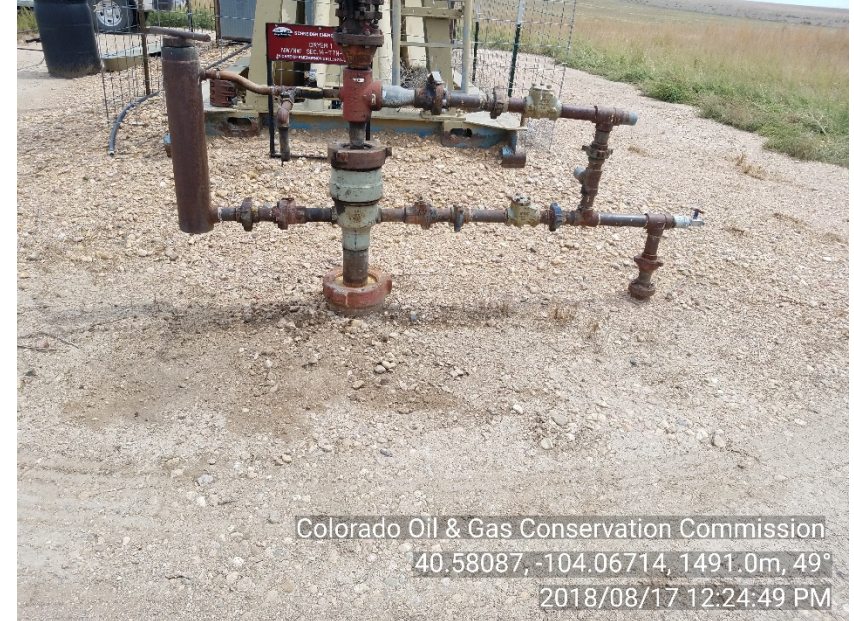
**Photo #6**

Dryer 1 (API # 05-123-24398) wellhead

*Bradenhead does not appear plumbed to surface*

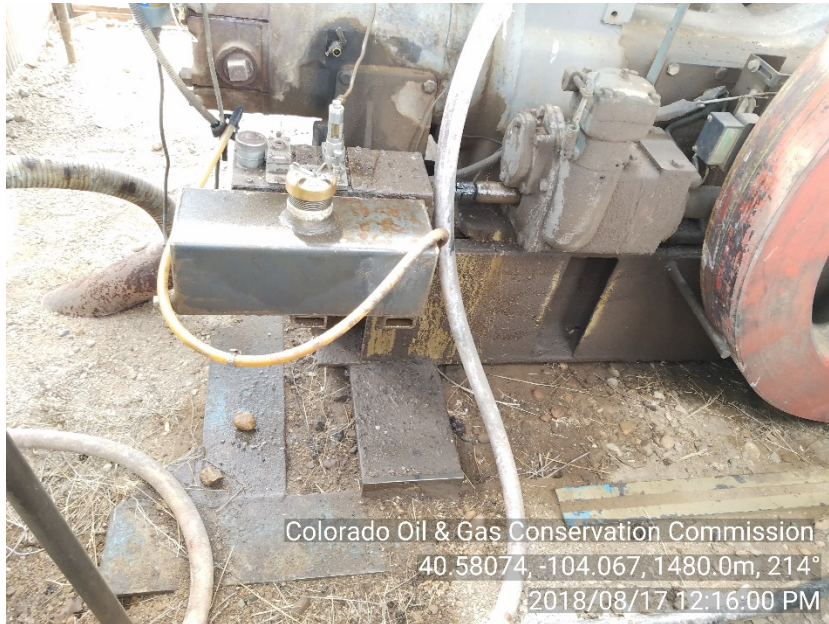
**Photo #7**

**Dryer 1 (API # 05-123-24398) Engine**

***Stained soil near engine base***

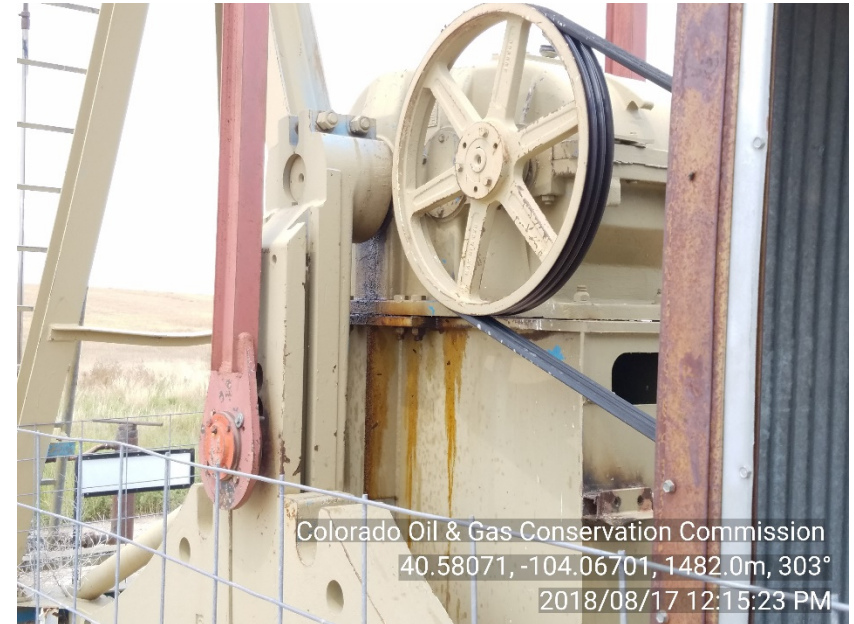
**Photo #8**

**Dryer 1 (API # 05-123-24398)**

***Gearbox stain & apparent seepage***

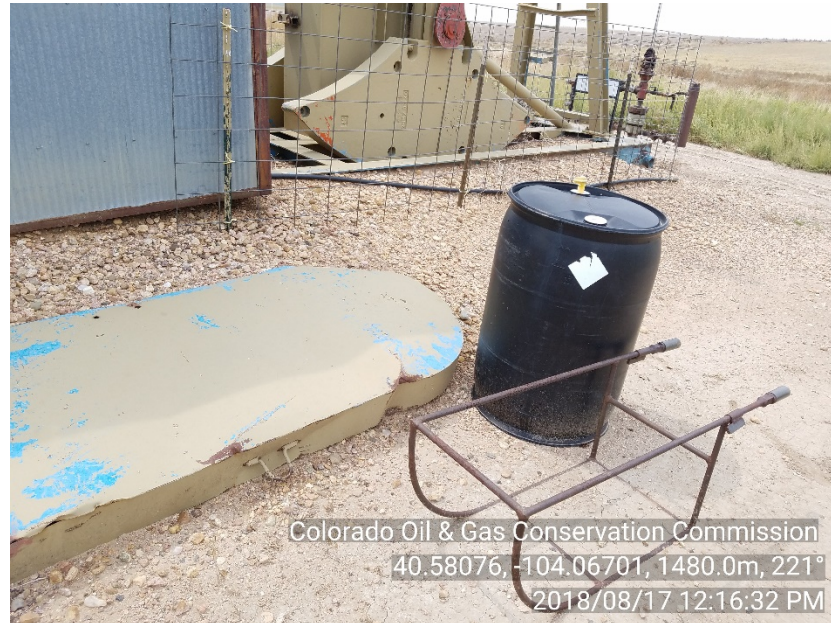
### Photo #9

Dryer 1 (API # 05-123-24398)

**Unused equipment (belt guard)**

**55-gal. Drum, labeling / placard appears illegible**
