# Inspection Photos

Operator: Gunnison Energy

API: 05-051-06120

Date: 7/25/2018

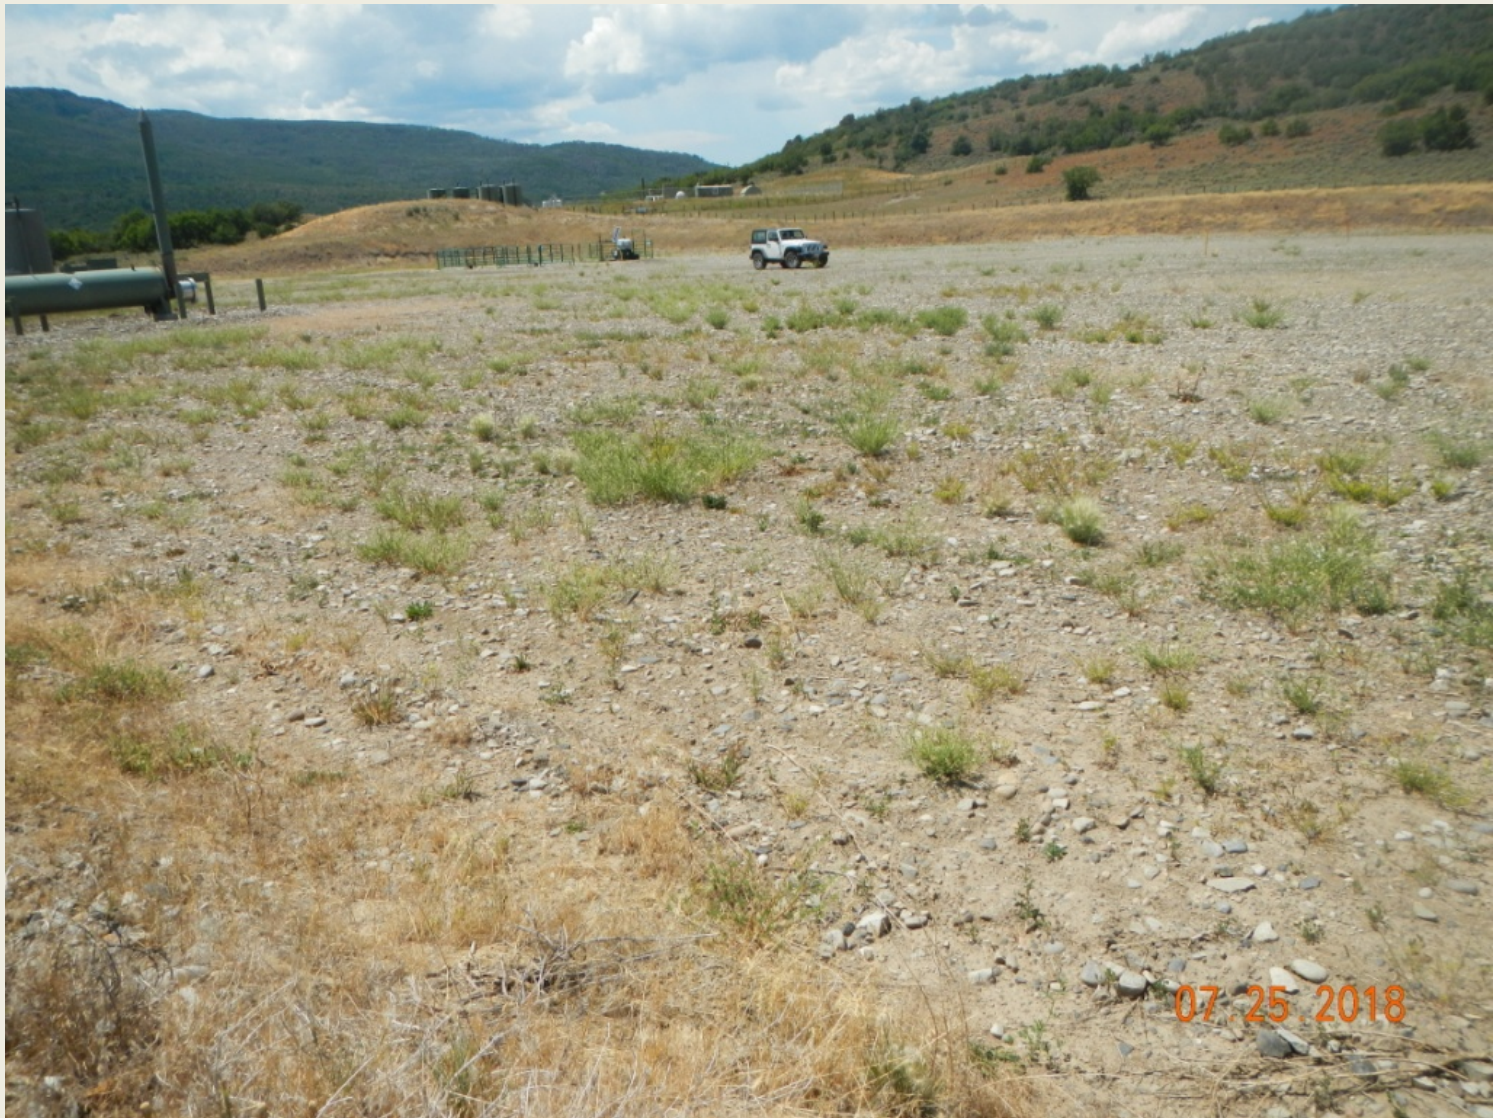
**Photo 1. View of the project area from the southeastern edge facing center.**

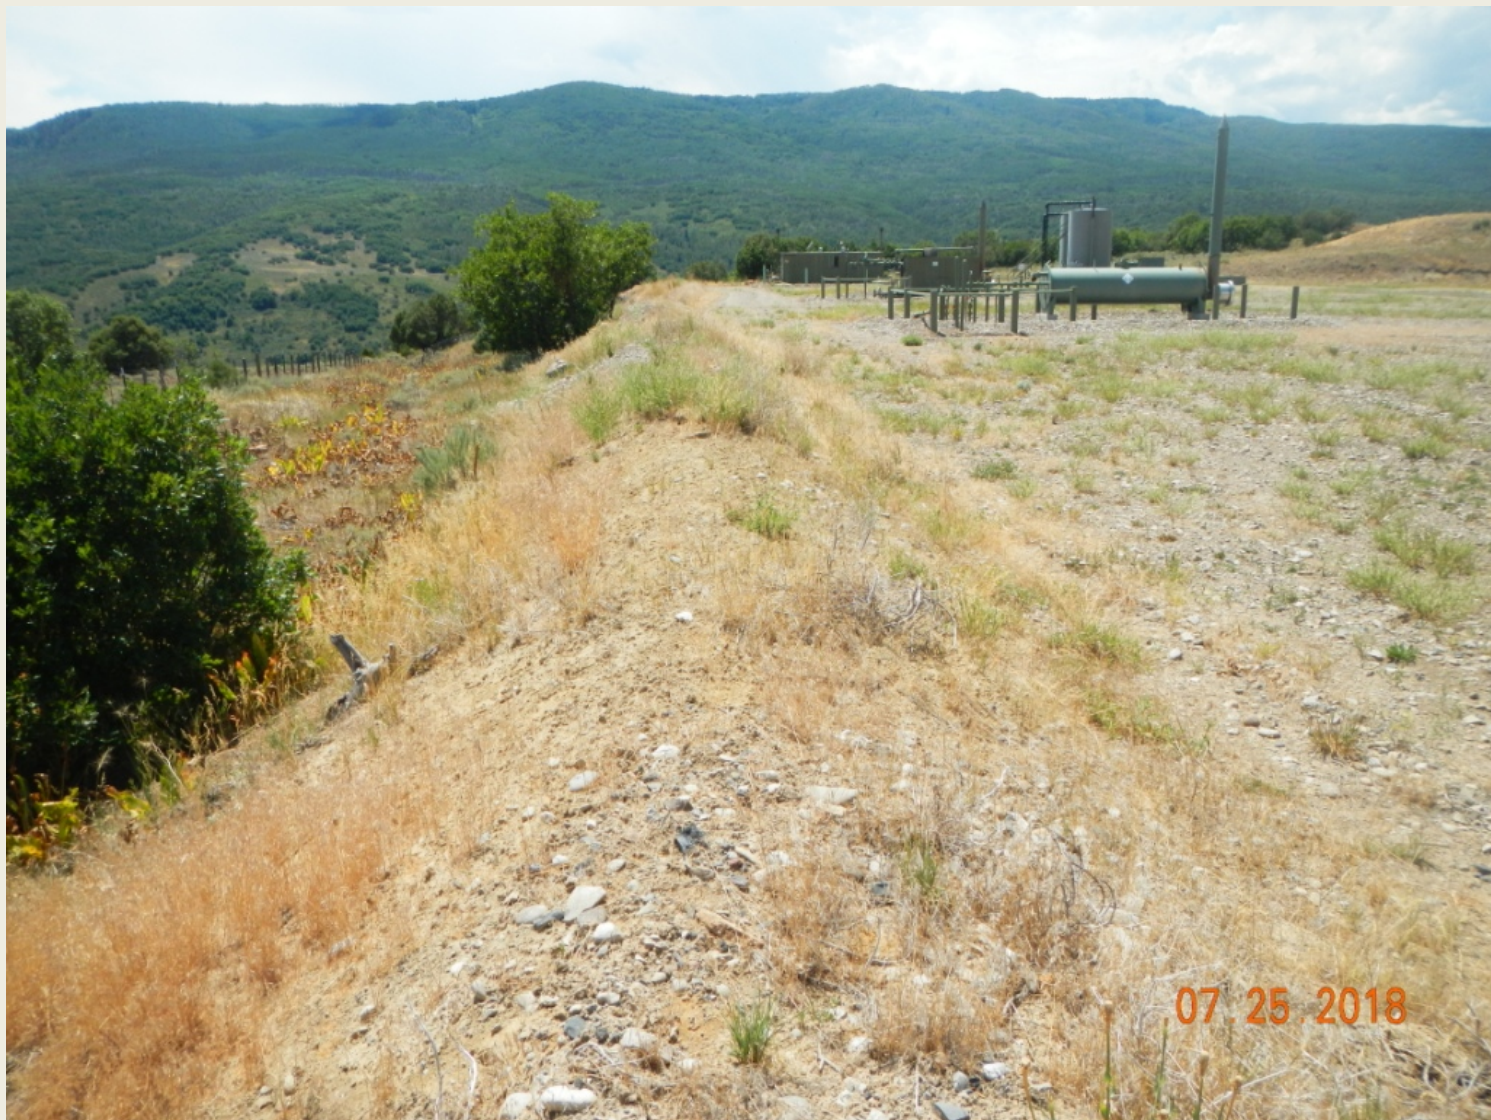
**Photo 2. View of the southeastern portion of the project area from the southeastern edge facing southwestward.**

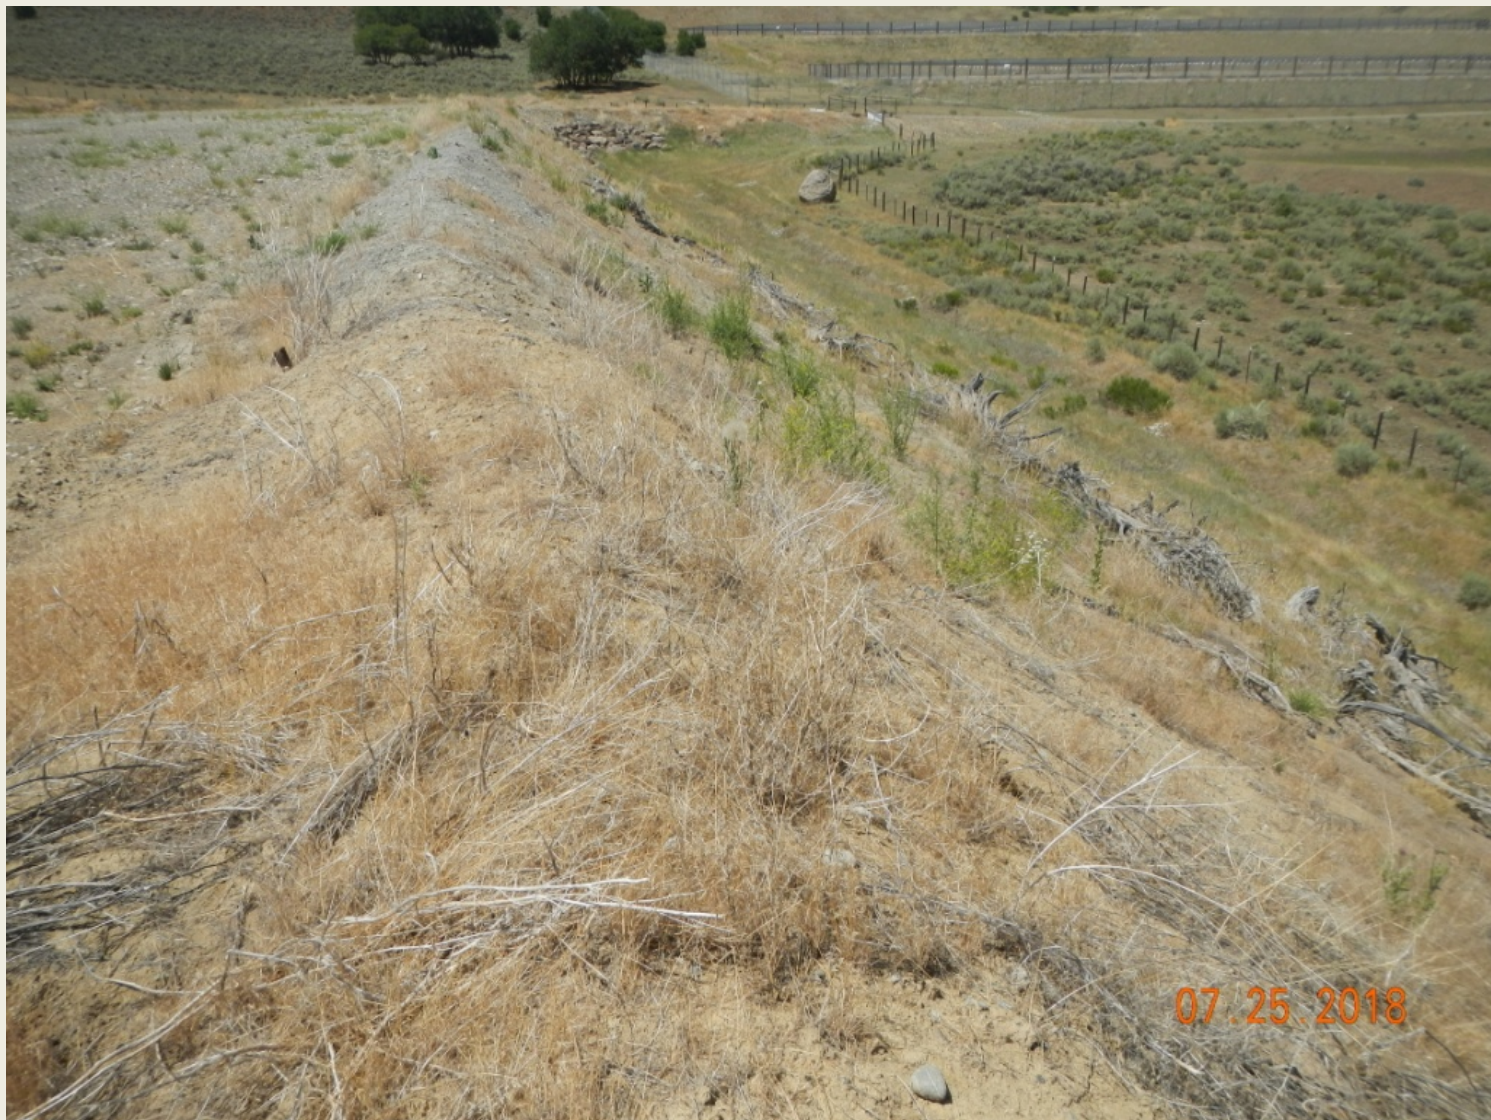
**Photo 3. View of the northeastern portion of the eastern edge facing northwestward.**

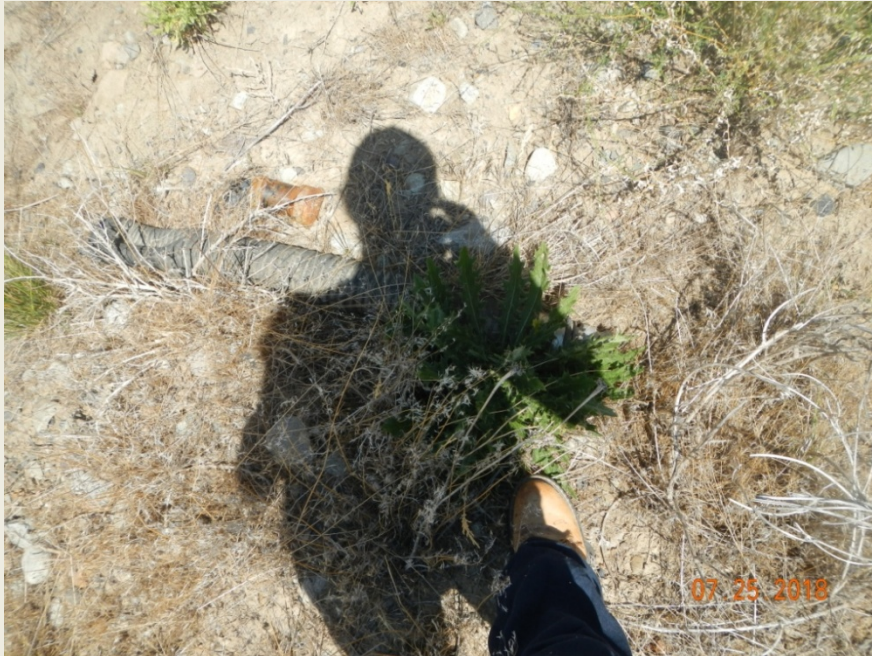
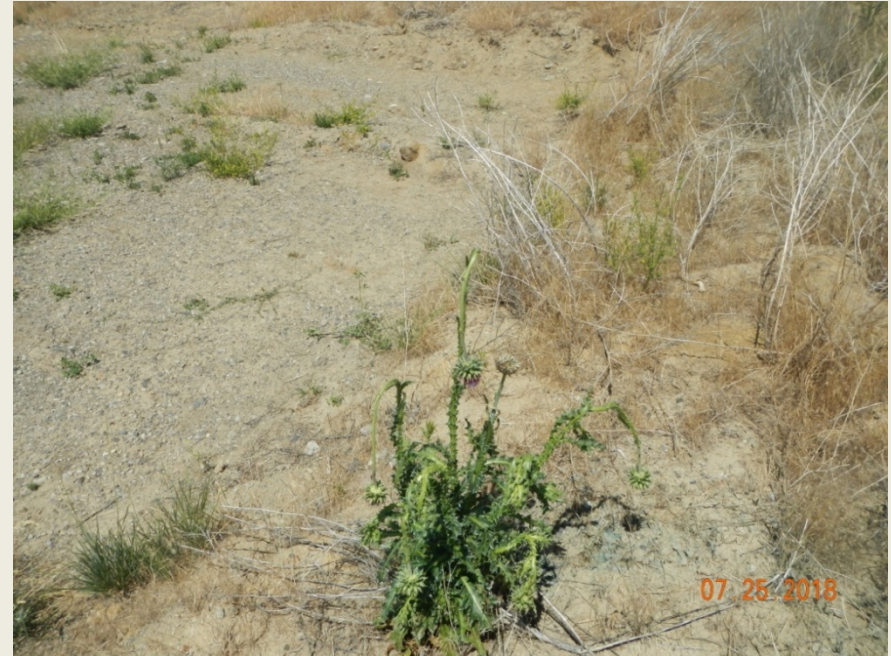
**Photo 4/5. View of the what appears to be herbicide treated musk thistle (right) and untreated bull thistle and debris (left) within the southeastern portion of the project area.**
