Inspection Photos

Operator: Gunnison Energy

API: 05-051-06126

Date: 7/25/2018

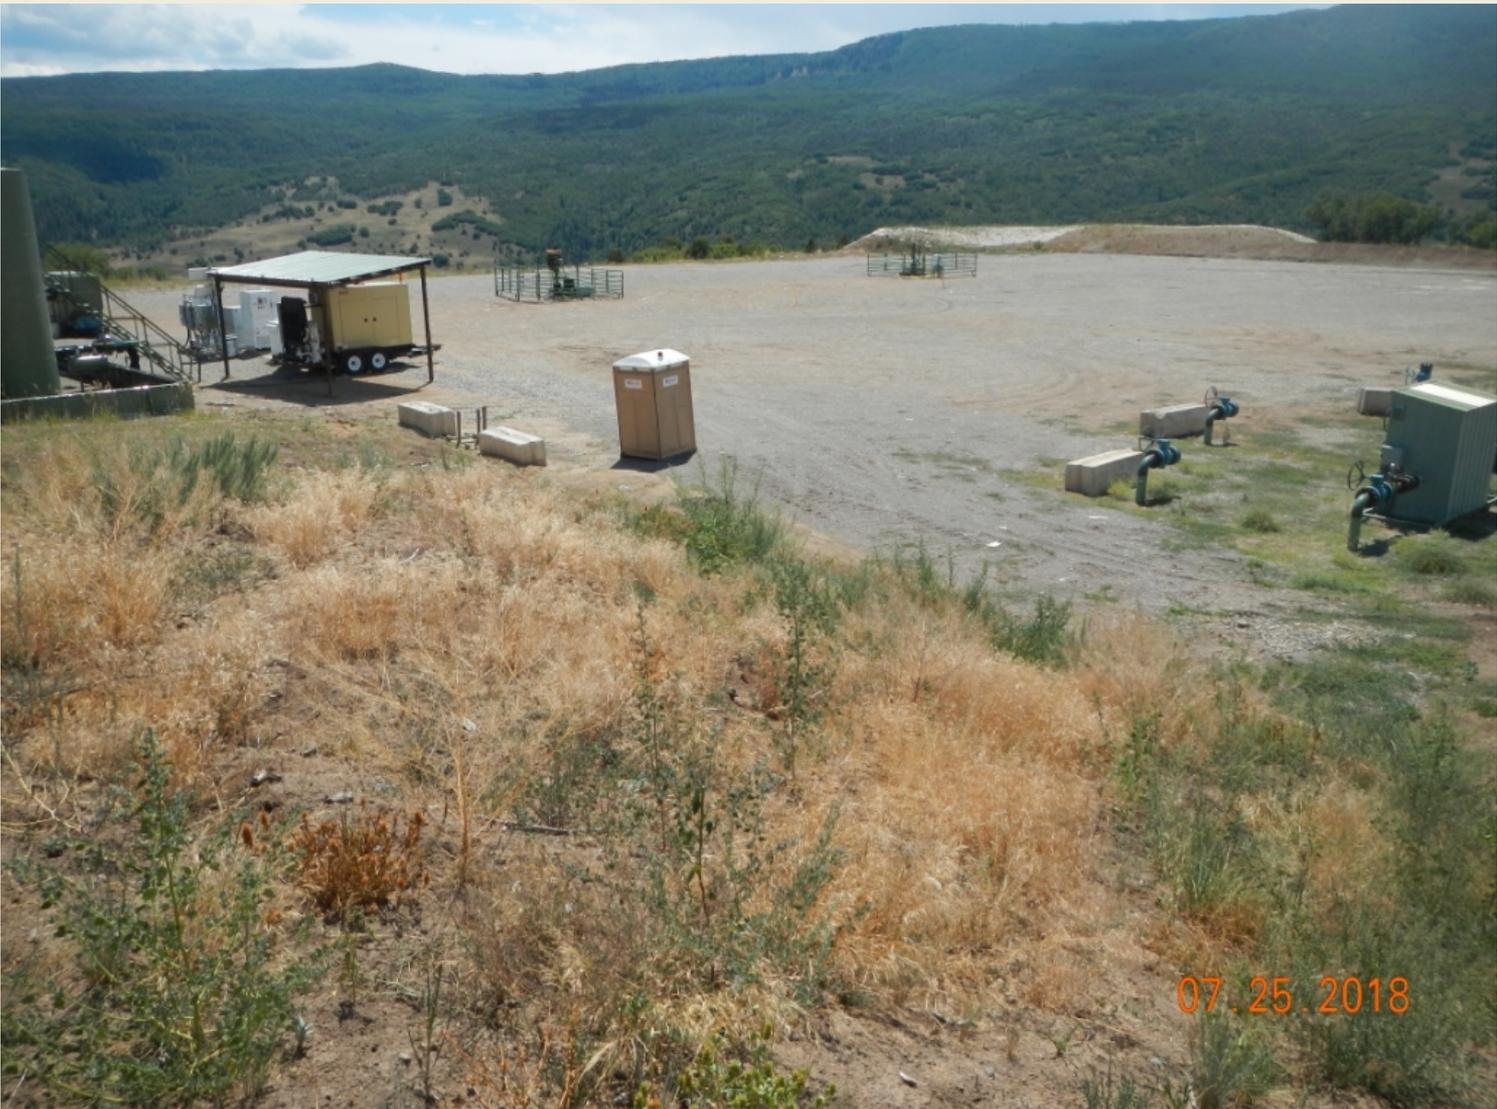
Photo 1. View of the project area from the northeastern edge facing center.

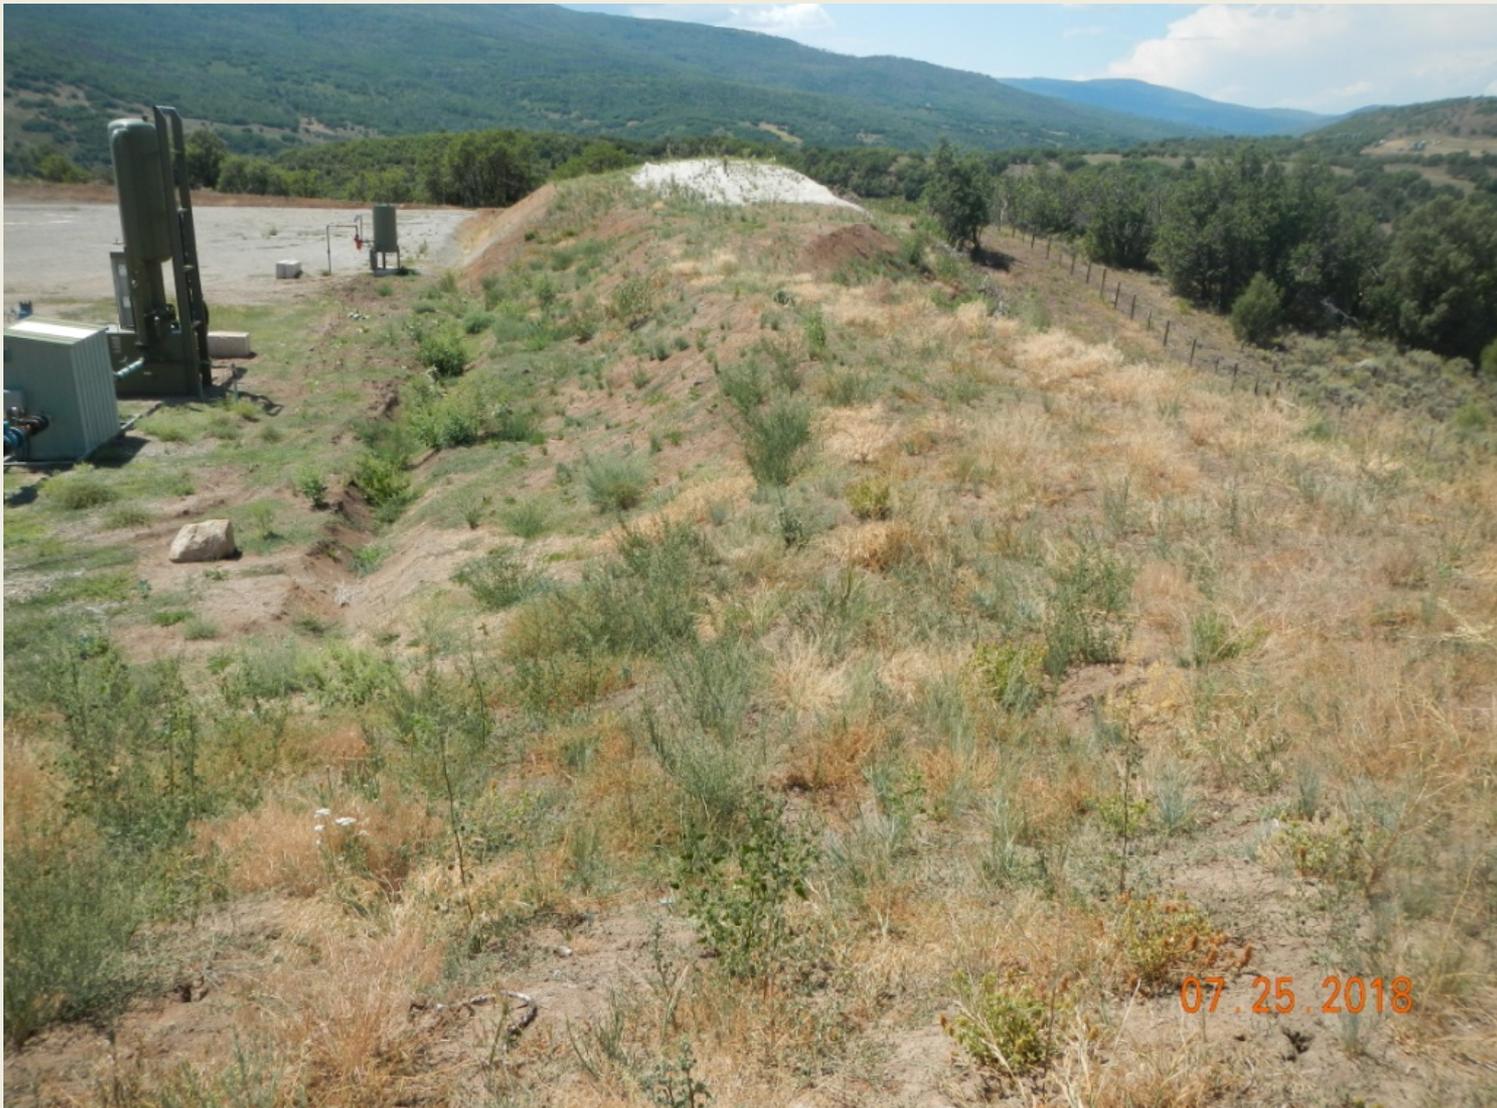
Photo 2. View of the northern portion of the project area from the northeastern edge facing westward.

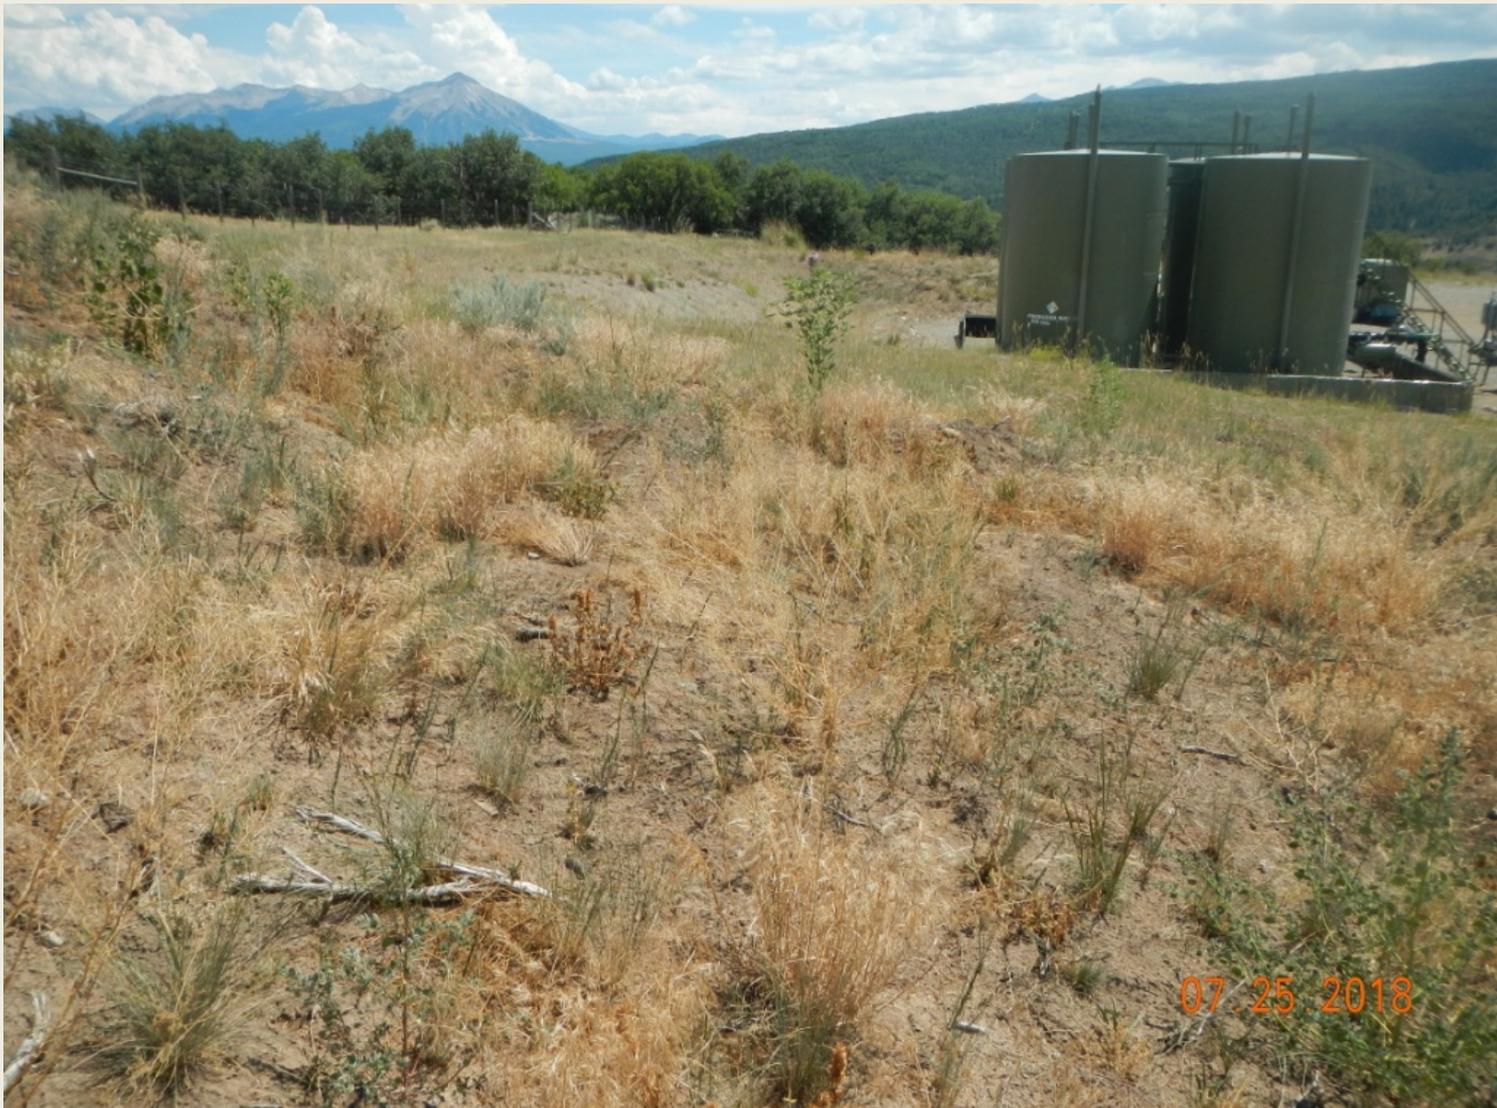
Photo 3. View of the eastern portion of the northeastern edge facing southward.

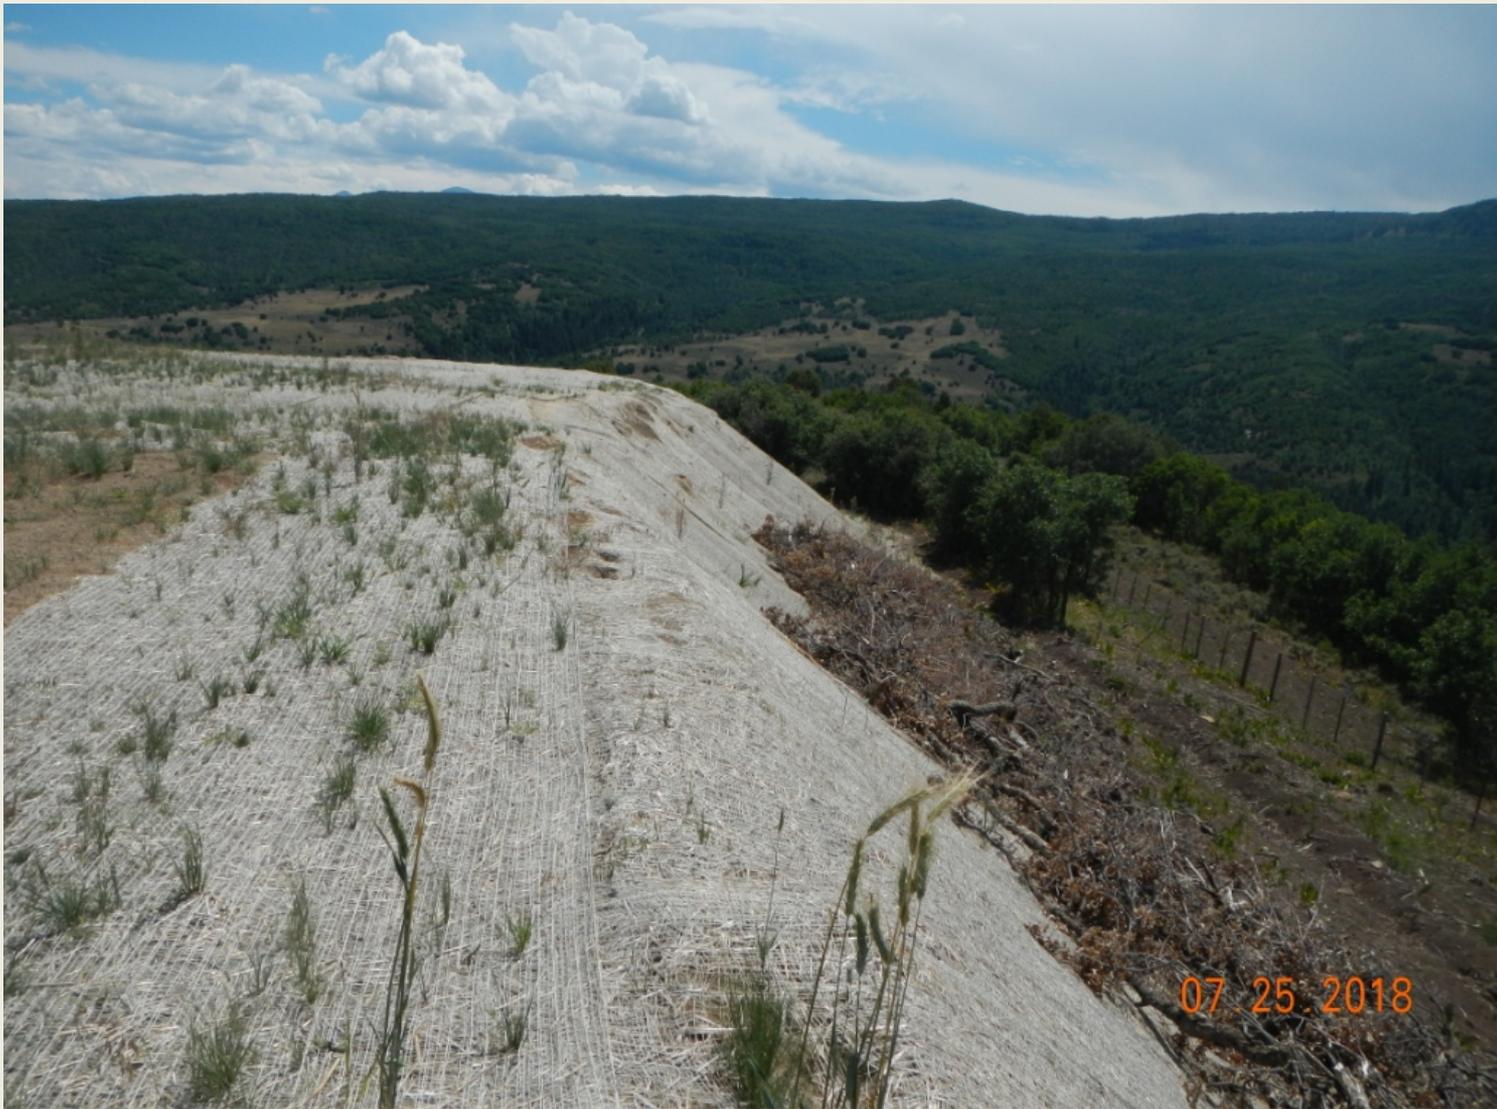
Photo 4. View of the southwestern portion of the project area facing southward. Some revegetation is progressing through erosional blankets.

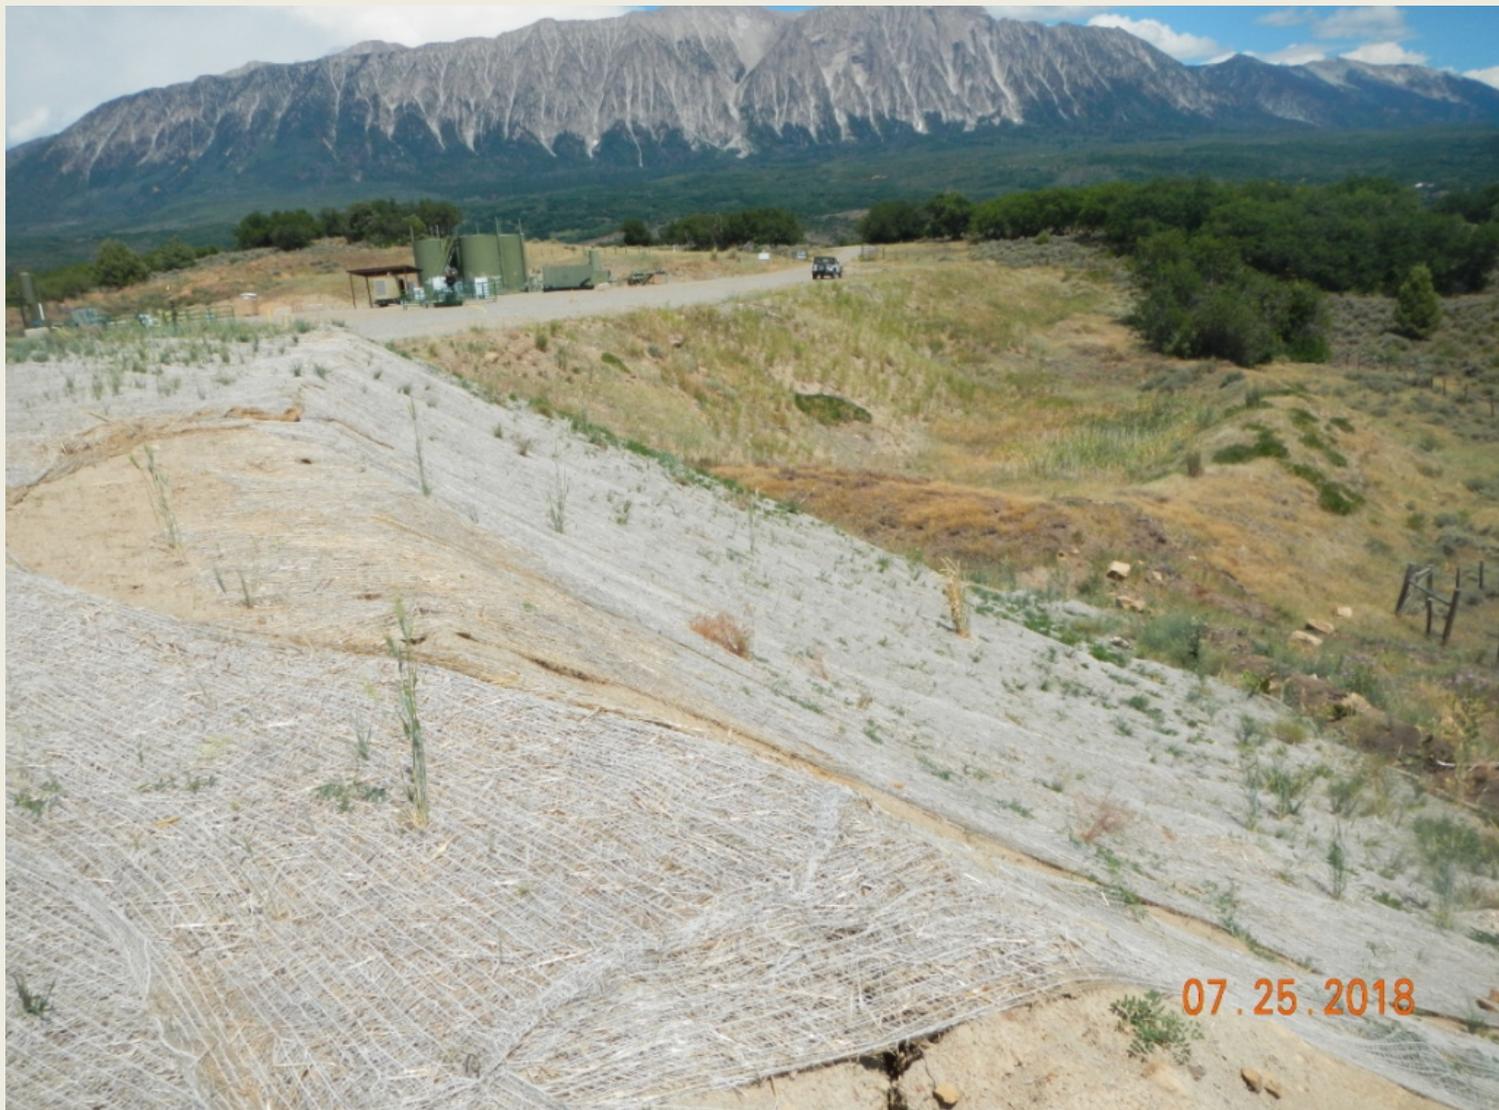
Photo 5. View of the southern portion of the project area from the southwestern corner facing eastward. Silt trap appears to be functioning.
