# Inspection Photos

Operator: PRONGHORN OPERATING LLC - 10422

Location ID: 387156

Inspection Doc. Number: 682503737

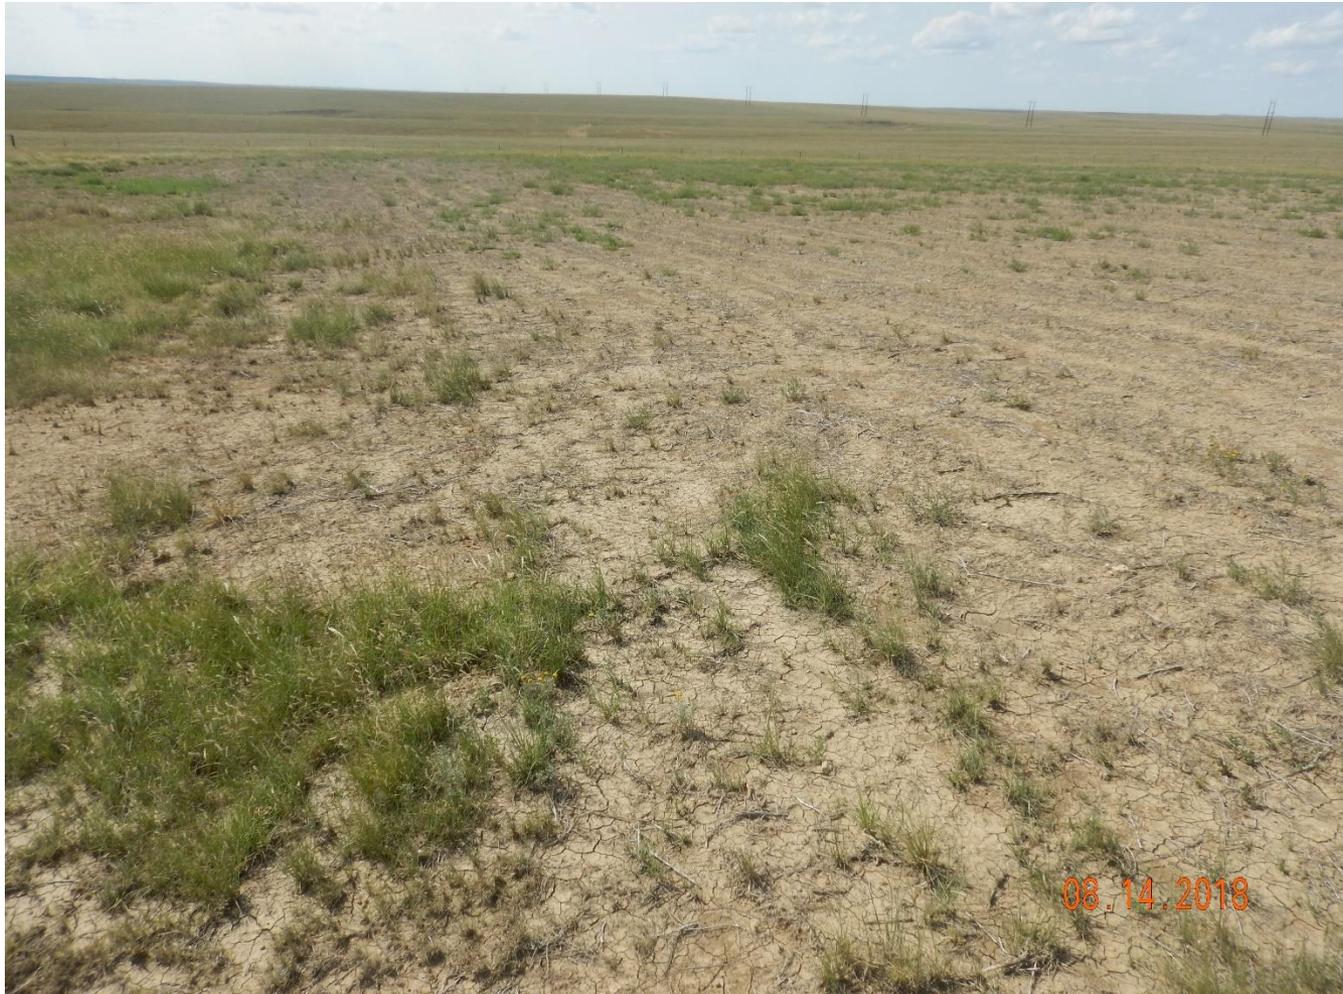
**Photo 1:** Photo taken from the south end of the location, facing west. Photos 1-4 provide an overview of the location, facing west, northwest, northeast, to east. Photo shows the reclamation area. Location remains predominantly bare and exposed soil. Vegetation observed predominantly undesirable weedy plant species. Unable to find evidence of work conducted per corrective actions.

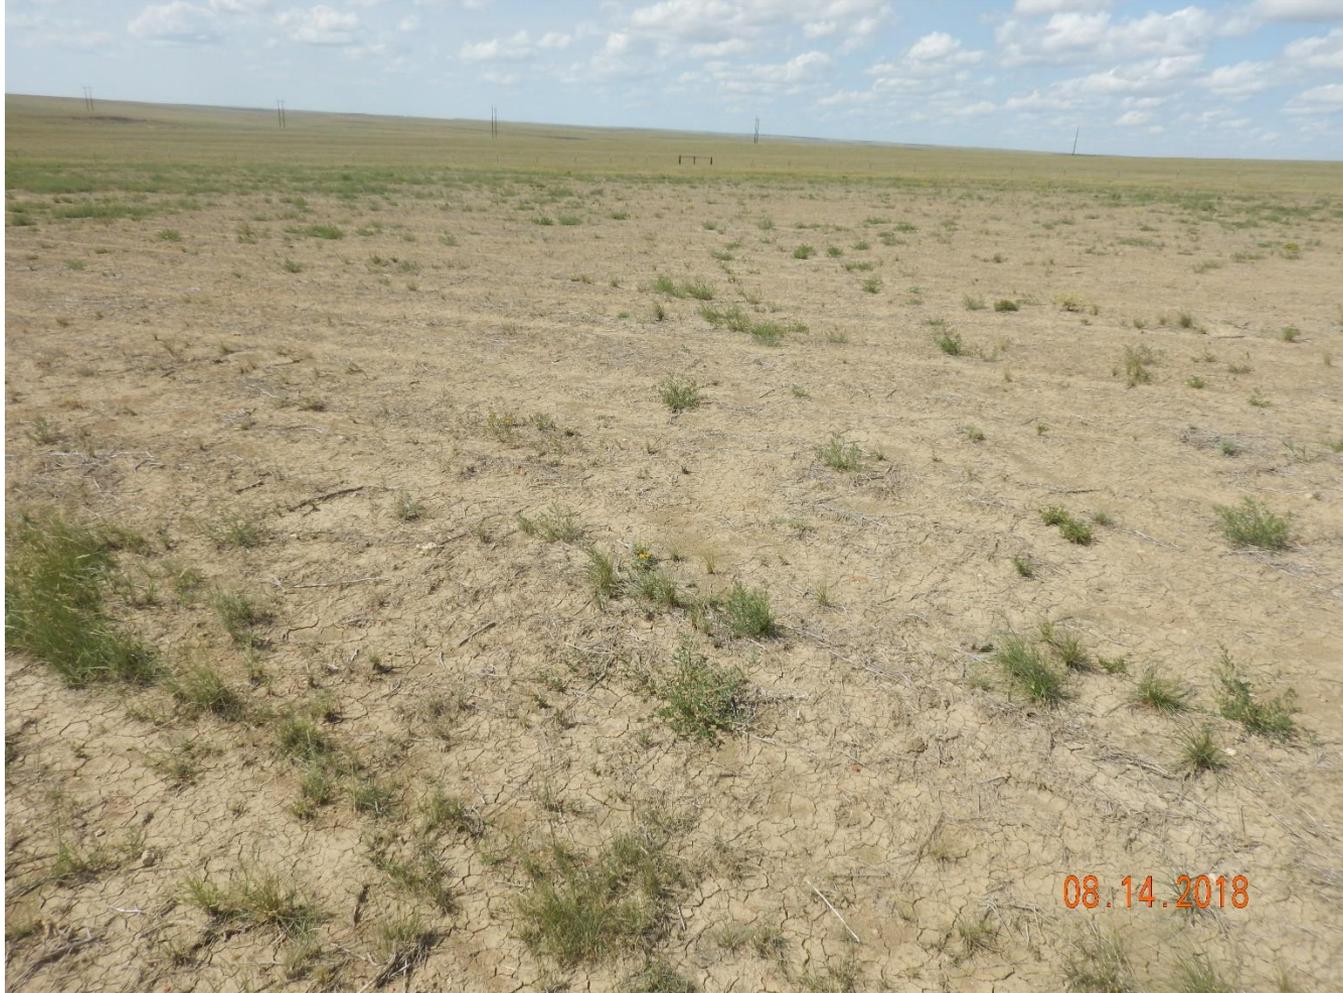
**Photo 2:** See comments under photo 1.

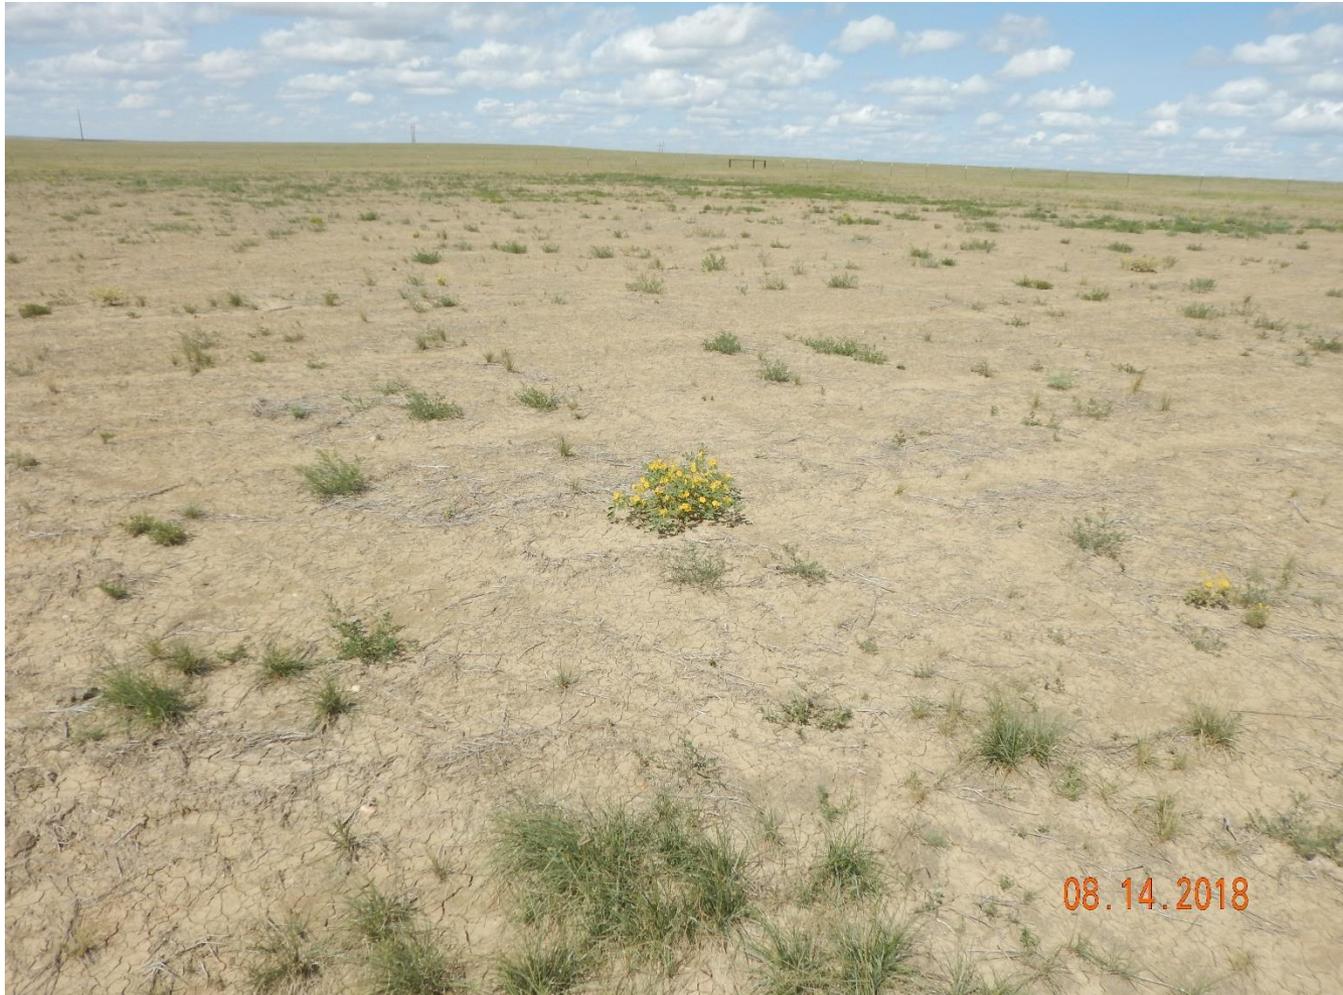
**Photo 3:** See comments under photo 1.

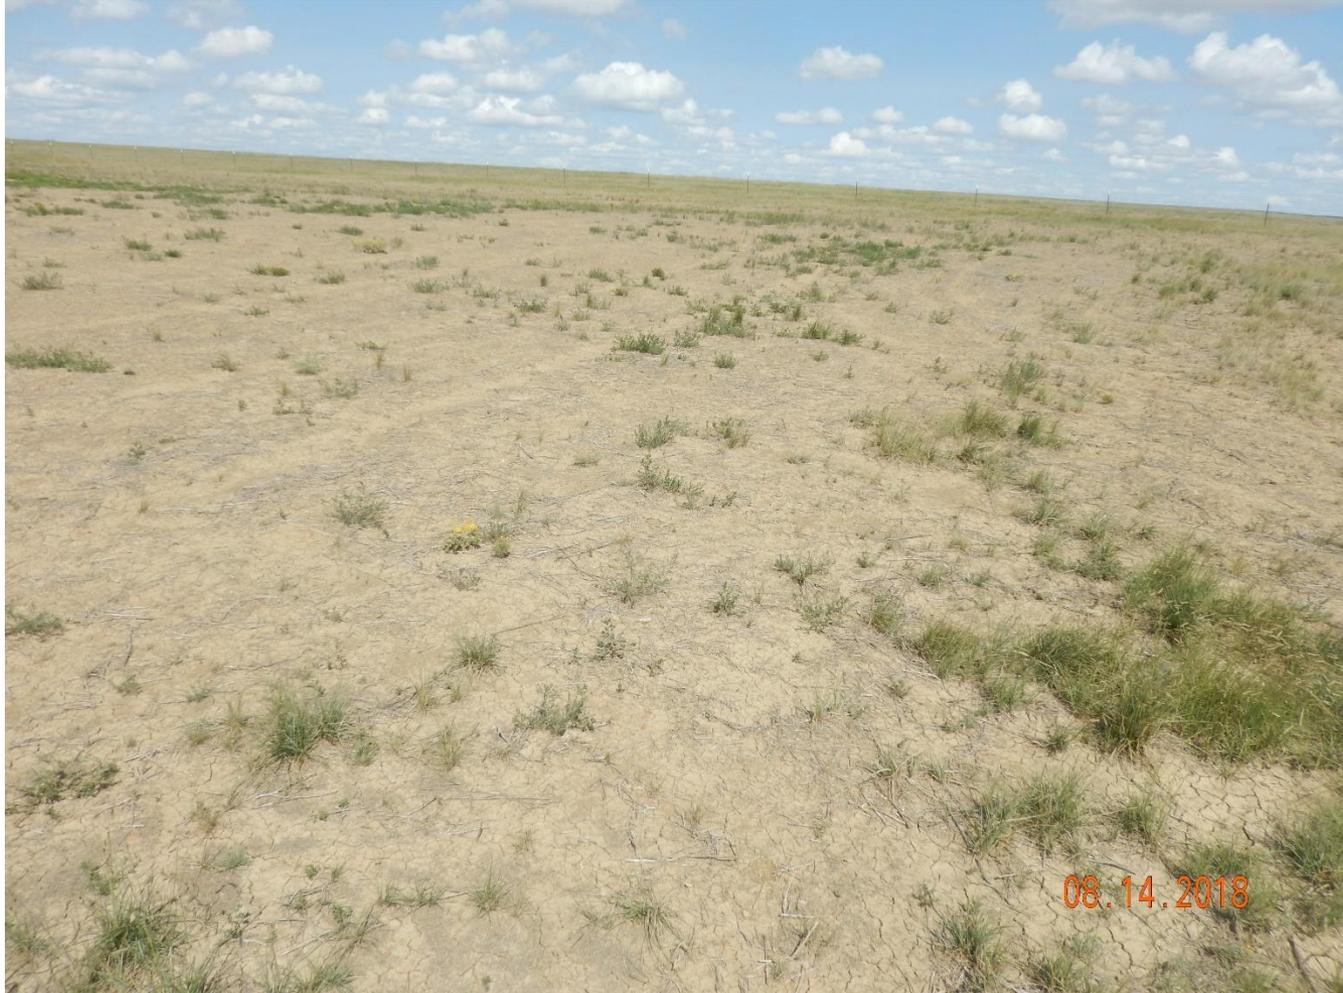
**Photo 4:** See comments under photo 1.

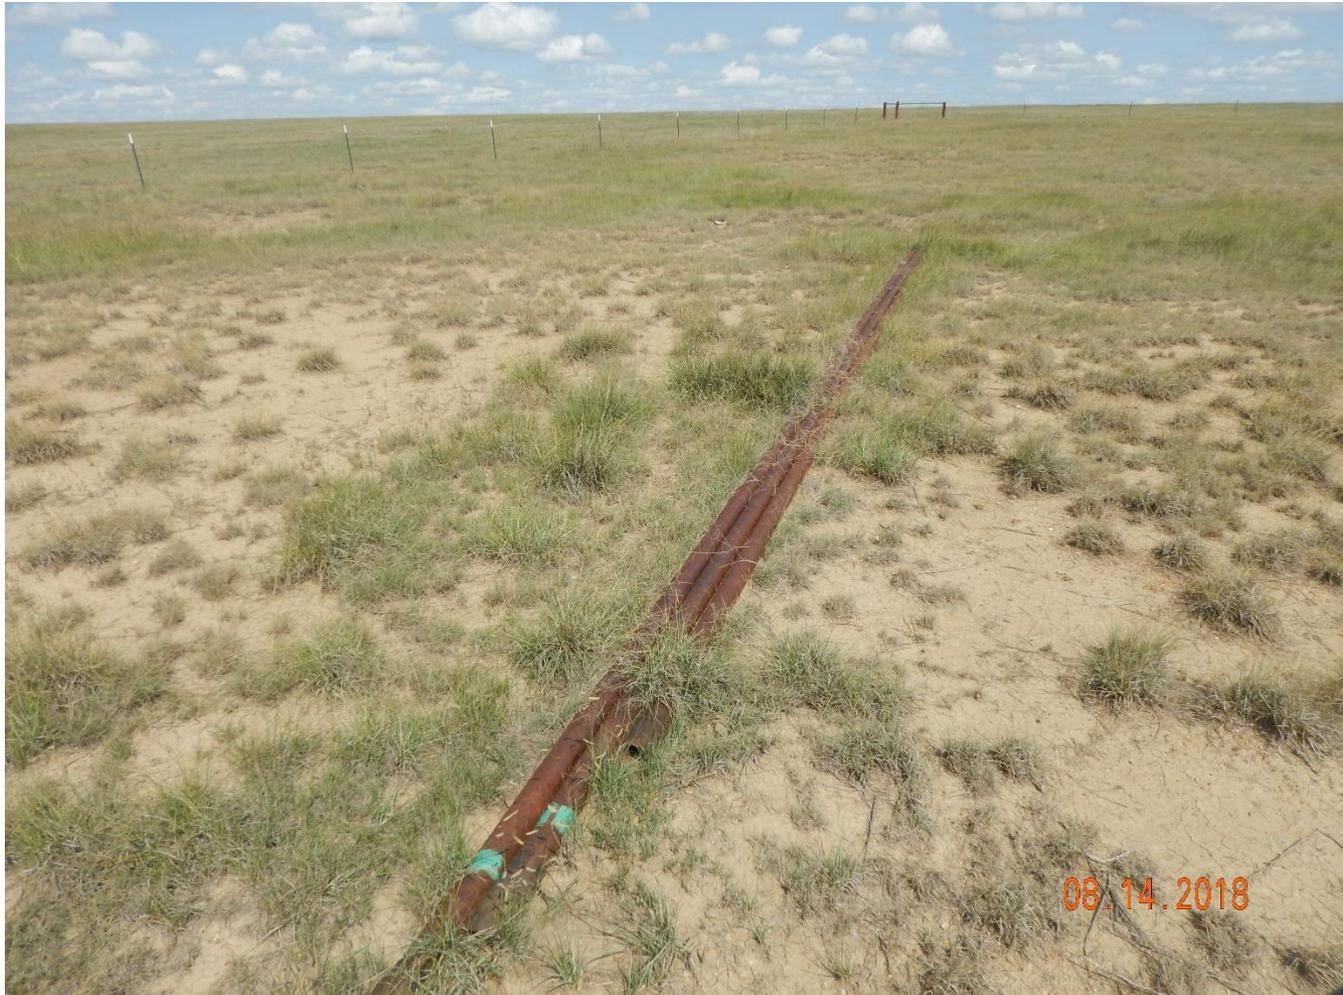
**Photo 5:** Photo taken from the north end of the location, facing northeast. Previous inspection documented pipe equipment remaining on location and required it to be removed. Photo shows pipe remains on location.

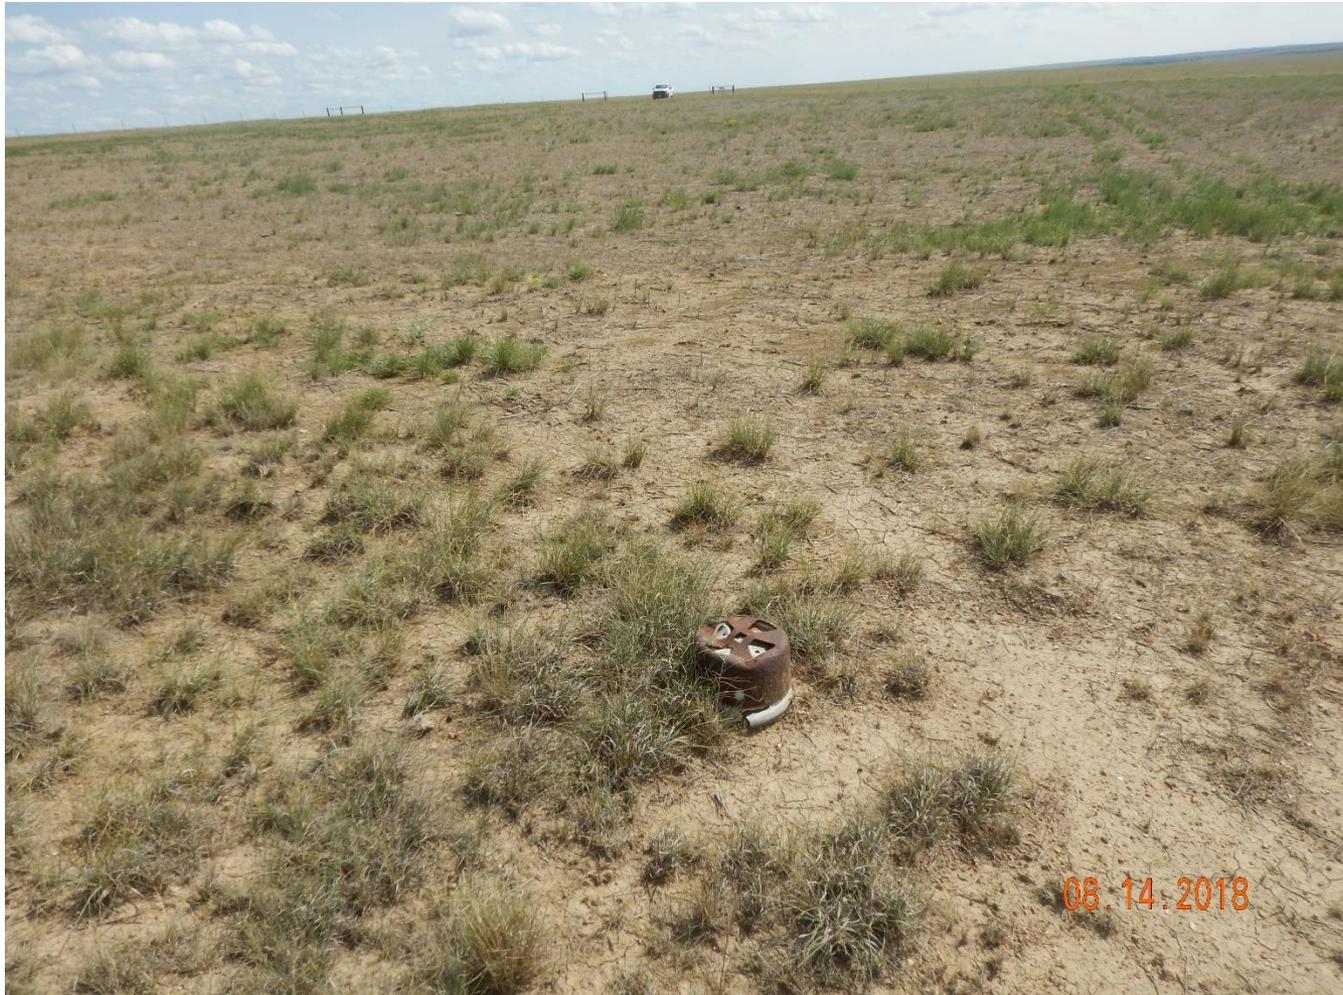
**Photo 6:** Photo taken from the north end of the location, facing south. Previous inspection documented equipment/trash debris remaining on location and required it to be removed. Photo shows equipment/trash debris remains on location.

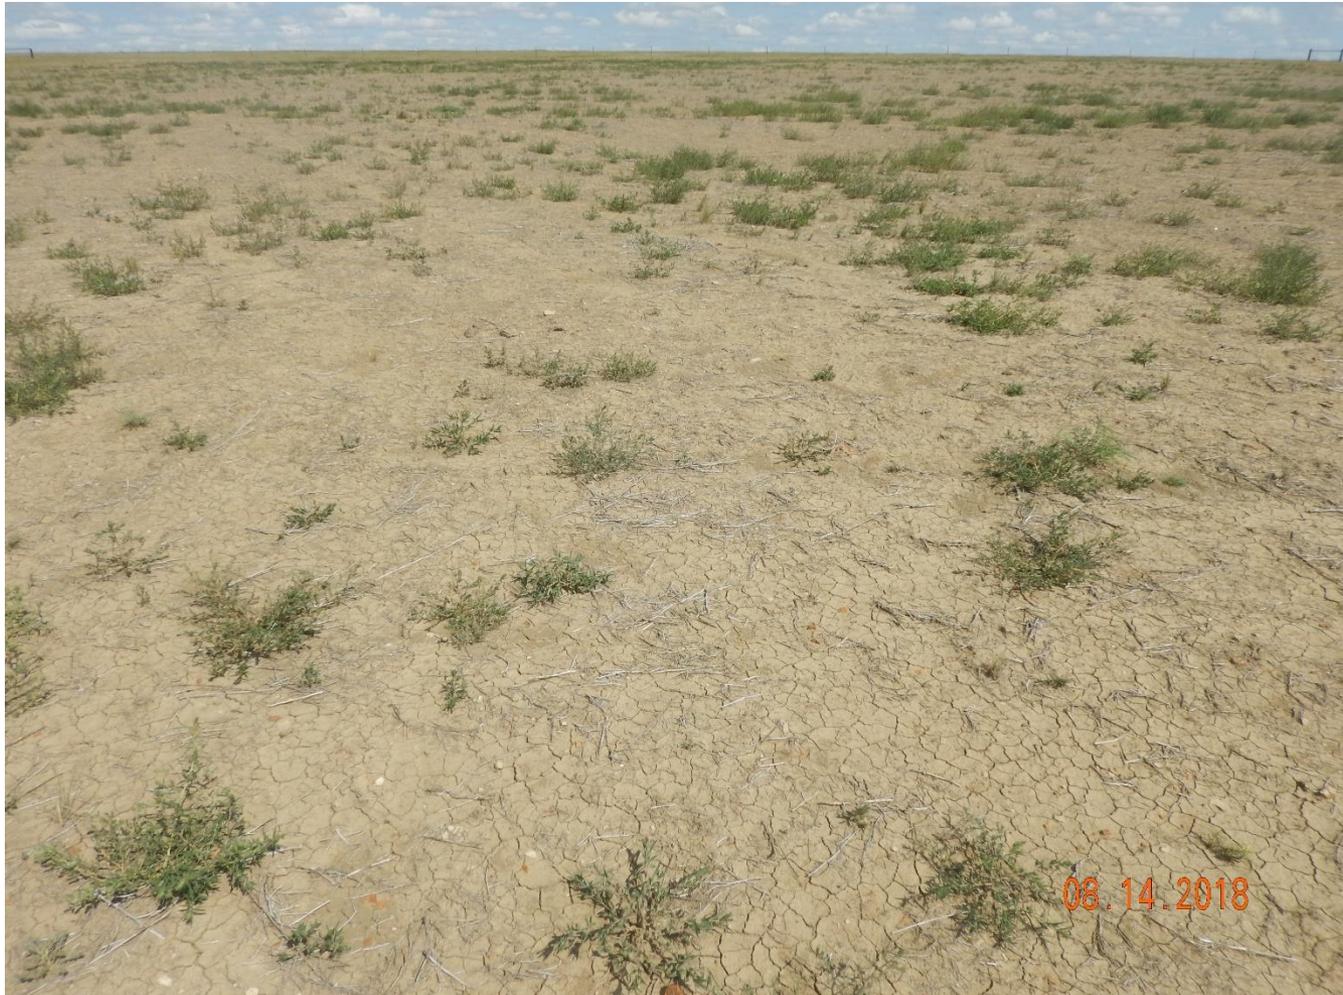
**Photo 7:** Photo taken from the west end of the location, facing east. Photo shows the reclamation area. Location remains predominantly bare and exposed soil. Vegetation observed predominantly undesirable weedy plant species. Unable to find evidence of work conducted per corrective actions.

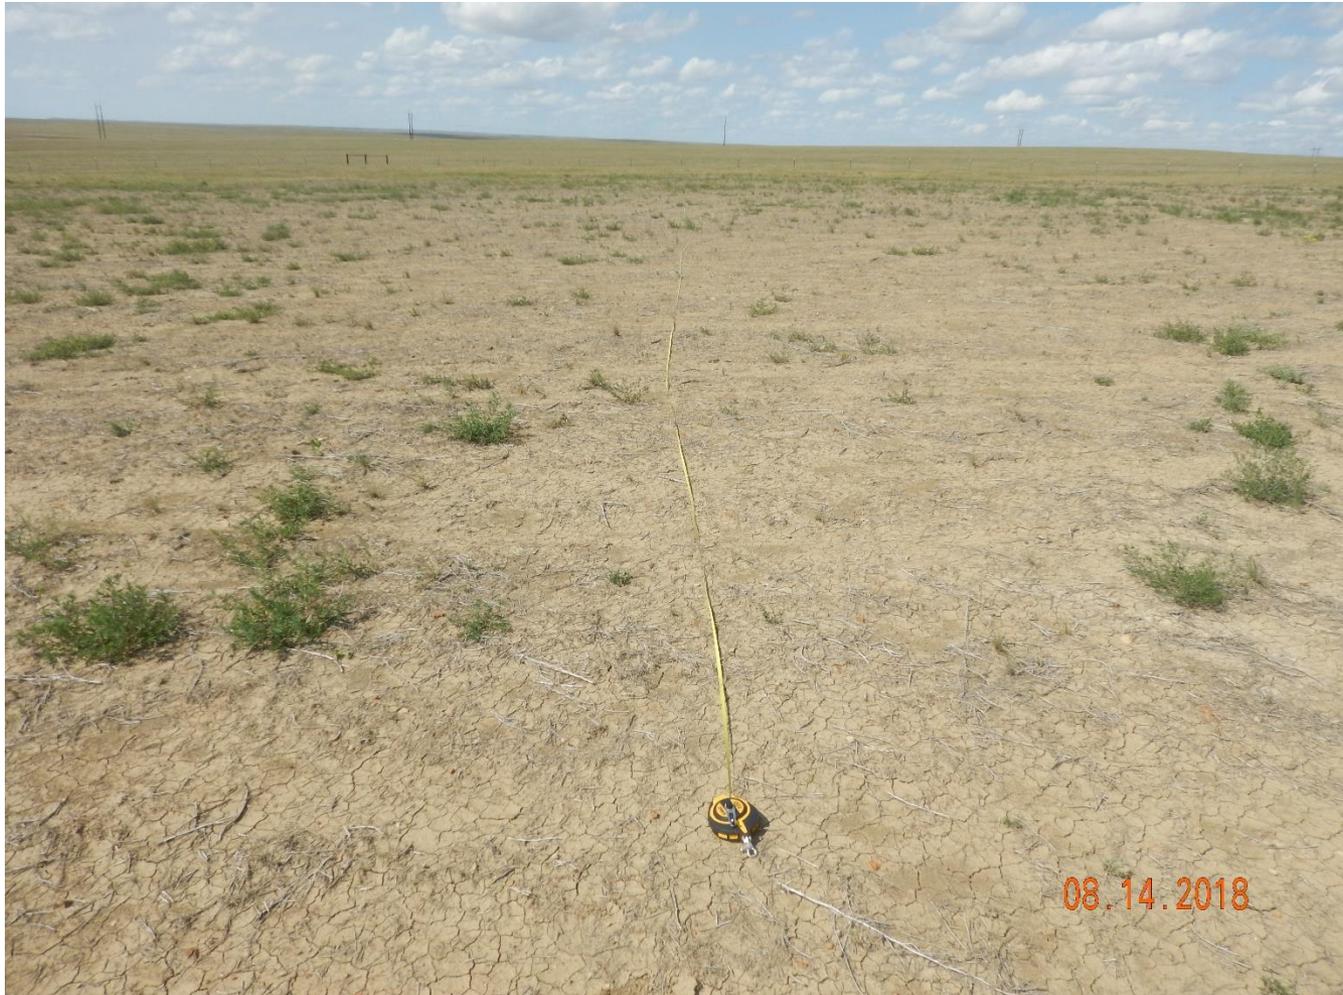
**Photo 8:** Photo taken from the central area of the location, facing north. Photo shows 1 of the 2 germination surveys conducted on the location.

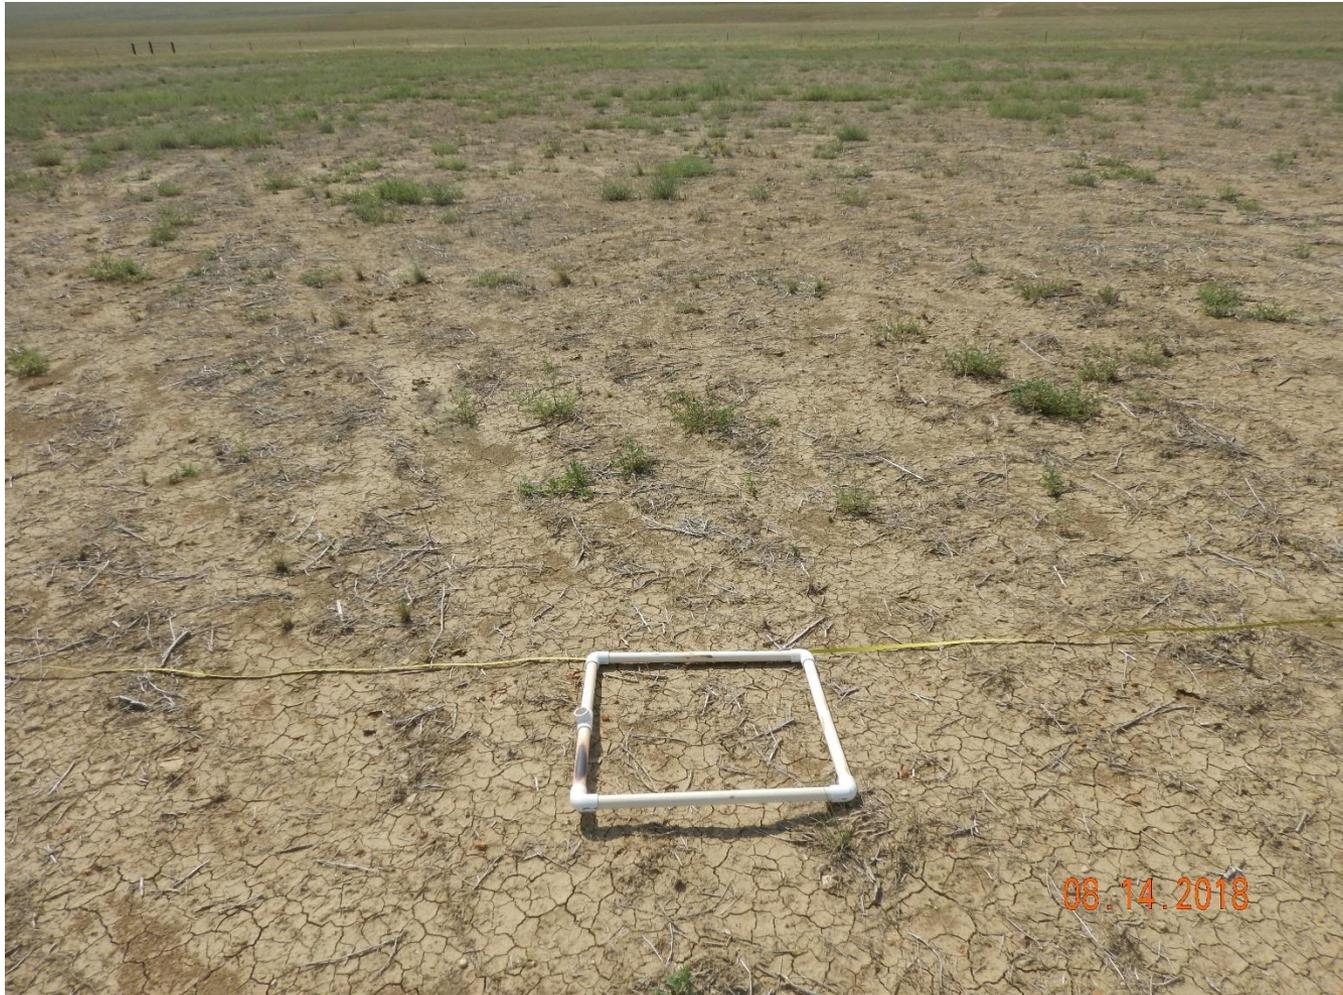
**Photo 9:** Photo taken from the midpoint of the germination survey. Photo shows location is mostly bare and exposed soil, and vegetation over the reclamation area is predominantly undesirable weedy plant species.

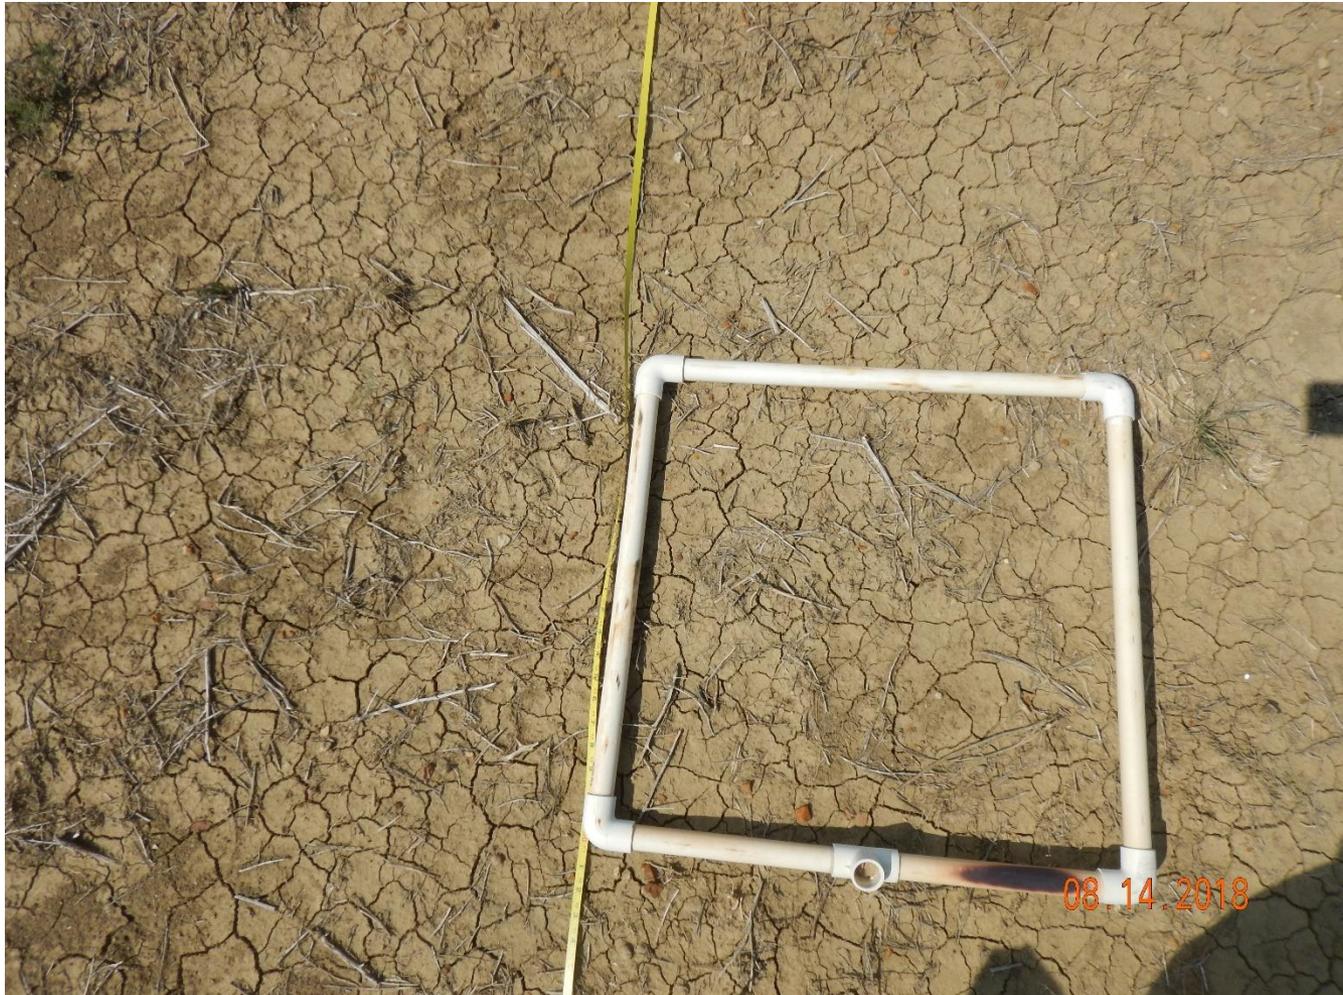
**Photo 10:** Photo taken from the midpoint of the germination survey. Survey shows location has an average germination of 0.8 seedlings per  $\frac{1}{2}$  m<sup>2</sup>, or 0.148 seedlings per square foot.

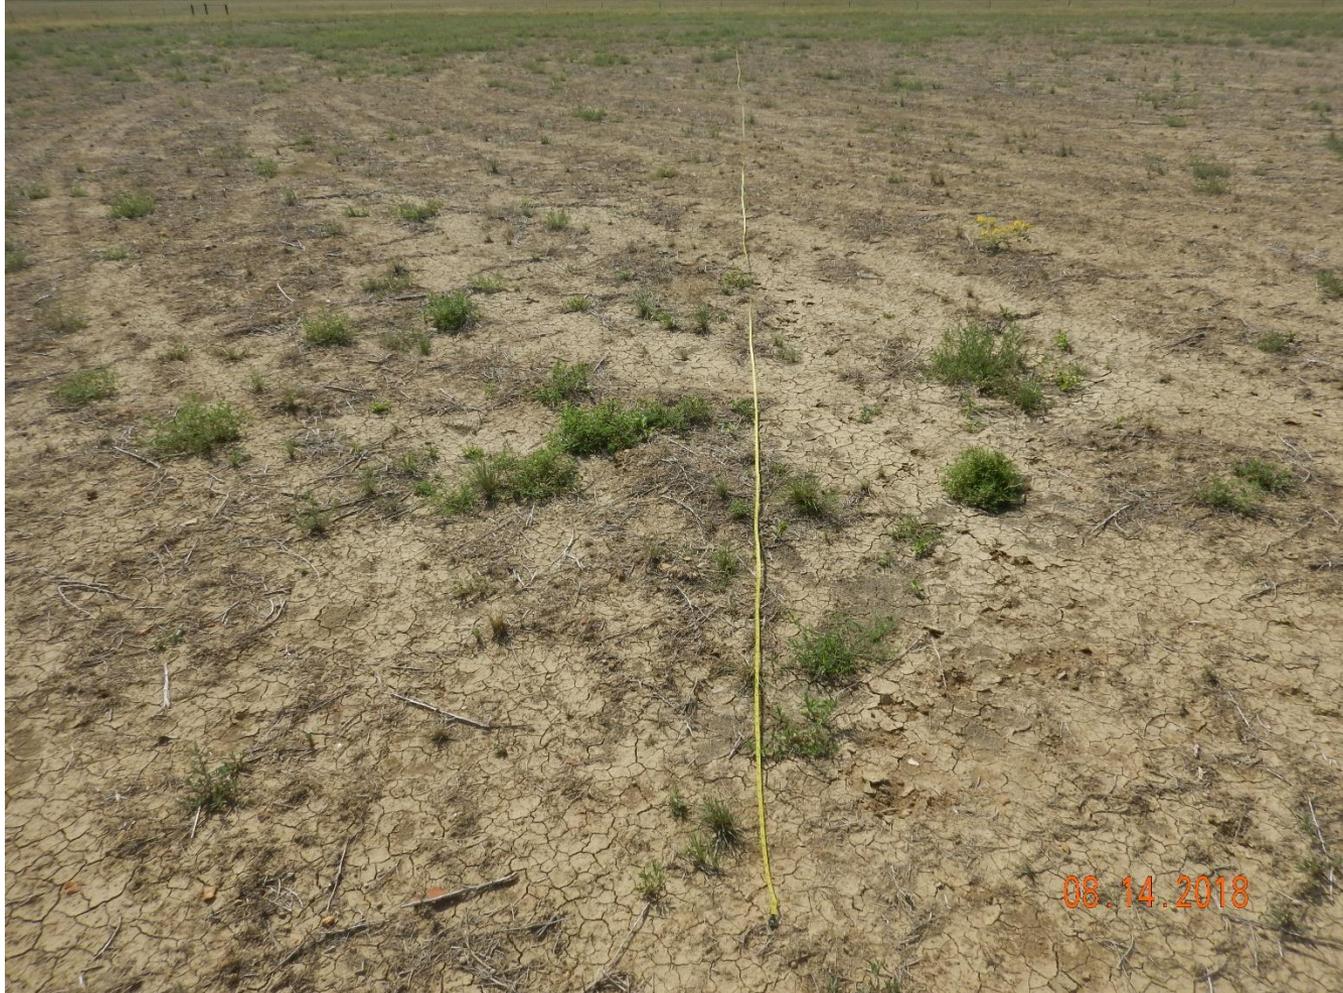
**Photo 11:** Photo taken from the north end of the location, facing south. Photo shows 2 of the 2 germination surveys conducted on the location. Survey 1 ran north/south in the middle of the location and Survey 2 ran east/west in the middle of the location. Surveys intersected at the 50<sup>th</sup> point (“+”)
