Inspection Photos

Operator: GRAND MESA OPERATING CO - 35080

Location ID: 456610

Inspection Doc. Number: 682503767

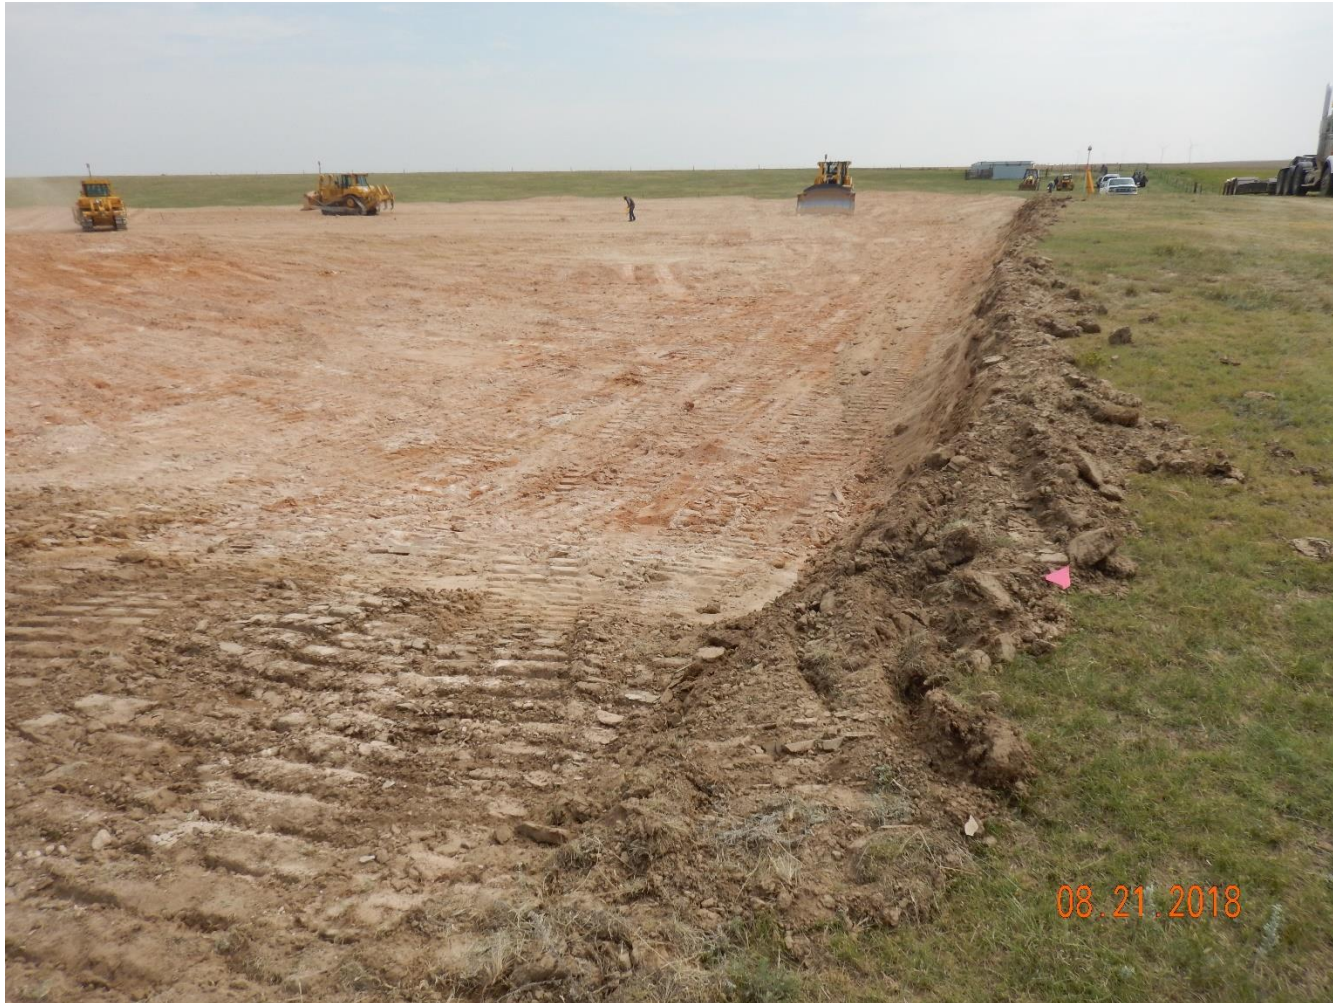
Photo 1: Photo taken from the southwest end of the location, facing east. Photo shows southern perimeter of the location and construction in process.

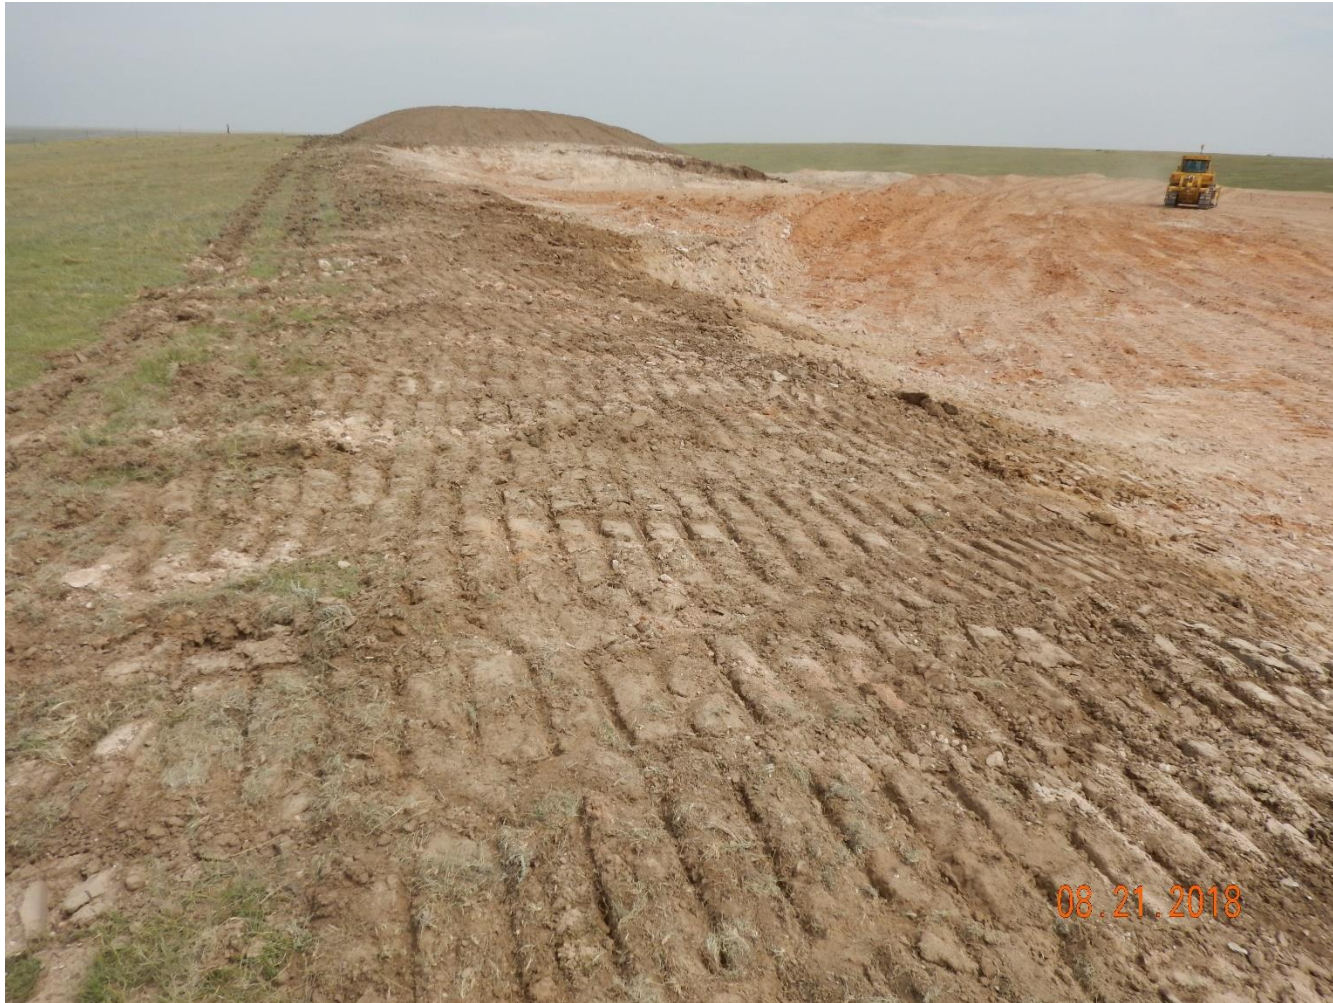
Photo 2: Photo taken from the southwest corner of the location, facing north. Photo shows construction in process. Photo also shows surface roughening (ripping) appears to have been installed on the western perimeter of the location. Surface roughening is a temporary BMP that should be used in conjunction with other BMPs and should not be used / replaced once pad construction and stabilization has completed

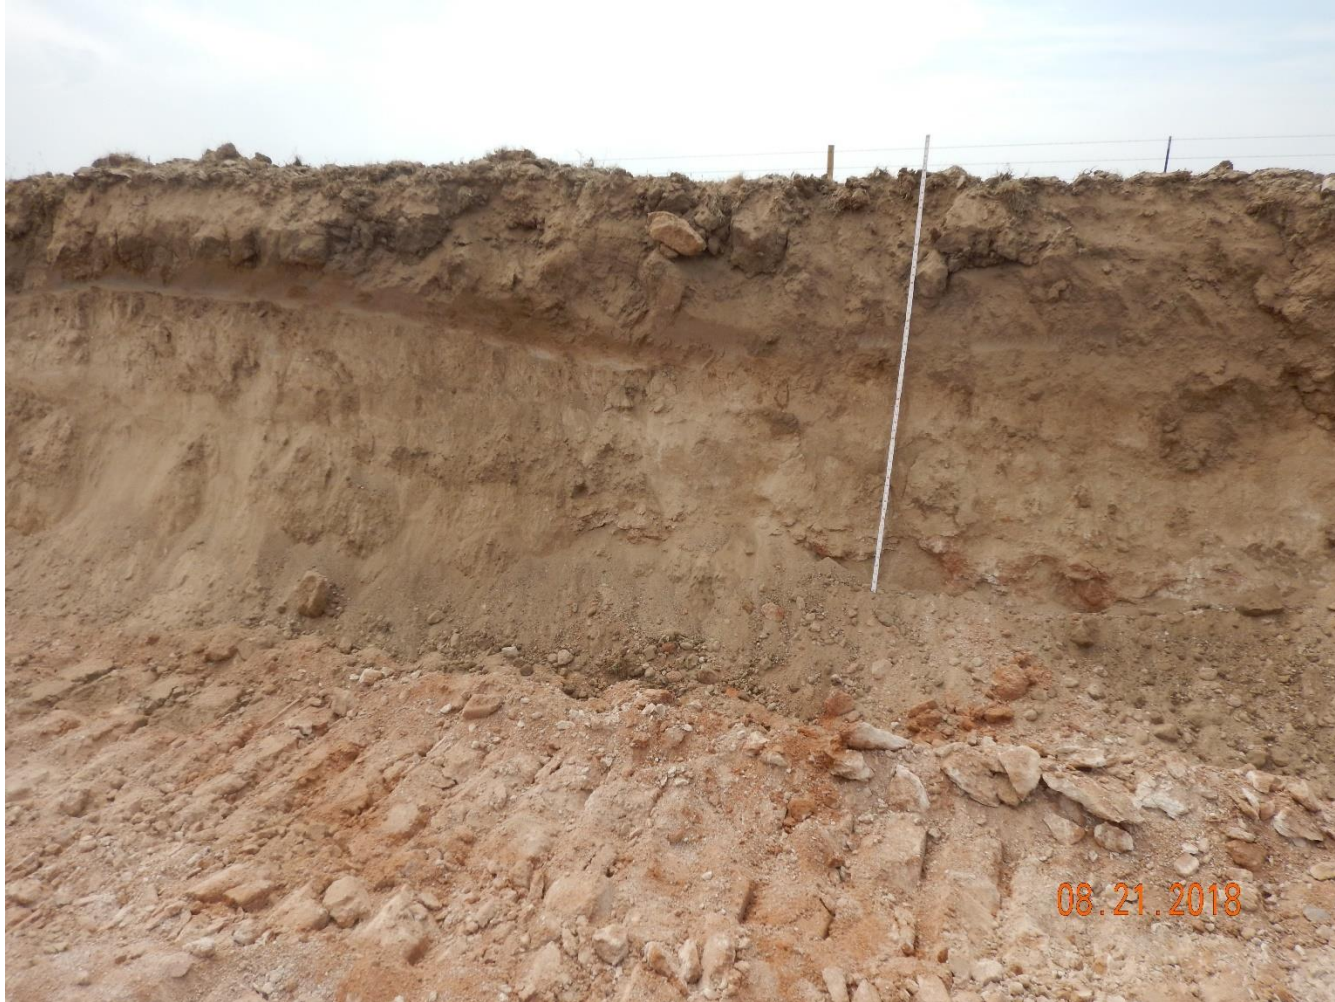
Photo 3: Photo taken from the south end of the location, facing south. Photo shows soil horizons from the cut. Topsoil layer appears to be ~2 feet in depth from surface.

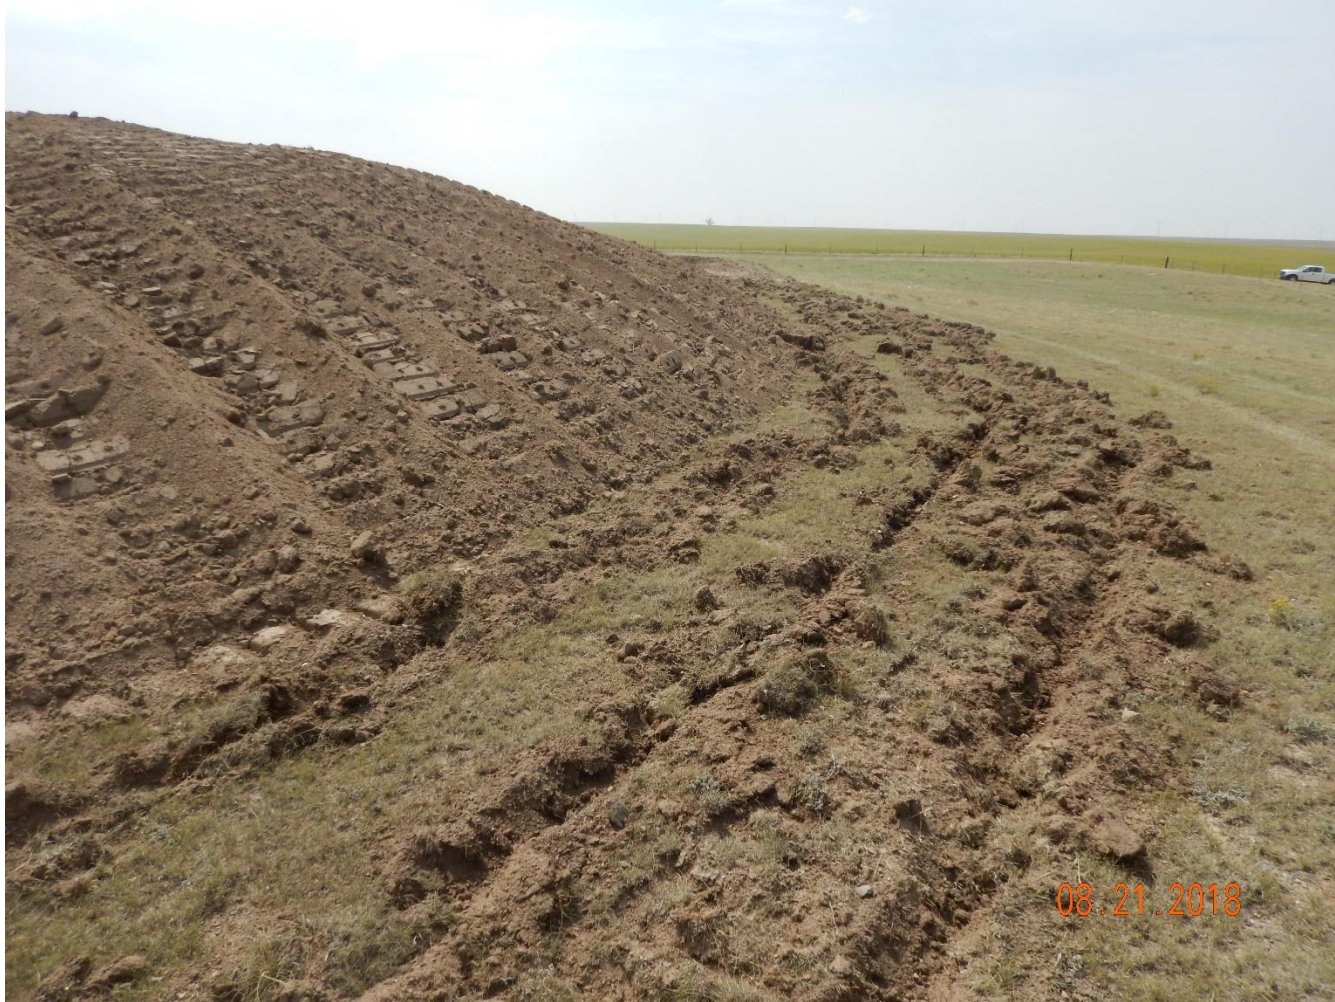
Photo 4: Photo taken from the northwest corner of the location, facing south. See comments under photo 2

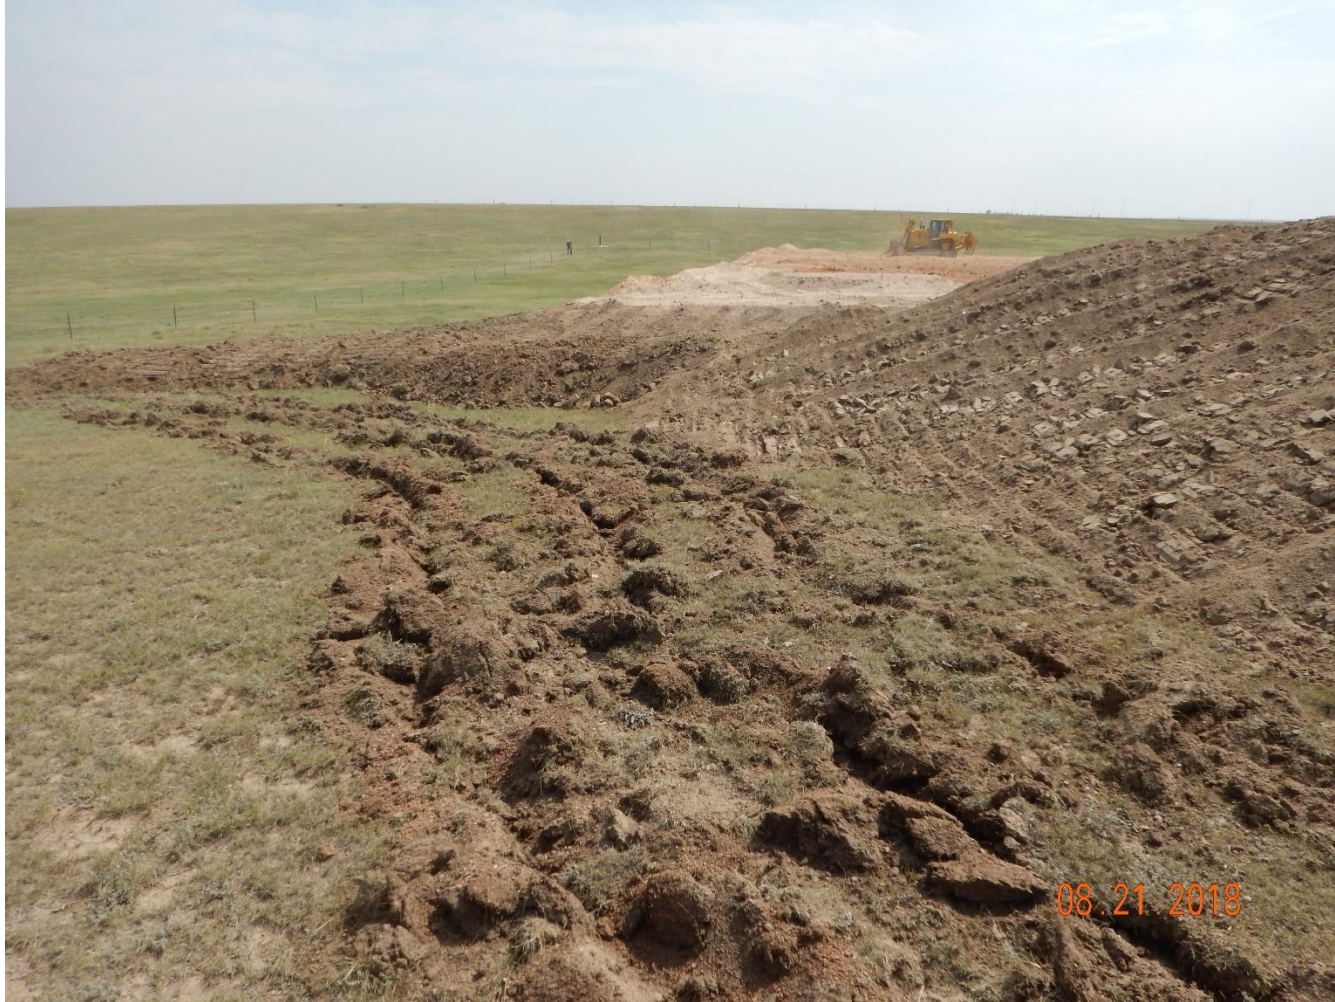
Photo 5: Photo taken from the northwest corner of the location, facing east. See comments under photo 2

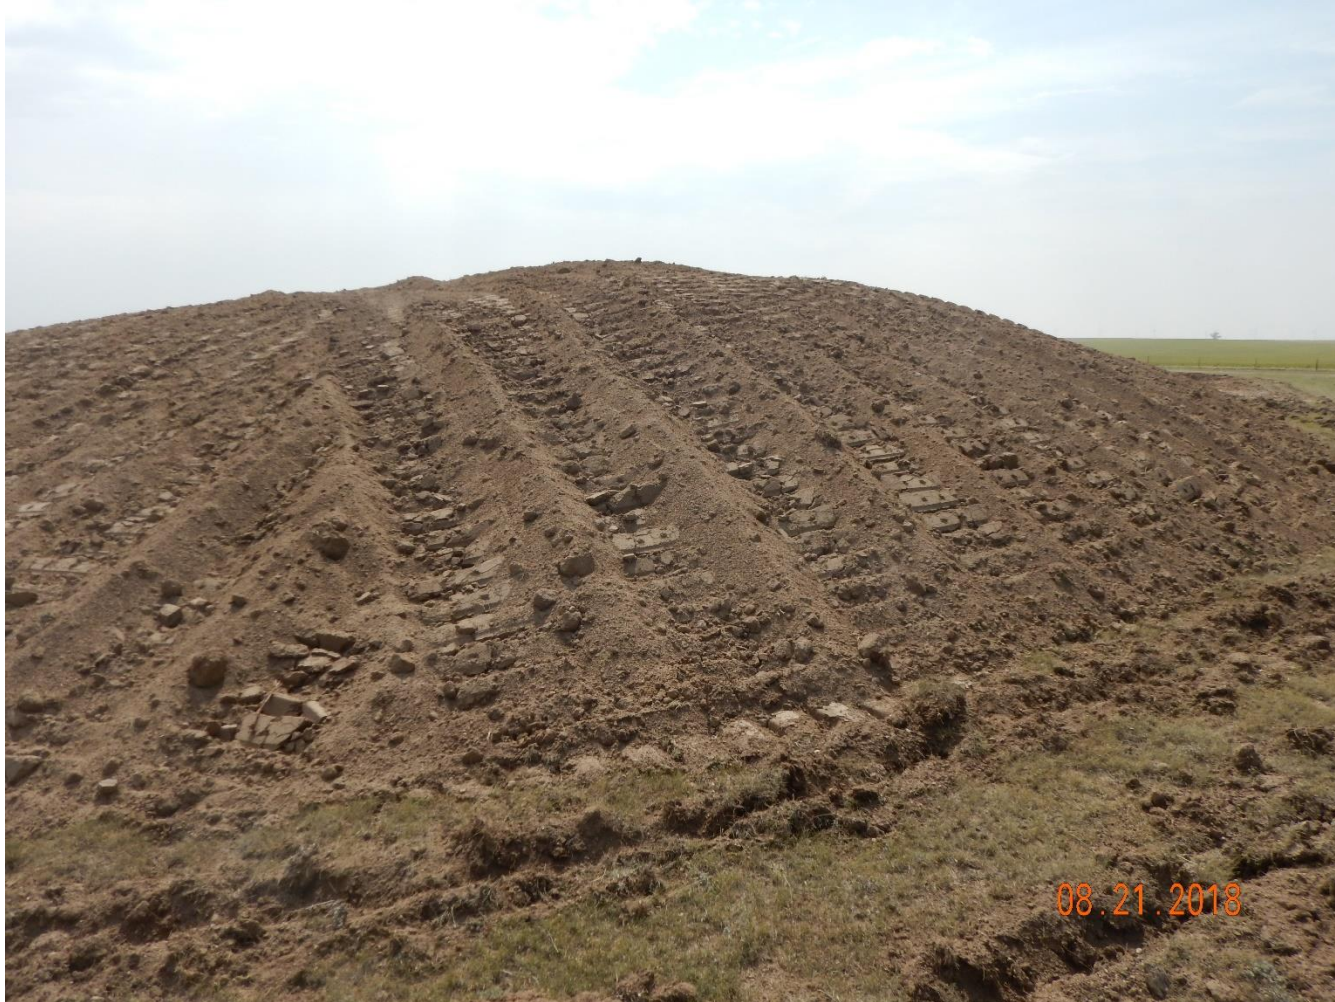
Photo 6: Photo taken from the north end of the location, facing south. Photo of topsoil stockpile

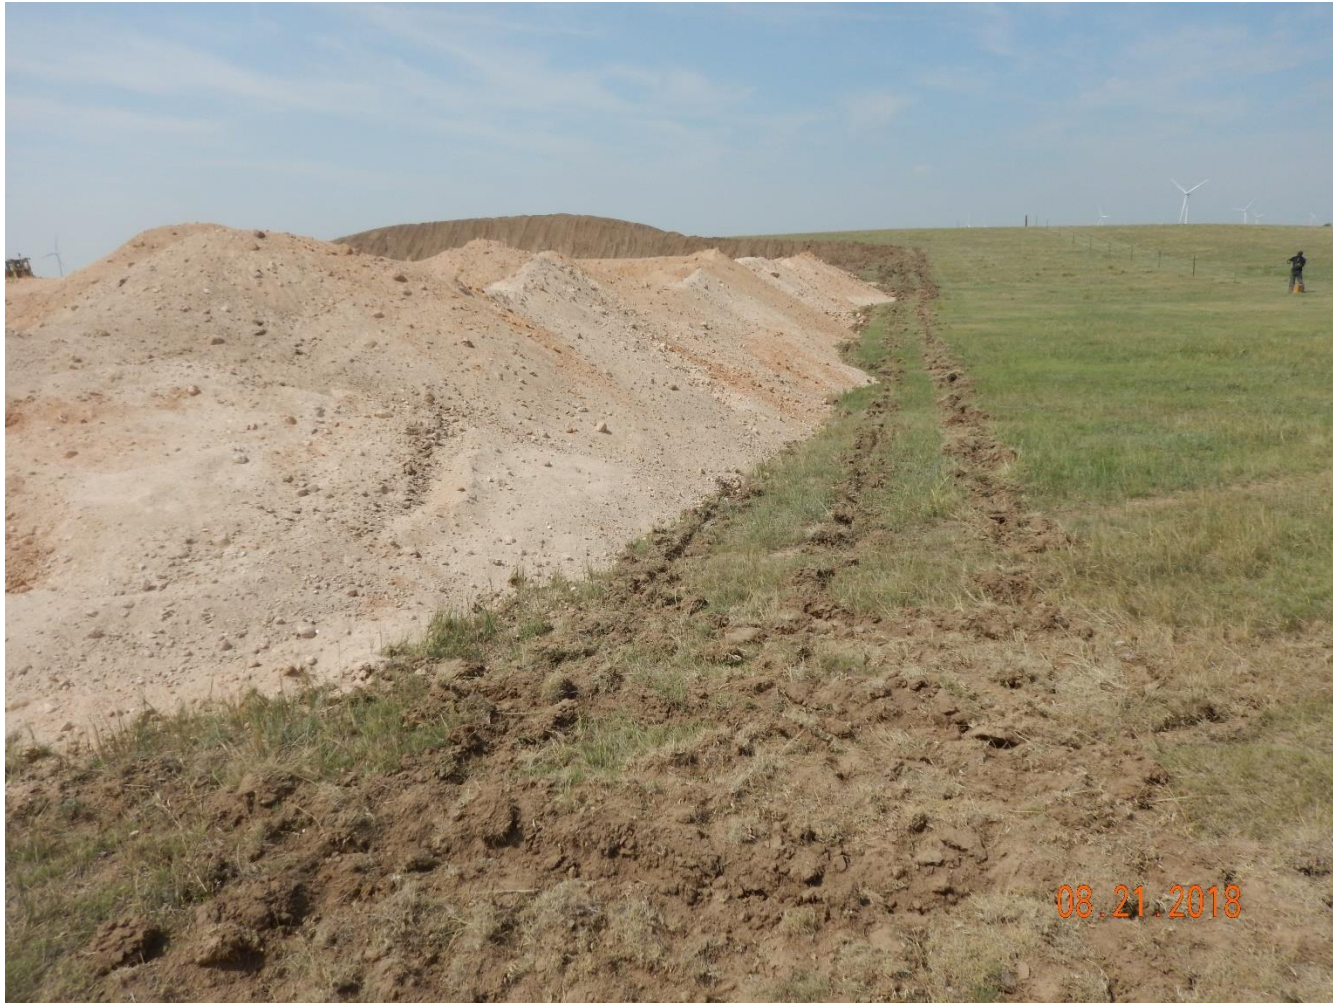
Photo 7: Photo taken from the southeast corner of the location, facing west. Photo shows surface roughening (ripping) installed along perimeter has filled with sediment and is not longer in proper functioning condition. BMP appears to be insufficient for the site and site's conditions.

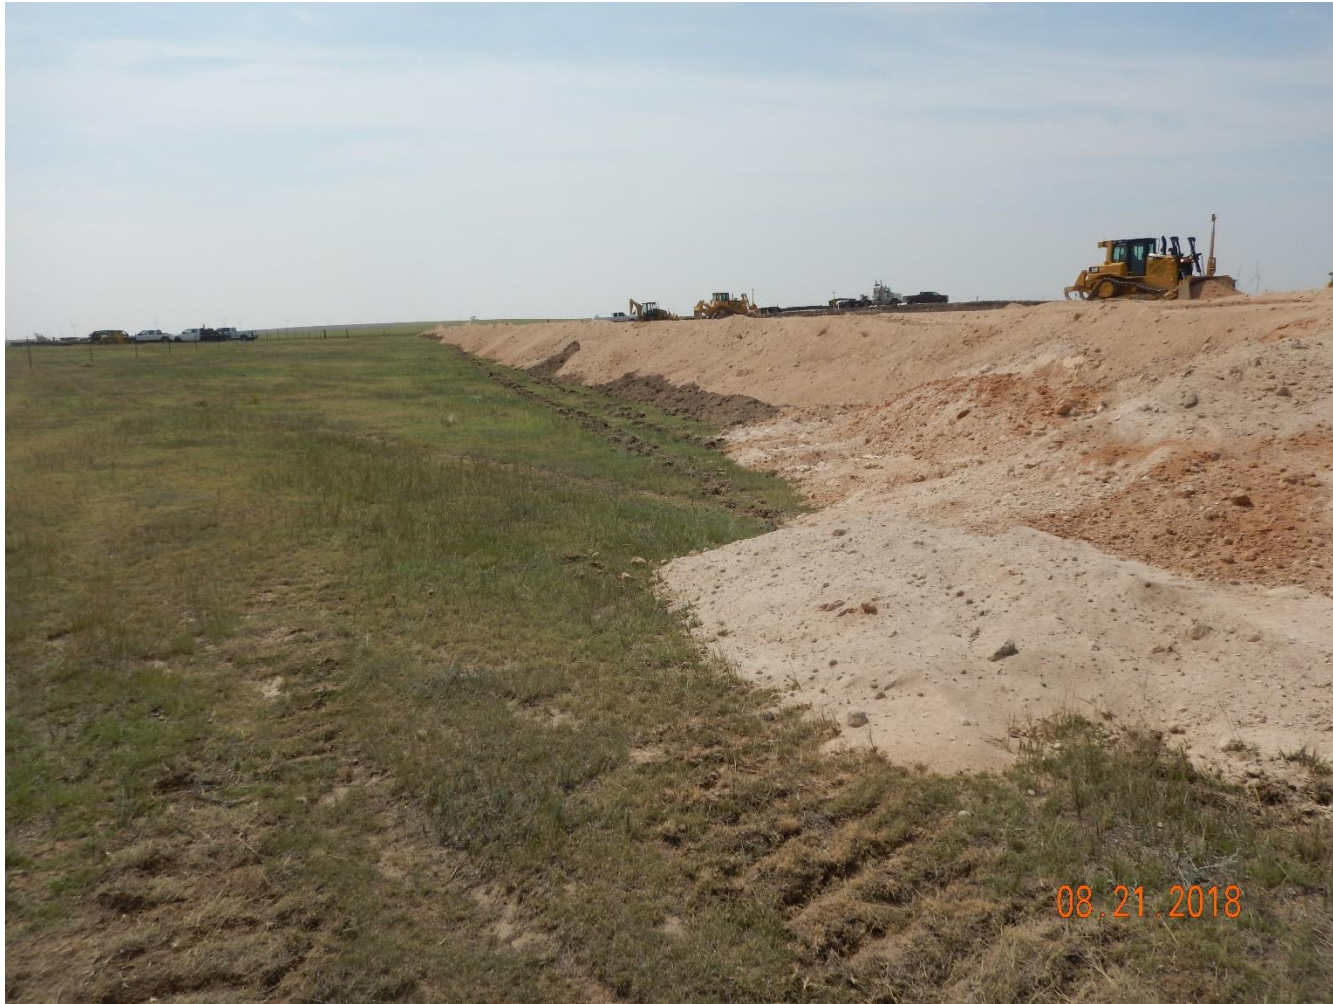
Photo 8: Photo taken from the southeast corner of the location, facing south. Photo shows surface roughening (ripping) installed along perimeter has filled with sediment and is not longer in proper functioning condition. BMP appears to be insufficient for the site and site's conditions.

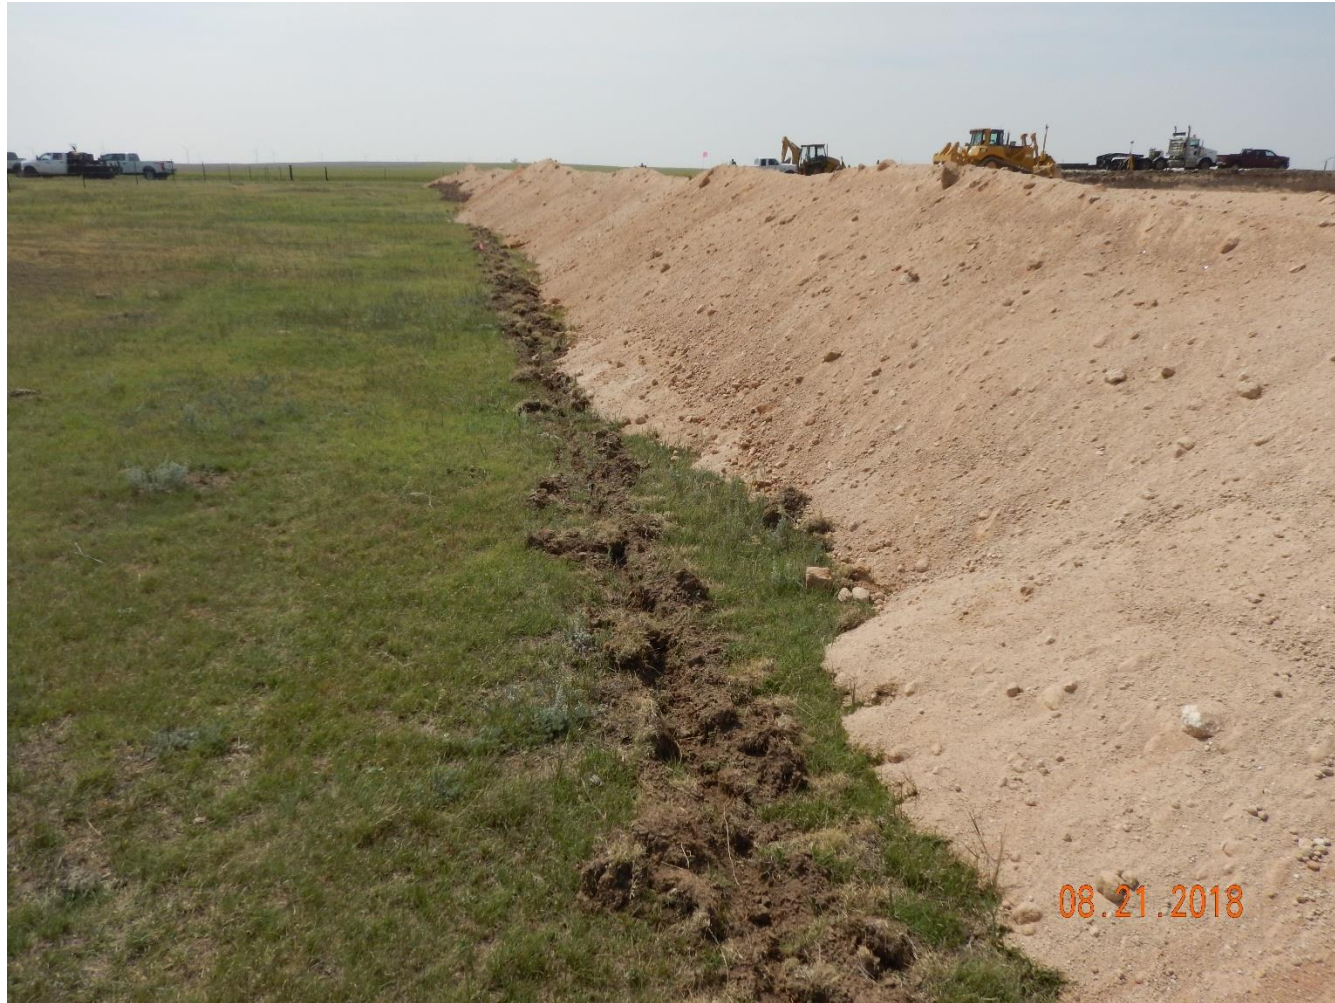
Photo 9: Photo taken from the east end of the location, facing south. Photo shows surface roughening (ripping) installed along perimeter has filled with sediment and is not longer in proper functioning condition. BMP appears to be insufficient for the site and site's conditions.

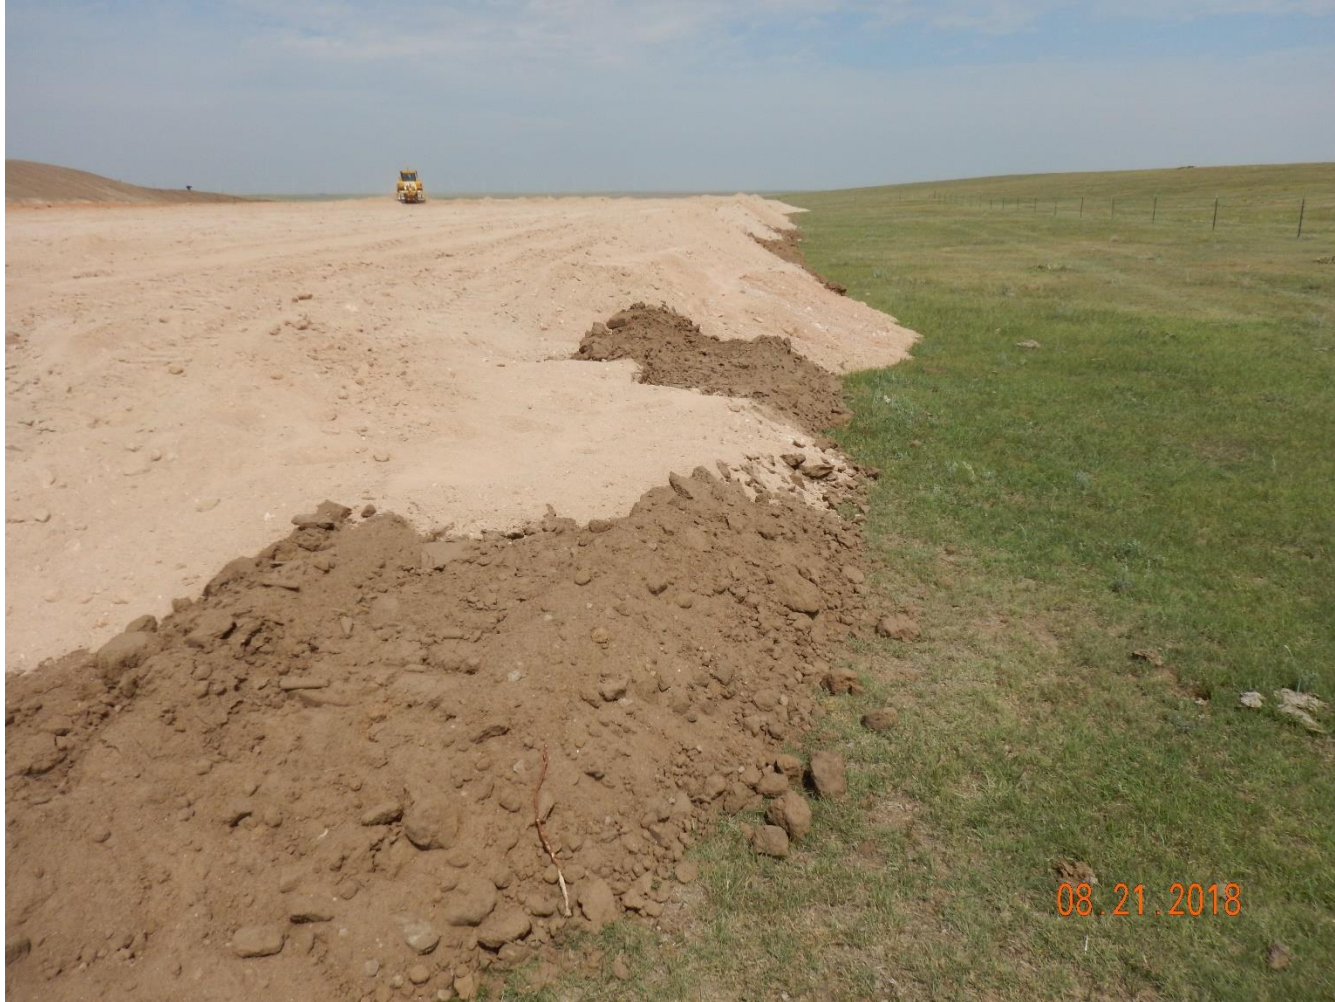
Photo 10: Photo taken from the southeast corner of the location, facing north. Photo shows insufficient perimeter stormwater and erosion controls have been installed.

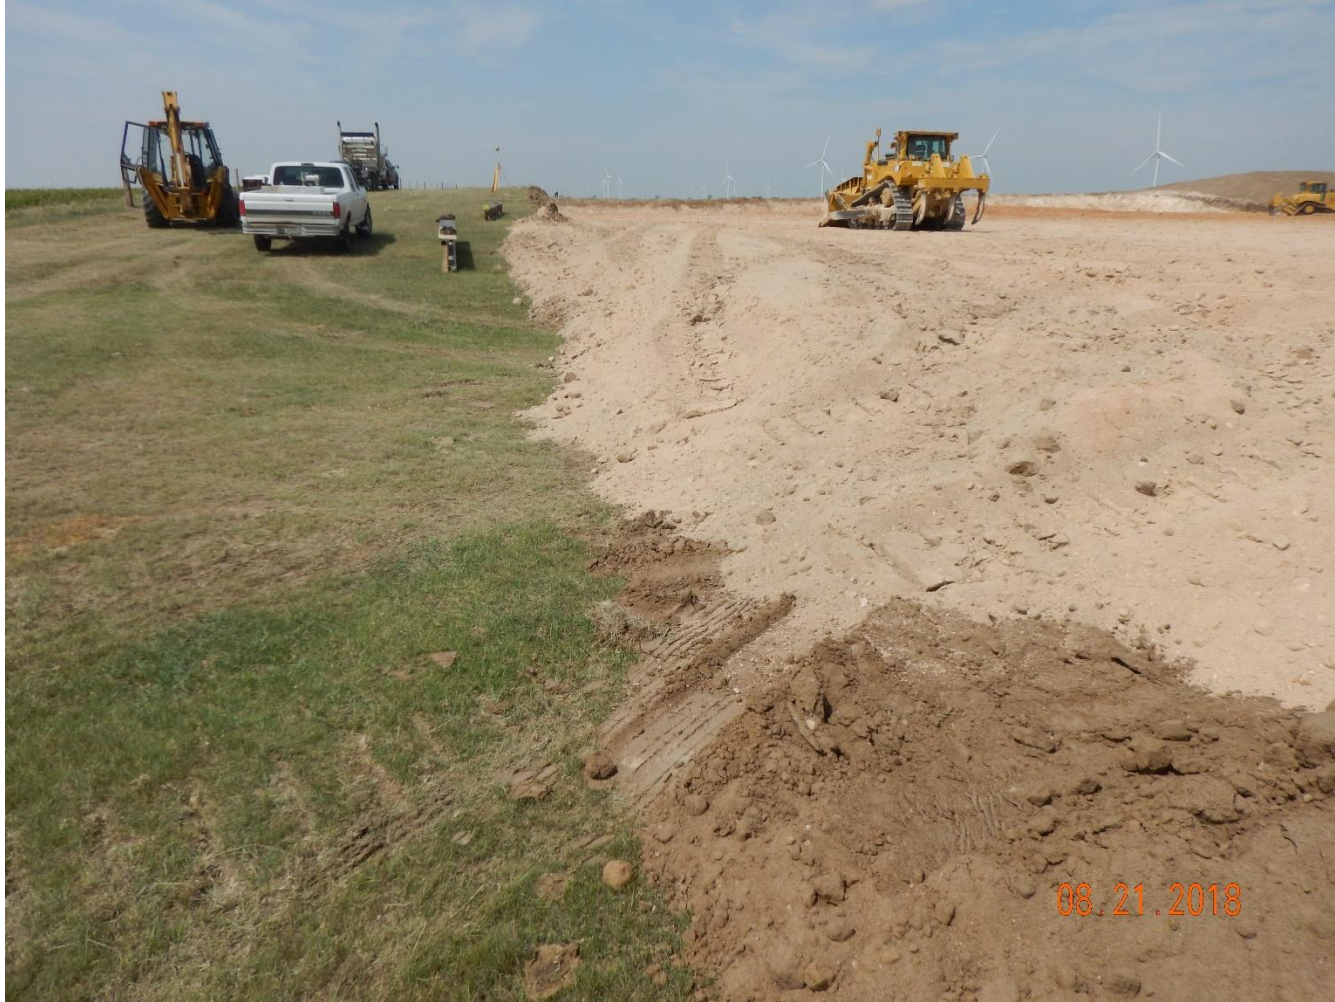
Photo 11: Photo taken from the southeast corner of the location, facing west. Photo shows insufficient perimeter stormwater and erosion controls have been installed.

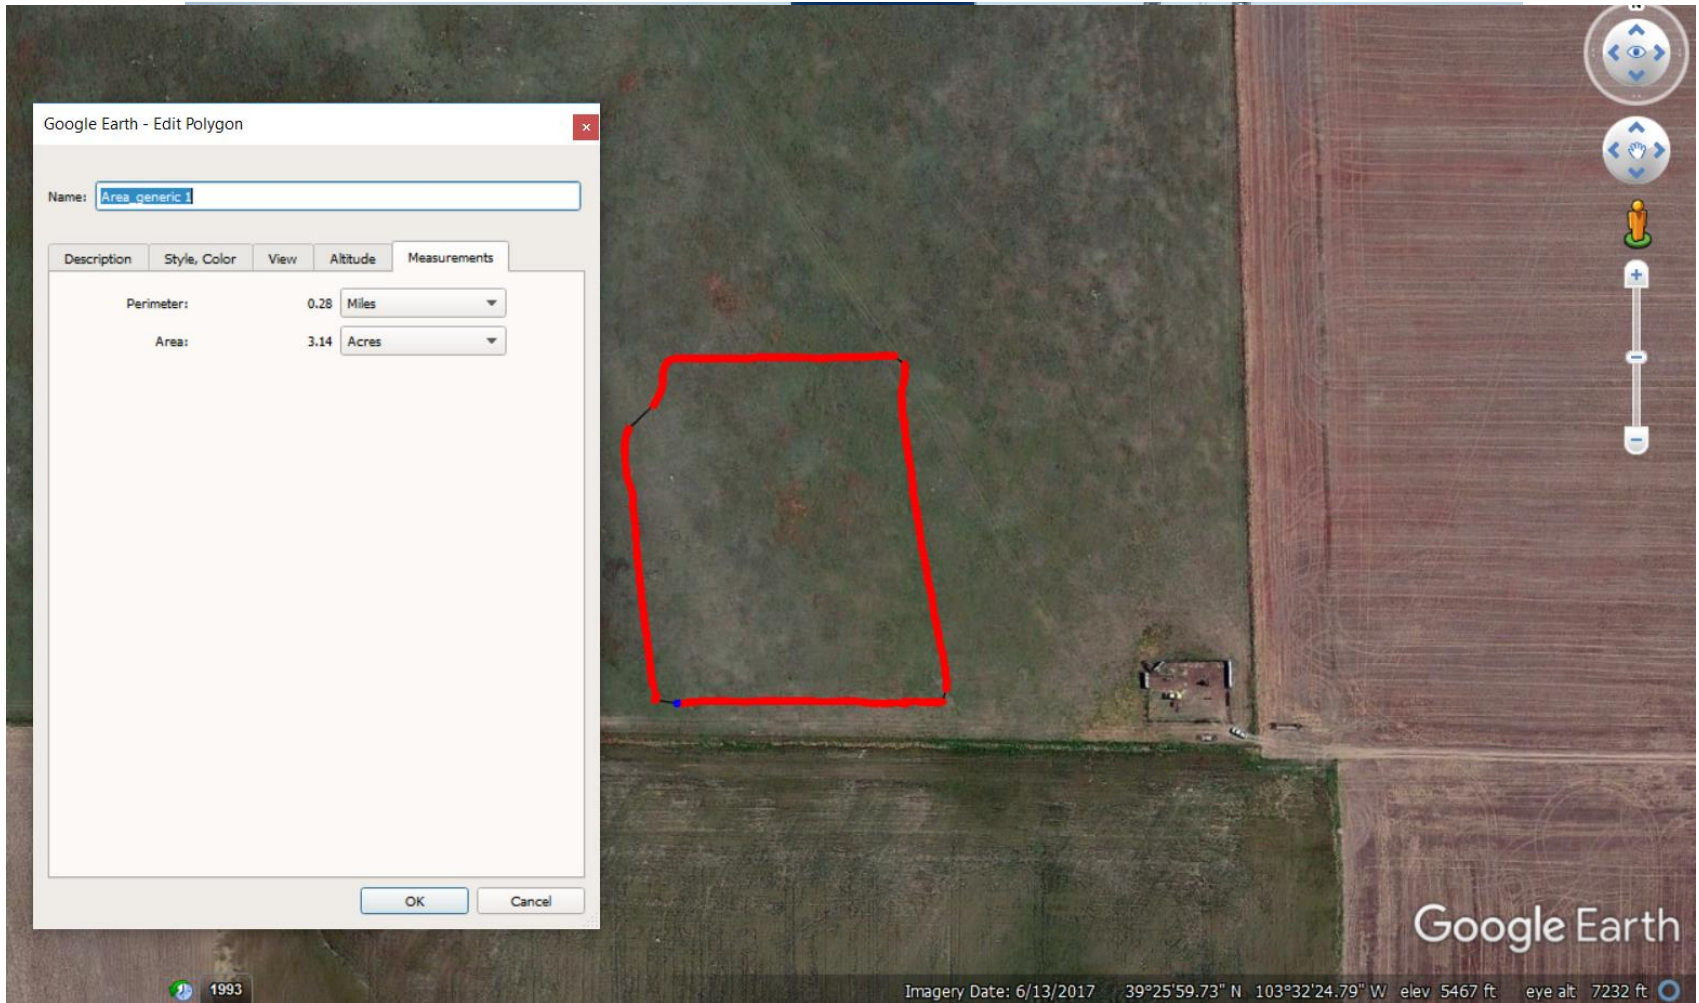
Photo 12: 2017 Google Earth aerial imagery. 2A doc. #401665224 states size of disturbance area during construction will be 2.5 acres in size. GPS measurements were conducted indicating that the disturbance area, not including the fence line, is 3.14 acres in size.
