## Inspection Photos

Location Name: D.O.C. Showers - 68N60W / 32NWSW

Location #: 330667

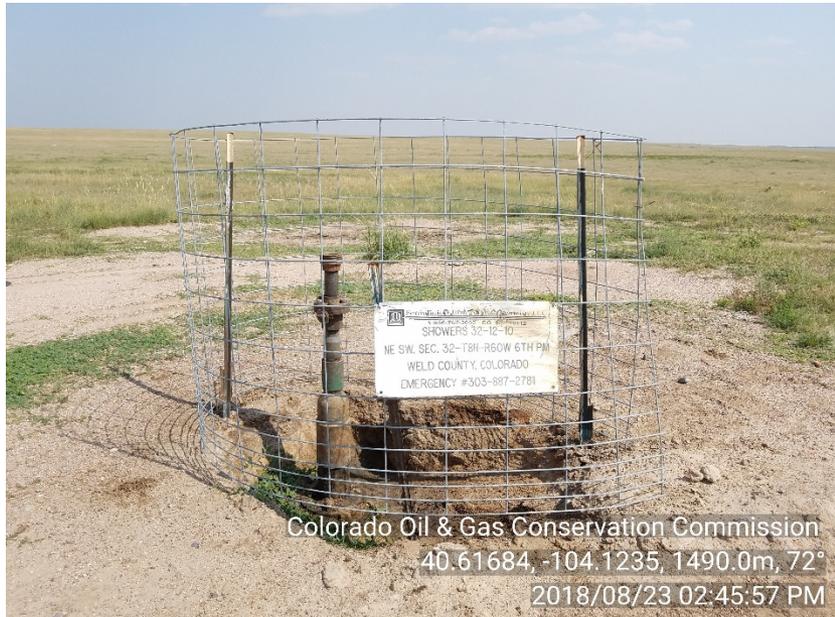
**Photo #1**

**D.O.C. Showers 32-12-10** (API # 05-123-19437)  
wellhead

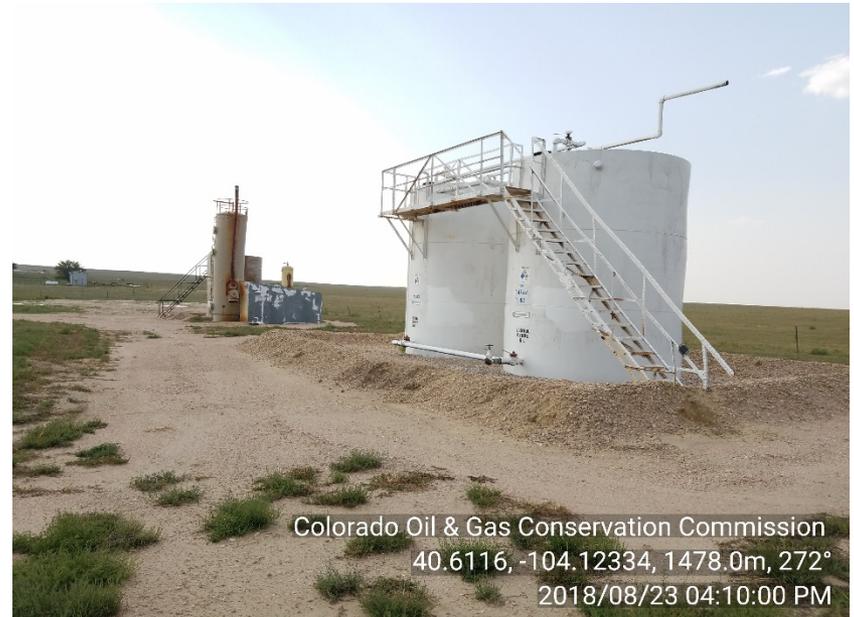
**Photo #2**

**D.O.C. Showers 32-12-10, Showers 32-5-7**  
Battery

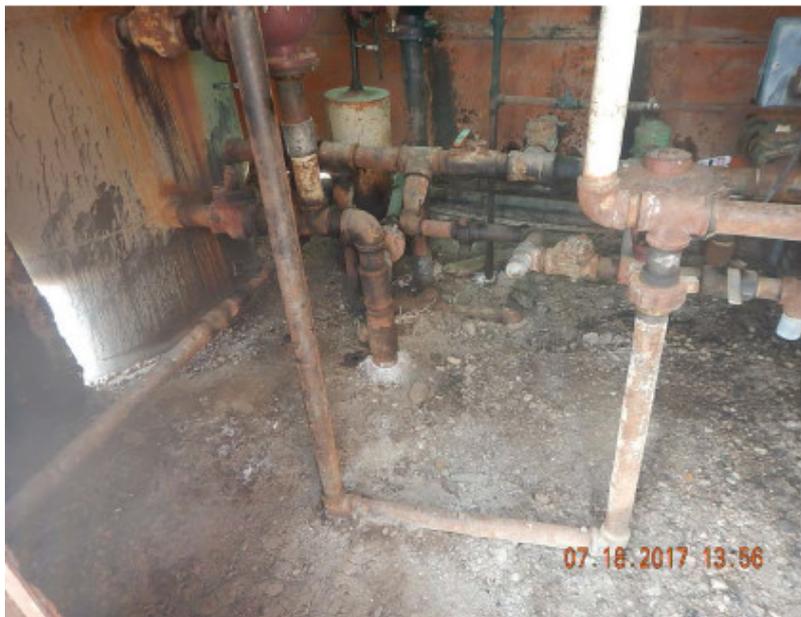
**Photo #3**

***D.O.C. Showers 32-12-10 , Showers 32-5-7***

Treater house

*From previous FIR*

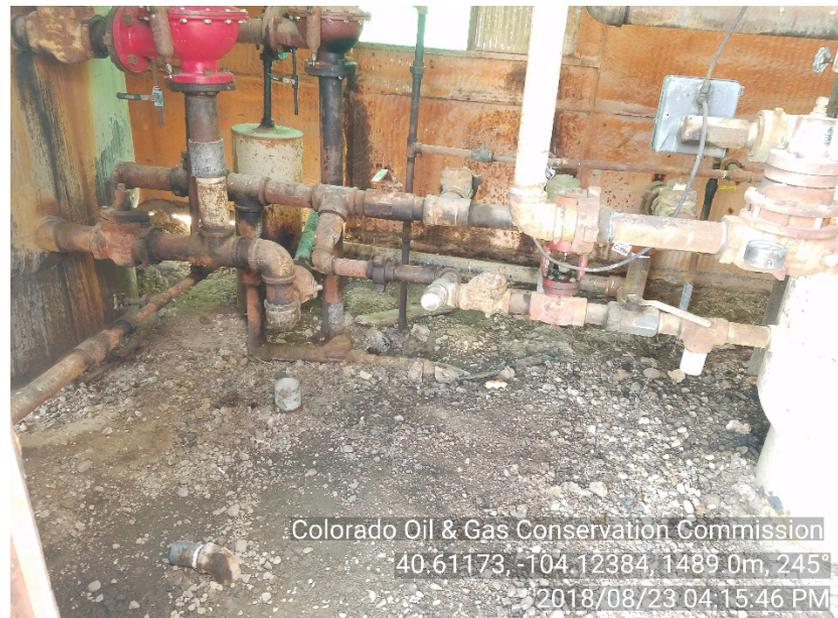
**Photo #4**

***D.O.C. Showers 32-12-10 , Showers 32-5-7***

Treater house

***Muddy floor, No hydrocarbons, no leaks***

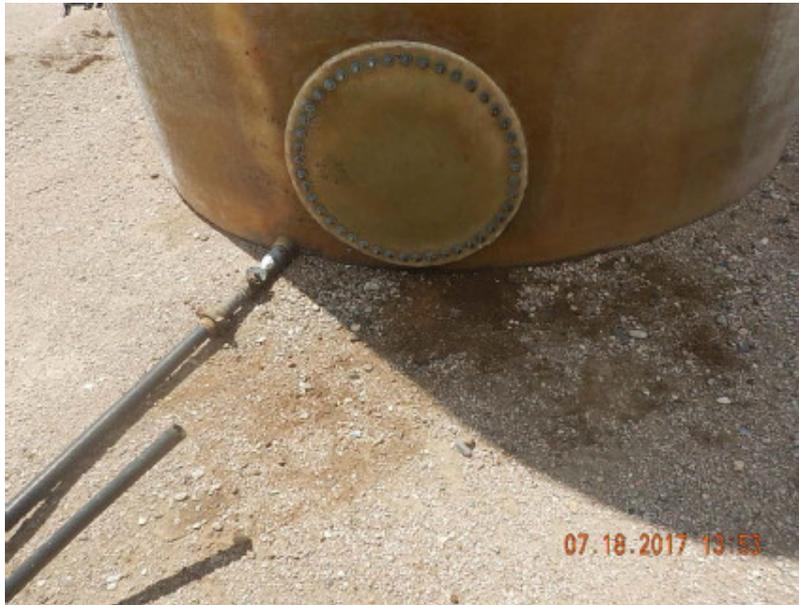
**Photo #5**

***D.O.C. Showers 32-12-10 , Showers 32-5-7***

H2O tank – stained soil

*From previous FIR*

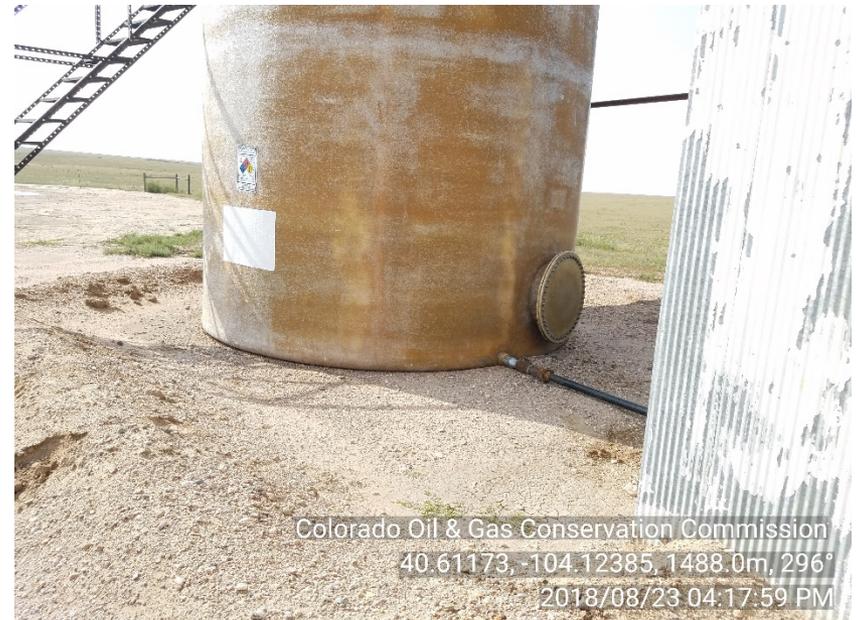
**Photo #6**

***D.O.C. Showers 32-12-10 , Showers 32-5-7***

H2O tank – stained soil

**Soil stains mitigated, New capacity label prep for stencil**

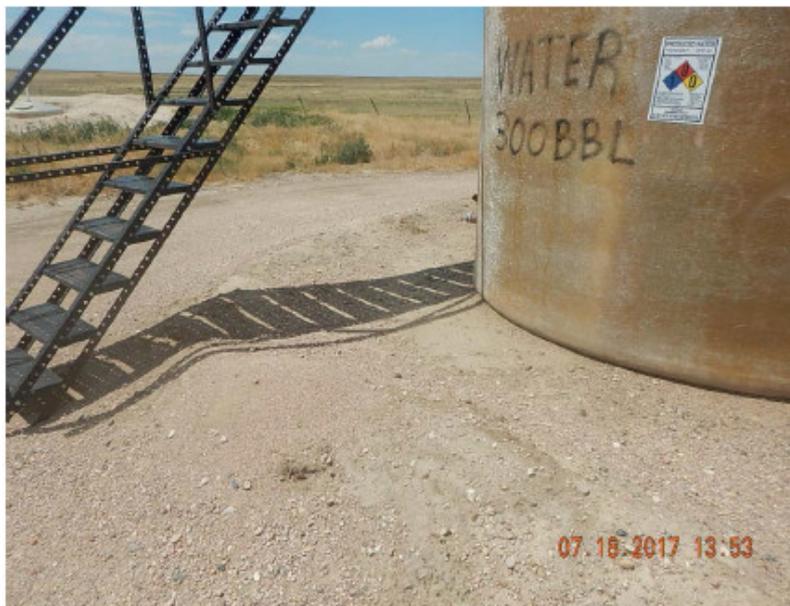
**Photo #7**

***D.O.C. Showers 32-12-10 , Showers 32-5-7***

H2O tank – low berms

*From previous FIR*

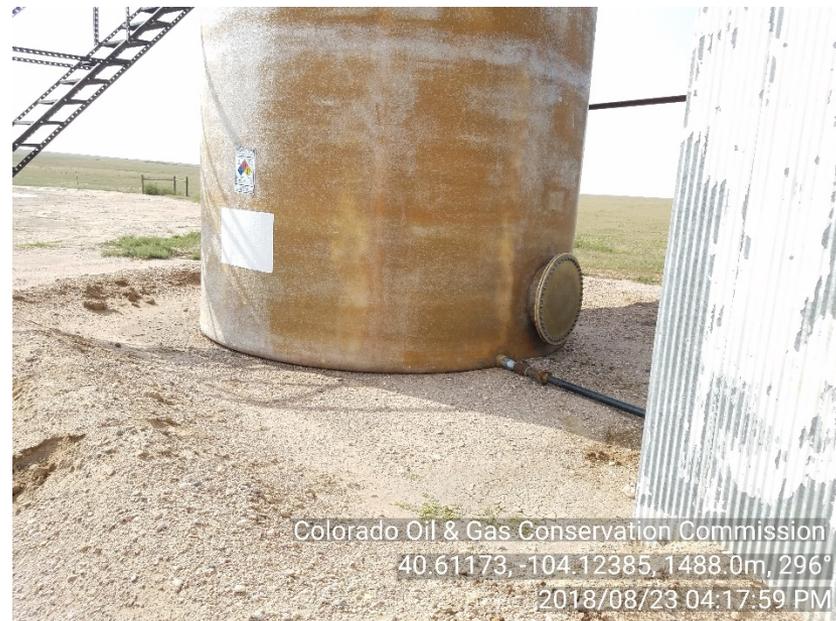
**Photo #8**

***D.O.C. Showers 32-12-10 , Showers 32-5-7***

H2O tank – berms

**Berms are inadequate**

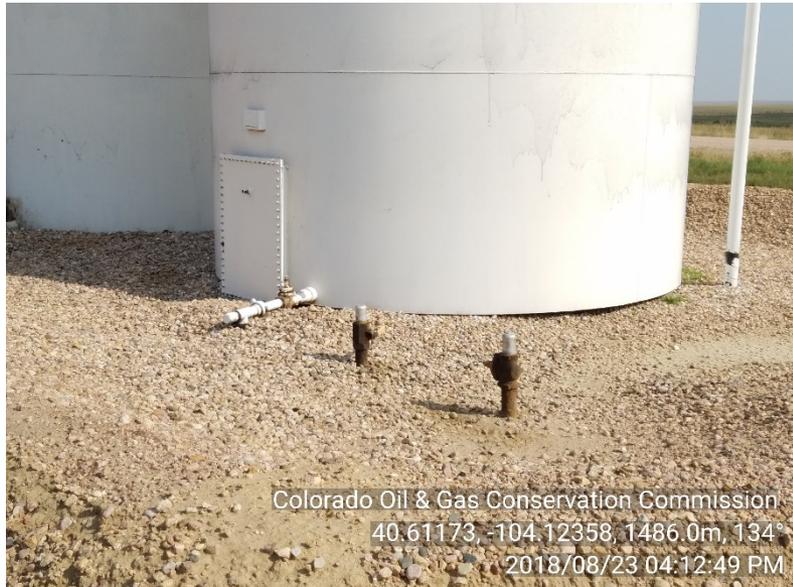
**Photo #9**

***D.O.C. Showers 32-12-10 , Showers 32-5-7***

**2 - Unmarked risers**

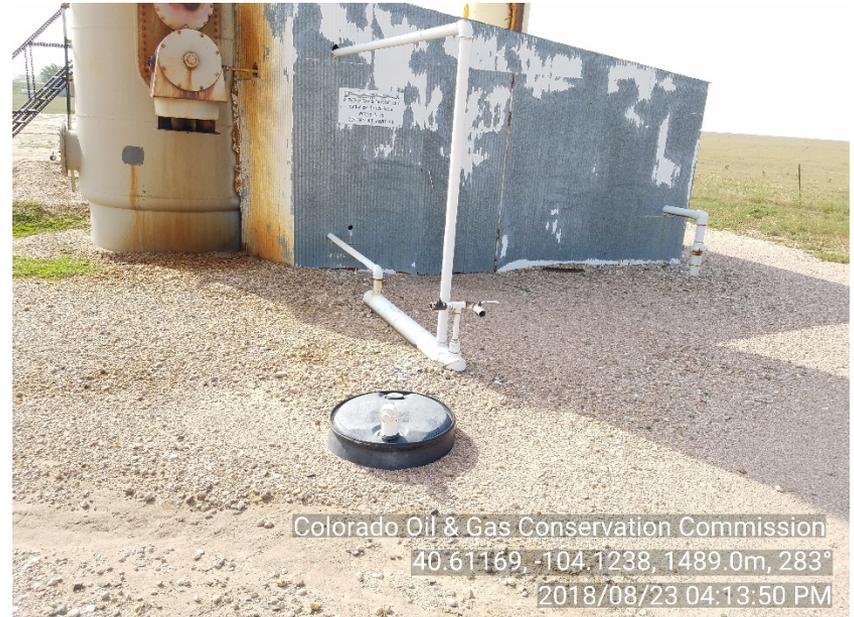
**Photo #10**

***D.O.C. Showers 32-12-10 , Showers 32-5-7***

**Scrubber sump**

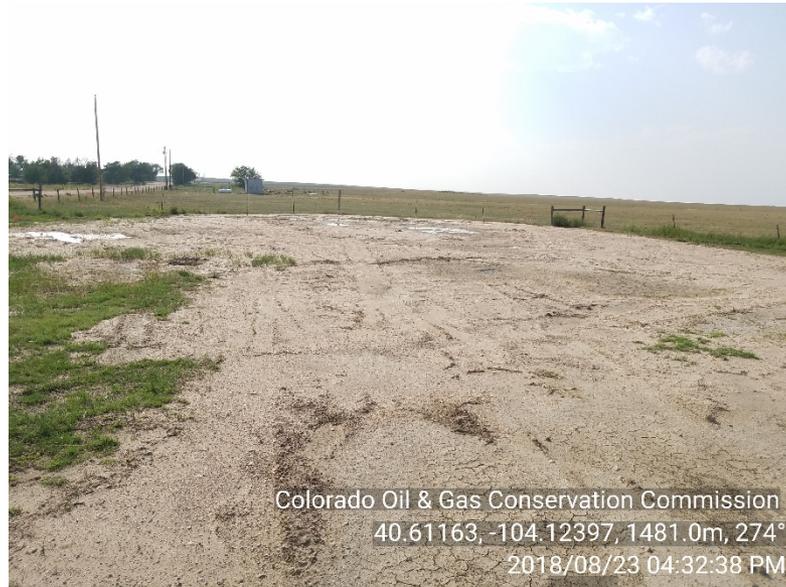
**Photo #11**

***D.O.C. Showers 32-12-10 , Showers 32-5-7***

**Closed Pit area**
