GM 236-34
API# 05-045-07640
Inspection# 689701746

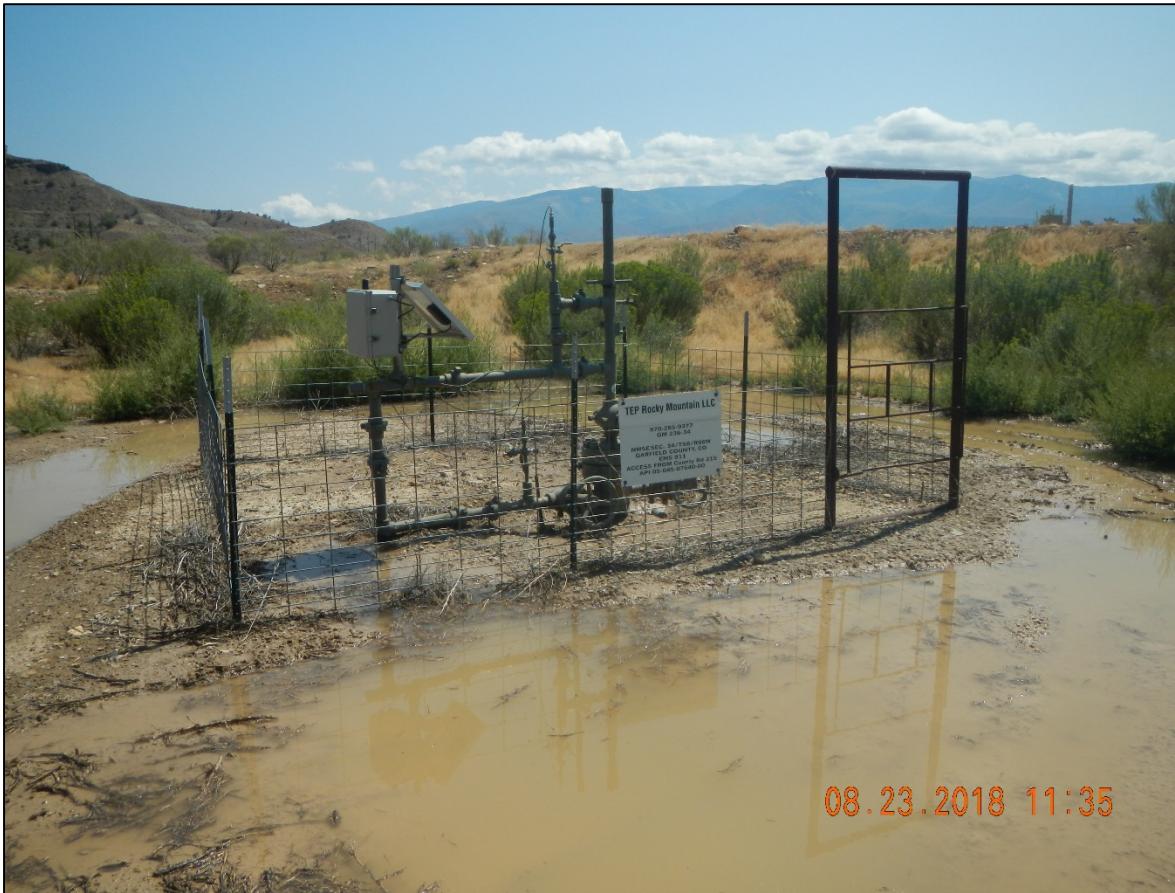
Well photo.

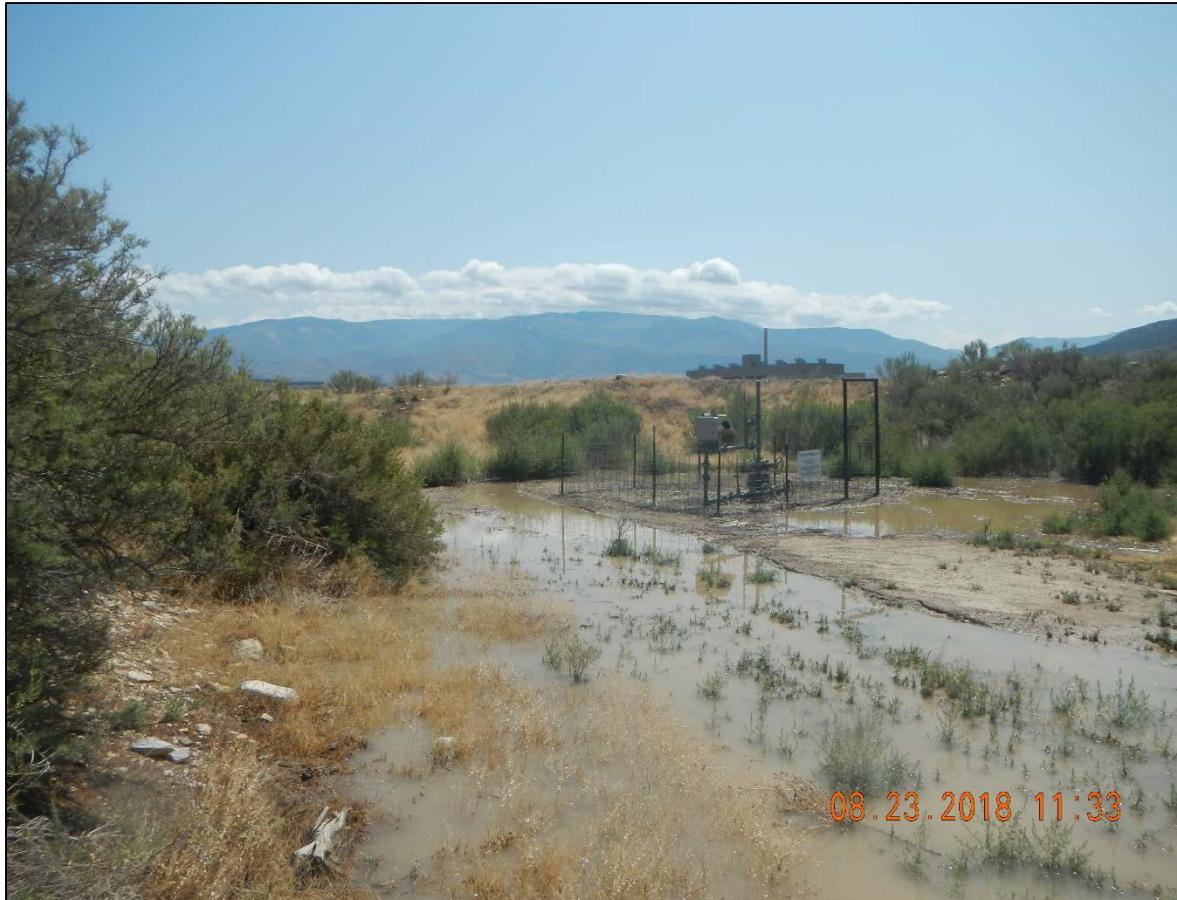
Weeds and storm water on location

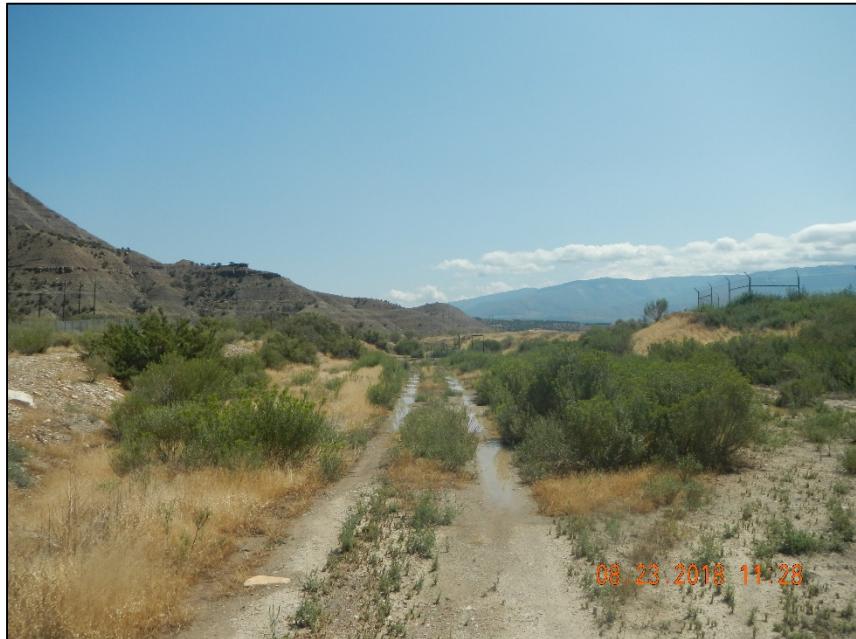
08.23.2018 11:28

Weeds and storm water on location

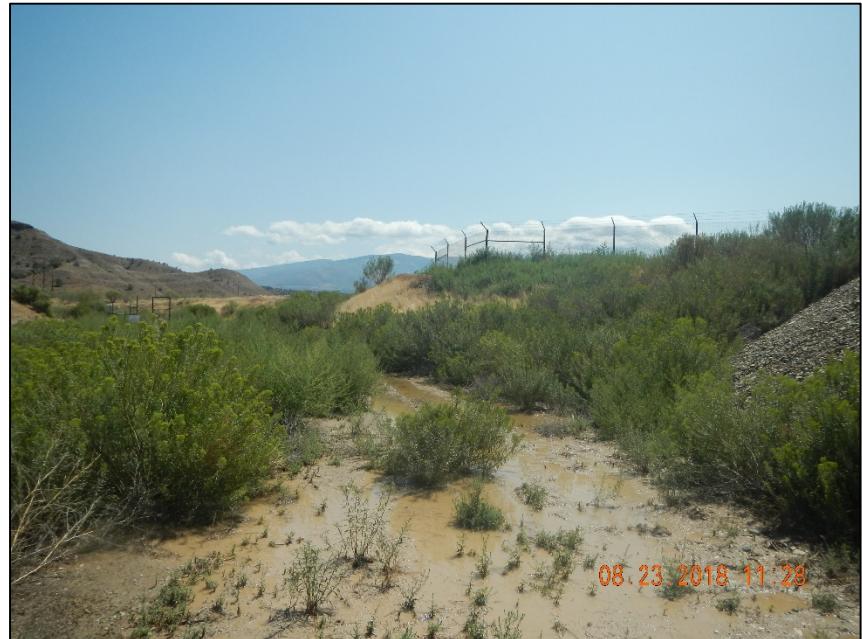
08.23.2018 11:28

Weeds and storm water on location

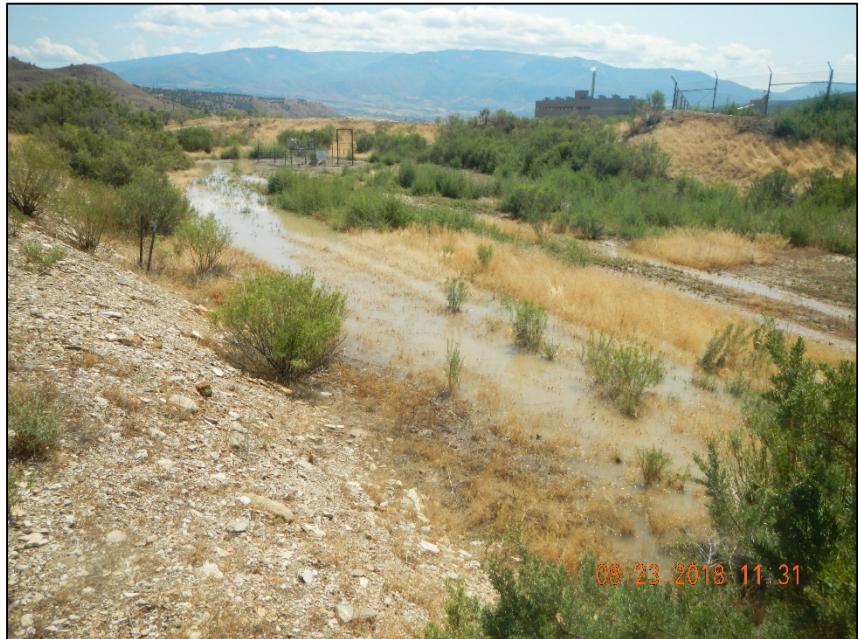
08.23.2018 11:31

Culvert inside of location wall unclear of status.

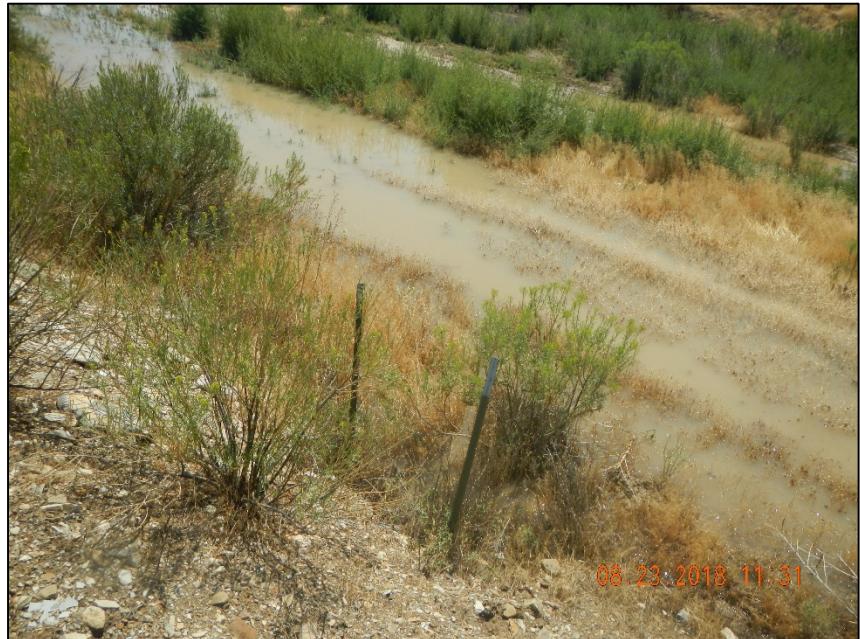
08.23.2018 11:31

Culvert inside of location wall unclear of status.

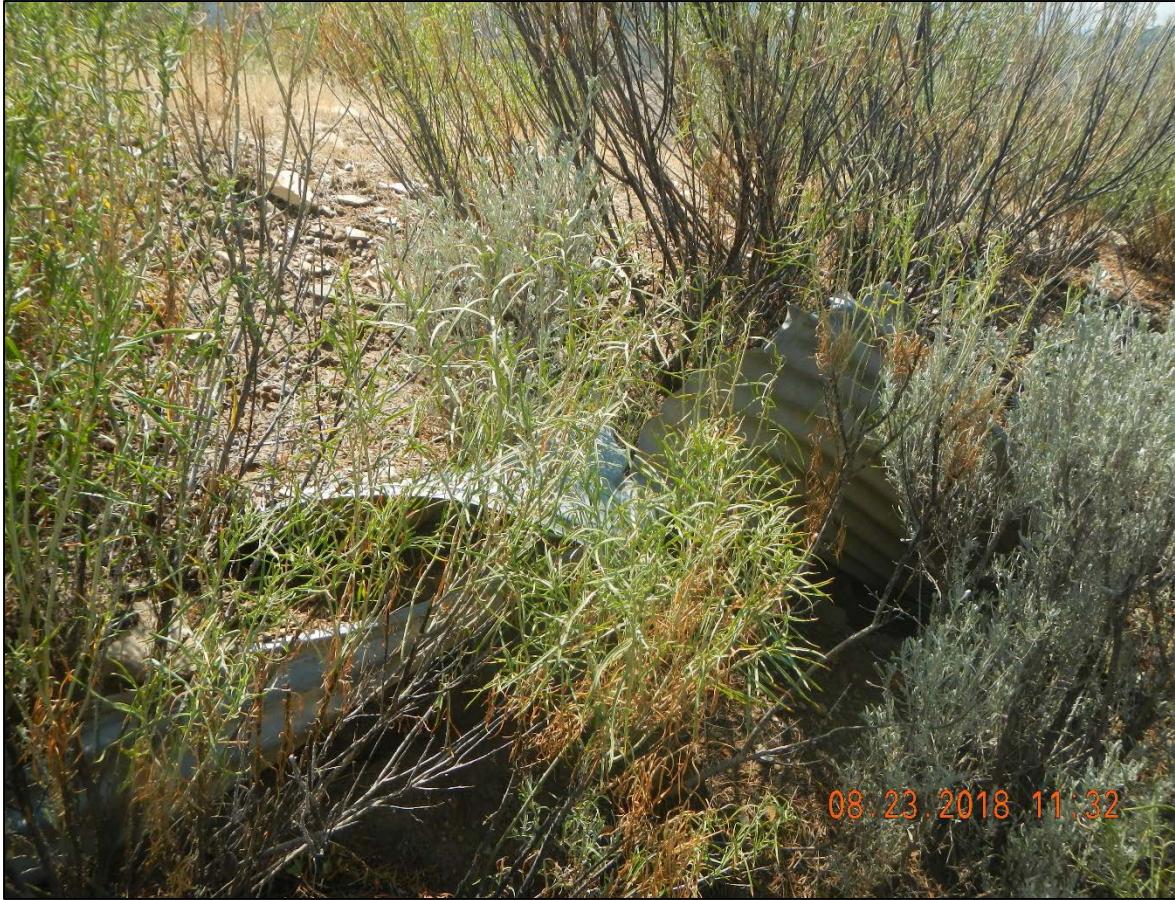
Culvert outside of location wall unclear of status.

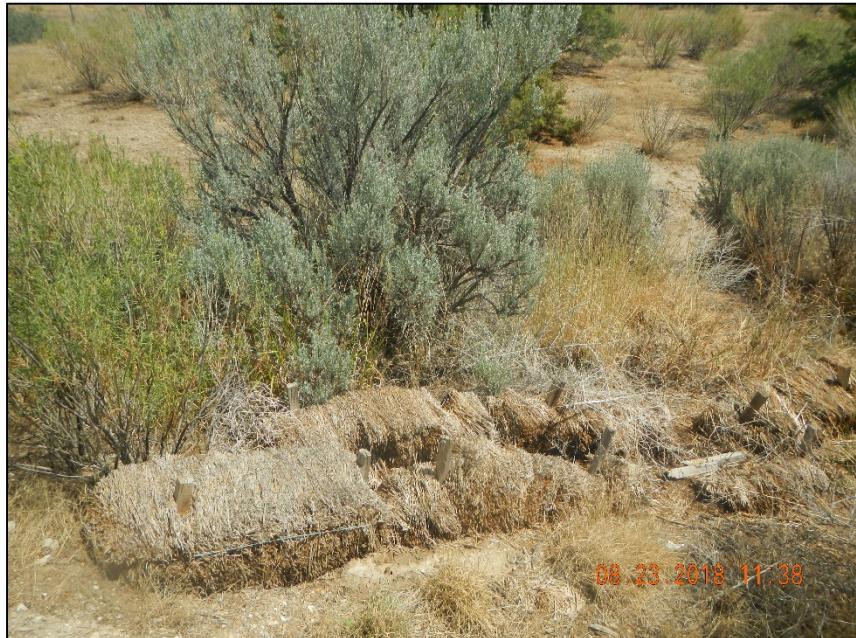
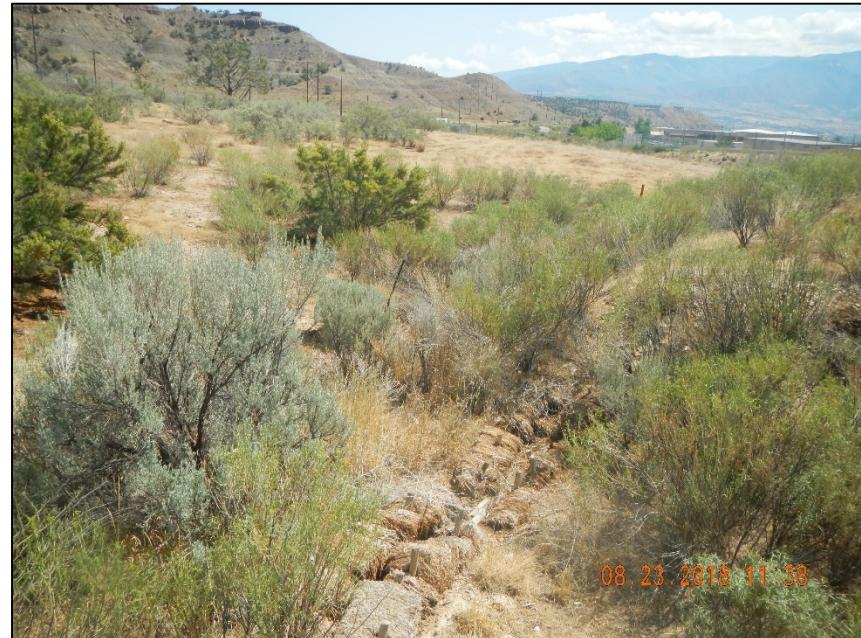
Damaged bales north east of location in drainage.

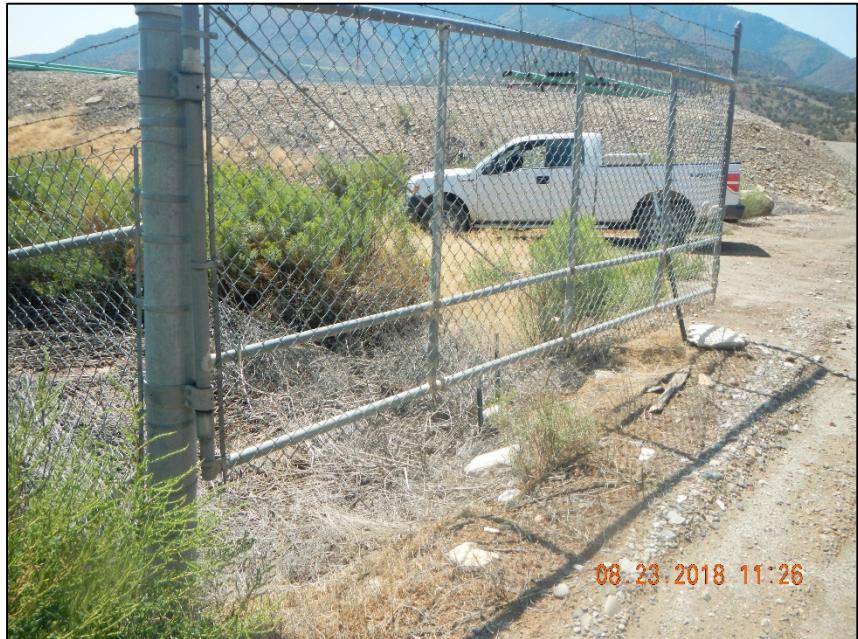
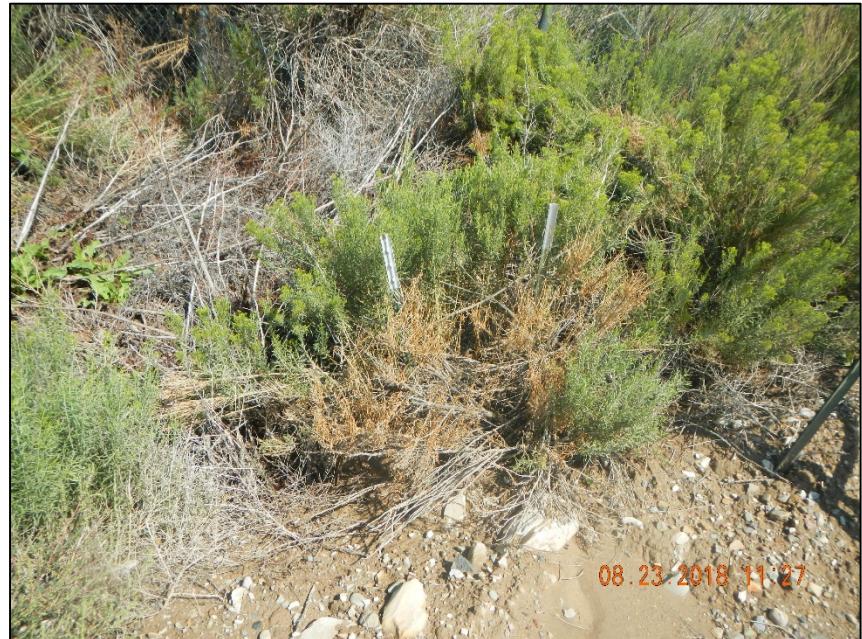
Weeds and weed debris in culvert basin on main road.
