Inspection Photos
Location Name: Falcon Seaboard 11-90-11 #2
API: 05-051-06061

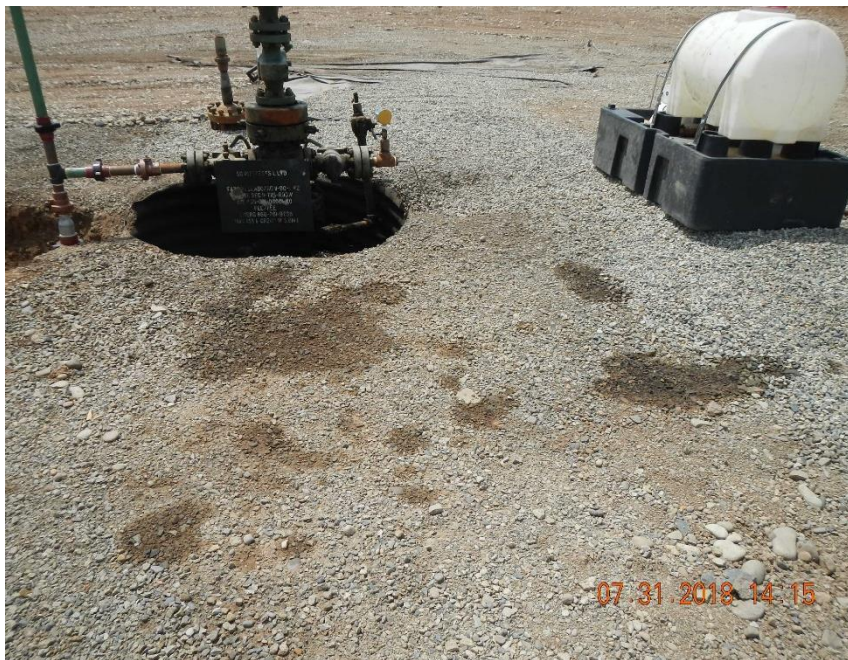
Stained soil near well head.

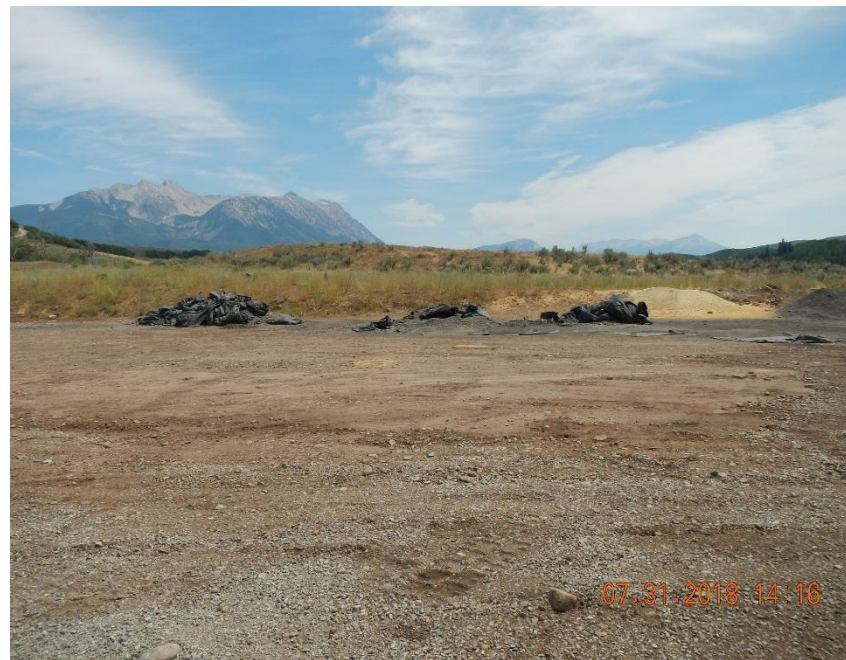
Remnants of liner.

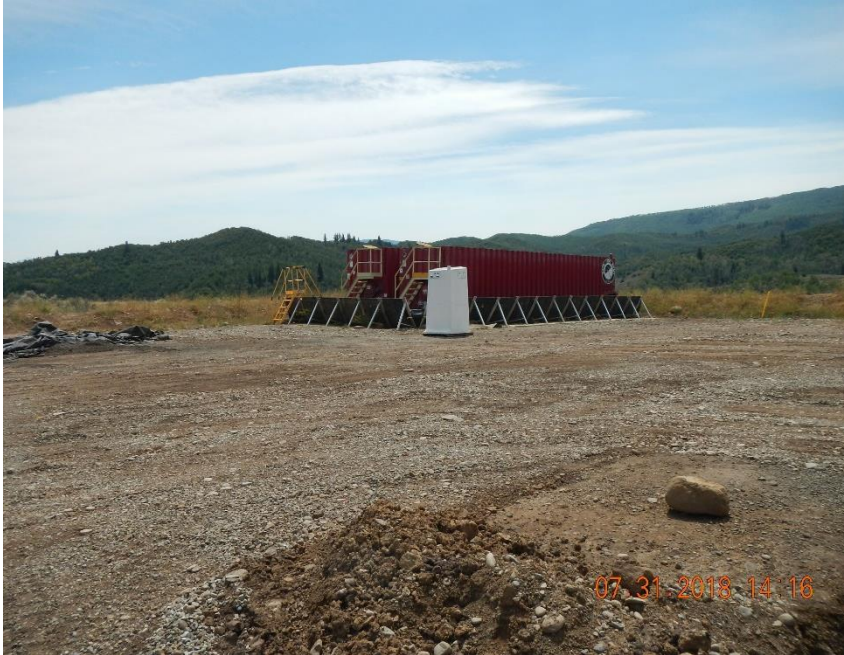
Frac tanks used for drilling fluid during drilling operations.

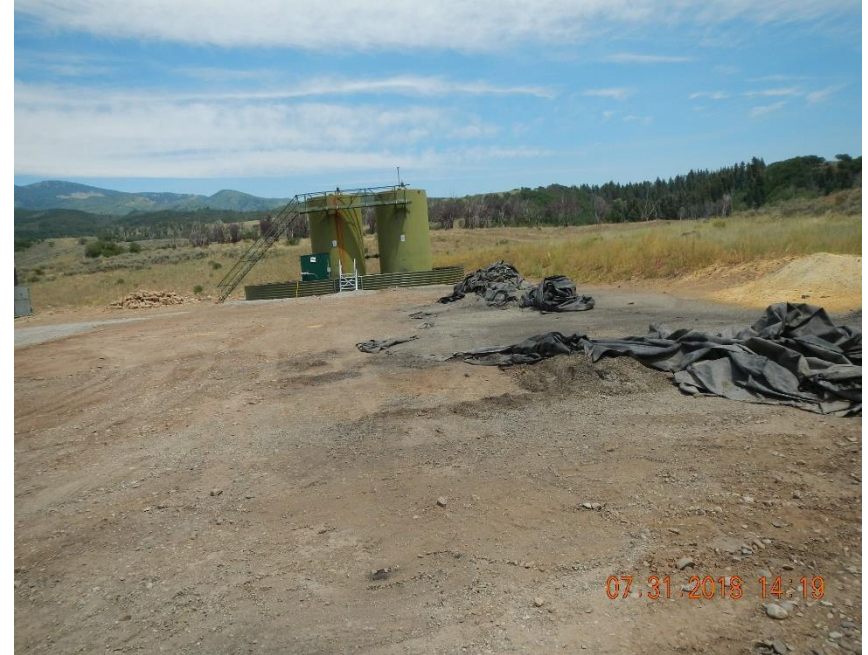
Scraps of liner from closed loop cuttings management area.

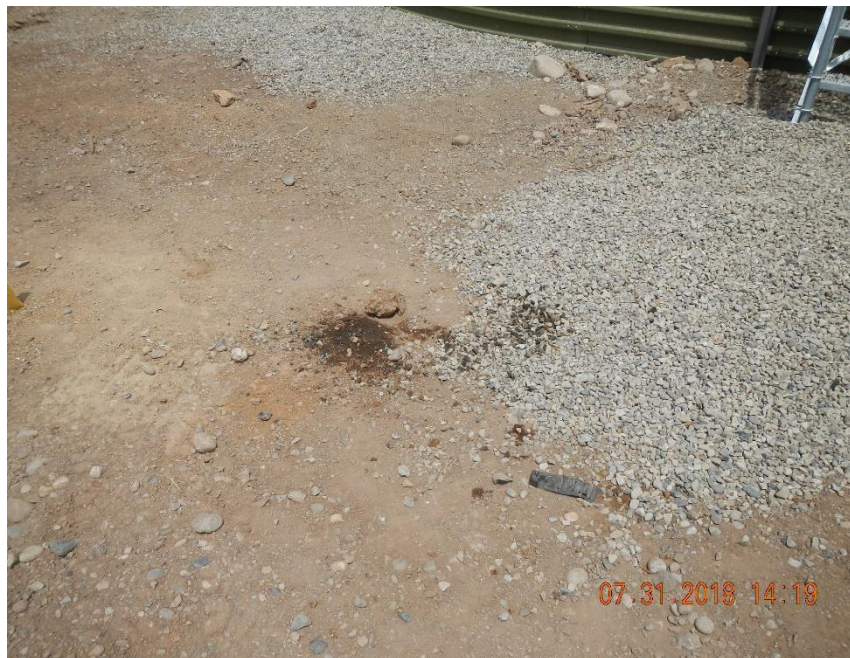
Various equipment leaks throughout location.
