Inspection Photo
Encana FEE 10-2D
API # 045-20395
Inspection # 689301832

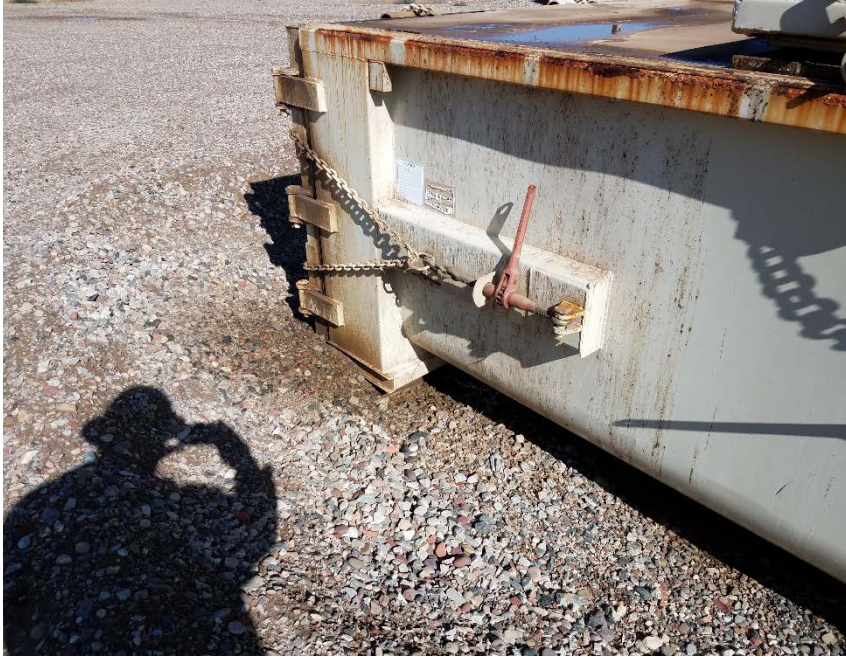
**Location Photo #3, stained ground by back of
blowdown tank.**

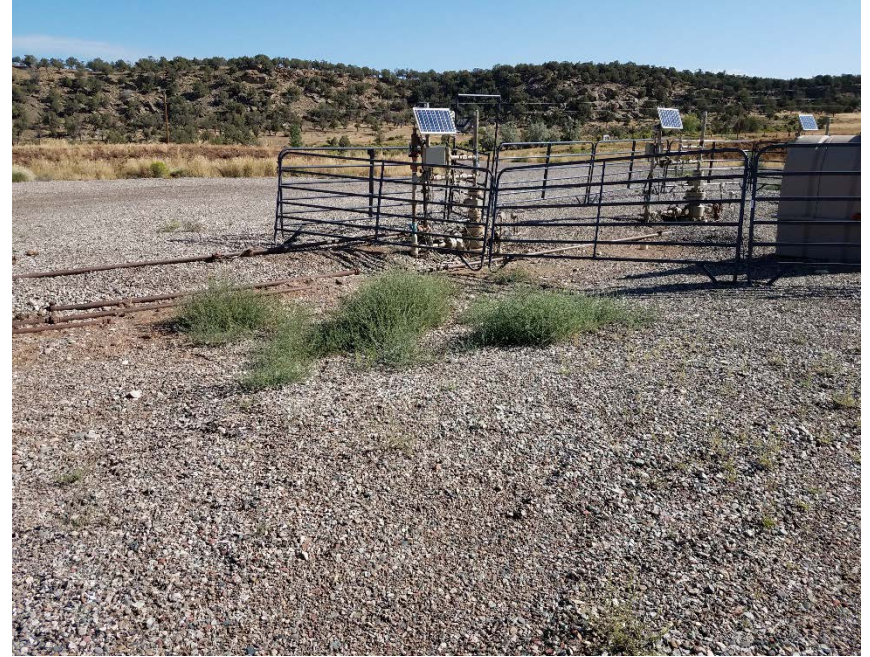
**Location Photo #4, Weeds near wellhead and
blowdown tank.**

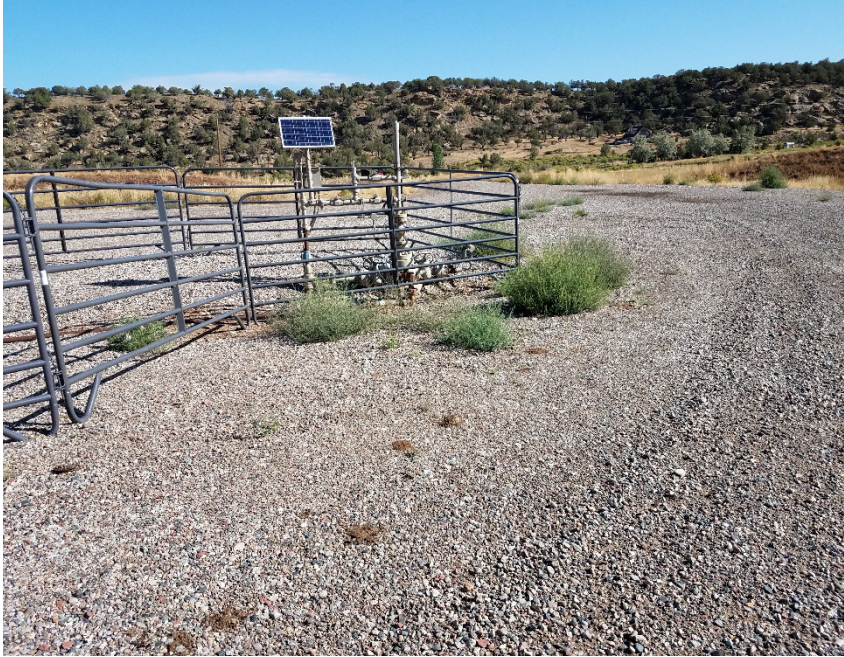
Location Photo #5, Weeds near welheads
