Inspection Photos  
Location Name: Pinnacle Unit 12-30  
API: 05-103-05906

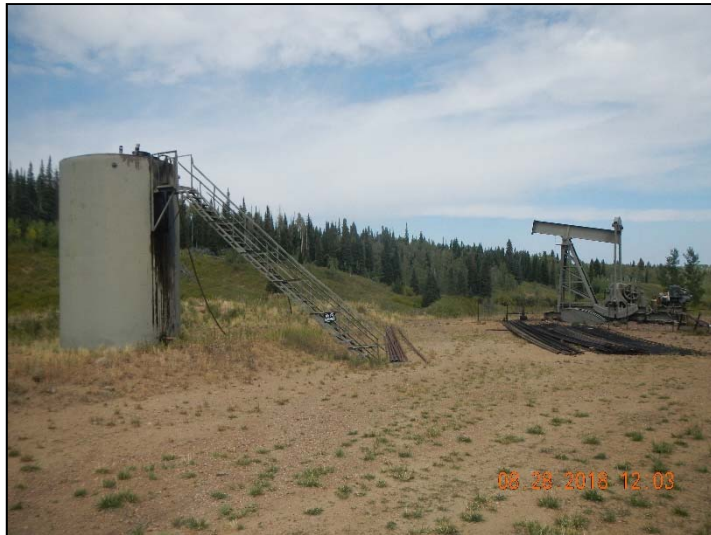
**Photo 1. Overview of location taken at entrance facing south.**

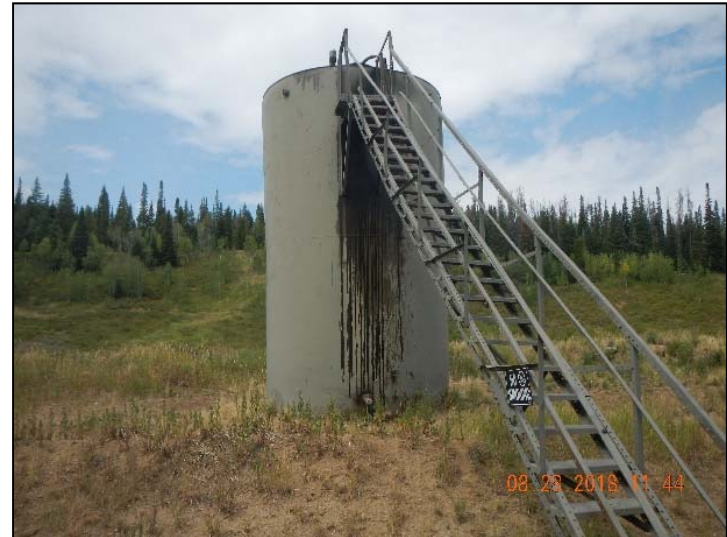
**Photo 2. No tank label, overflow leading to soil staining.**

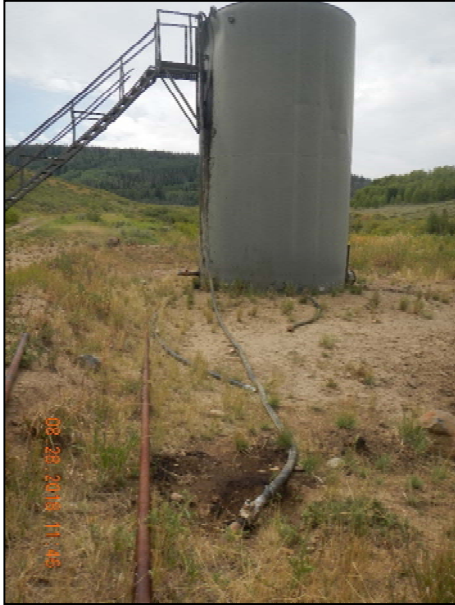
**Photo 3. Stained soil in tank battery berm.**

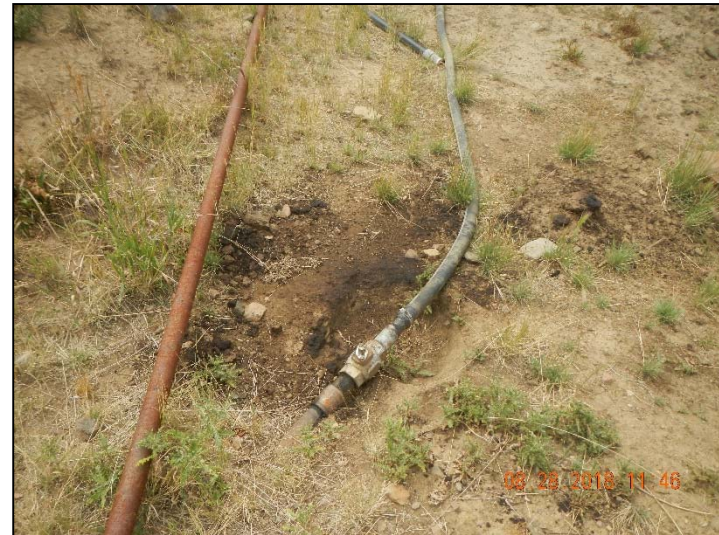
**Photo 4. Close up of Photo 3.**

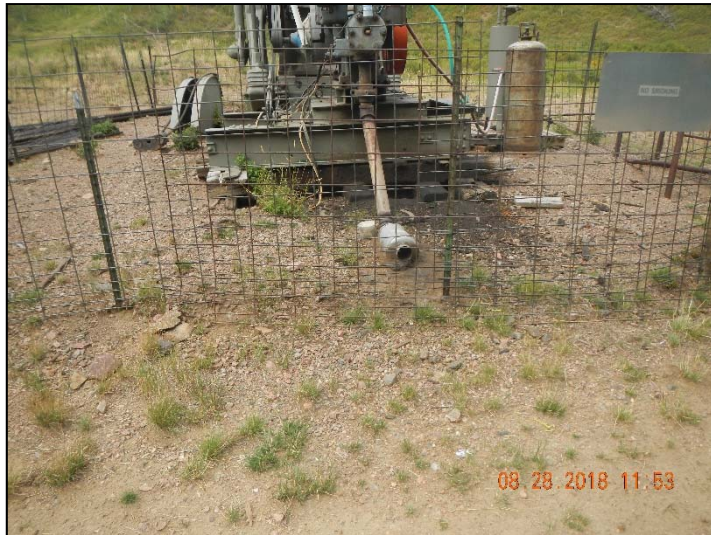
**Photo 5. Stained soil at pump jack exhaust.**

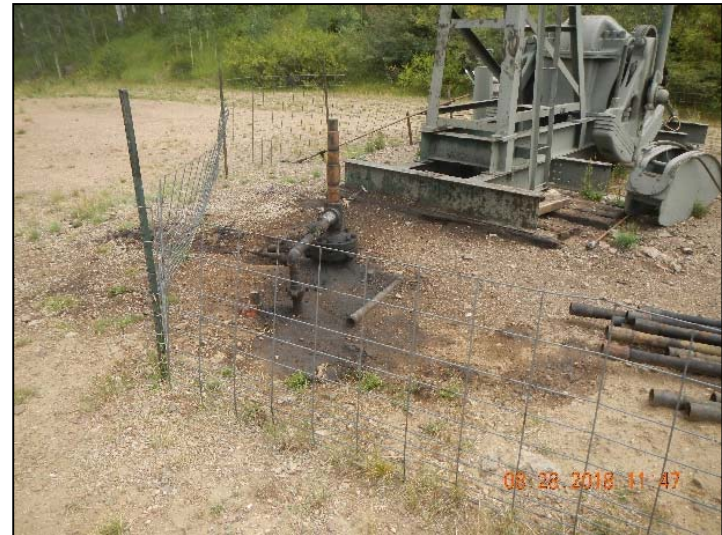
**Photo 6. Stained soil at wellhead.**

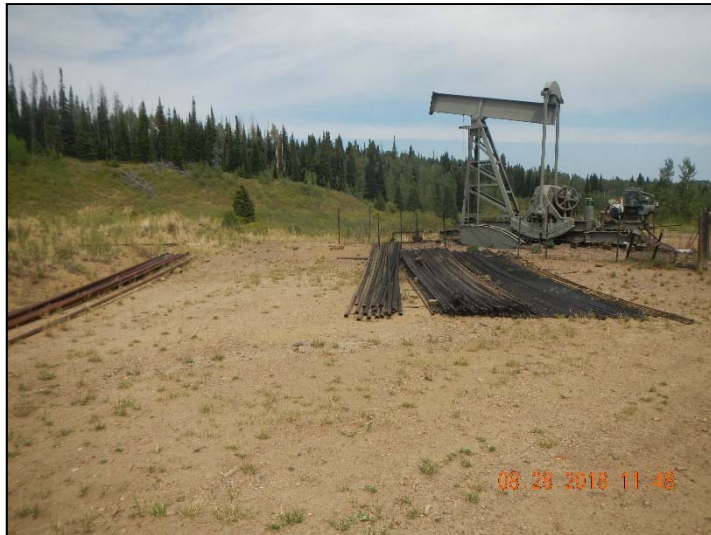
**Photo 7. Rods and tubing stored on location.**

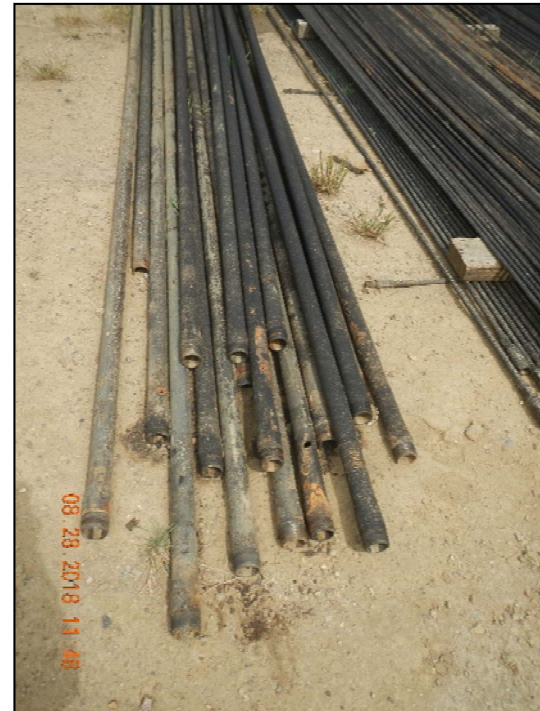
**Photo 8. Soil staining under stored tubing.**
