GR 23-34
API# 05-045-06640
Inspection# 689701751

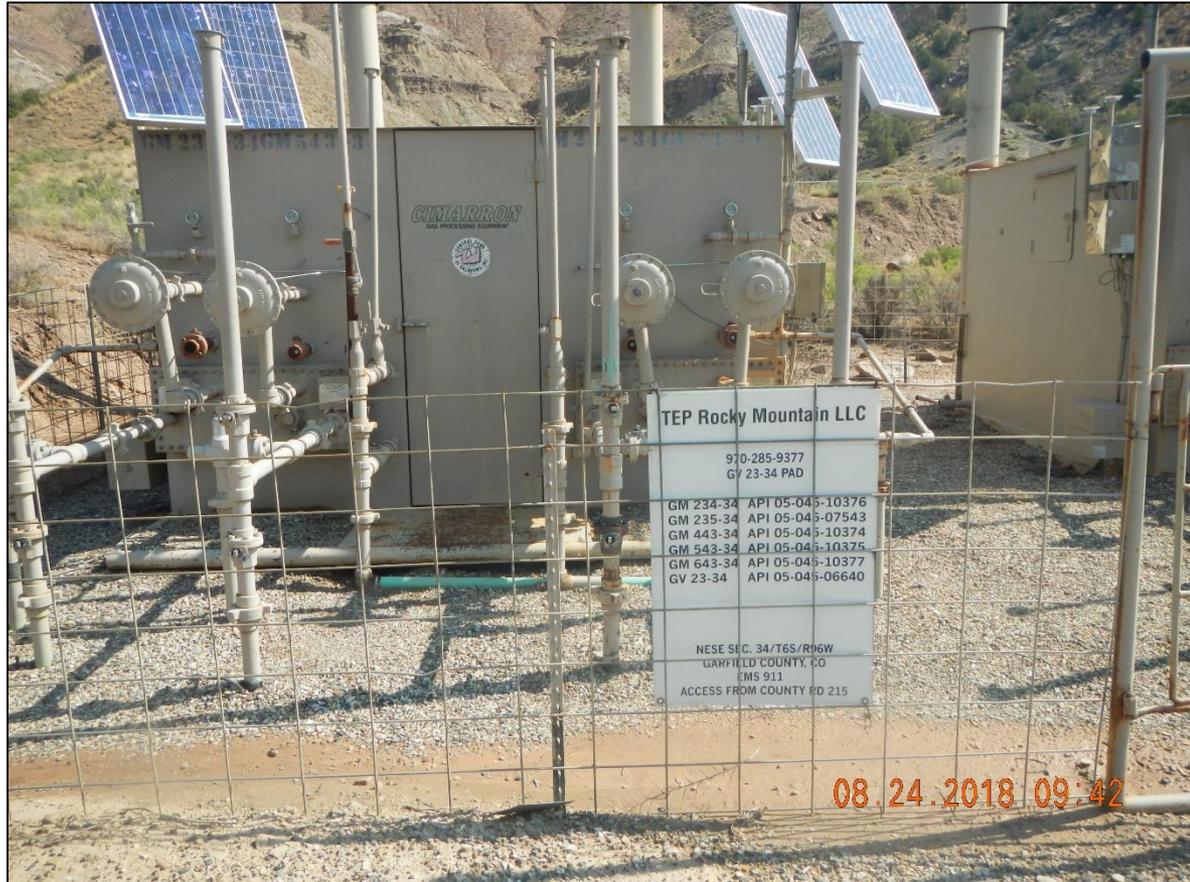
Well photo.

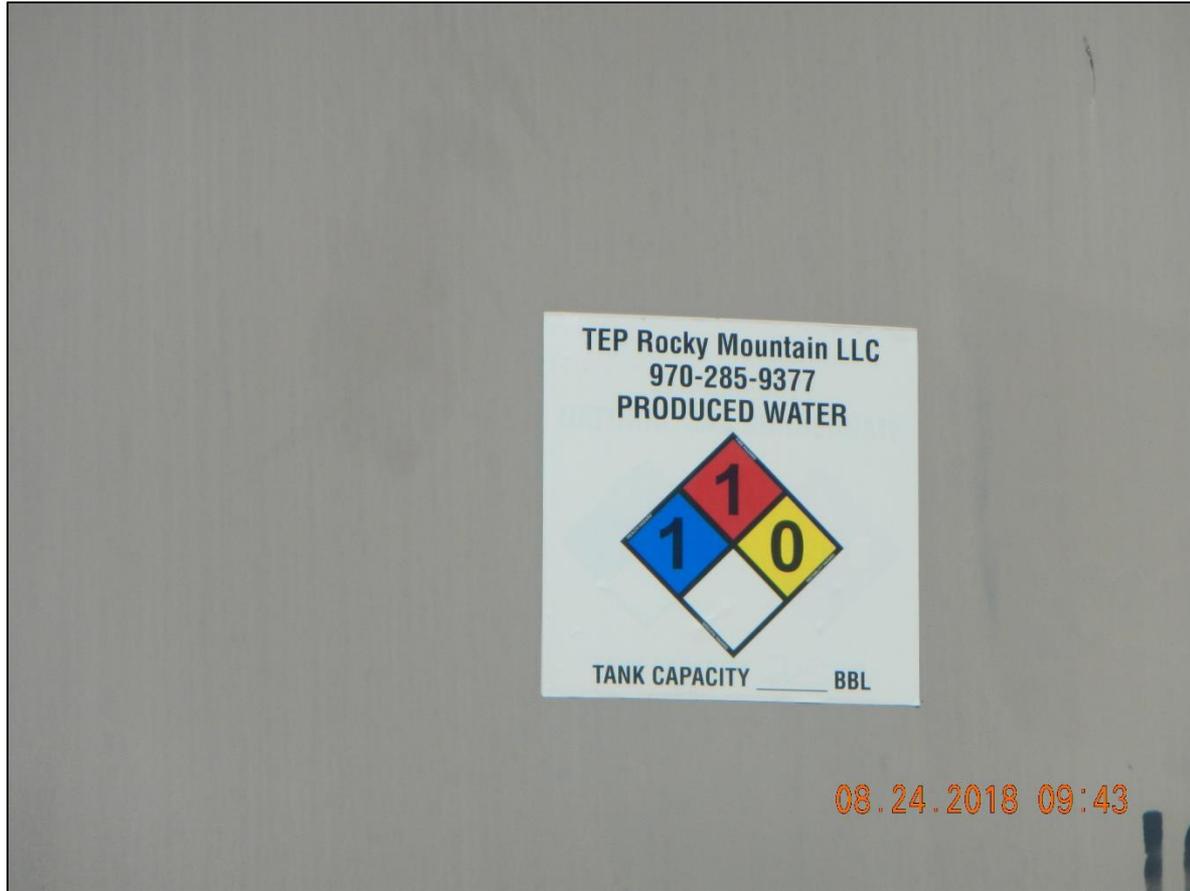
Tank capacity is blank.

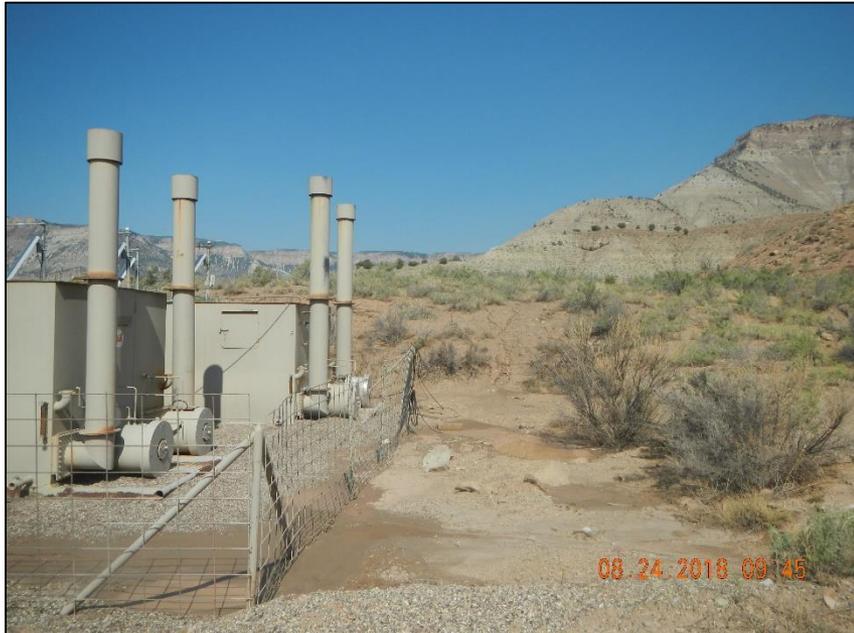
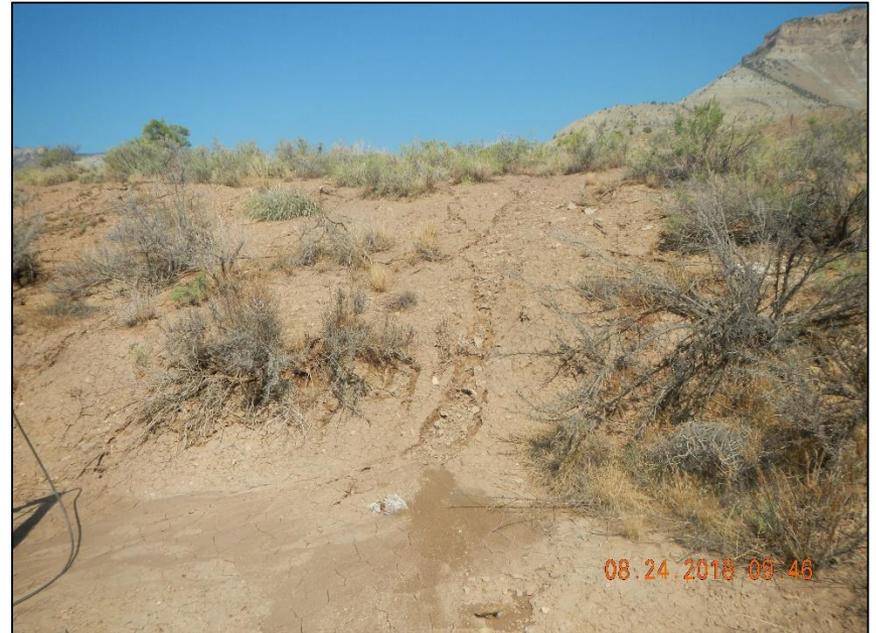
Erosion and movement of sediment

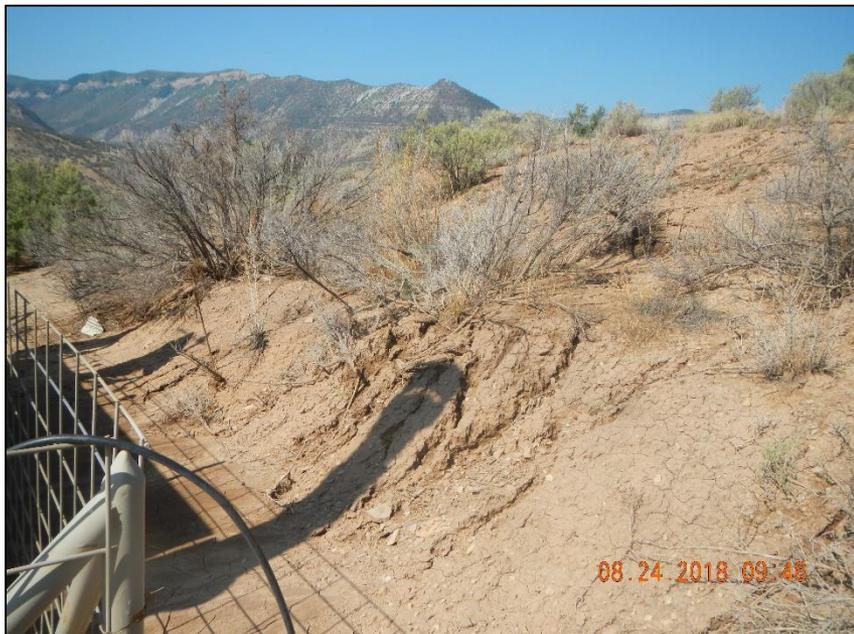
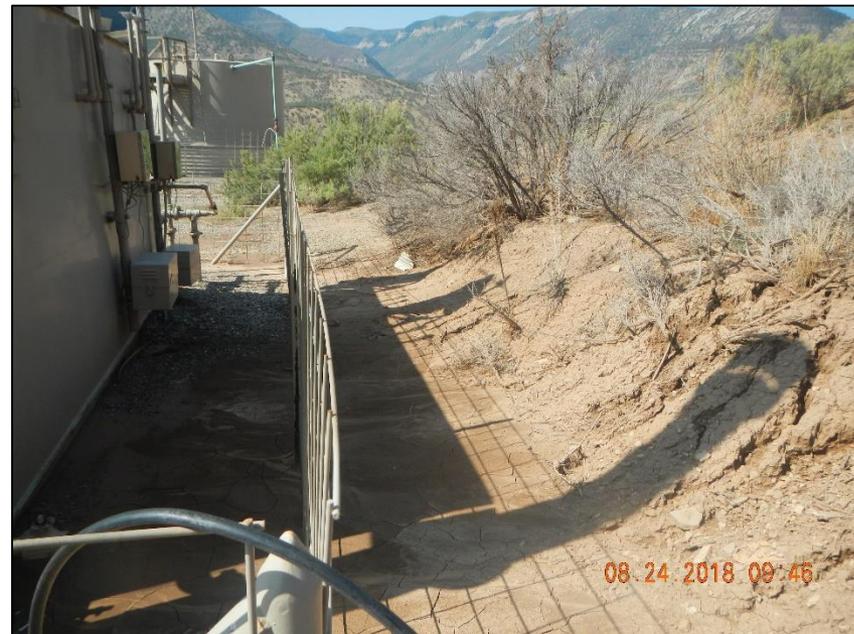
Erosion and movement of sediment

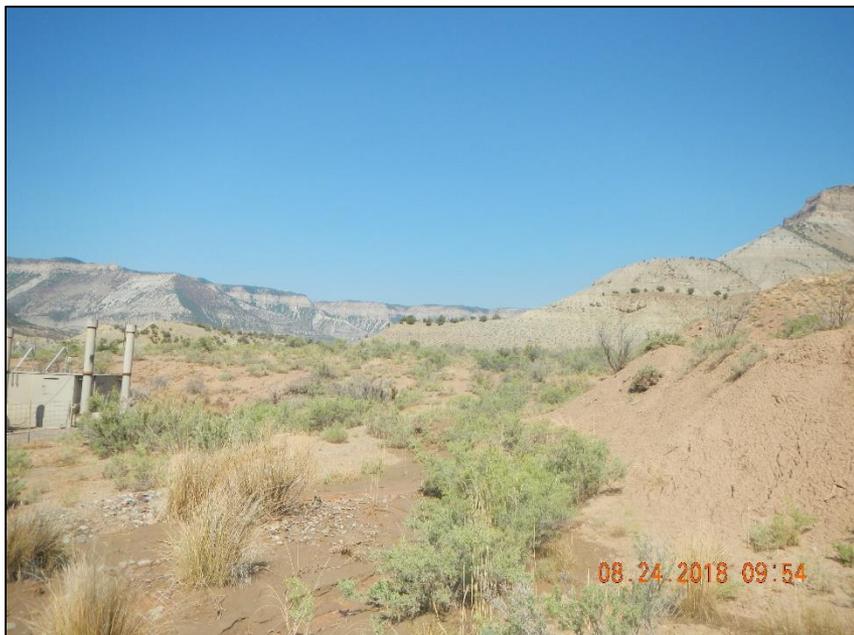
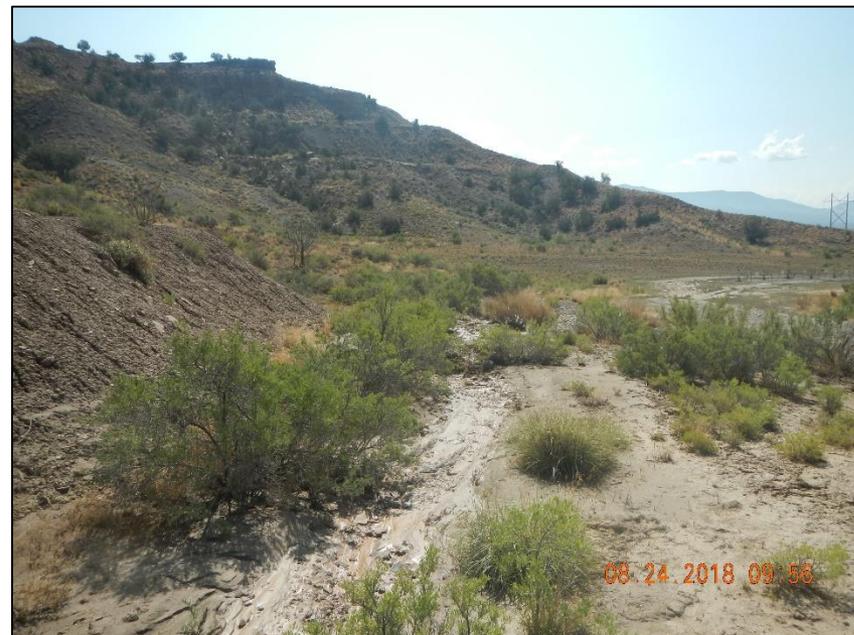
Sediment built up in ditch

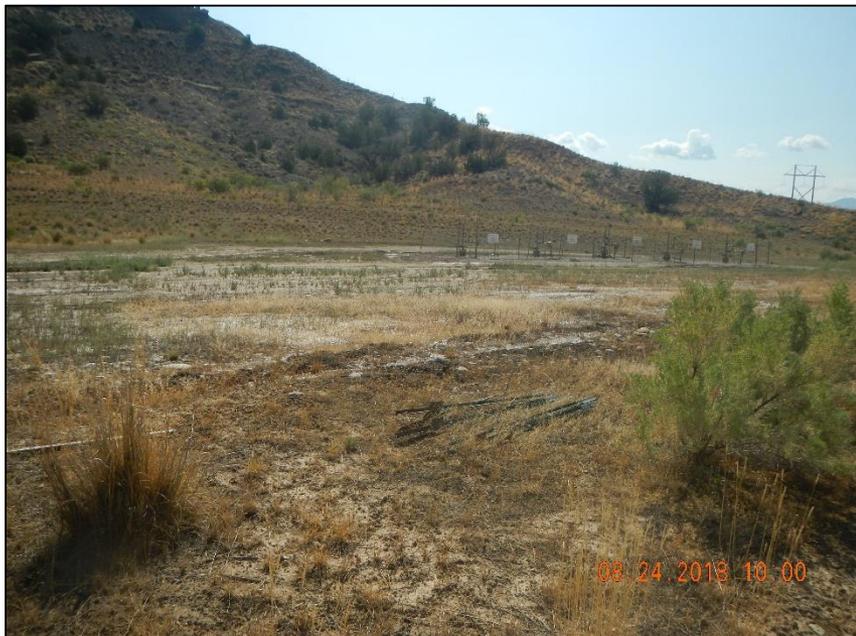
Unused fence materials.

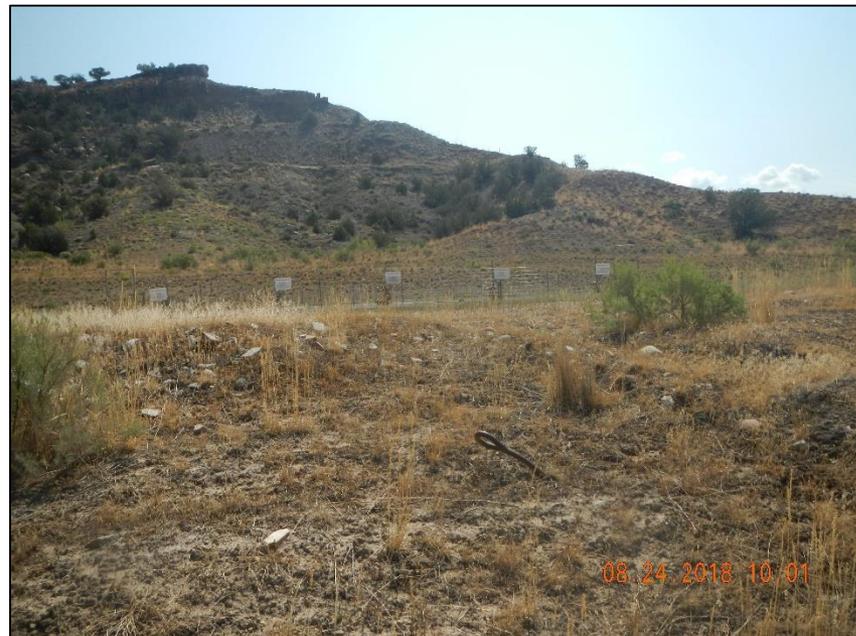
Unmarked deadman

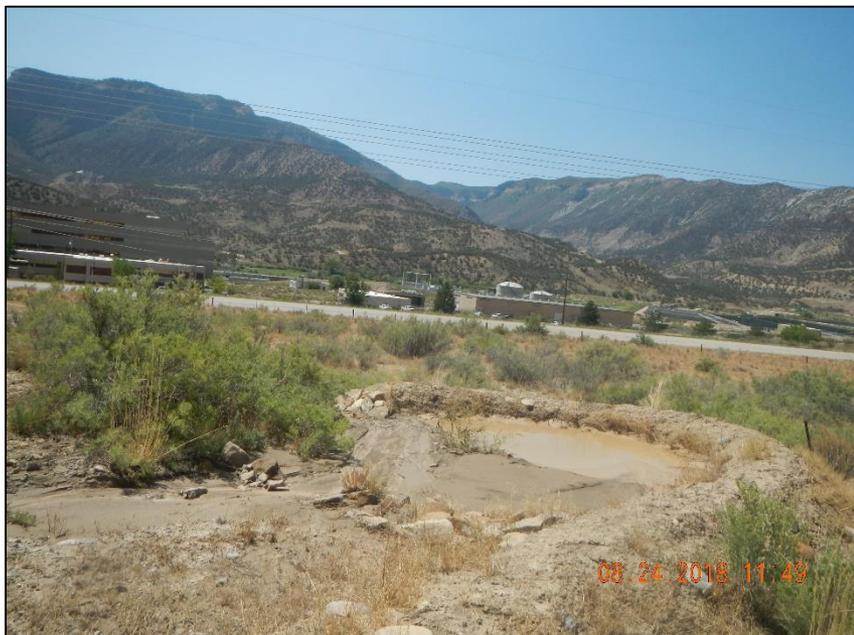
Check dam built up with sediment.

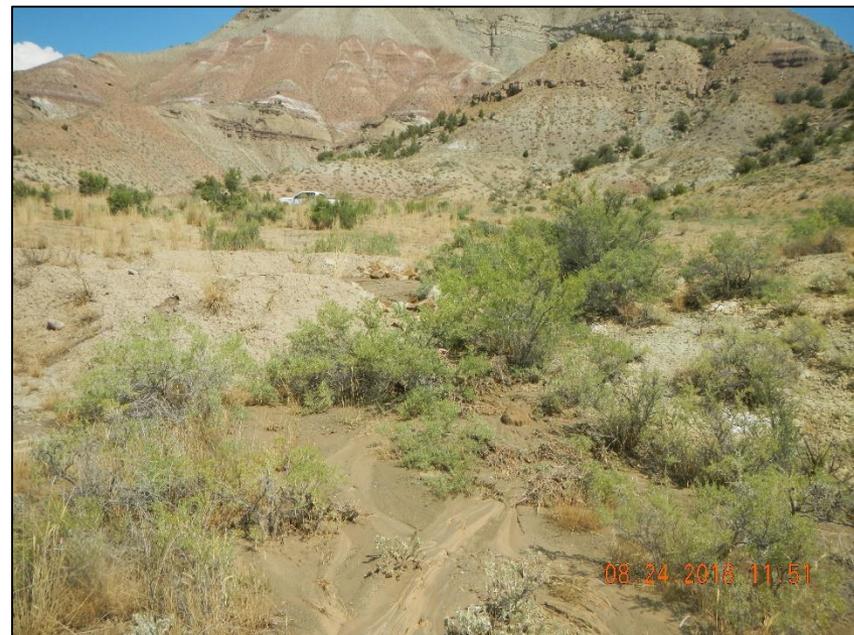
Sediment leaving check dam.

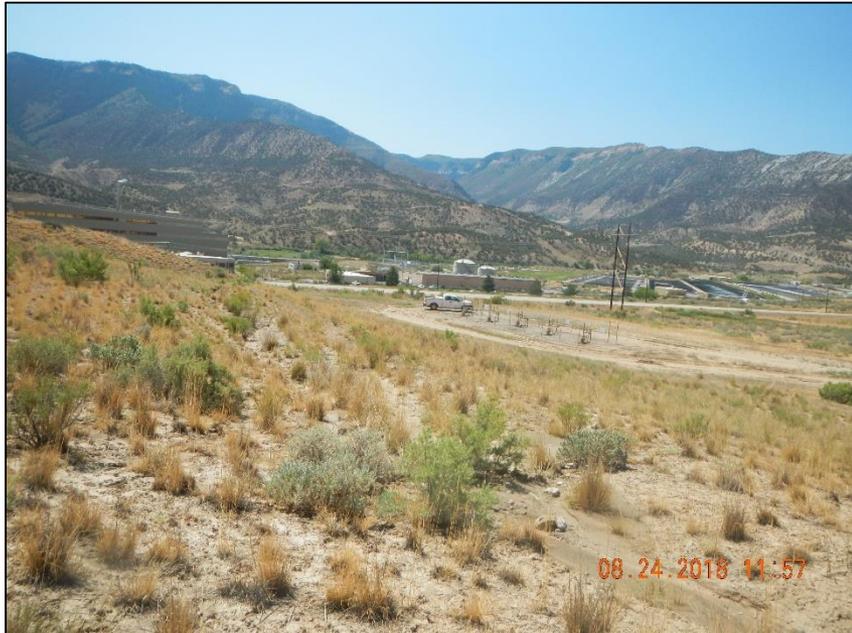
Diversion ditch built up with sediment.

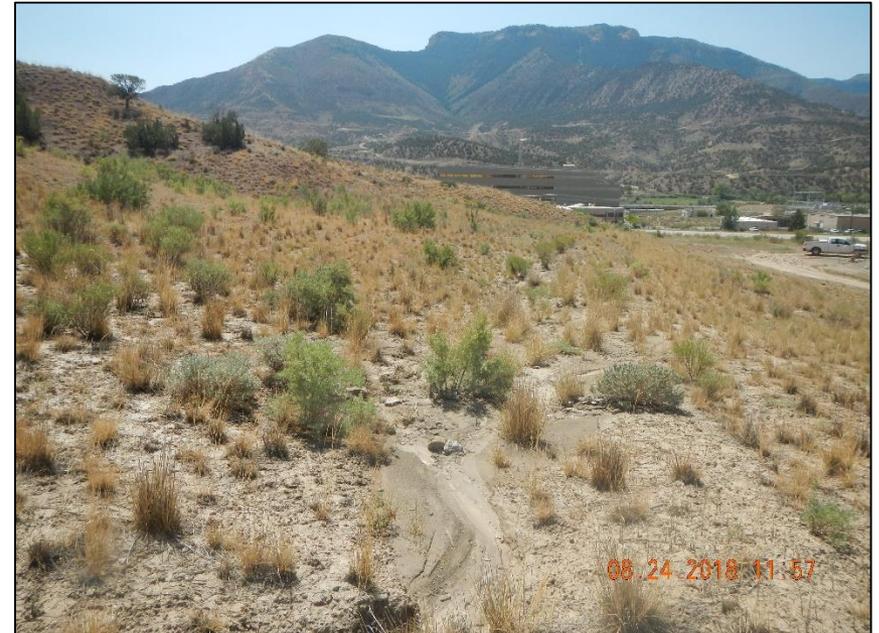
Sediment washing over ditch.

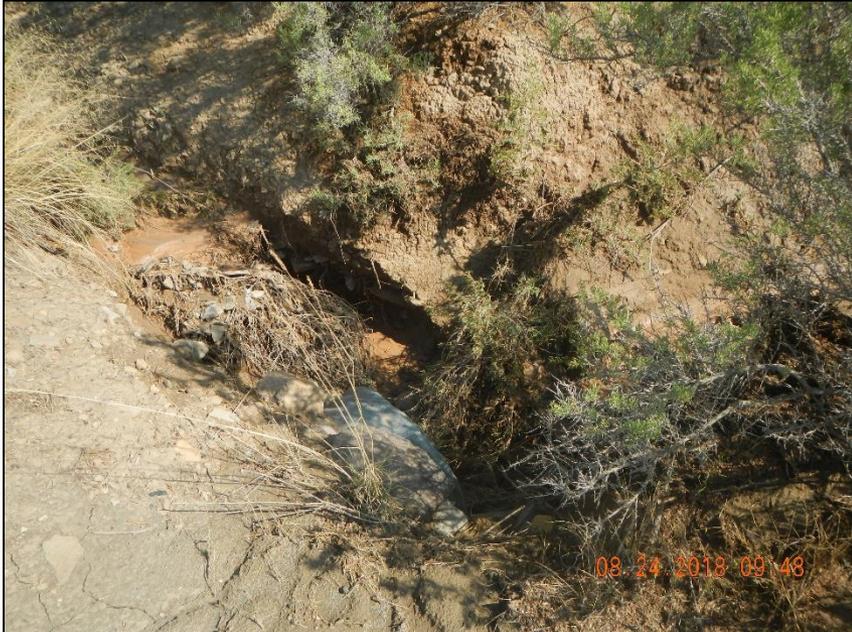
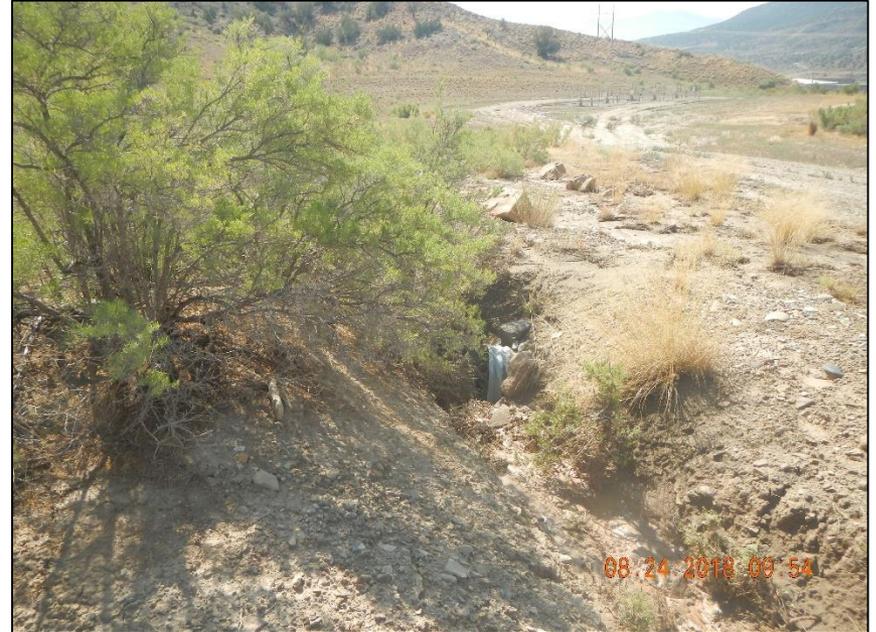
Culvert has dead weed debris

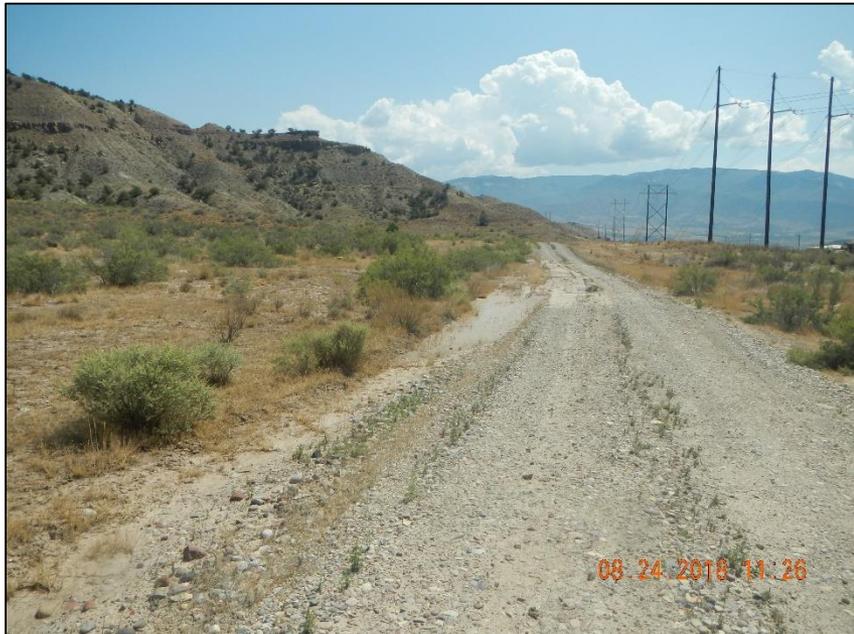
Road ditch needs maintained

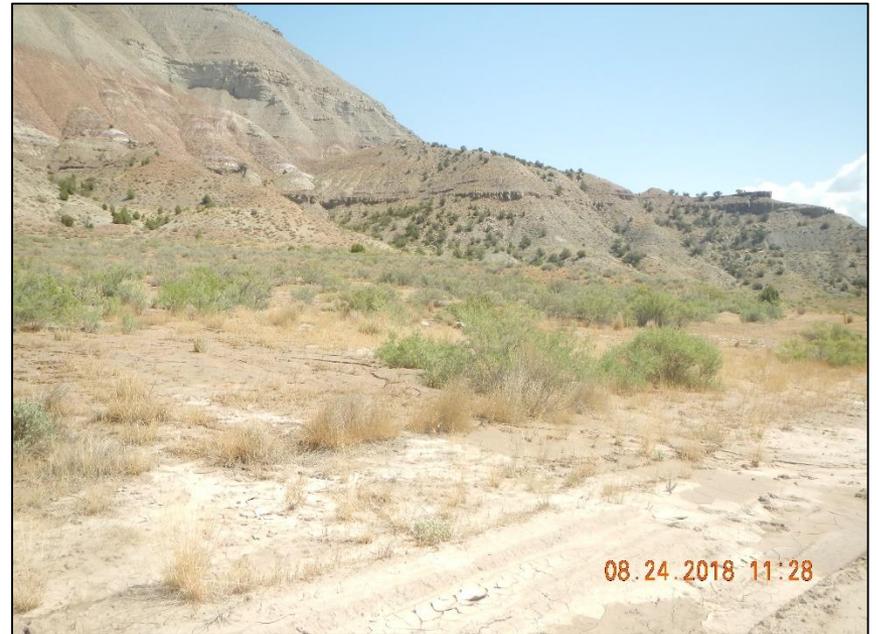
Sediment flow over road way
