Inspection Photos

Loc#335699

Operator: Caerus

Inspection Number: 692400057

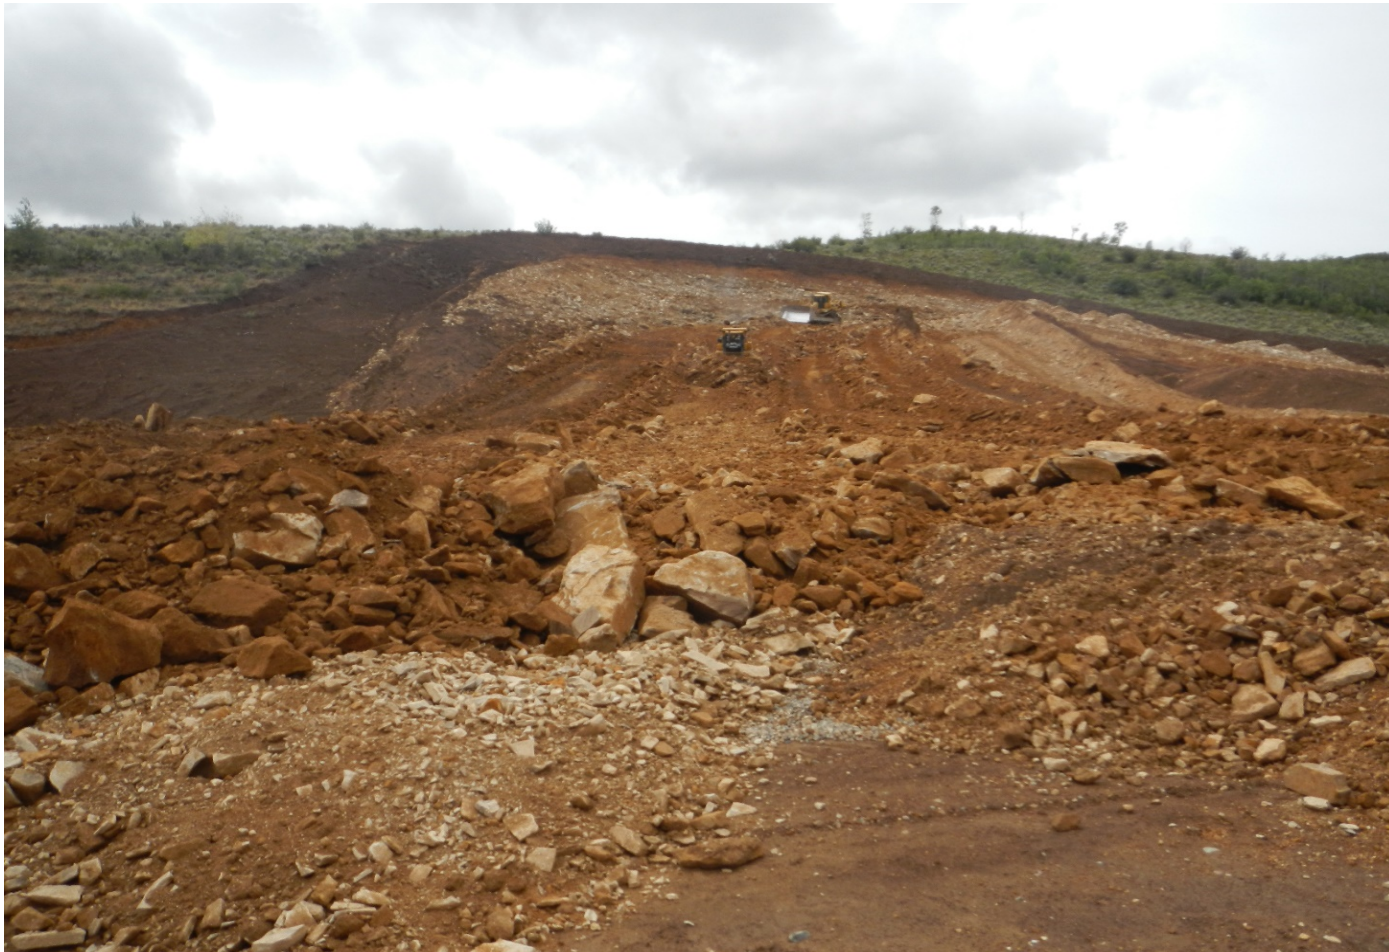
Photo#1:
Overview of Location to Southwest.

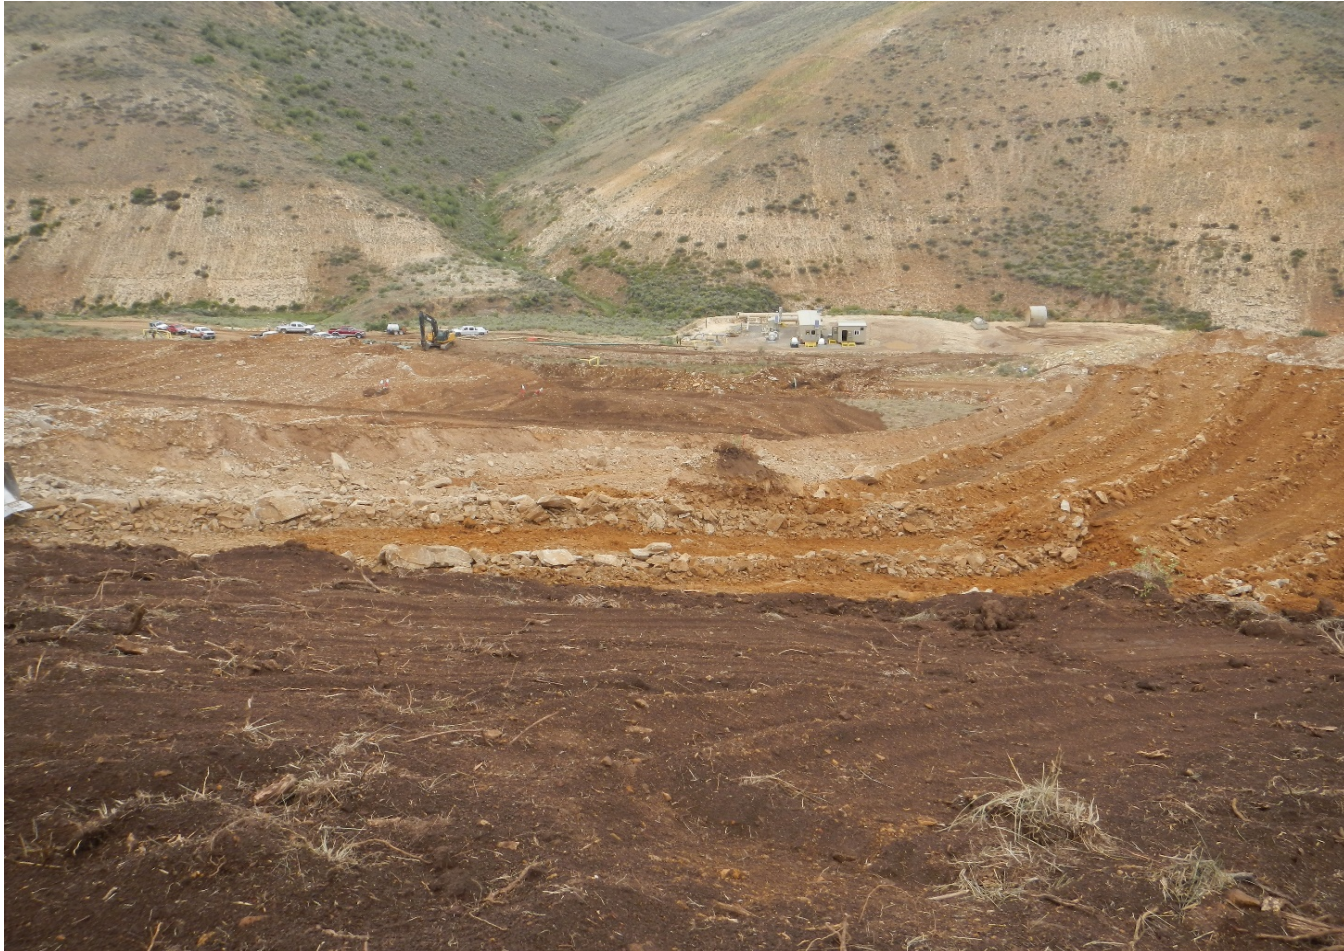
Photo#2:
Overview of Location from top of cut slope to Northwest.

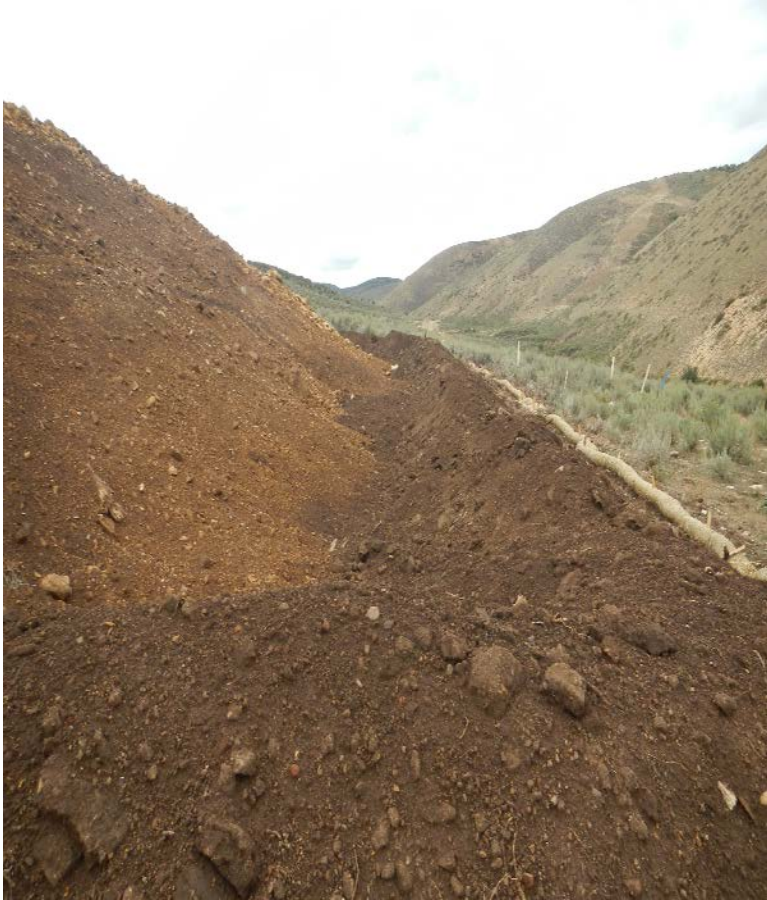
Photo#3:

Topsoil windrowed along toe of Fill slope is not being protected / segregated as required by the reclamation rules.

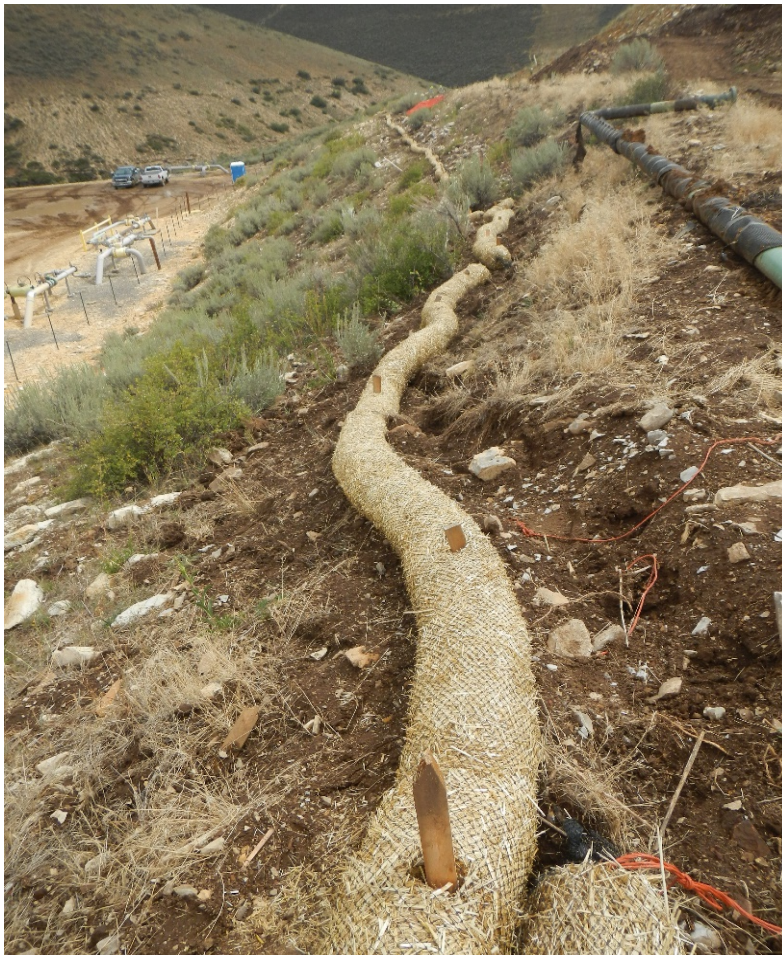
Photo#5:
BMPs have been installed around Location Perimeter

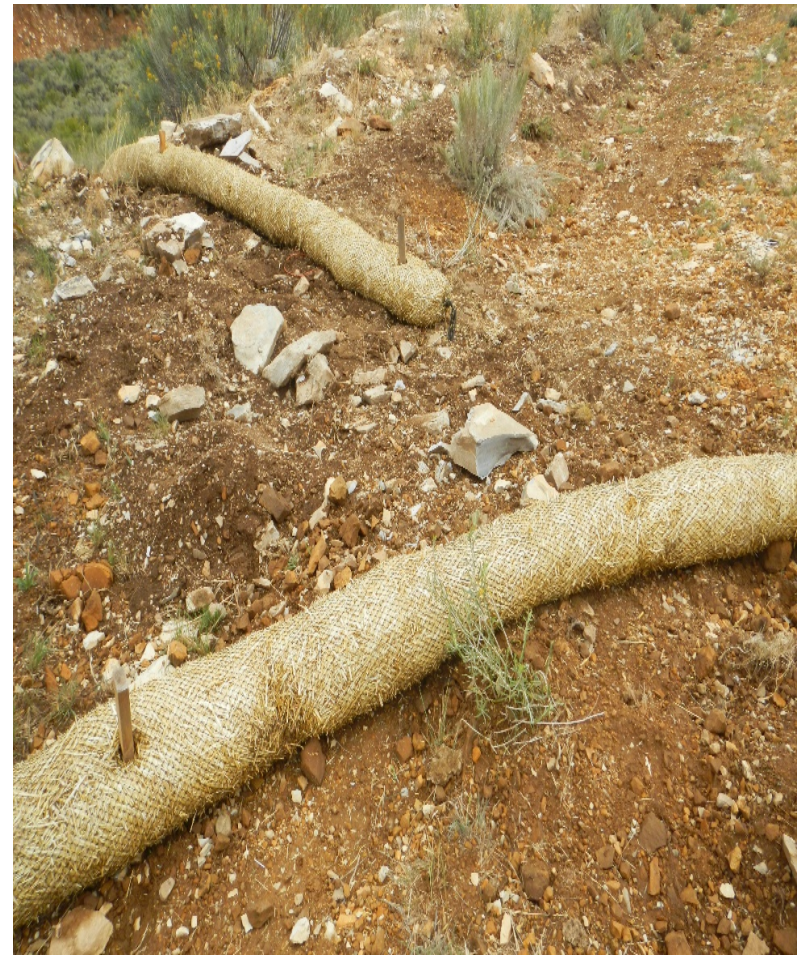
Photo#6:
Some Wattles are not properly seated in.

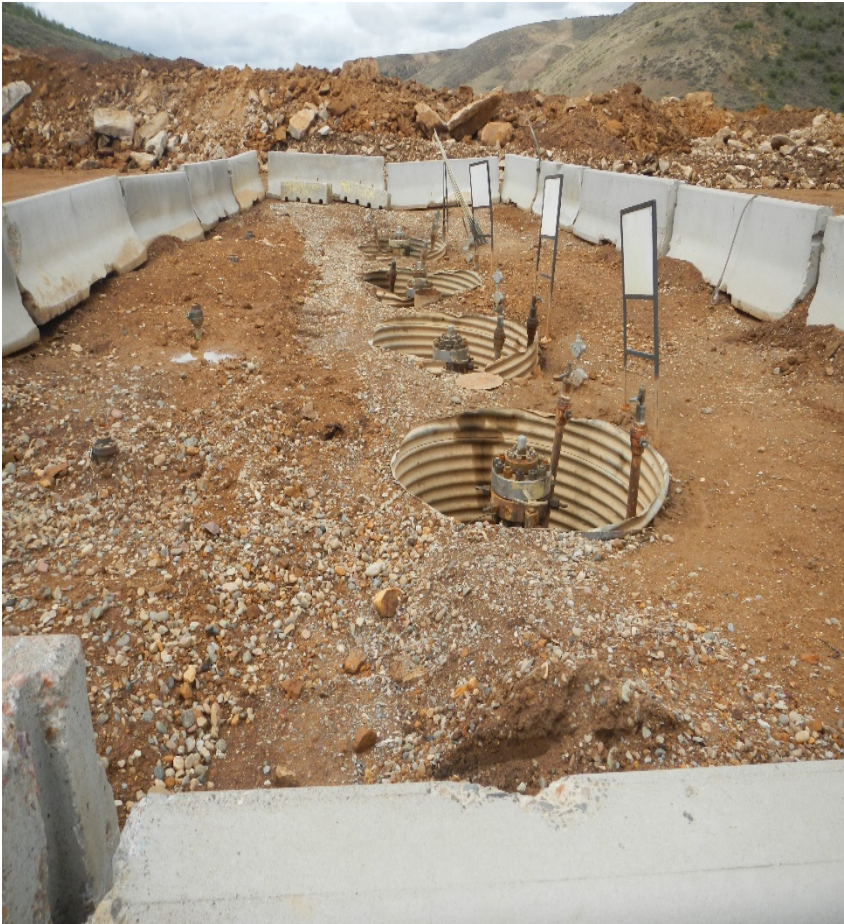
Photo#7:

Well Cellars do not have covers installed.

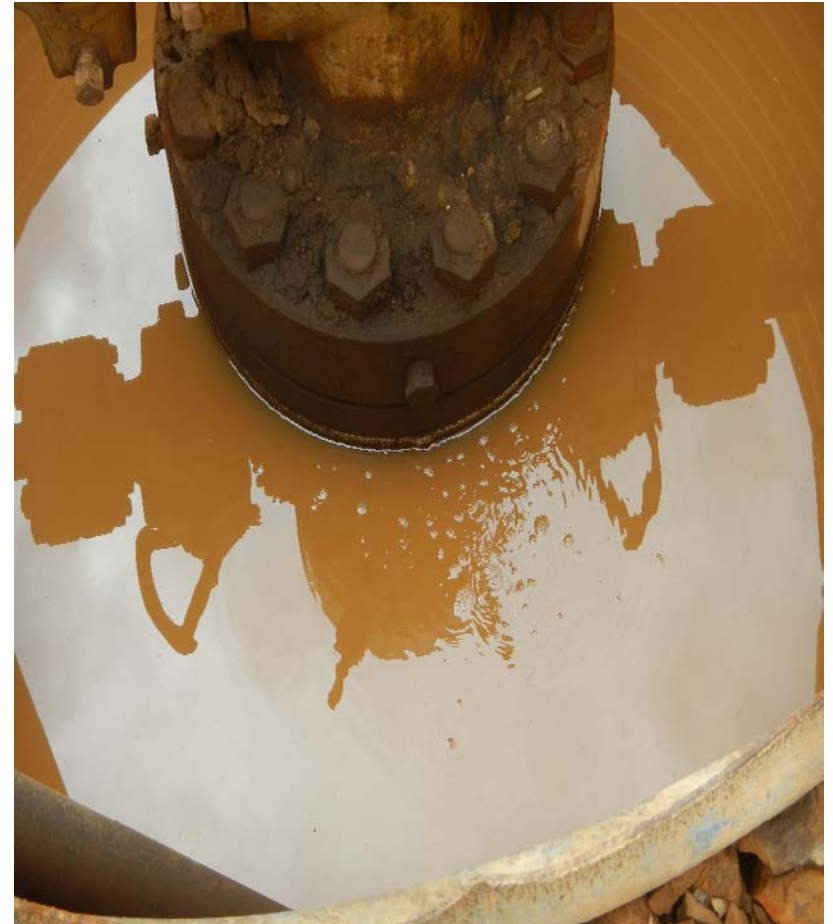
Photo#8:

One Well head (API#045-13007) was bubbling/leaking.
