Inspection Photos
Location Name: Diemoz A3
API: 05-045-19924

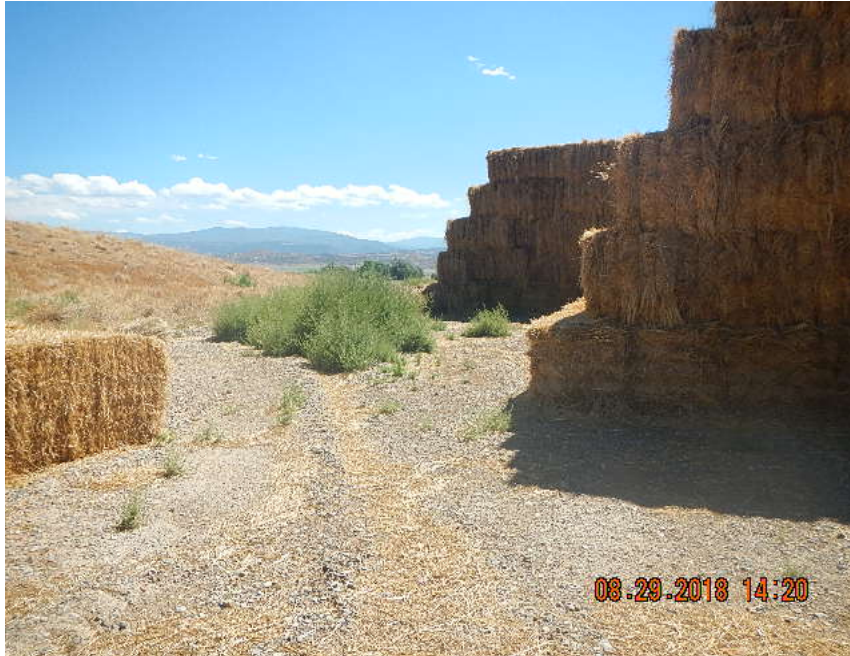
Weeds on the East Side of location

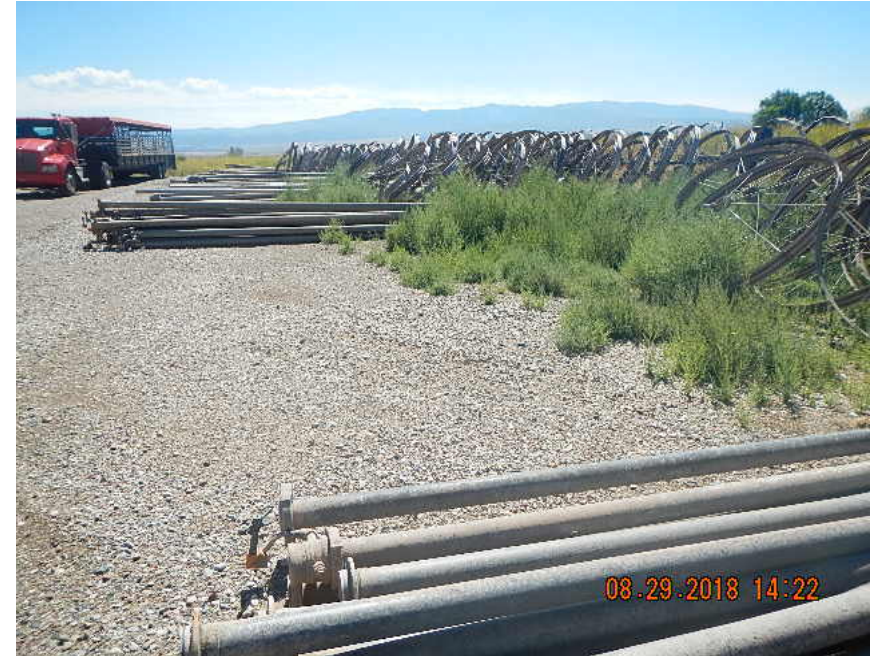
Weeds at the west side of location

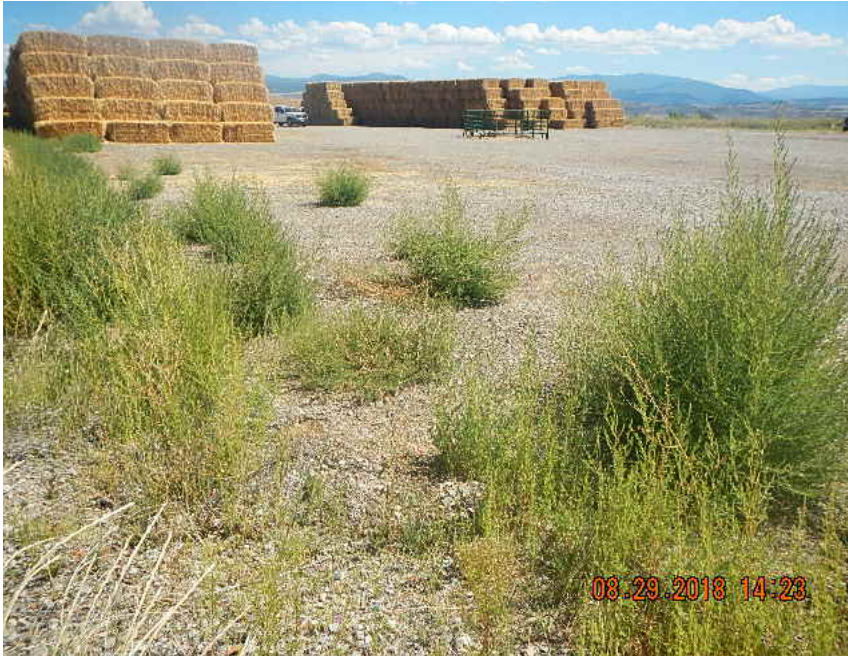
Location used for storage

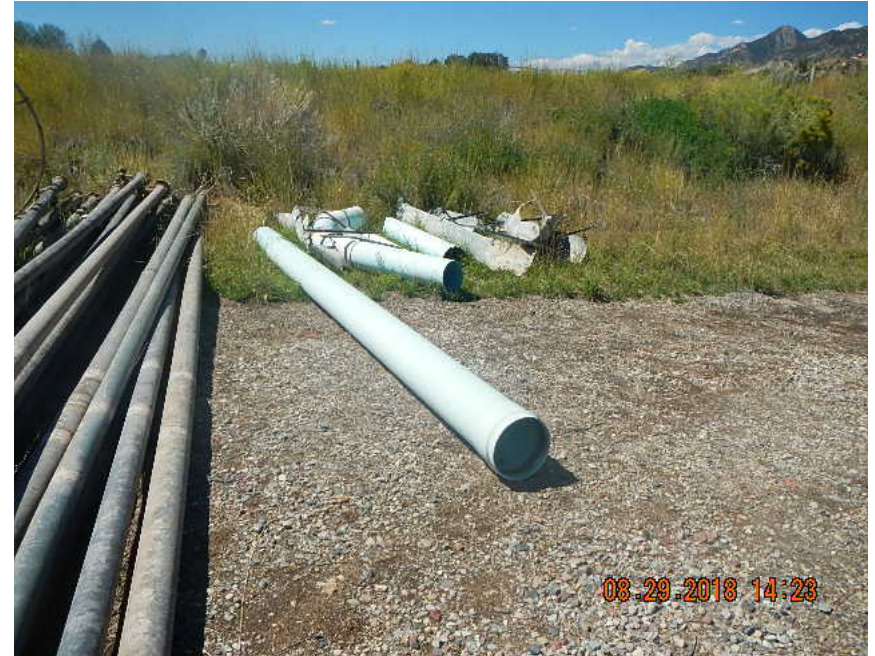
Location used for storage

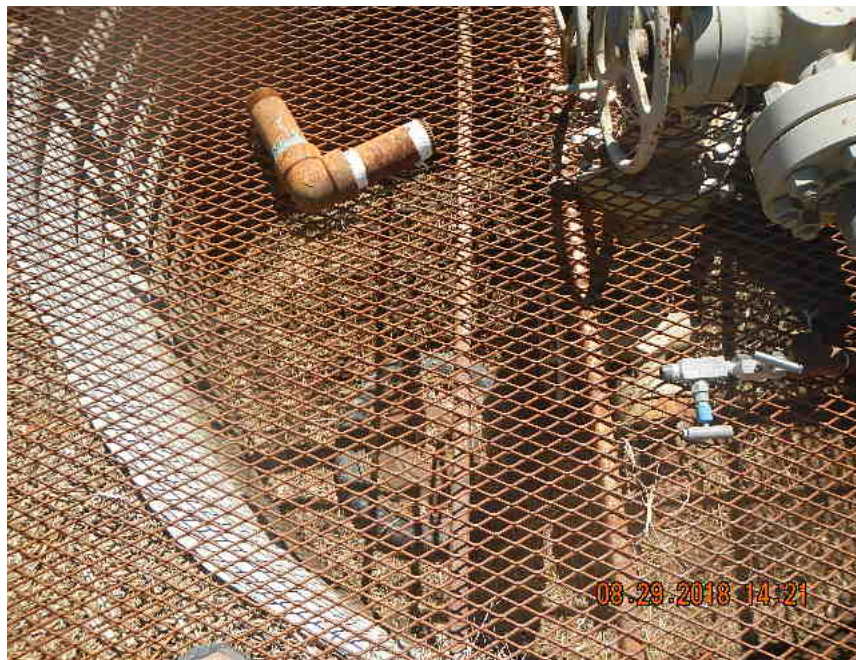
Debris around well head, inside cellar. Tire is inside of this cellar.

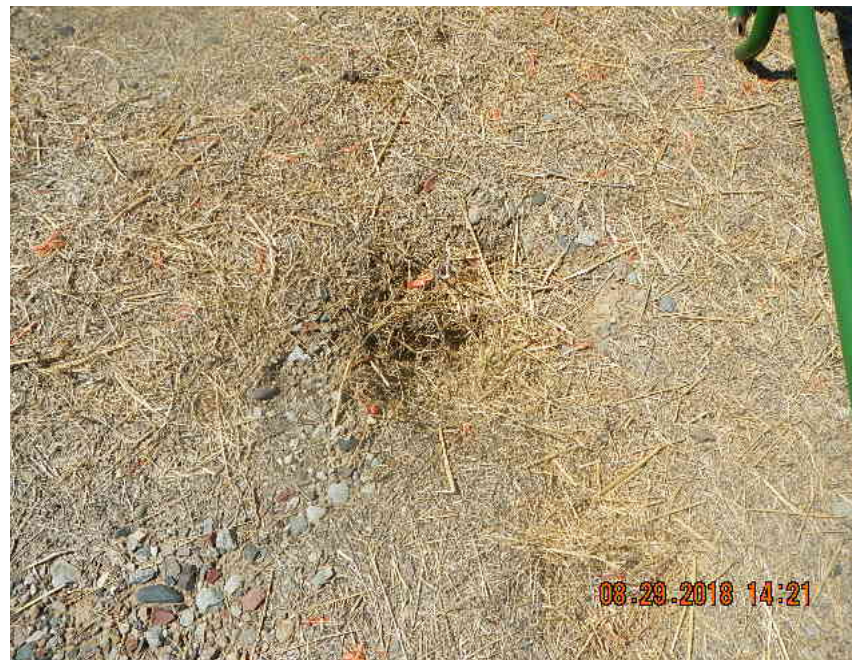
Open Bore hole with debris covering

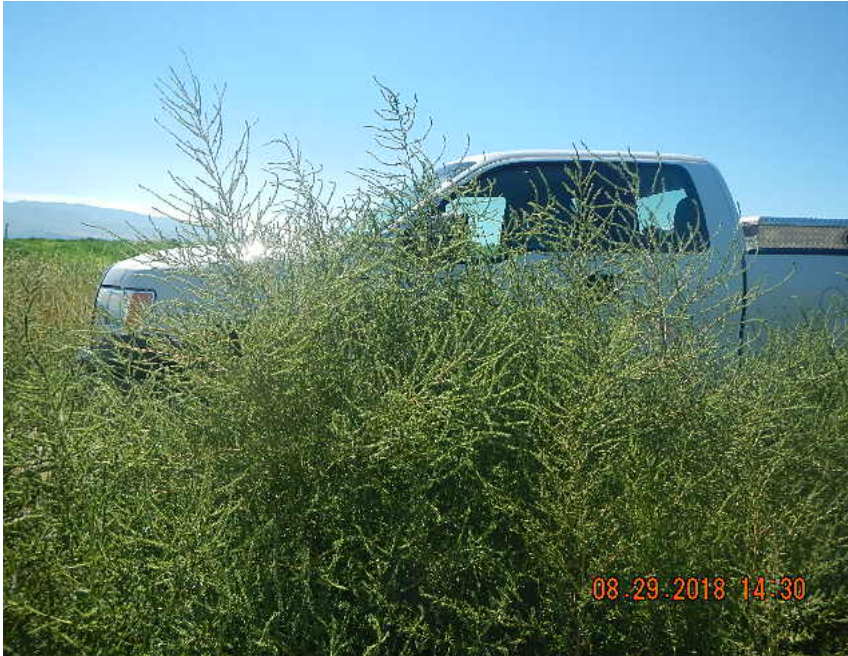
Weed along lease road

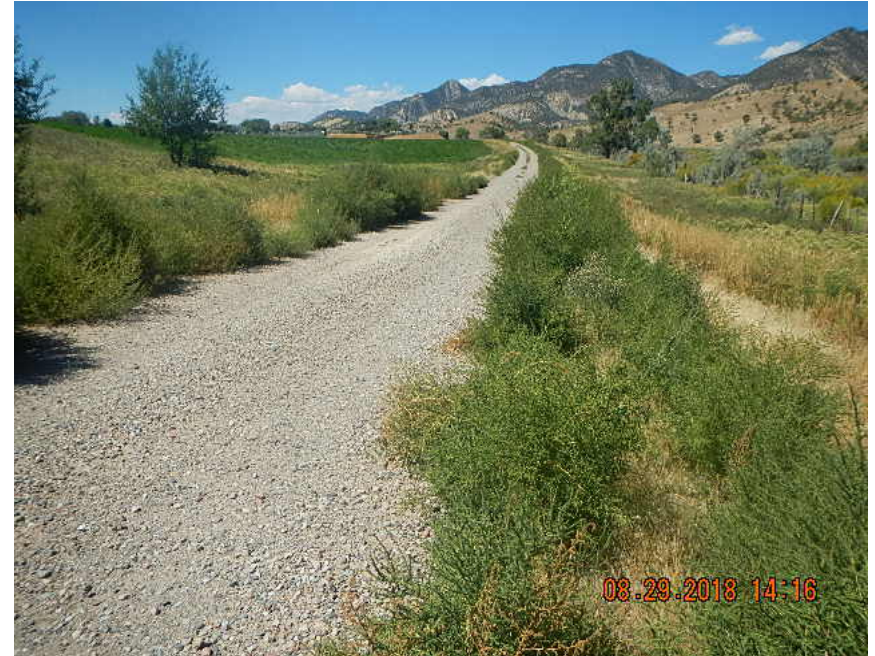
Weed along lease road
