# Inspection Photos

Operator: WHITING OIL & GAS CORPORATION -  
96155

Location ID: 436874

Inspection Doc. Number: 682503794  
Weld County, CO

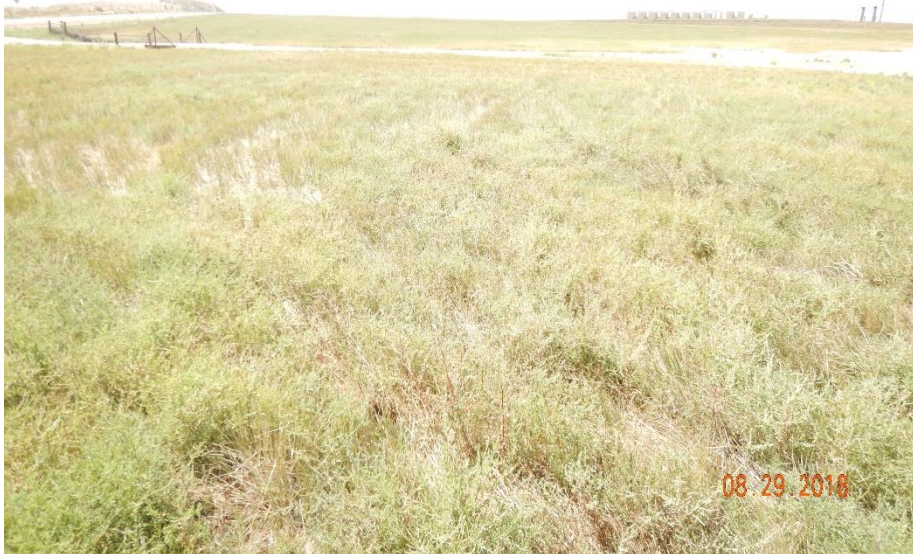
**Photo 1:** Photo taken from the southeast end of the interim areas, facing west.

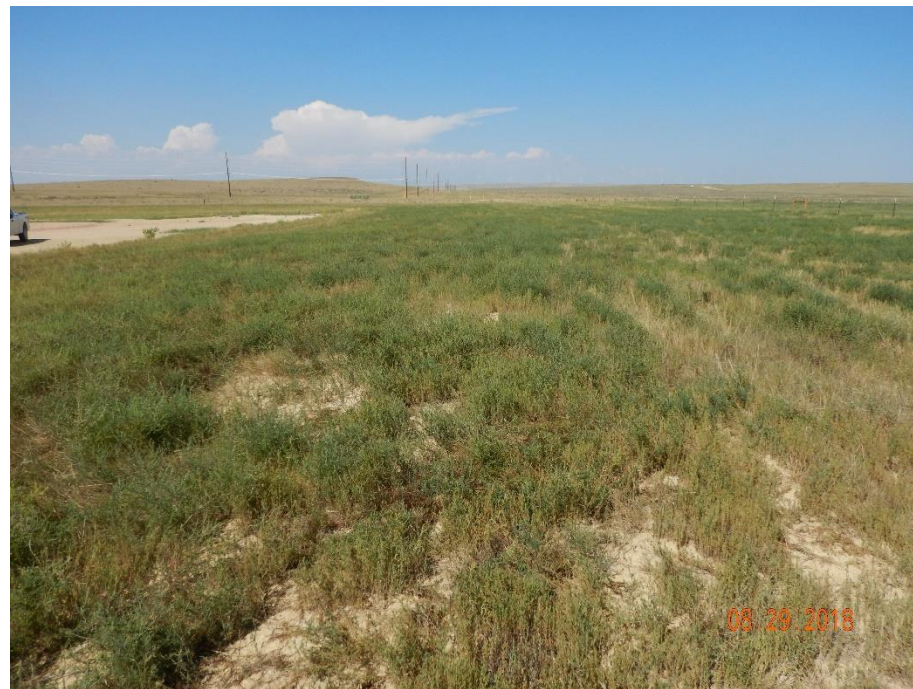
**Photo 2:** Photo taken from the northeast end of the interim areas, facing west.

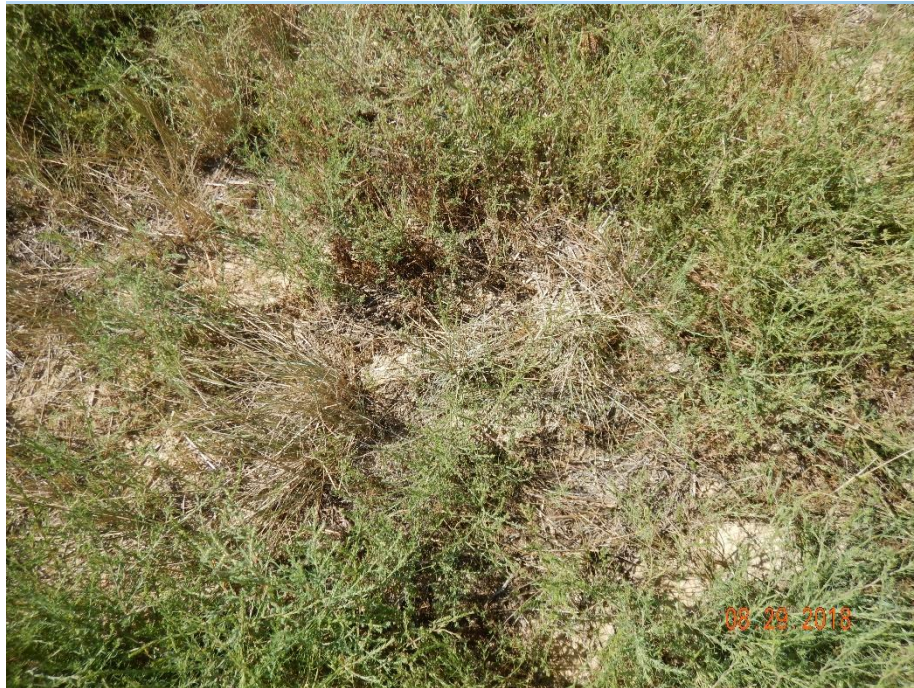
**Photo 3:** Photo taken from the interim area. Vegetation within the interim areas appear to be predominantly undesirable weedy plant species. However, desirable perennial vegetative germination is evident within the understory. Advise weed management to facility desirable vegetative establishment.

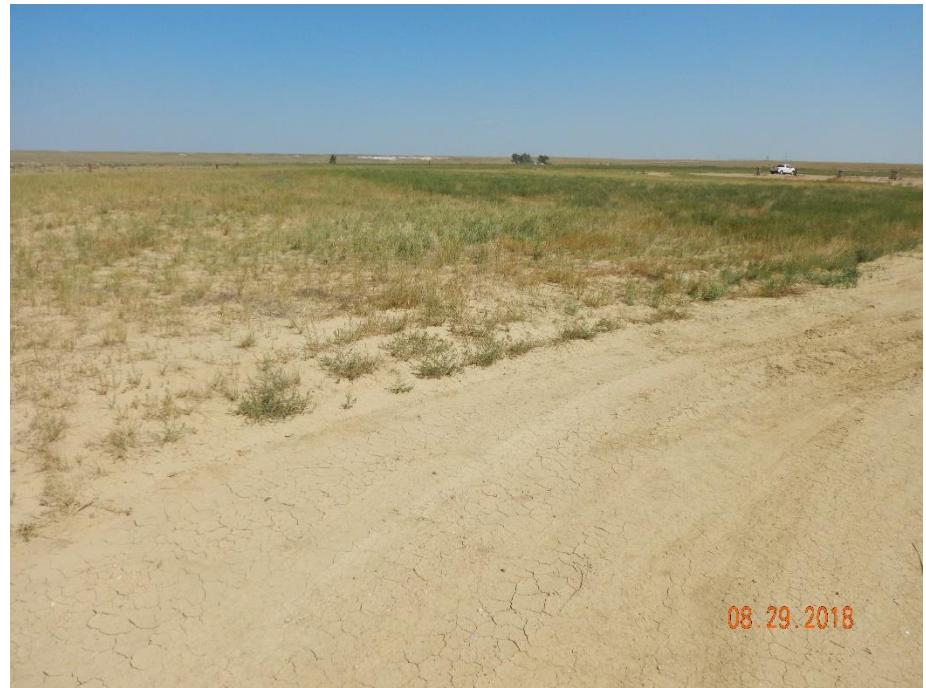
**Photo 4:** Photo taken from the northeast end of the location, facing east. Photos 4-6 provide an overview of the location from east, to southeast, to south.

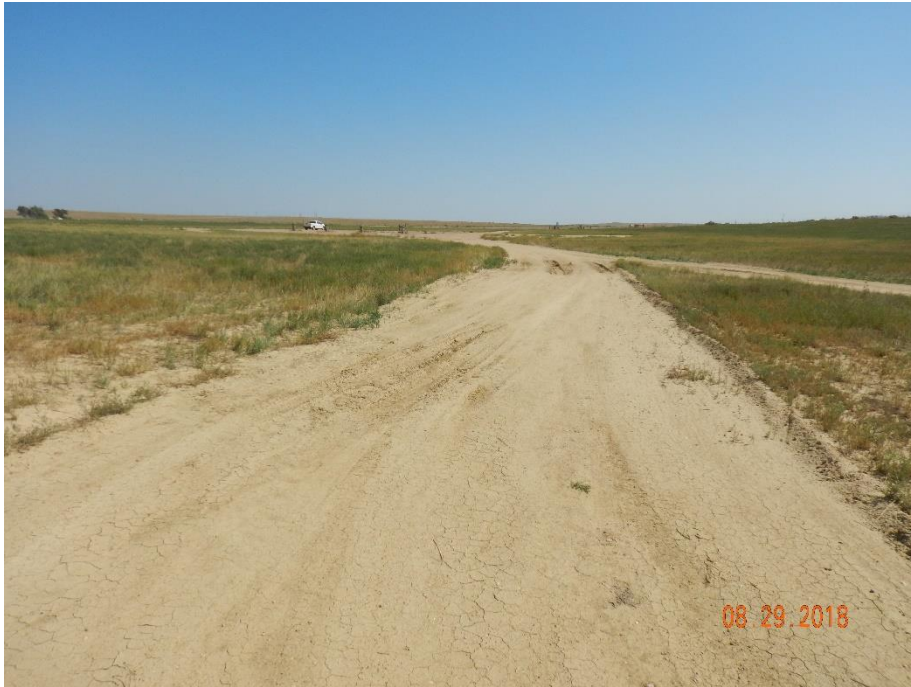
**Photo 5:** Photo taken from the northwest corner of the location. Facing west. Photo shows interim reclamation in process. Photo also shows stormwater ditch along perimeter.

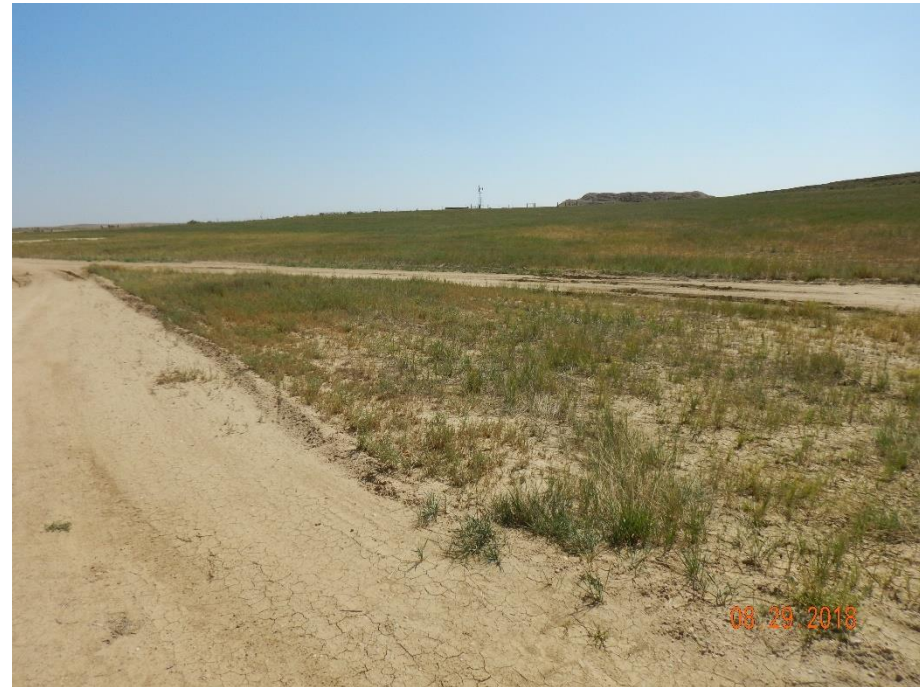
**Photo 6:** Photo taken from the north end of the location. Photo shows area where the ditch appears to have filled in over time and erosion degradation is beginning to occur. Advise maintenance to mitigate any additional disturbances.

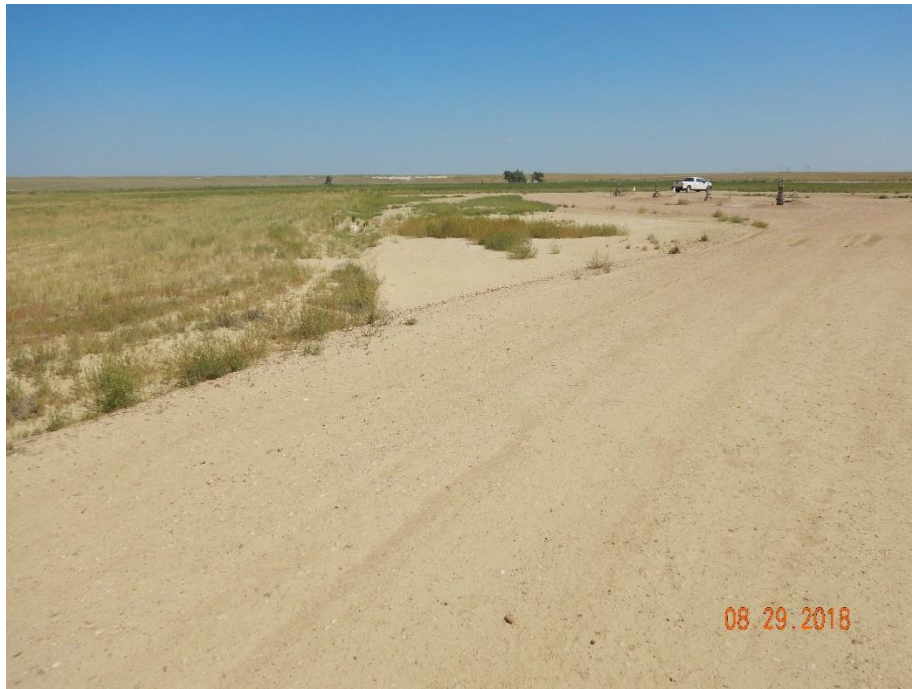
**Photo 7:** Photo taken from the northwest end of the location, facing east. Photo shows areas around the wells that do not appear to be reasonably needed for production activities do not appear to have been reclaimed or stabilized.

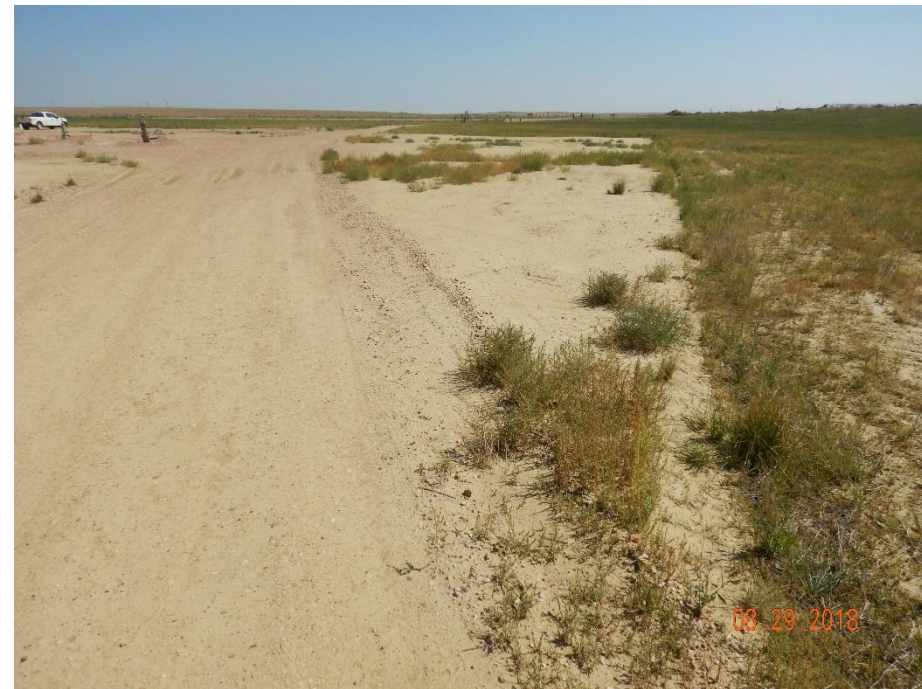
**Photo 8:** Photo taken from the northwest end of the location, facing south. Photo shows areas around the wells that do not appear to be reasonably needed for production activities do not appear to have been reclaimed or stabilized.

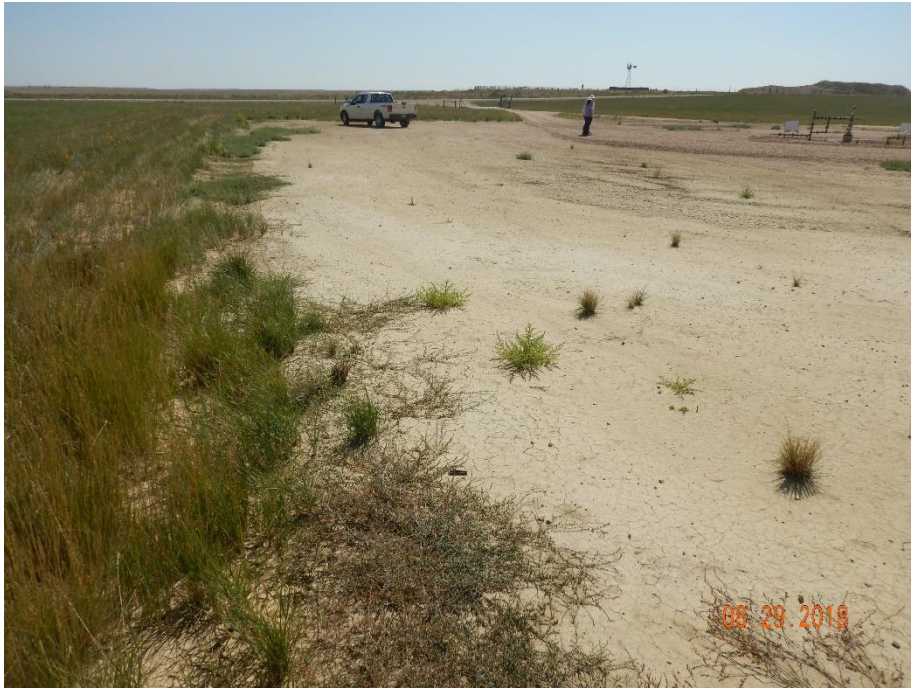
**Photo 9:** Photo taken from the northeast end of the location, facing south. Photo shows areas around the wells that do not appear to be reasonably needed for production activities do not appear to have been reclaimed or stabilized.

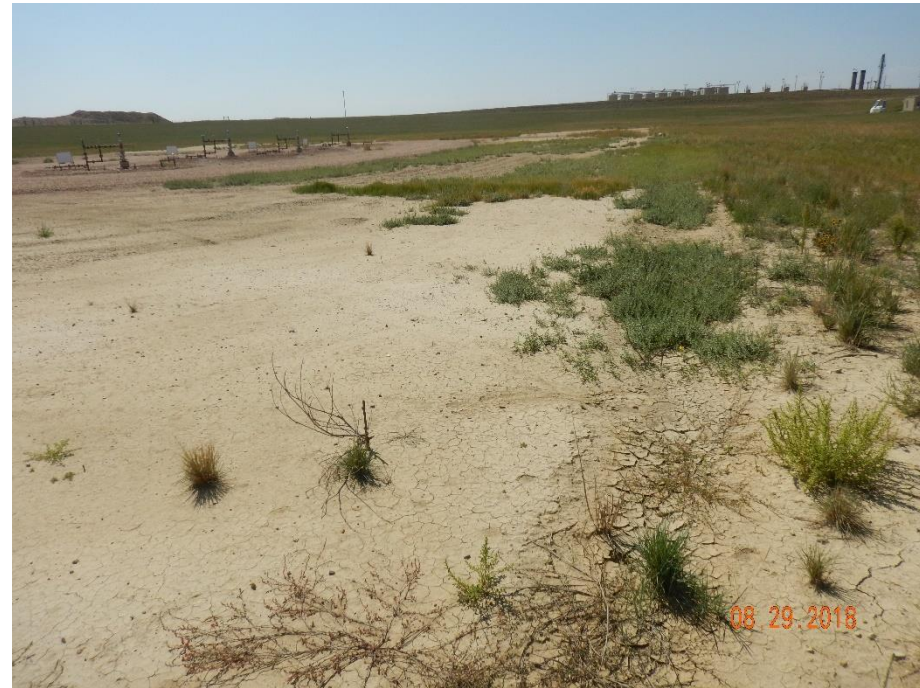
**Photo 10:** : Photo taken from the northeast end of the location, facing west. Photo shows areas around the wells that do not appear to be reasonably needed for production activities do not appear to have been reclaimed or stabilized.

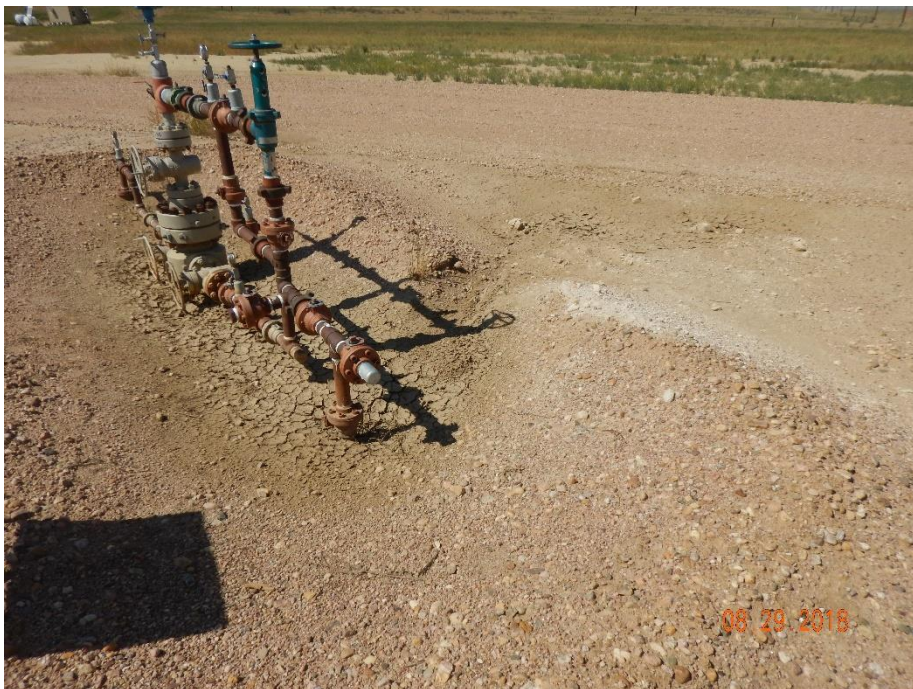
**Photo 11:** Photo taken from the wells, photo shows berm at well no longer in proper functioning condition.

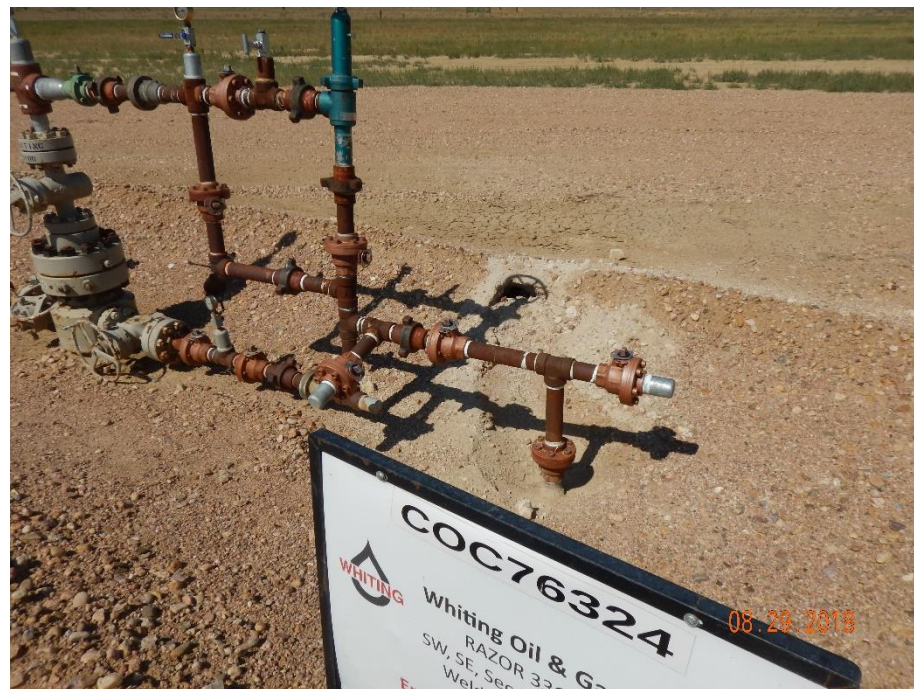
**Photo 12:** Photo taken from the wells, photo shows berm at well no longer in proper functioning condition.
