Inspection Photos
Location Name: Joker / 36-9-62
Location #: 417683

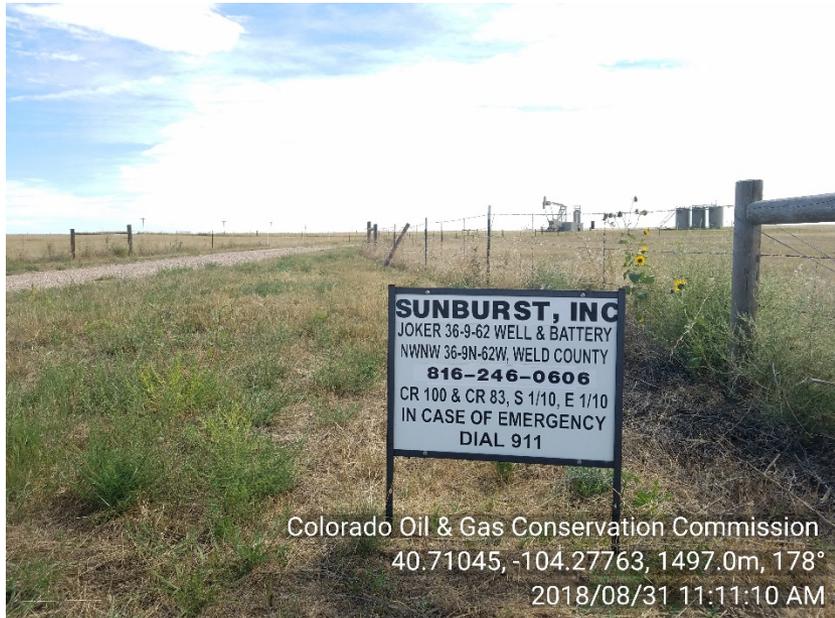
Photo #1
Joker 36-9-62 (API # 05-123-31719)
Sign at access road

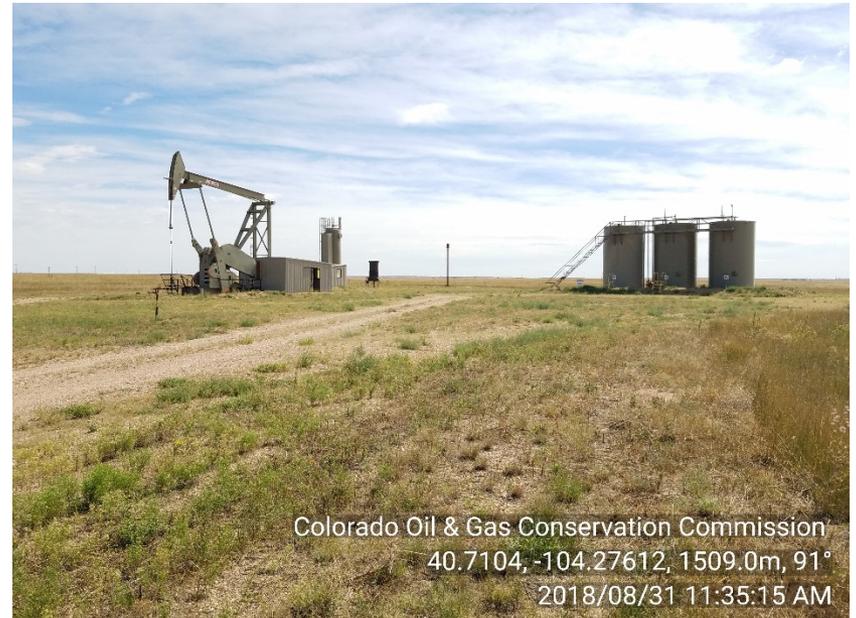
Photo #2
Joker 36-9-62 (API # 05-123-31719)
Battery

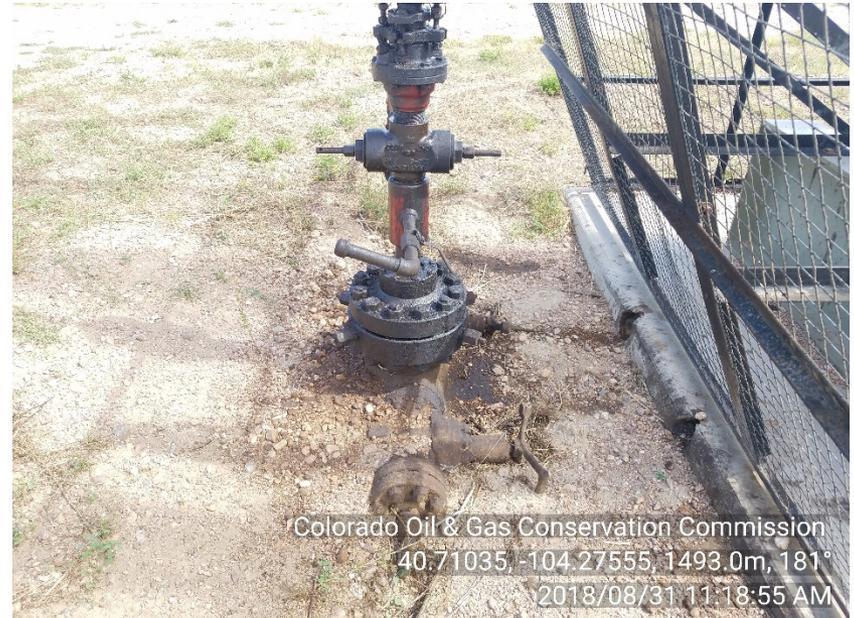
Photo #4
Joker 36-9-62 (API # 05-123-31719) wellhead
Stained soil
Bradenhead not plumbed to surface

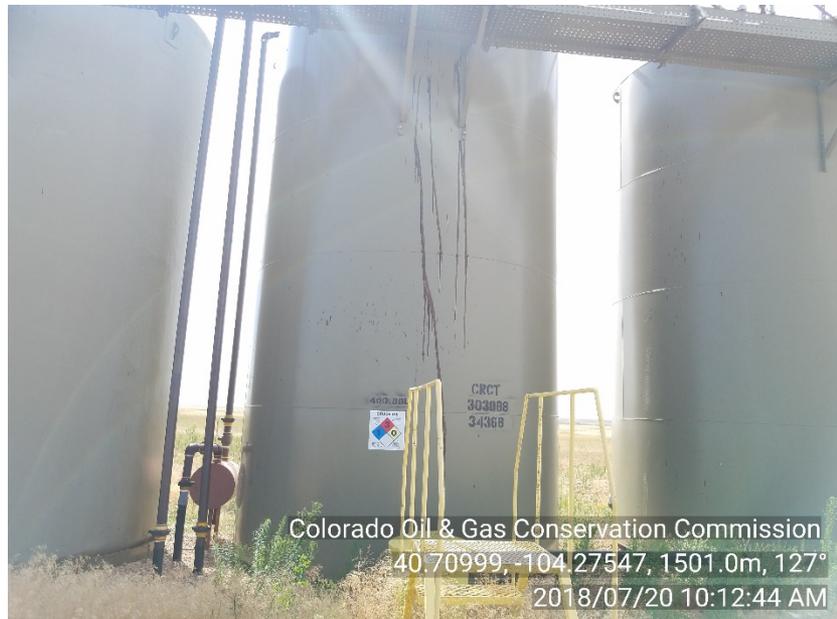
Photo #5
Joker 36-9-62 Oil & H2O tanks
Stain on middle tank
From previous FIR

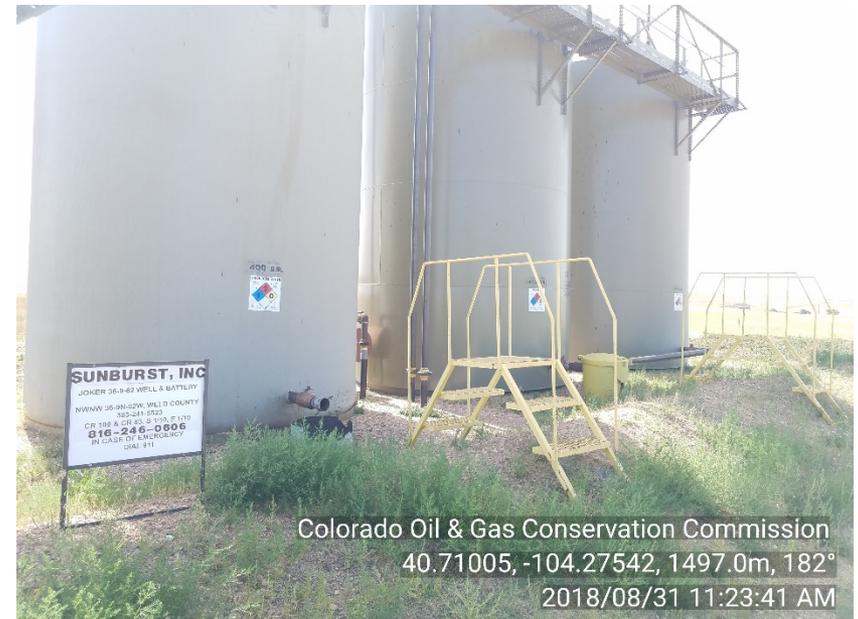
Photo #6
Joker 36-9-62 Oil & H2O tanks
Middle tank stain removed

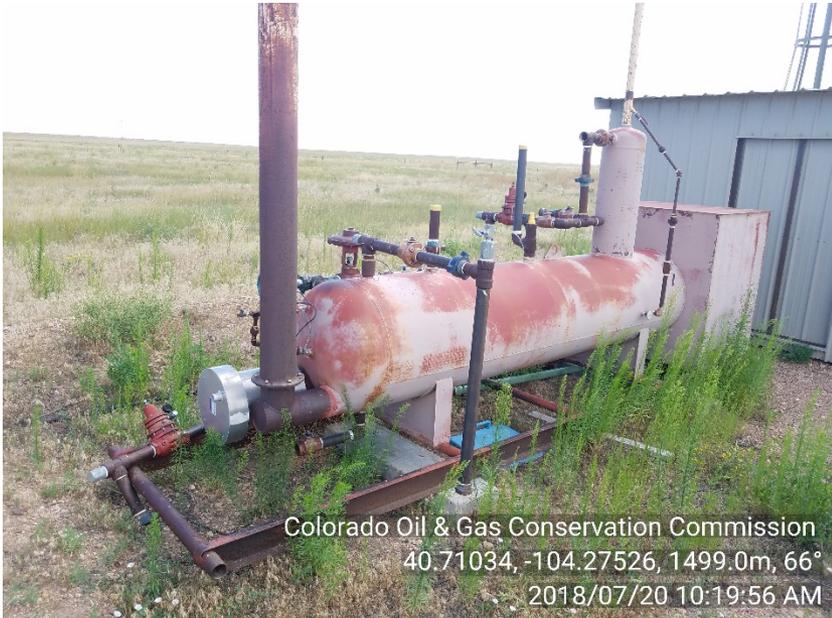
Photo #7

Unused equipment, weeds
From previous FIR

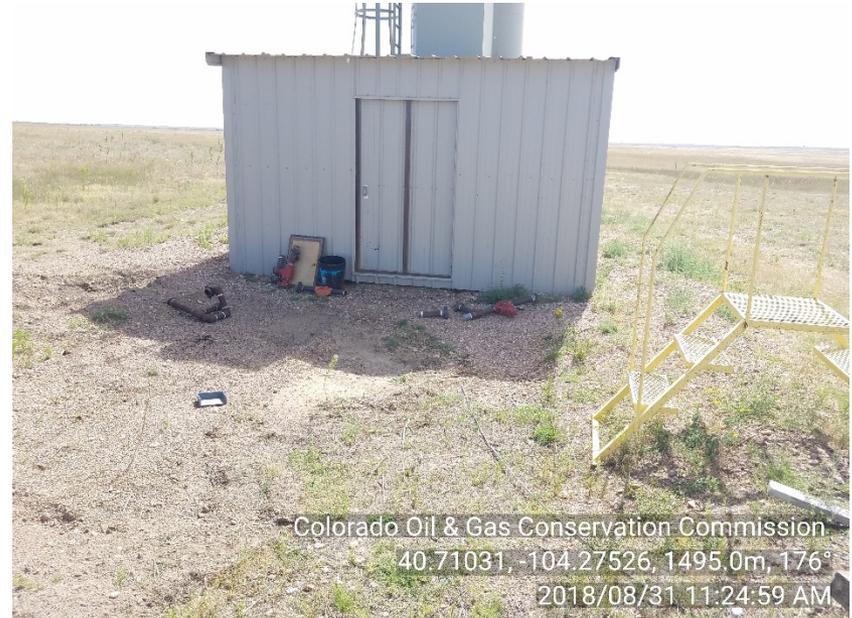
Photo #8

Weeds / Separator removed

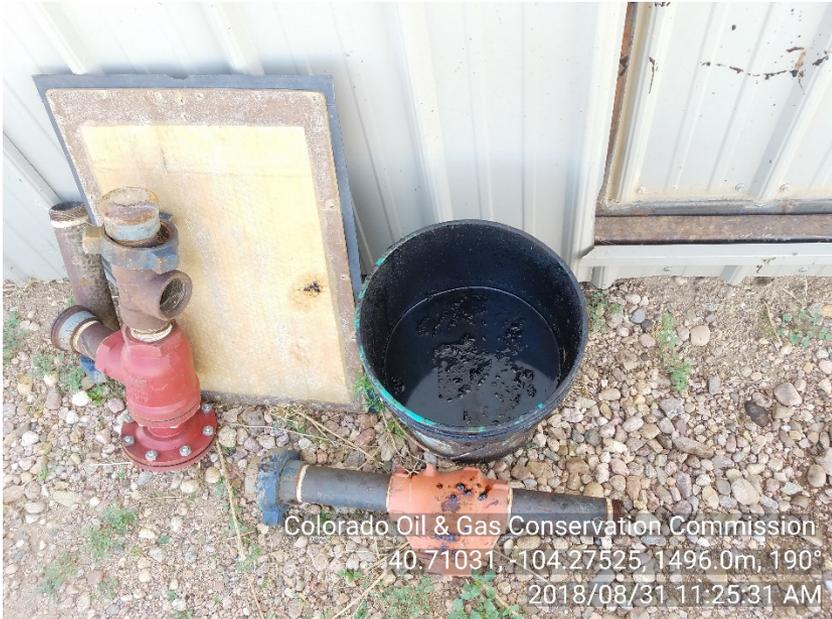
Photo #9
Joker 36-9-62

Oily waste bucket / unused fittings

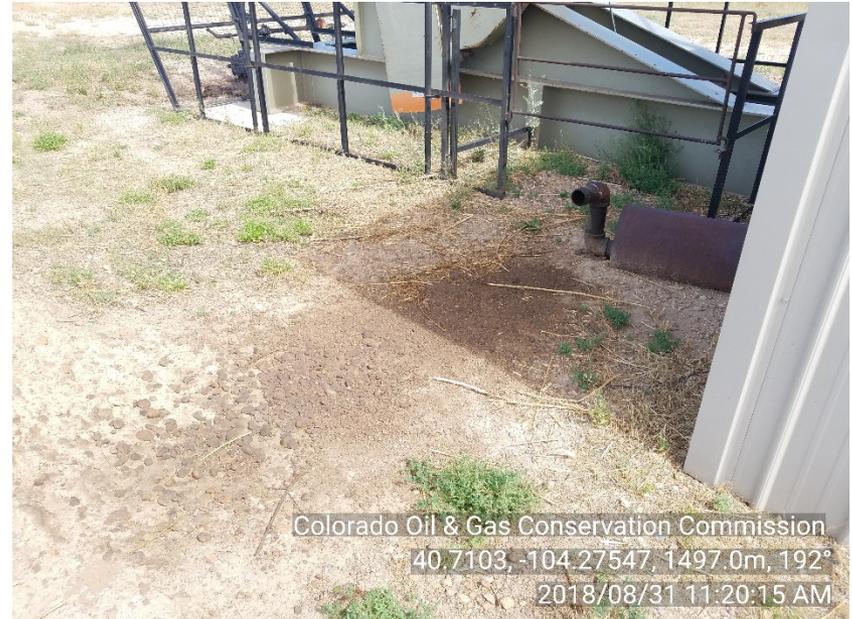
Photo #10
Joker 36-9-62

Stained soil near engine exhaust

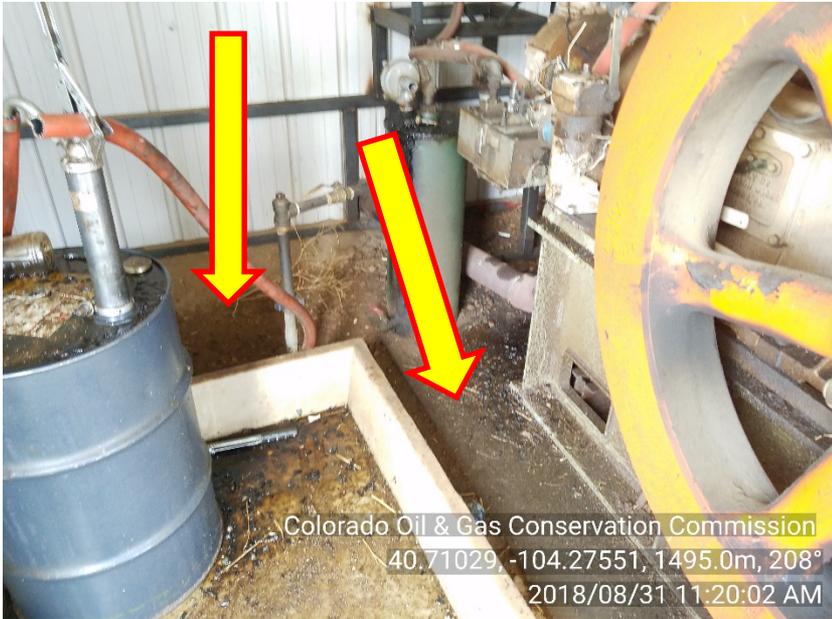
Photo #11
Joker 36-9-62 Engine house
Stained soil & engine base

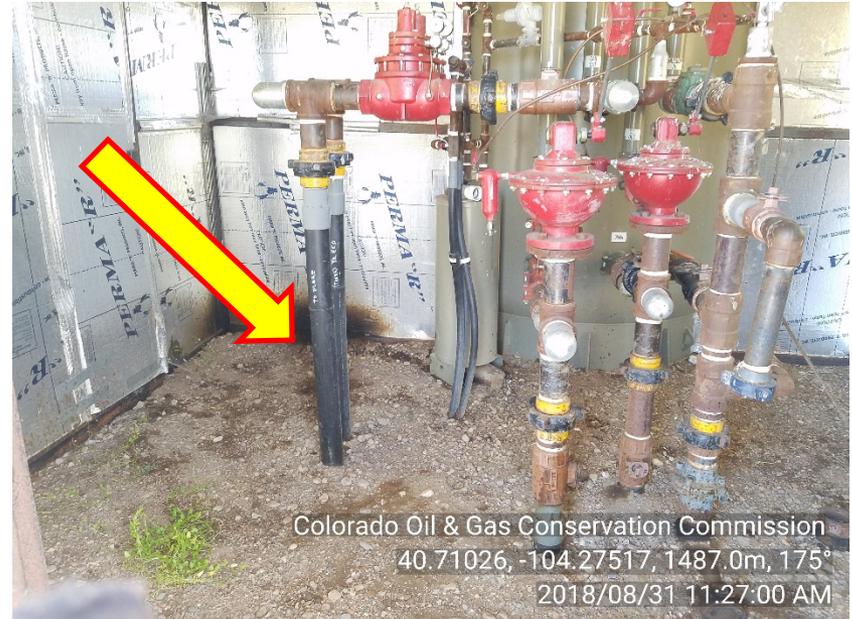
Photo #12
Joker 36-9-62 Treater house
Stained soil & wall

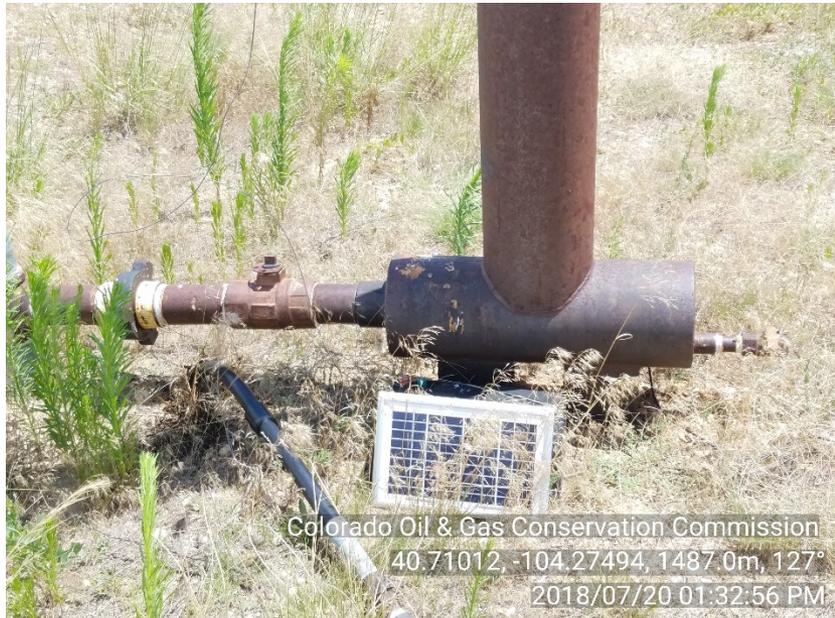
Photo #13
Joker 36-9-62 Candlestick Flare
Flare inlet open
From previous FIR

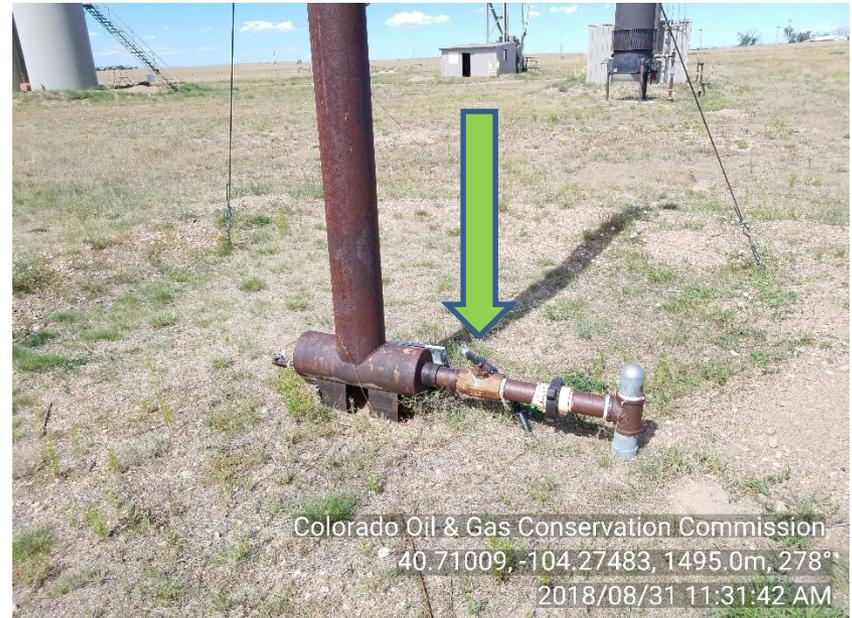
Photo #14
Joker 36-9-62 Candlestick Flare
Flare inlet Closed.
Venting has ceased.

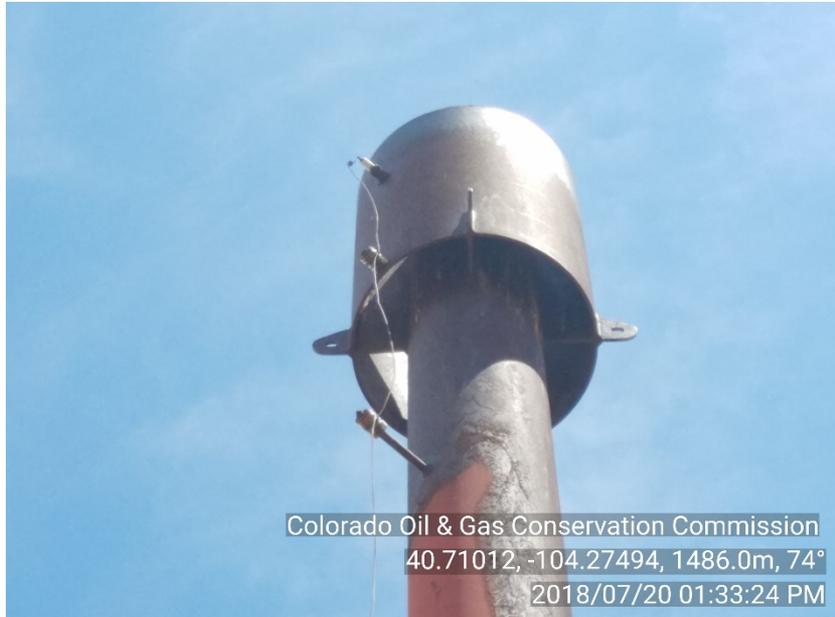
Photo #15
Joker 36-9-62 Candlestick Flare
Disconnected ignition wire
From previous FIR

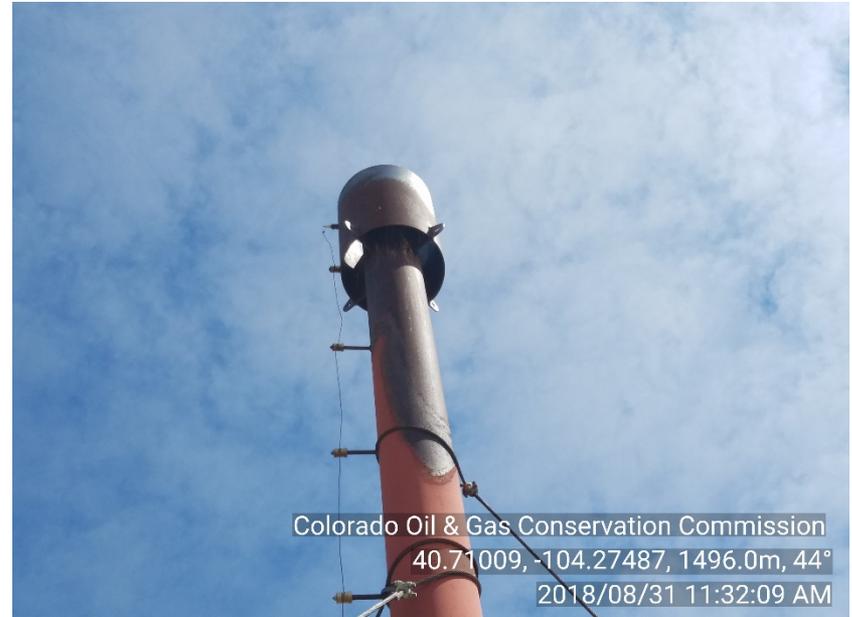
Photo #16
Joker 36-9-62 Candlestick Flare
Ignition wire remains disconnected

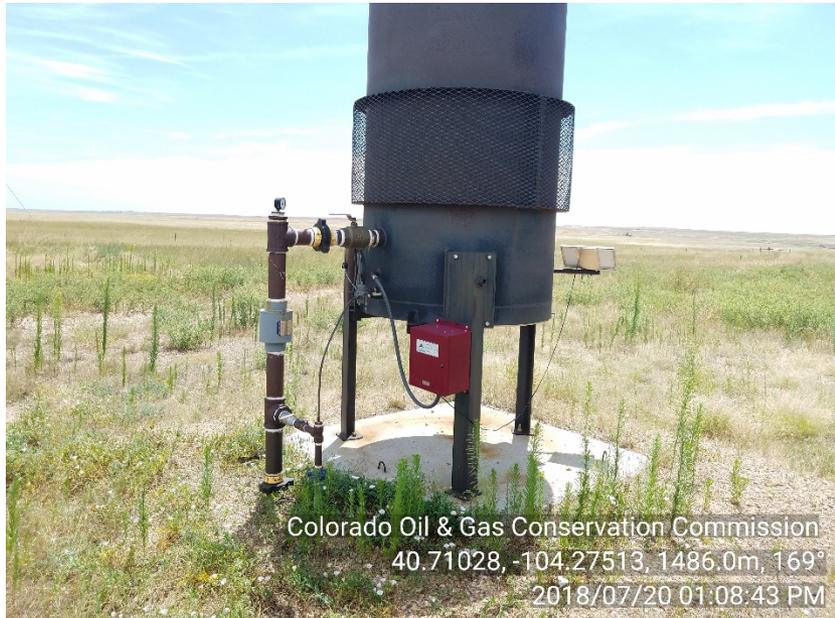
Photo #17

Inlet valve is shut. Not in operation.

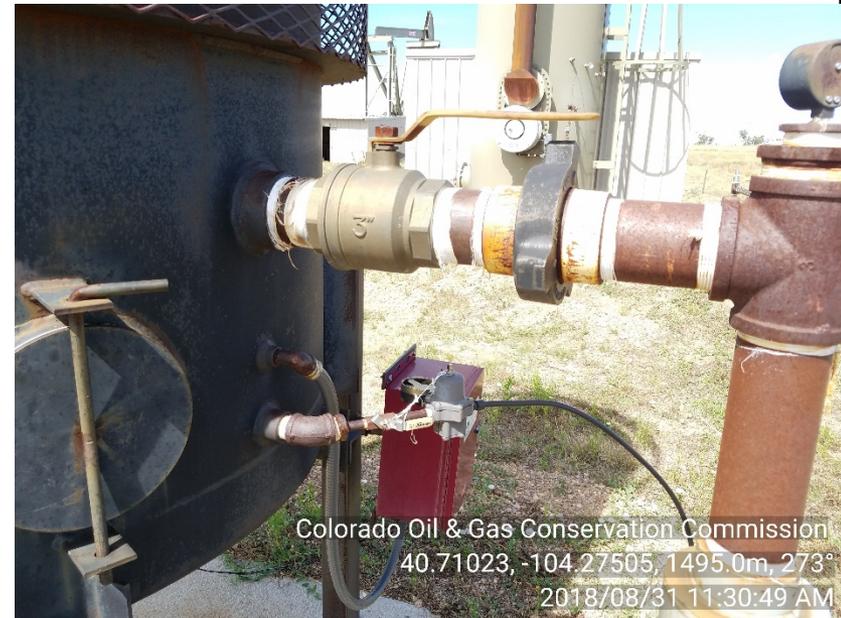
Photo #18

Inlet & pilot valves open. Pilot is unlit.

ECD not in operation

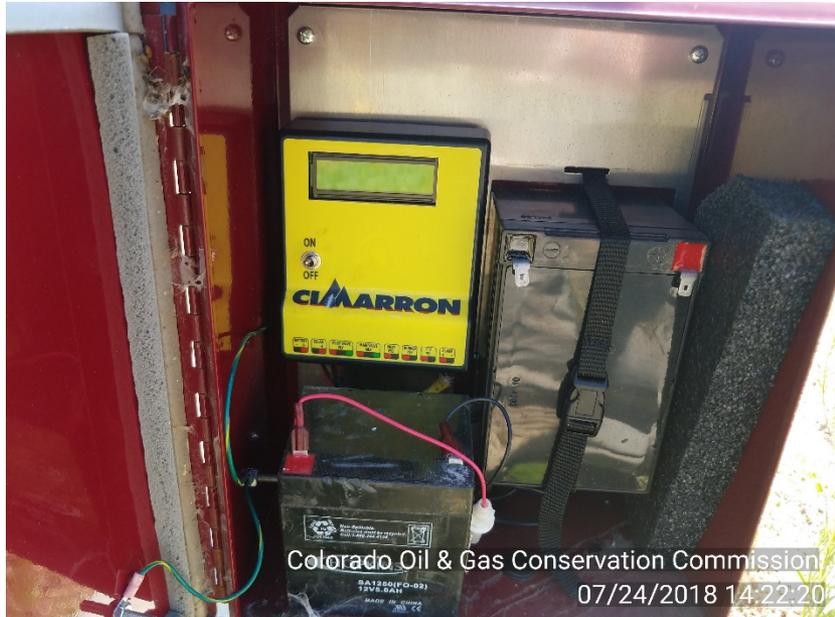
Photo #19

Joker 36-9-62 ECD Pilot Ignition
Switch is ON. Battery appears bad
From previous FIR

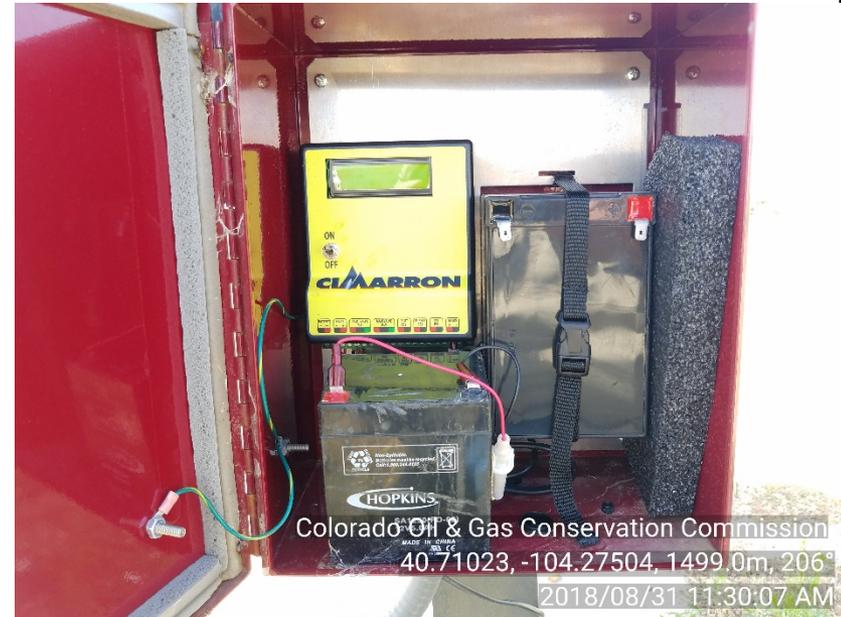
Photo #20

Joker 36-9-62 ECD Pilot Ignition
Switch is ON. Battery appears bad
ECD not in operation

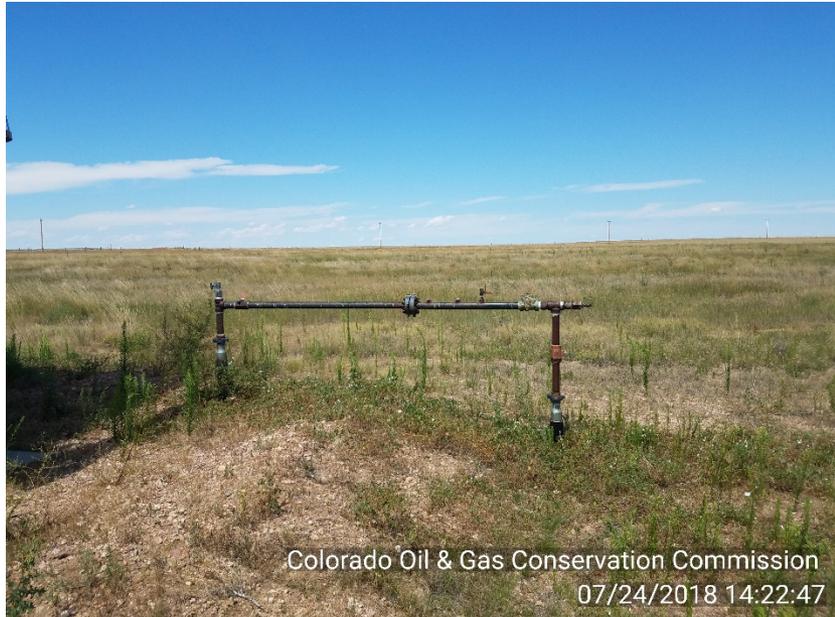
Photo #21
Joker 36-9-62 Gas meter run
Valves appear partially open
From previous FIR

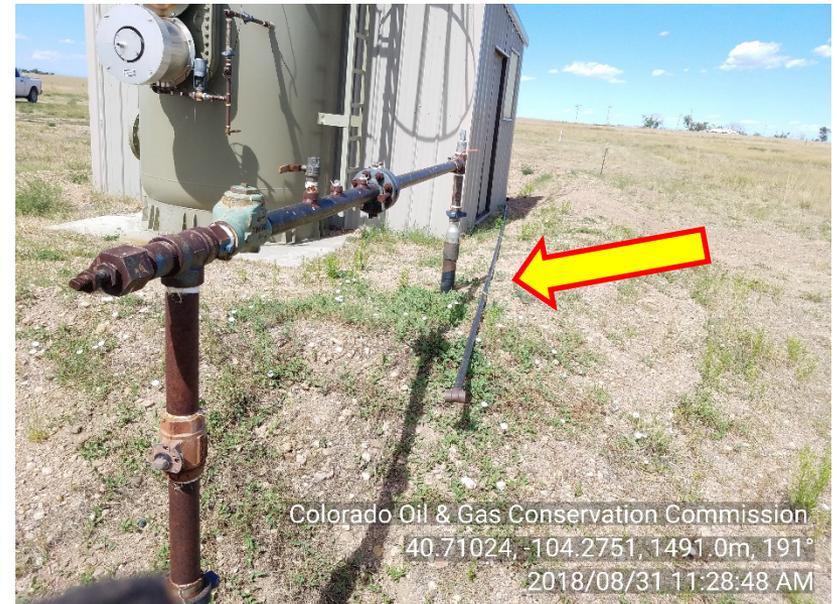
Photo #22
Joker 36-9-62 Gas meter run
Valves appear Closed
Unused Equip (Line pipe)

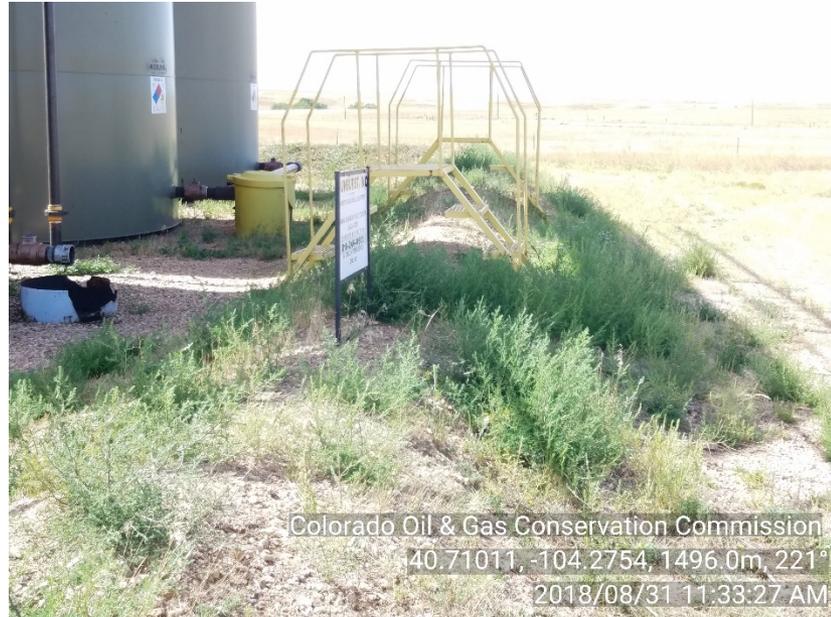
Photo #23
Joker 36-9-62 Tank berms
Weeds need cut
