Inspection Photos
Location Name: Fish Creek Unit 2 (8-20)
API: 05-107-06020

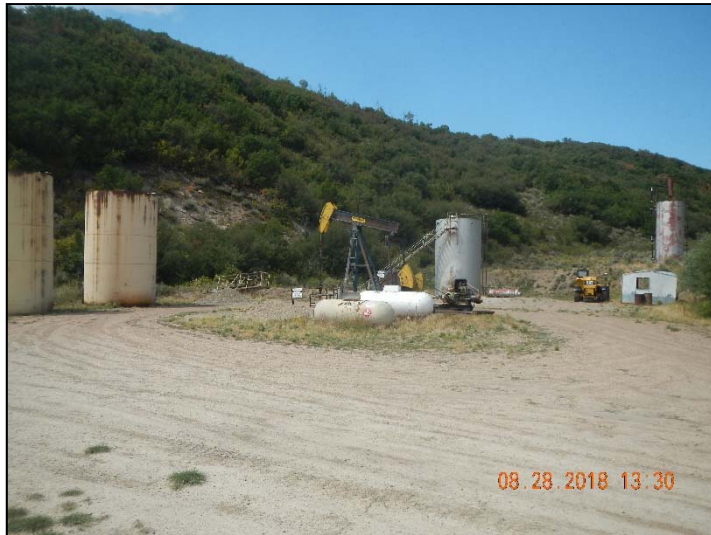
Photo 1. Overview of location taken at entrance facing northwest.

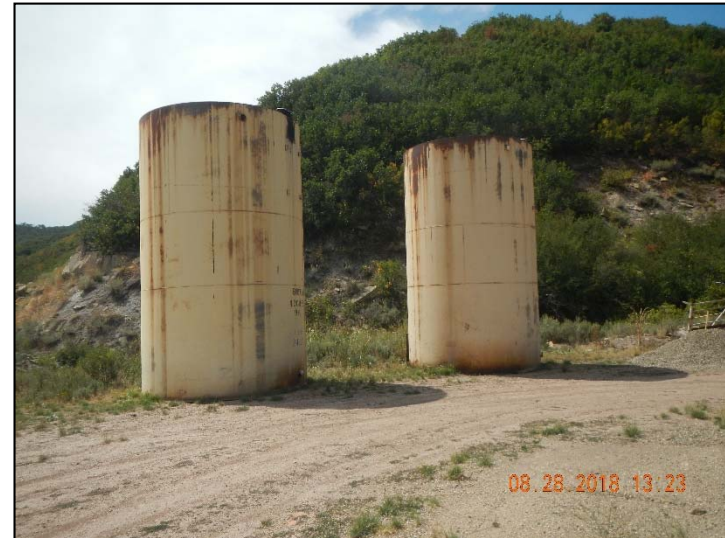
Photo 2. Tanks stored on location.

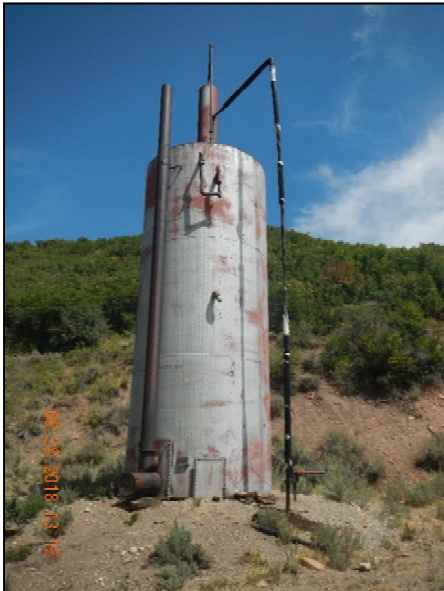
Photo 3. Gunbarrel separator with no berm and stained soil at base.

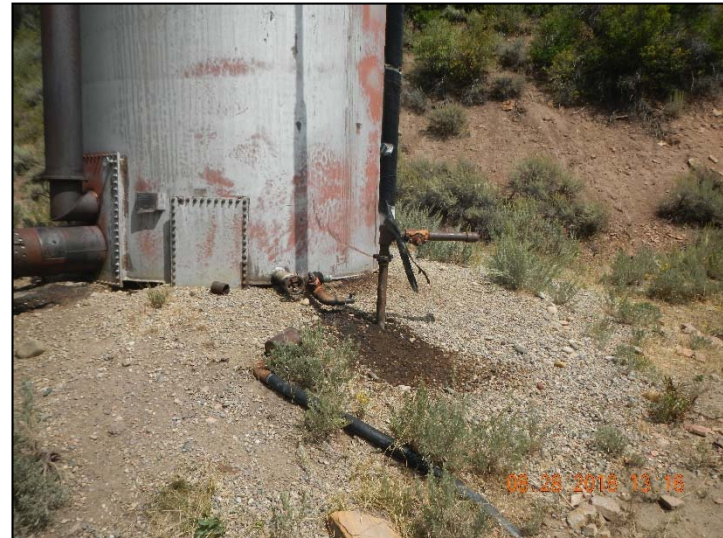
Photo 4. Close-up of stained soil.

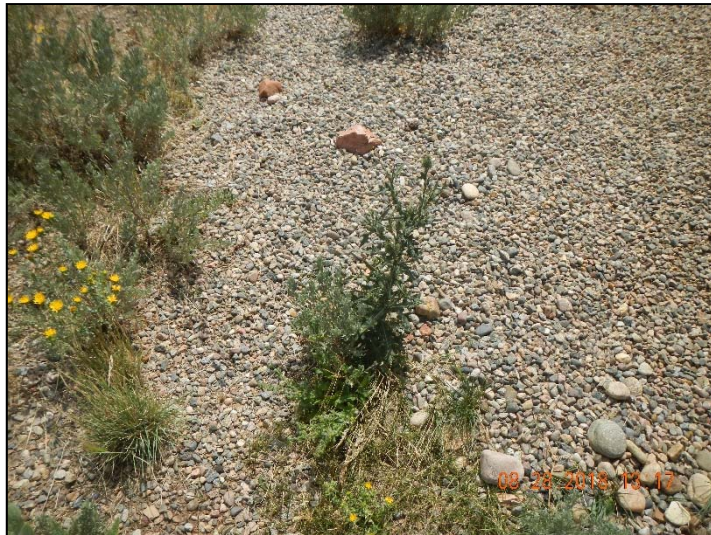
Photo 5. Example of noxious weeds on location.

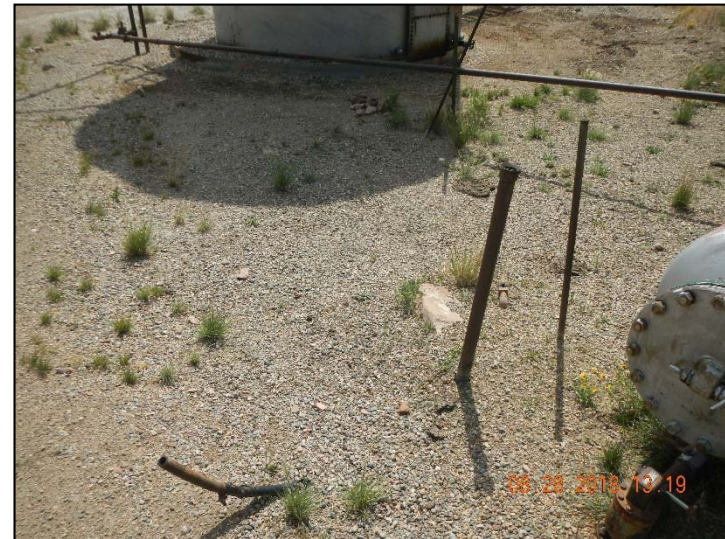
Photo 6. Unmarked risers.

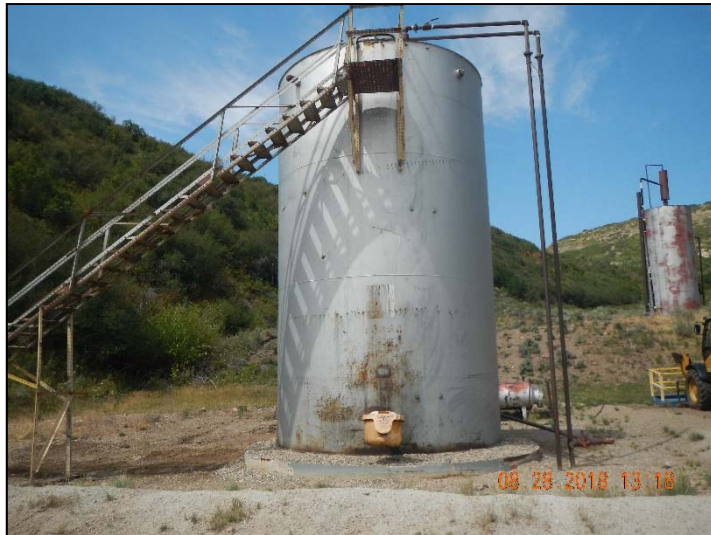
Photo 7. Unlabeled tank. Stained soil in tank berm.

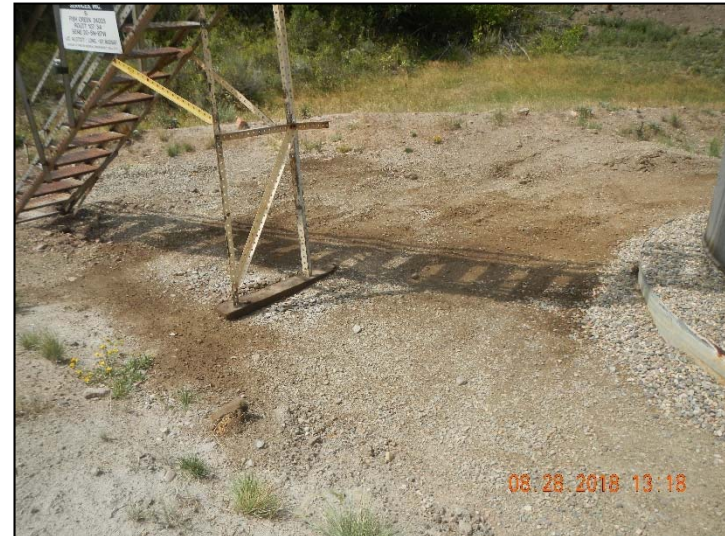
Photo 8. Stained soil in tank berm.

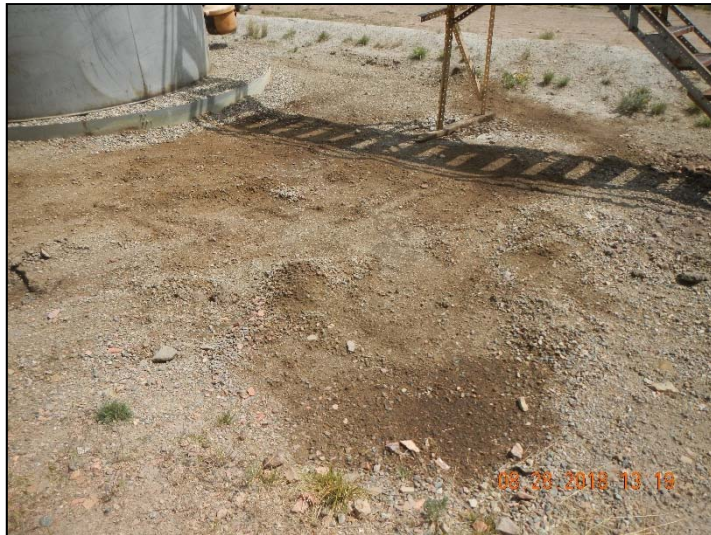
Photo 9. Stained soil in tank berm.

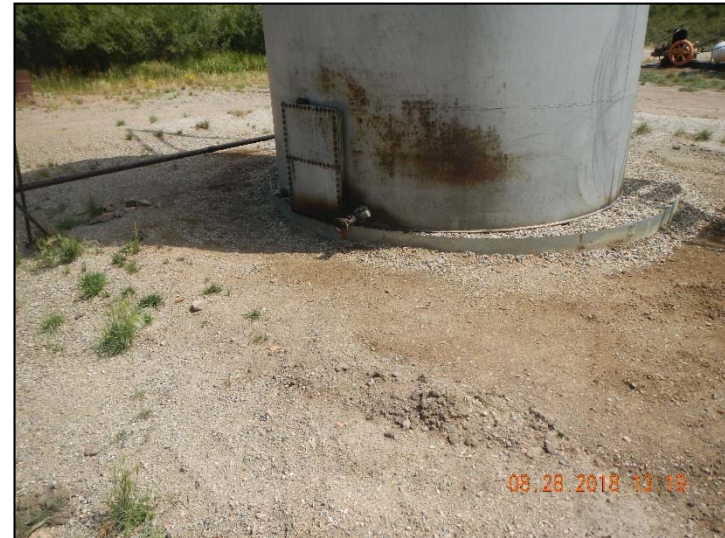
Photo 10. Stained soil in tank berm.

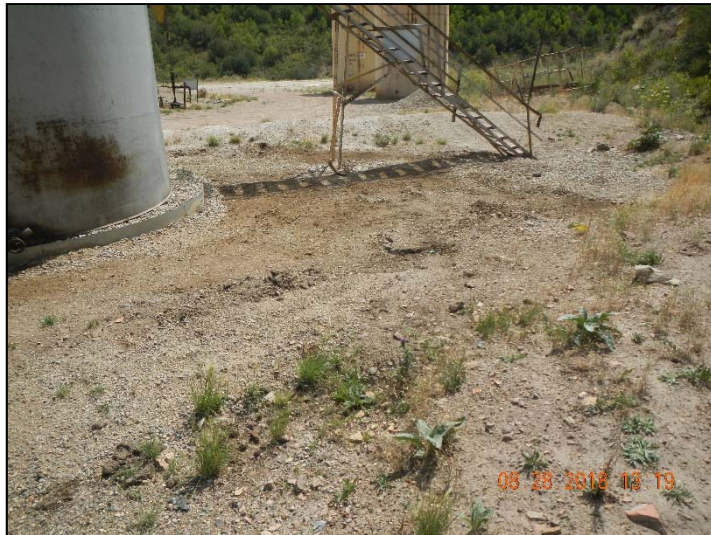
Photo 11. Stained soil in tank berm.

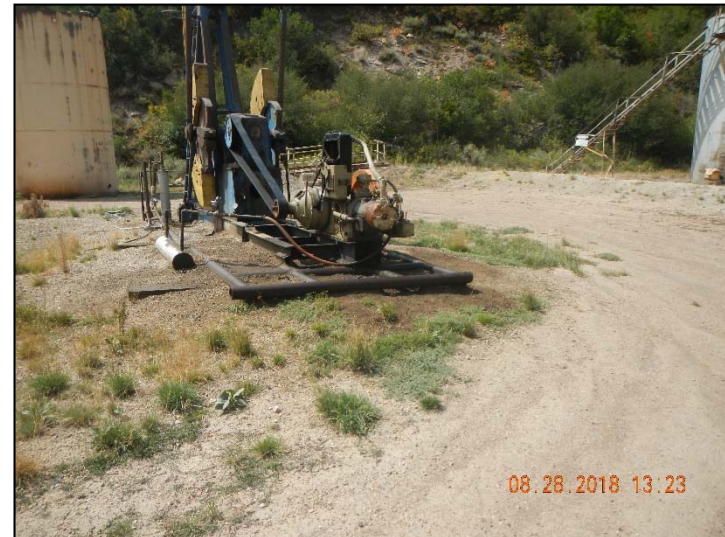
Photo 12. Stained soil at pump jack exhaust.

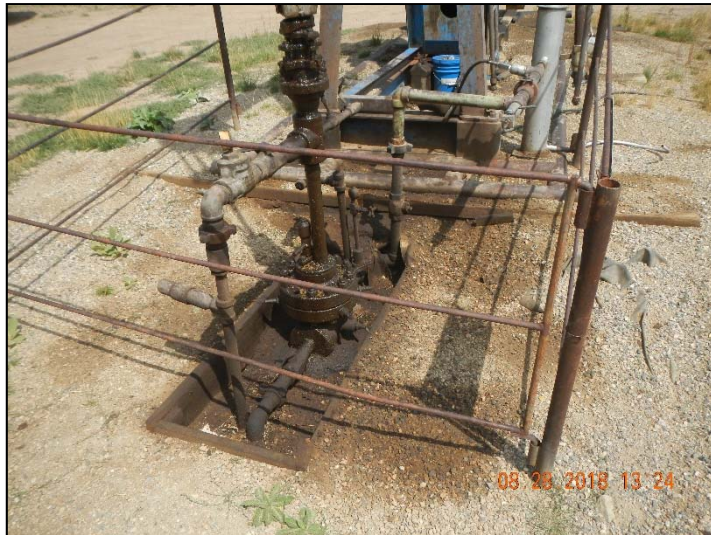
Photo 13. Stained soil at wellhead.

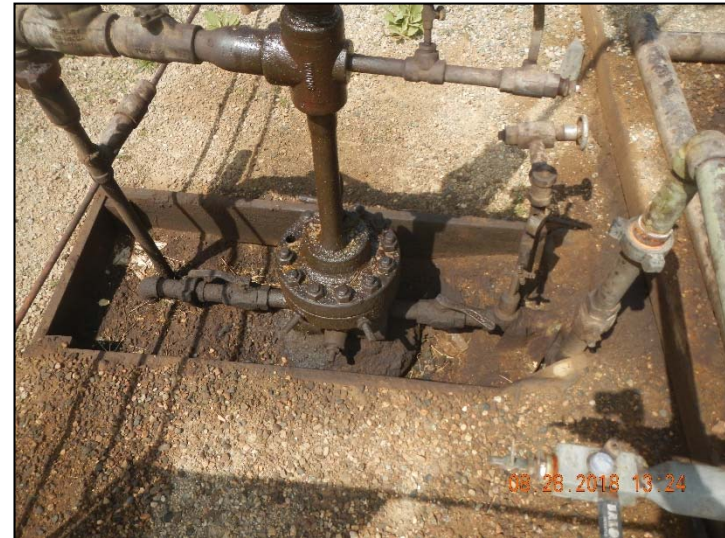
Photo 14. Stained soil at wellhead.

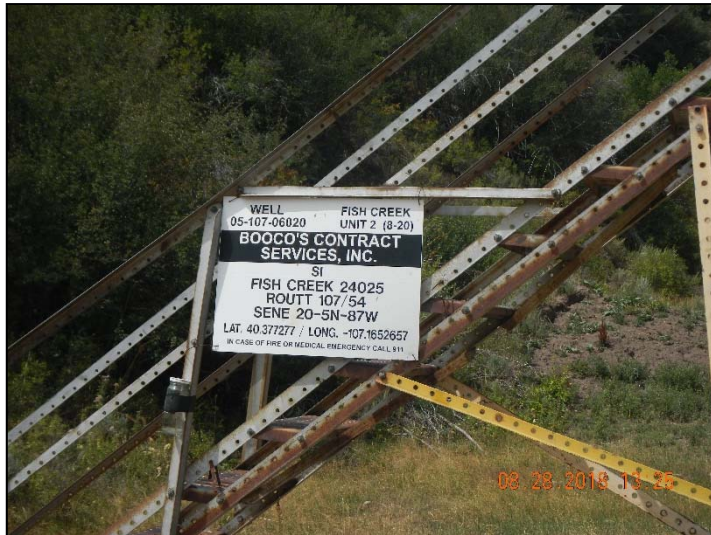
Photo 15. Battery sign only contains 911, no operator emergency contact number.

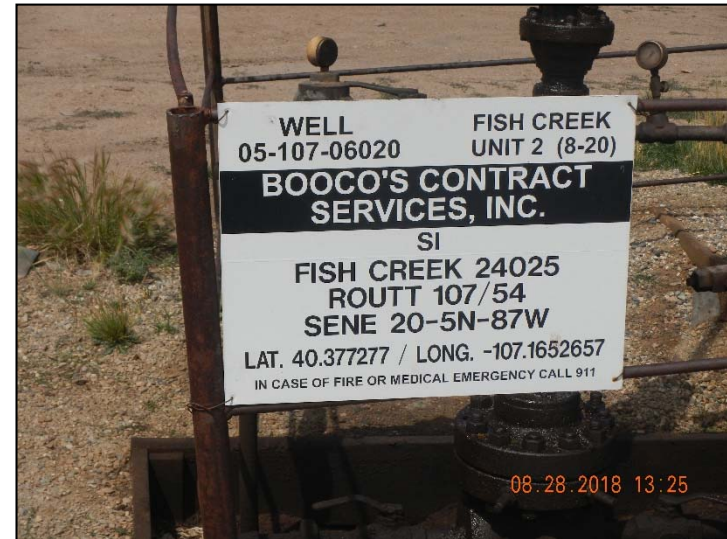
Photo 16. Wellhead sign only contains 911, no operator emergency contact number.
