Construction and Stormwater Inspection

Operator: KERR MCGEE OIL & GAS ONSHORE LP #47120

Location ID: 448107

Inspection Photos
Location Name: SHARON /11-21HZ
Location ID: 448107

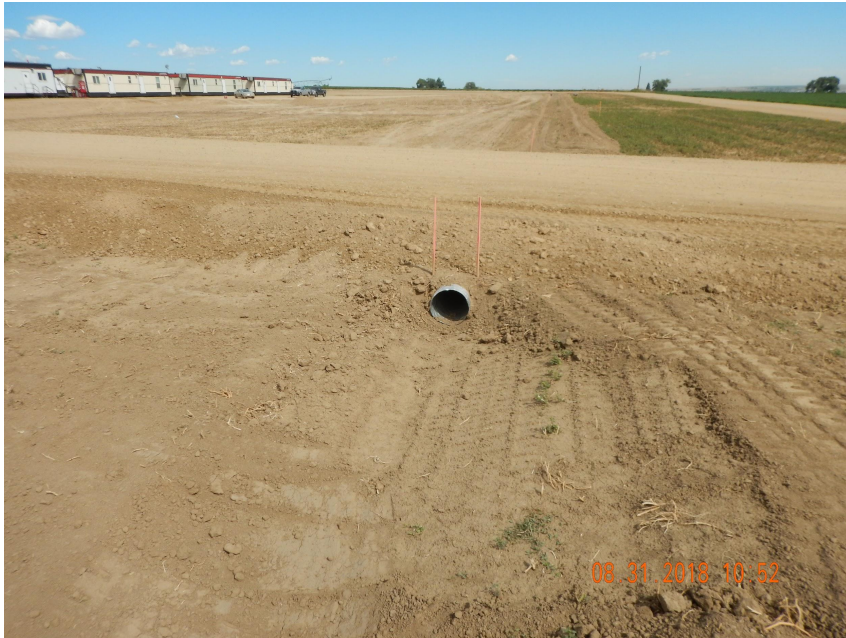
Photo 1. Photo taken from the entrance of the well location, facing North. Vehicle tracking pad was observed at the intersection of CR42. Ditch and berm BMP has been installed around the entire perimeter of the location in conjunction with other BMPs.

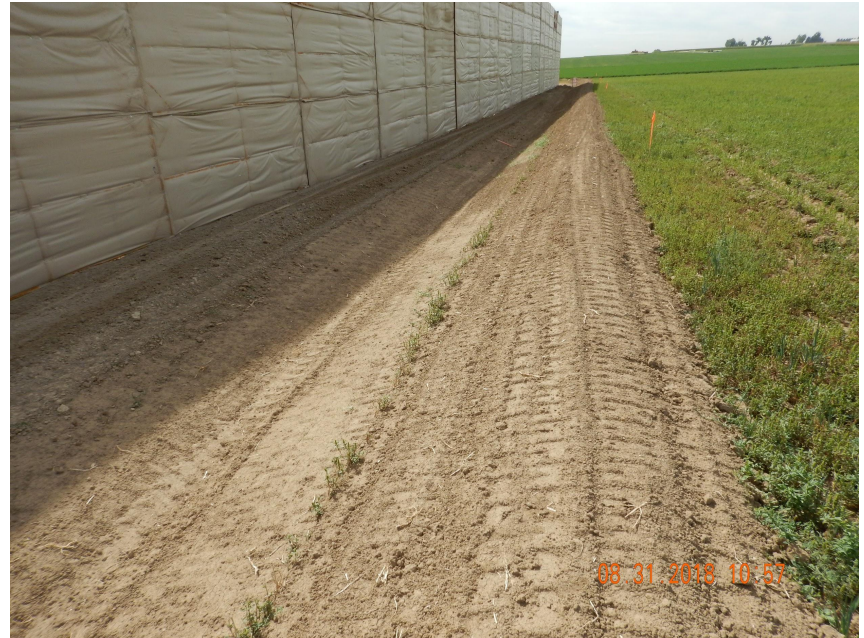
Photo 2. Photo taken from the northwestern location, facing South. See comments under Photo 1.

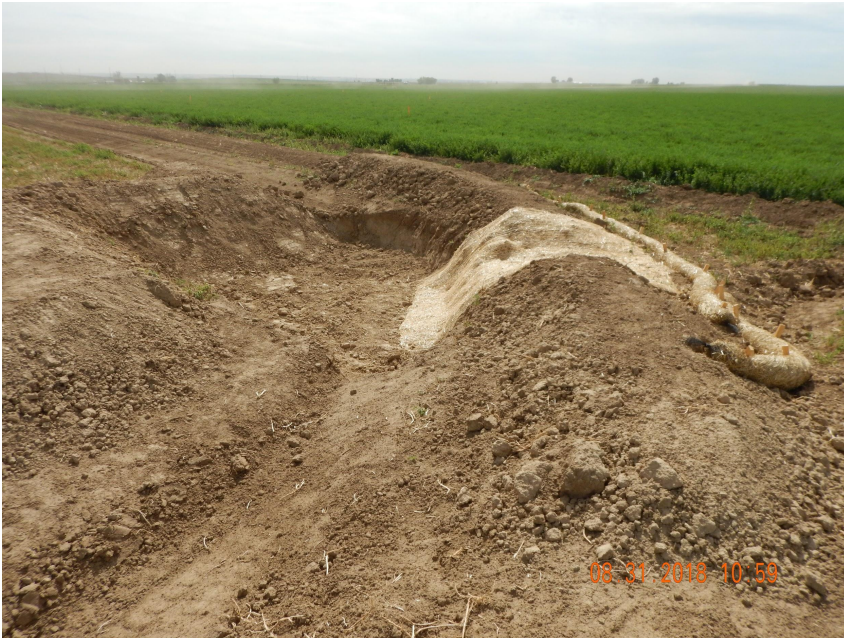
Photo 3. Photo taken from the southwest sediment trap, facing South. Sediment trap has been installed with an outlet protection device but no inlet protection.

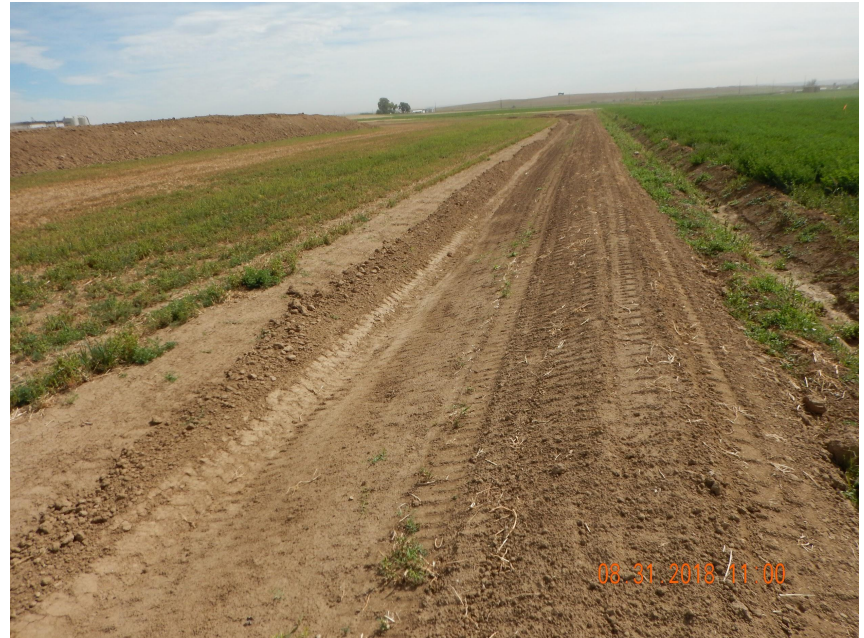
Photo 4. Photo taken from the southwestern location, facing East. See comments under Photo 1.

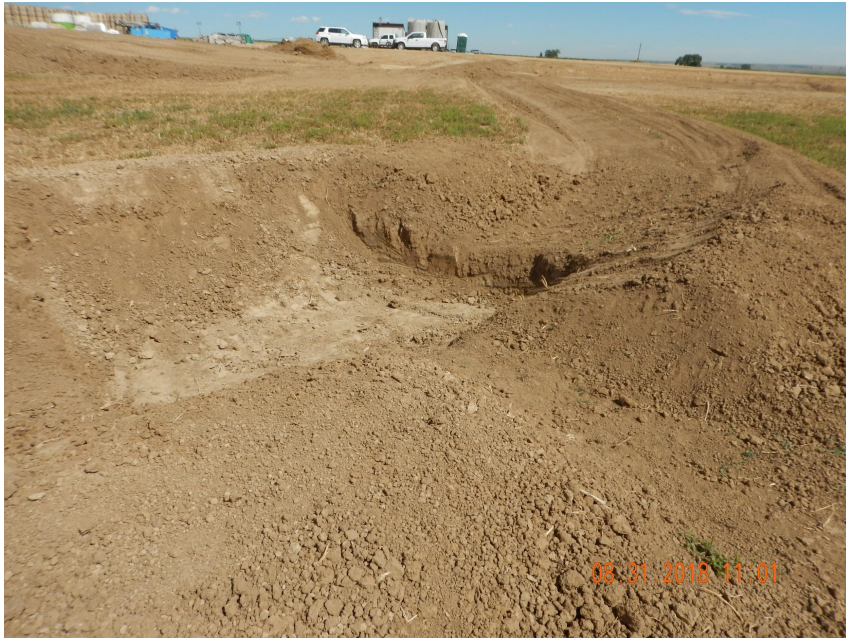
Photo 5. Photo taken from the southern sediment trap, facing North. Appears this was designed to be a sediment trap because of the outfall, but has not been completed.

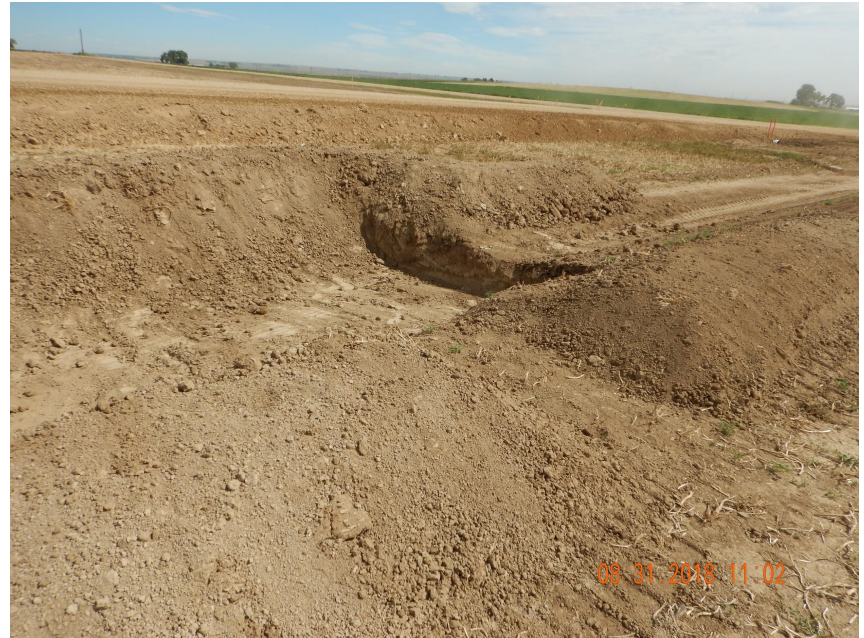
Photo 6. Photo taken from the southeastern sediment trap, facing East. See comments under Photo 5.

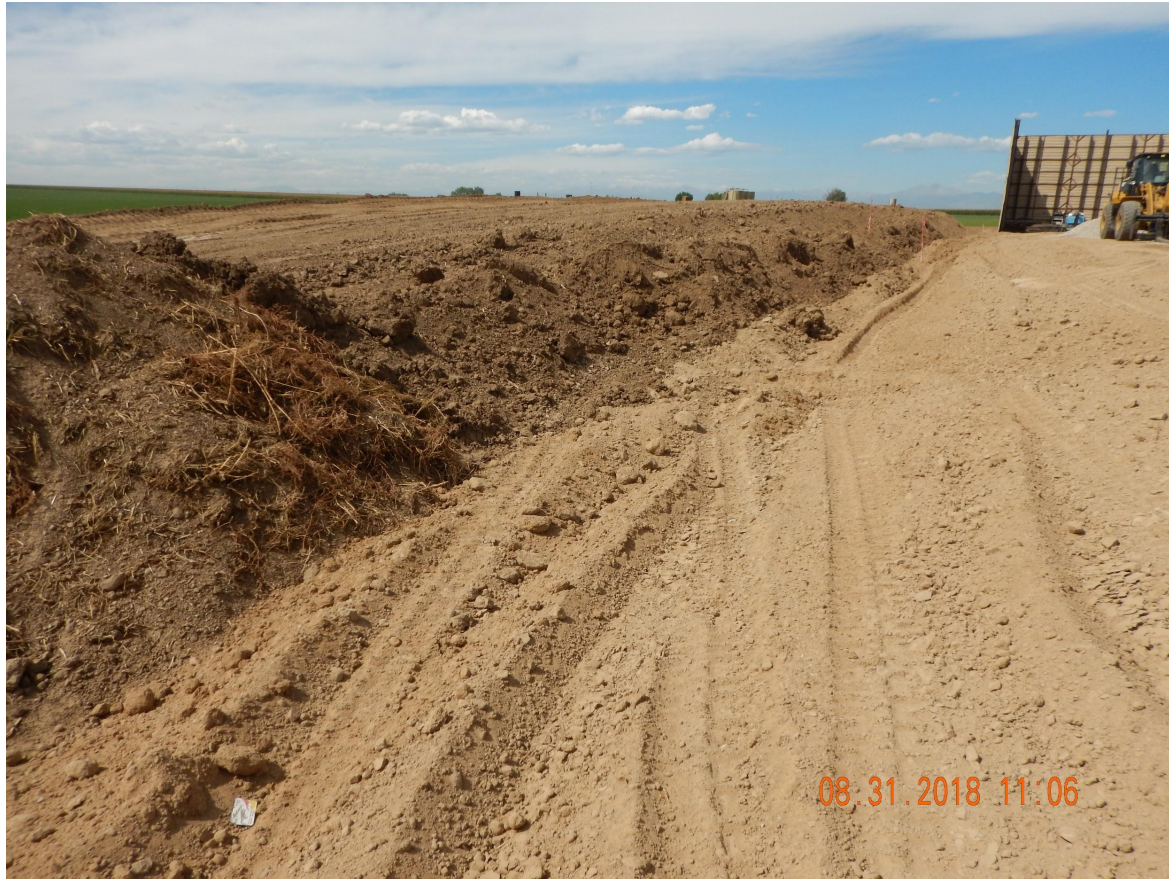
Photo 7. Photo taken from the eastern topsoil stockpile, facing West. Topsoil has been salvaged and stored along the southern location. However, topsoil has not been stabilized and drilling operations are underway.
