Inspection Photos

Location Name: Pond G Centralized E&P Waste Management Facility

Facility ID: #437578 Pit ID: #414402

Inspection Date: August 29, 2018

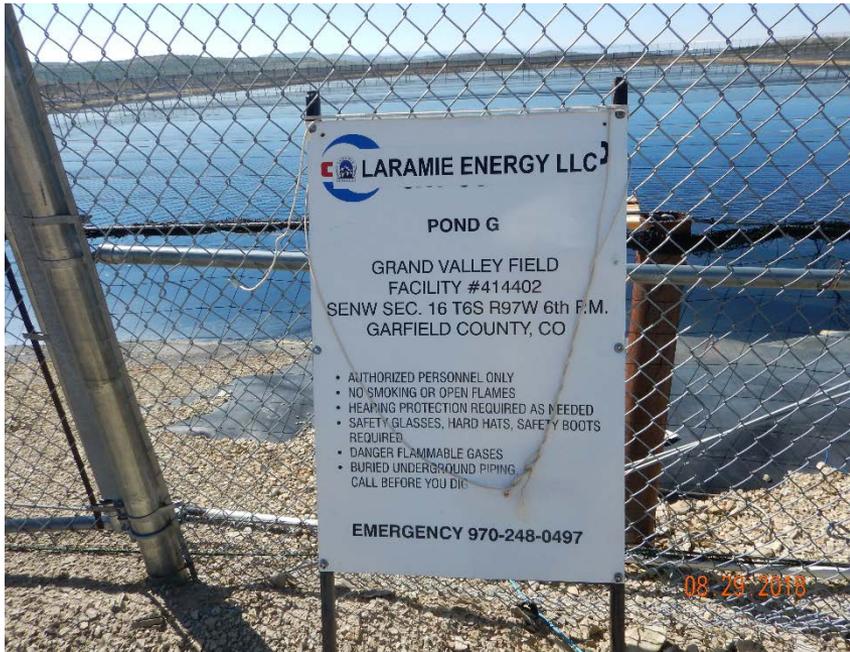
Photo #1 – Pit facility sign located on north side of pit.

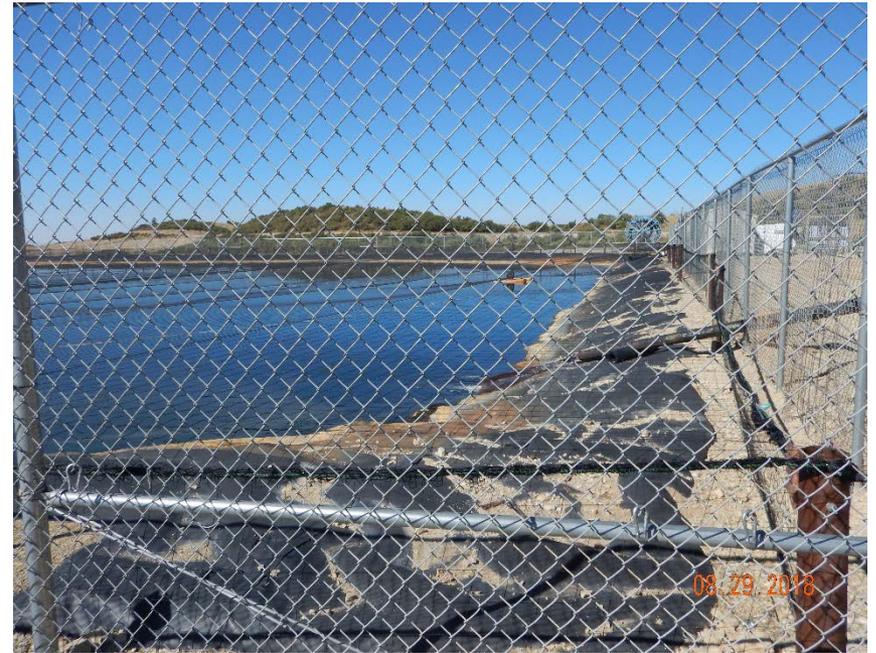
Photo #2 – View of pit from NE corner. Note foreign debris (angular rocks) on top of pit liner.

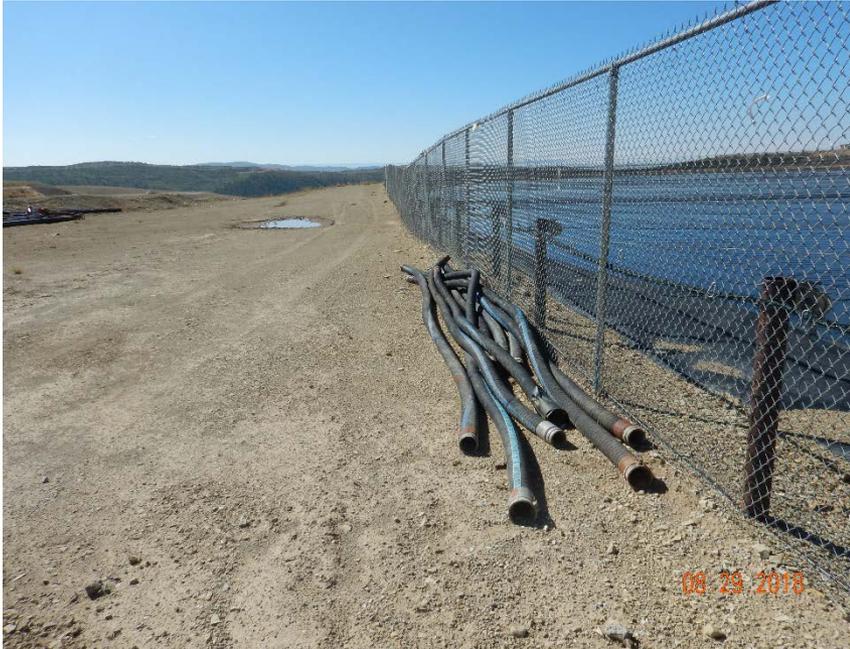
Photo #3 – Hoses stored on east side of pit, looking south.

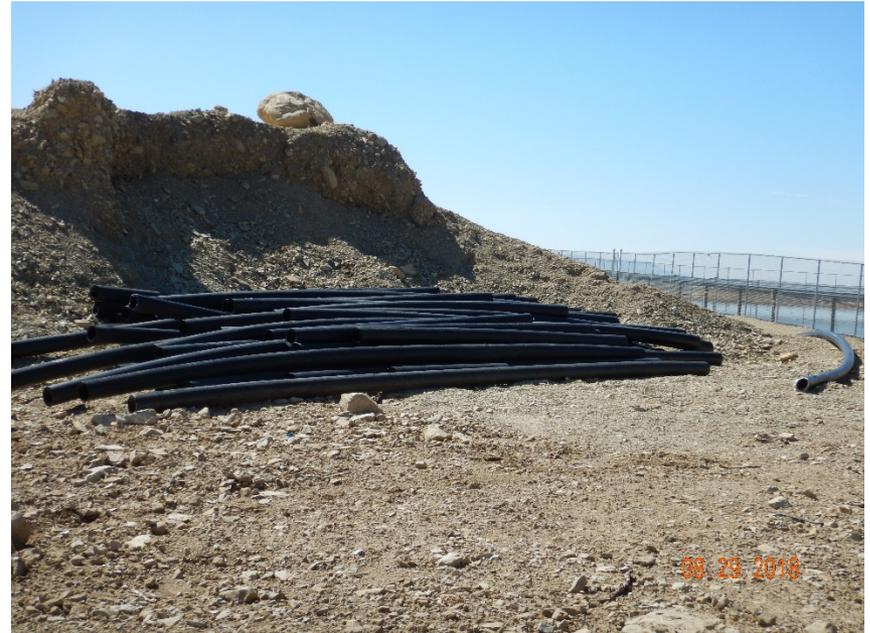
Photo #4 – Additional equipment storage east of pit.

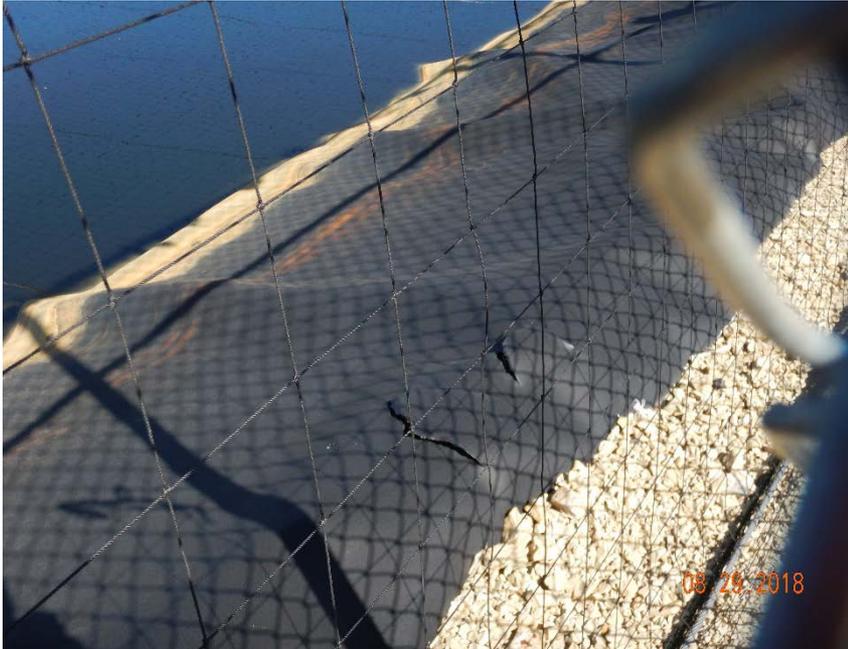
Photo #5 – Holes observed in east pit berm liner (near anchor trench).

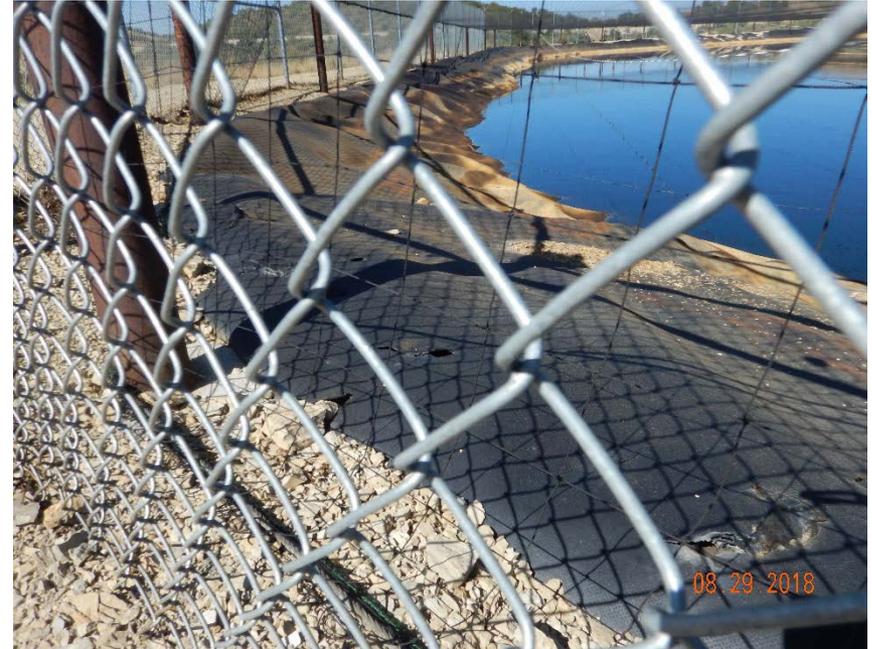
Photo #6 – Holes observed in SE corner of pit liner. Note absence of freeboard monitoring method around perimeter of pit.

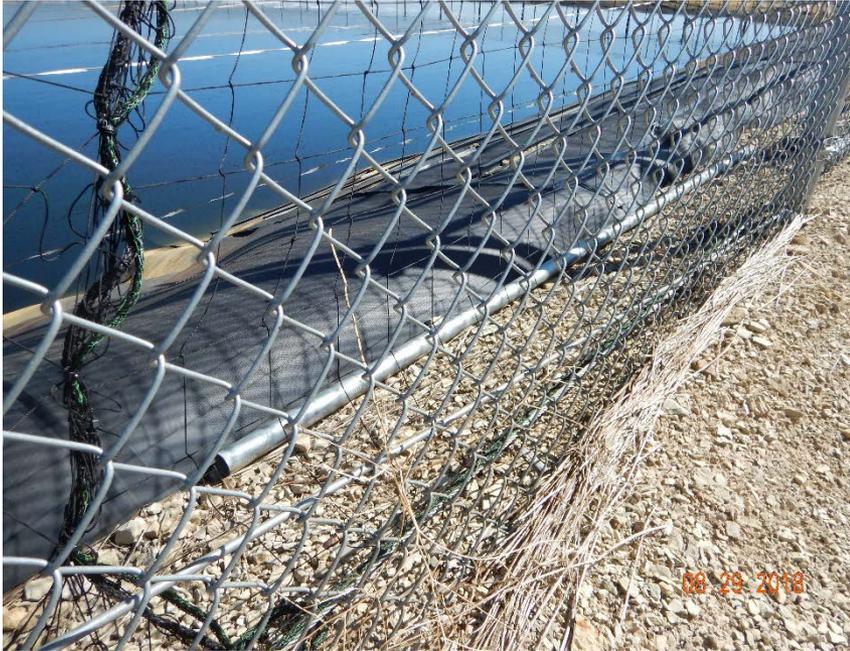
Photo #7 – Metal pipe observed inside of netting on south side of pit.

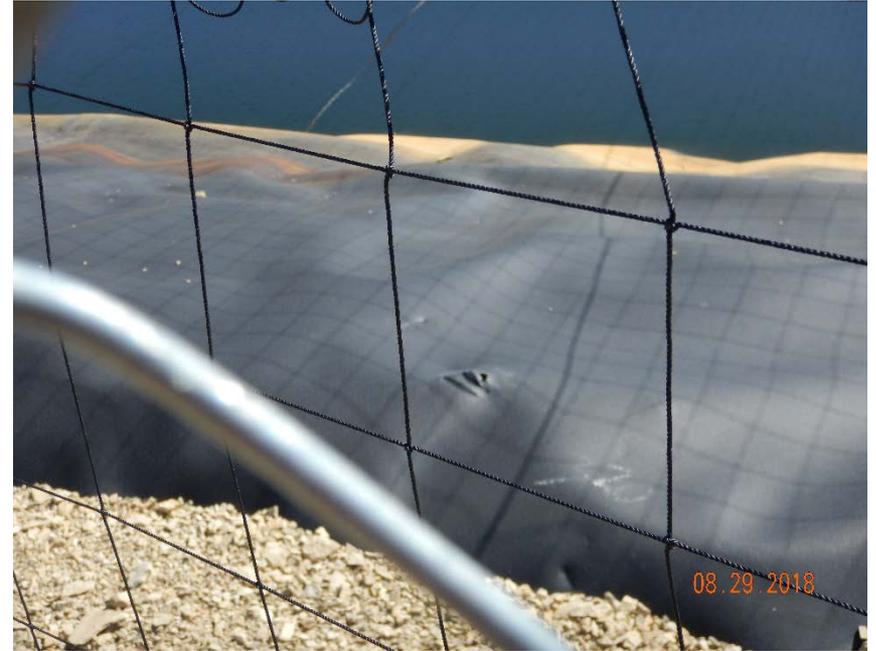
Photo #8 – Hole in liner observed on west pit berm.

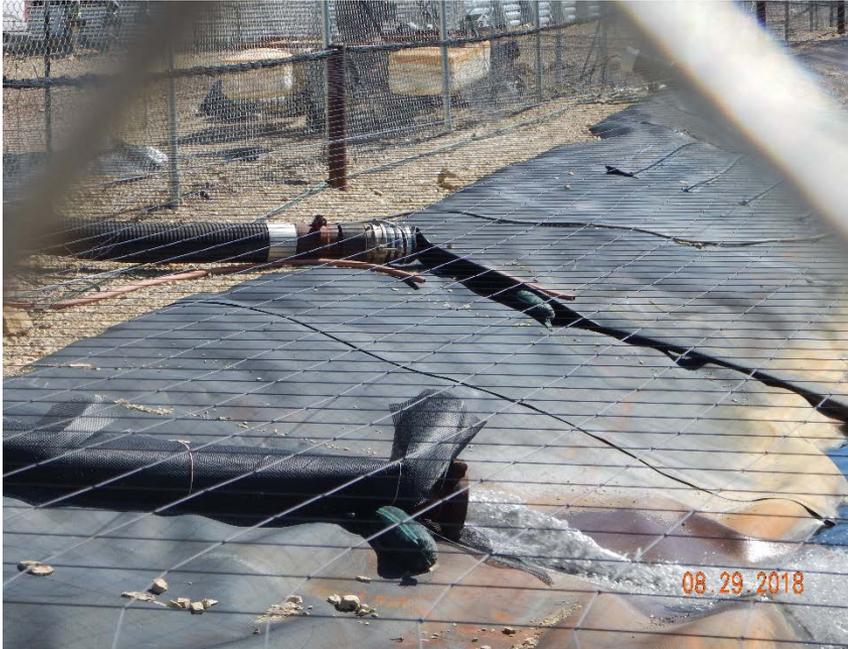
Photo #9 – Hoses with camlocks in direct contact with pit liner at NW corner of pit.

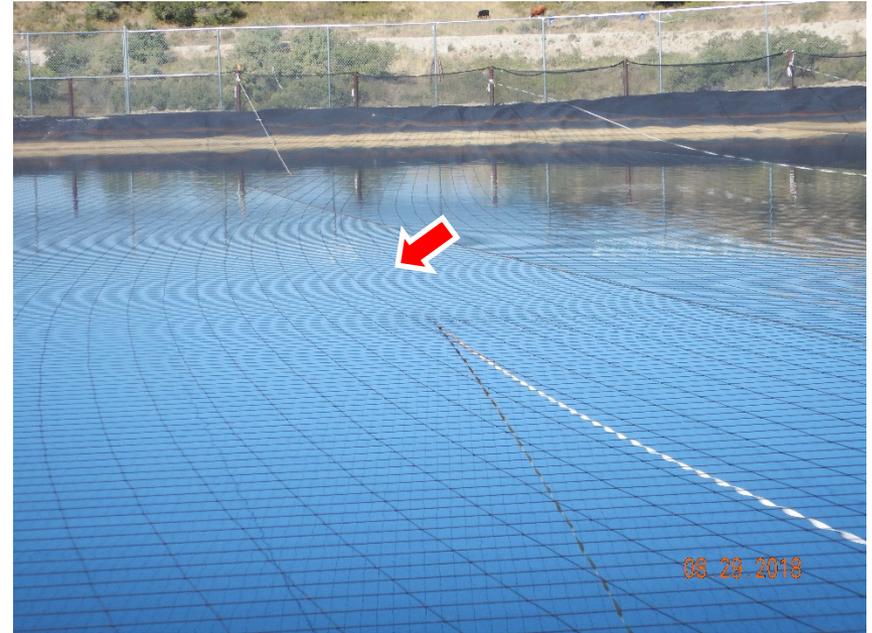
Photo #10 – White, ratcheted straps have enough slack to dip into pit fluids (red arrow), view from east side of pit.

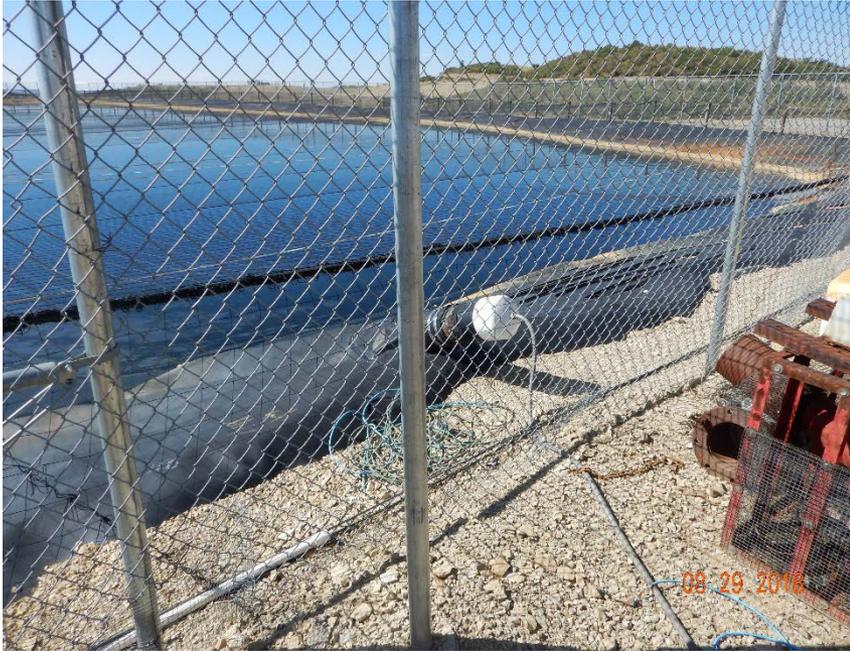
Photo #11 – Leak detection system on north side of pit.

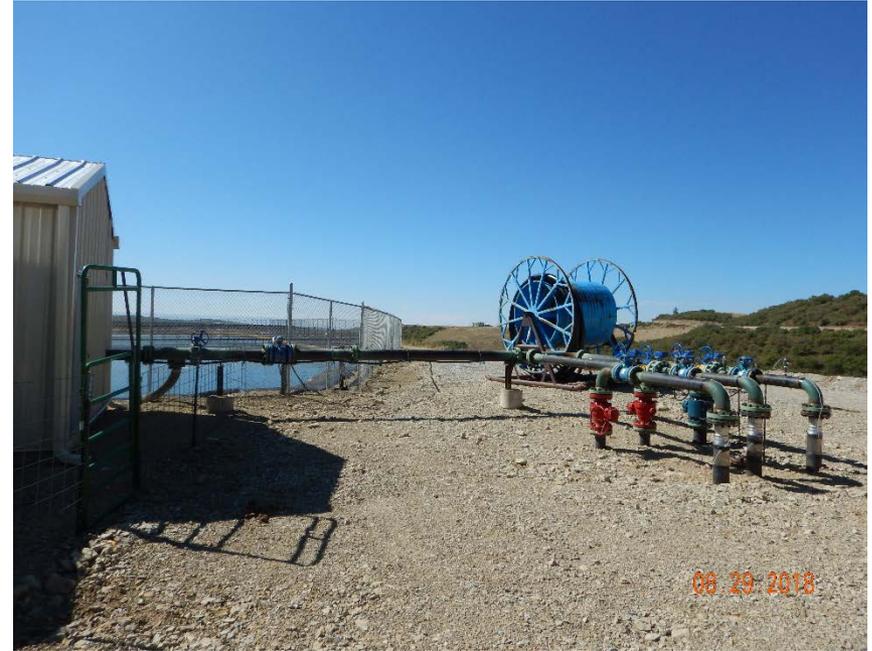
Photo #12 – Pipeline manifold and unused HDPE surface pipe spool observed at NW corner of pit.

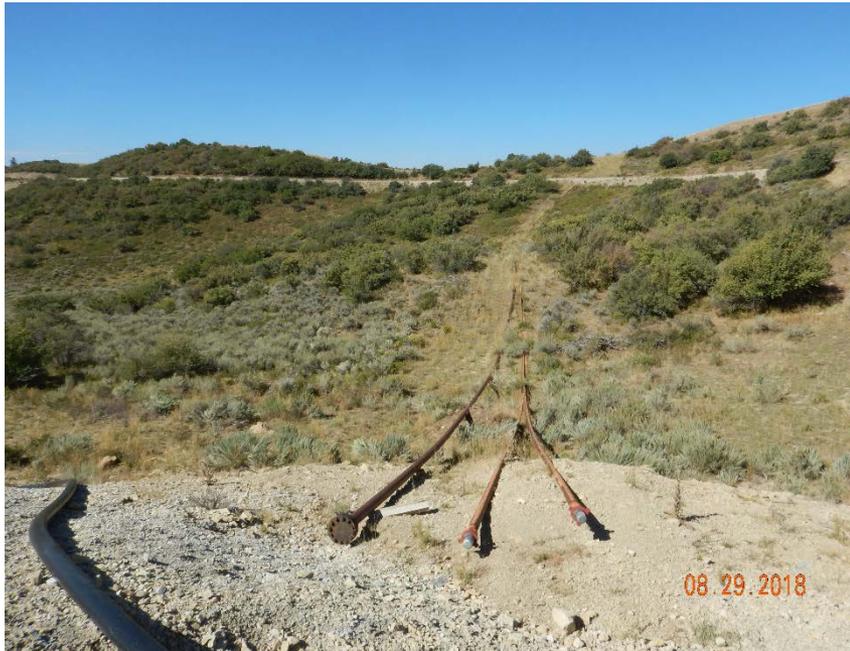
Photo #13 – Capped and plugged off-location surface pipelines leading into location from NW corner, looking west. Note black HDPE surface pipeline in bottom left corner of photo is disconnected.

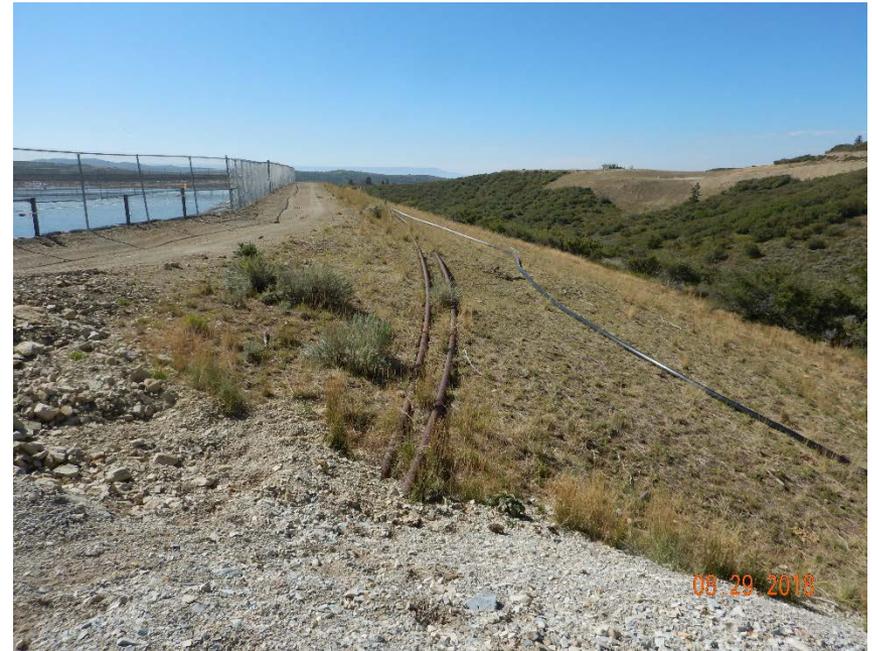
Photo #14 – Steel off-location surface pipelines lead from NW corner of pit toward production facility SE of location (next photo). HDPE surface line was disconnected on date of inspection.

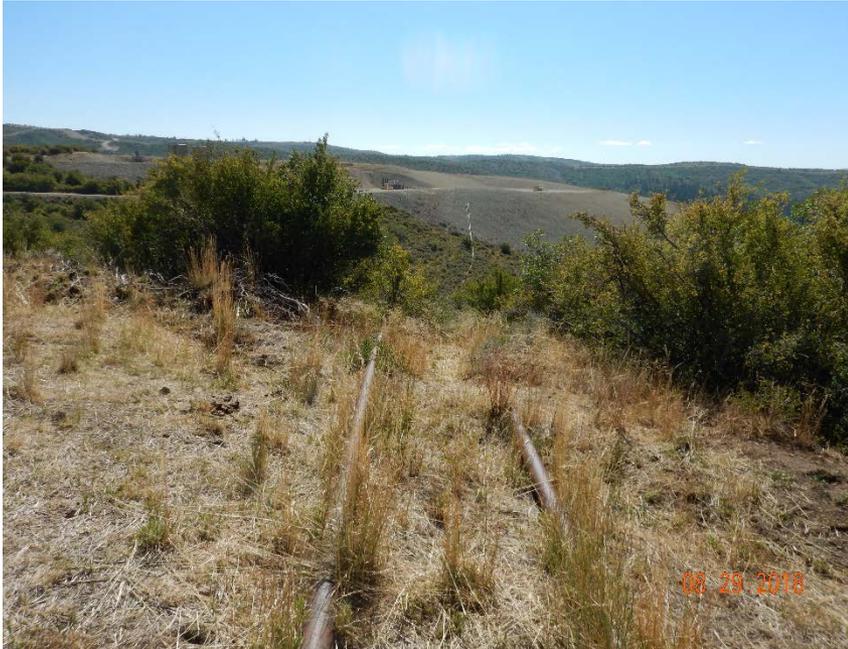
Photo #15 – Looking SE along steel off-location surface pipelines from previous photo.

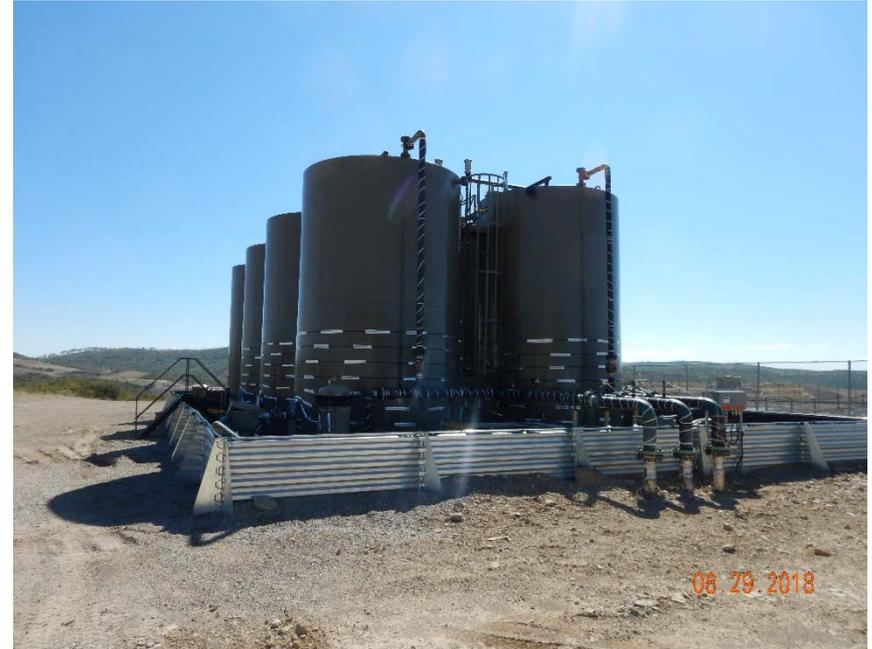
Photo #16 – Array of steel ASTs used as gun barrel separators, located at NE corner of pit.

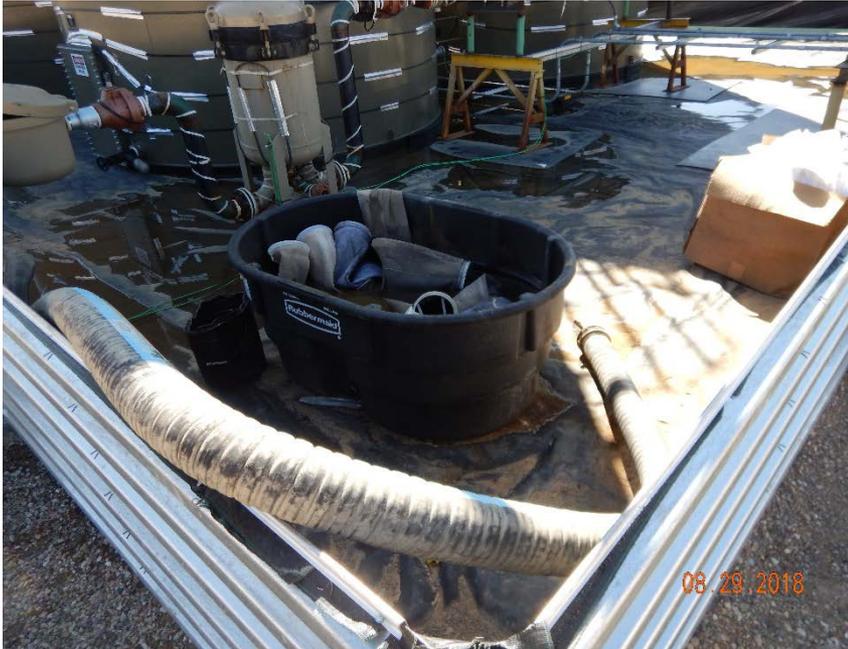
Photo #17 – Unused equipment (hose with camlock, metal bucket, and cardboard box) inside of NW corner of tank battery. Per operator, Rubbermaid tub contains filter socks to be used inside of battery.

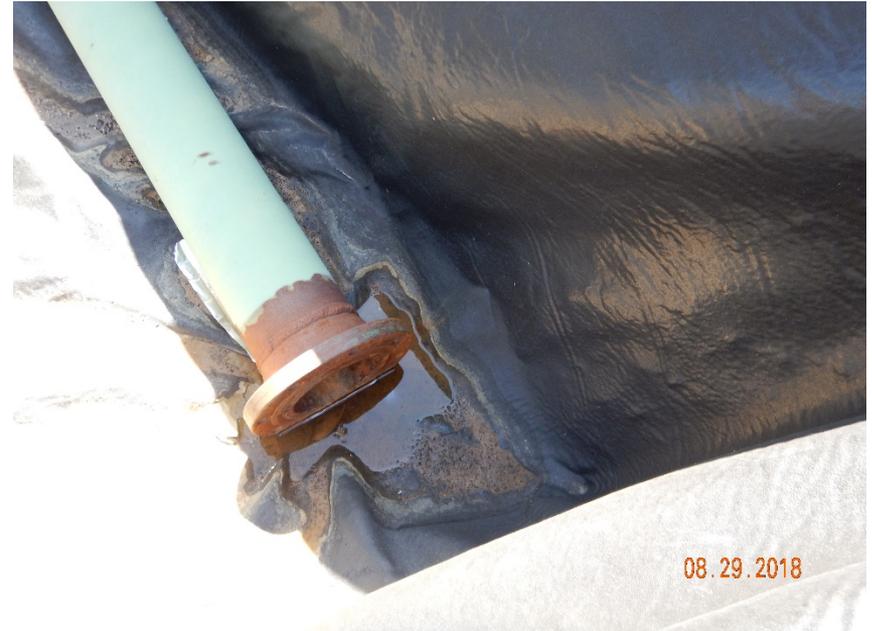
Photo #18 – Steel pipe stored on top of liner on south side of tank berm.

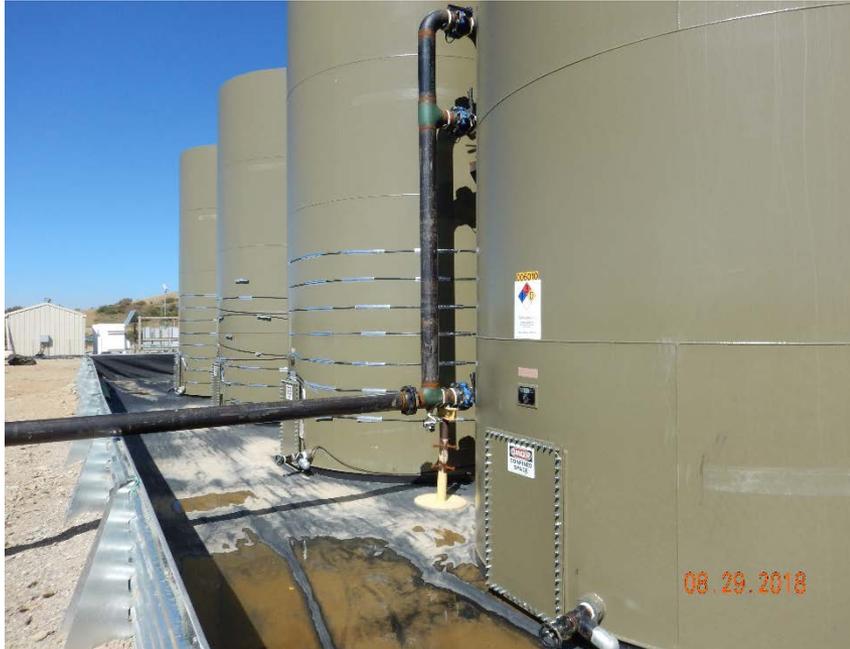
Photo #19 – View of gun barrel tank battery from SE corner. Note only two condensate tanks on east end of battery have labels and placards.

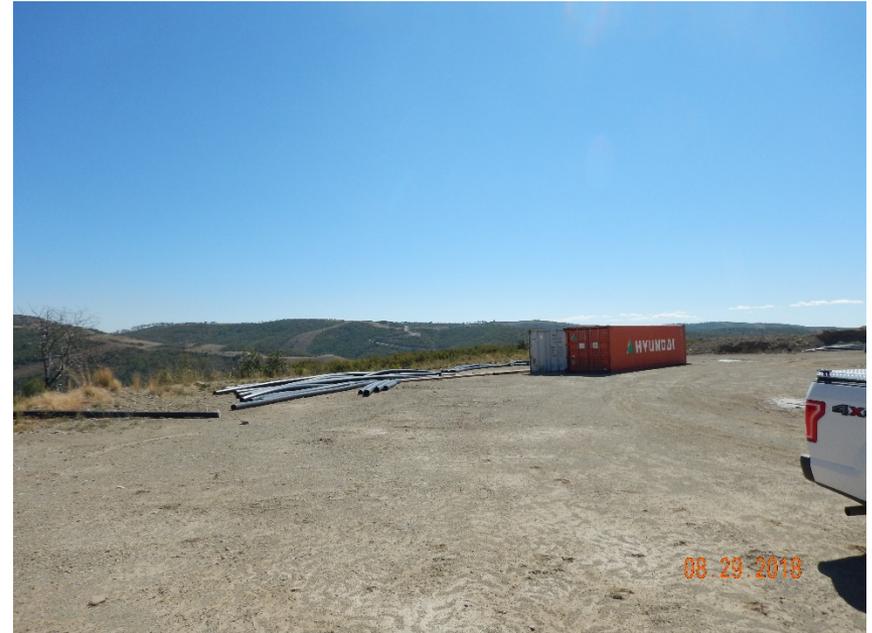
Photo #20 – Unused equipment stored northeast of pit.
