Inspection Photos

Operator: XTO Energy

API: 05-067-05187

Date: 8/21/2018

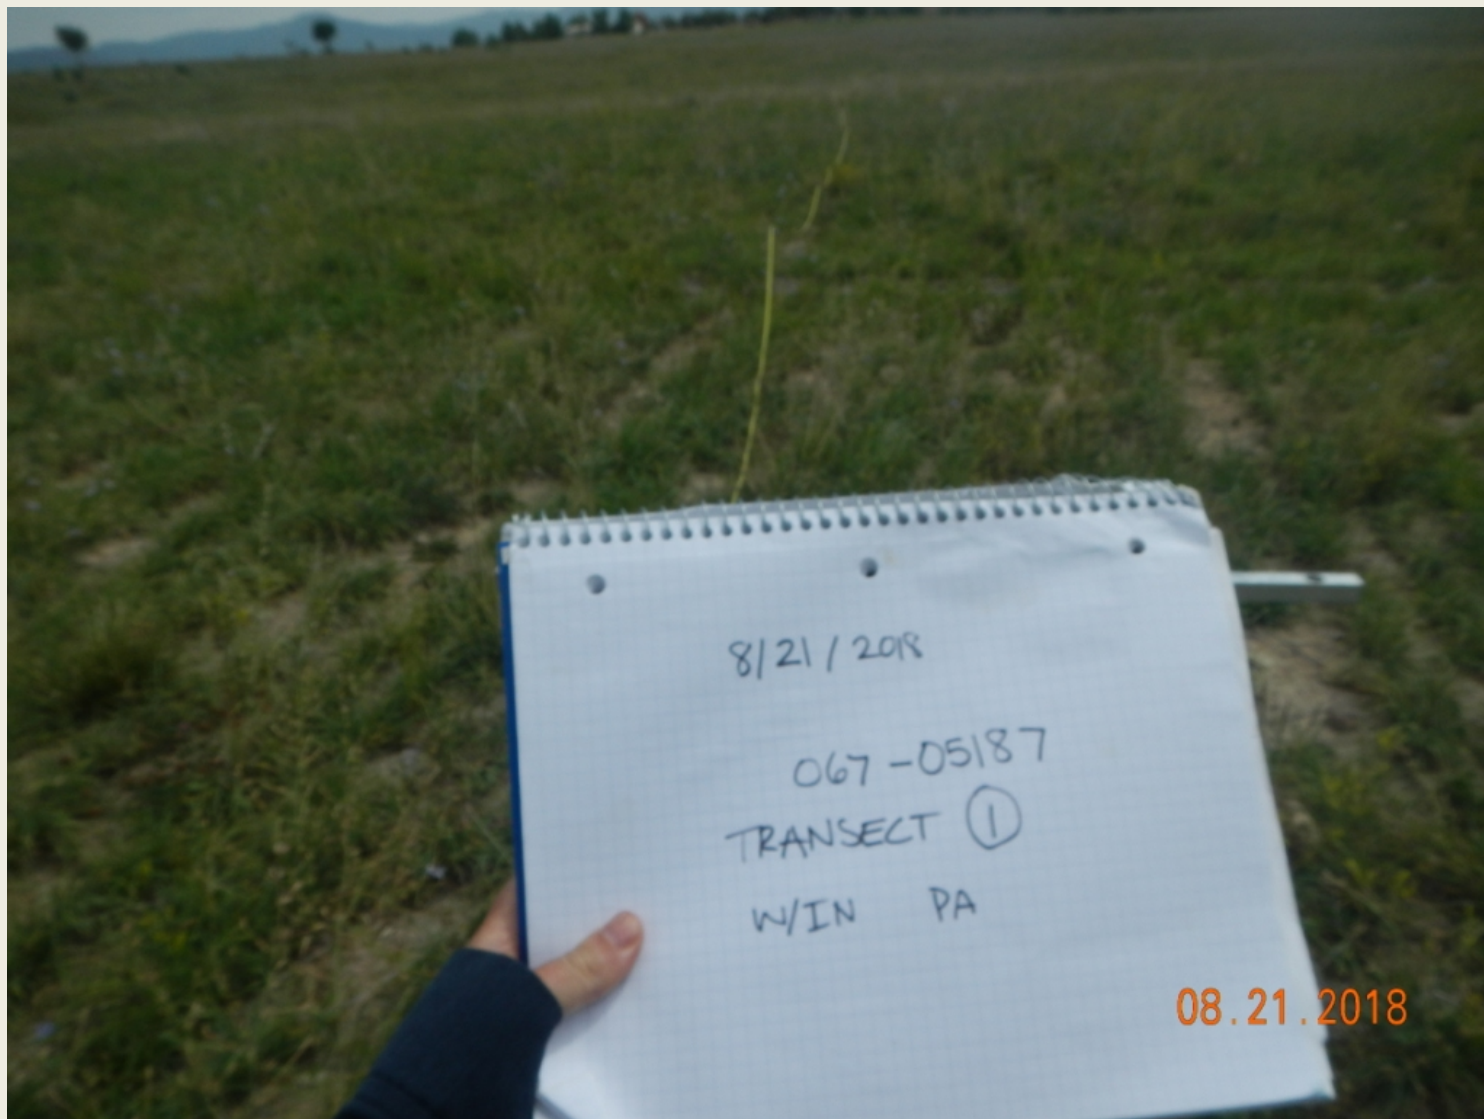
Photo 1. View of beginning of transect 1 facing eastward.

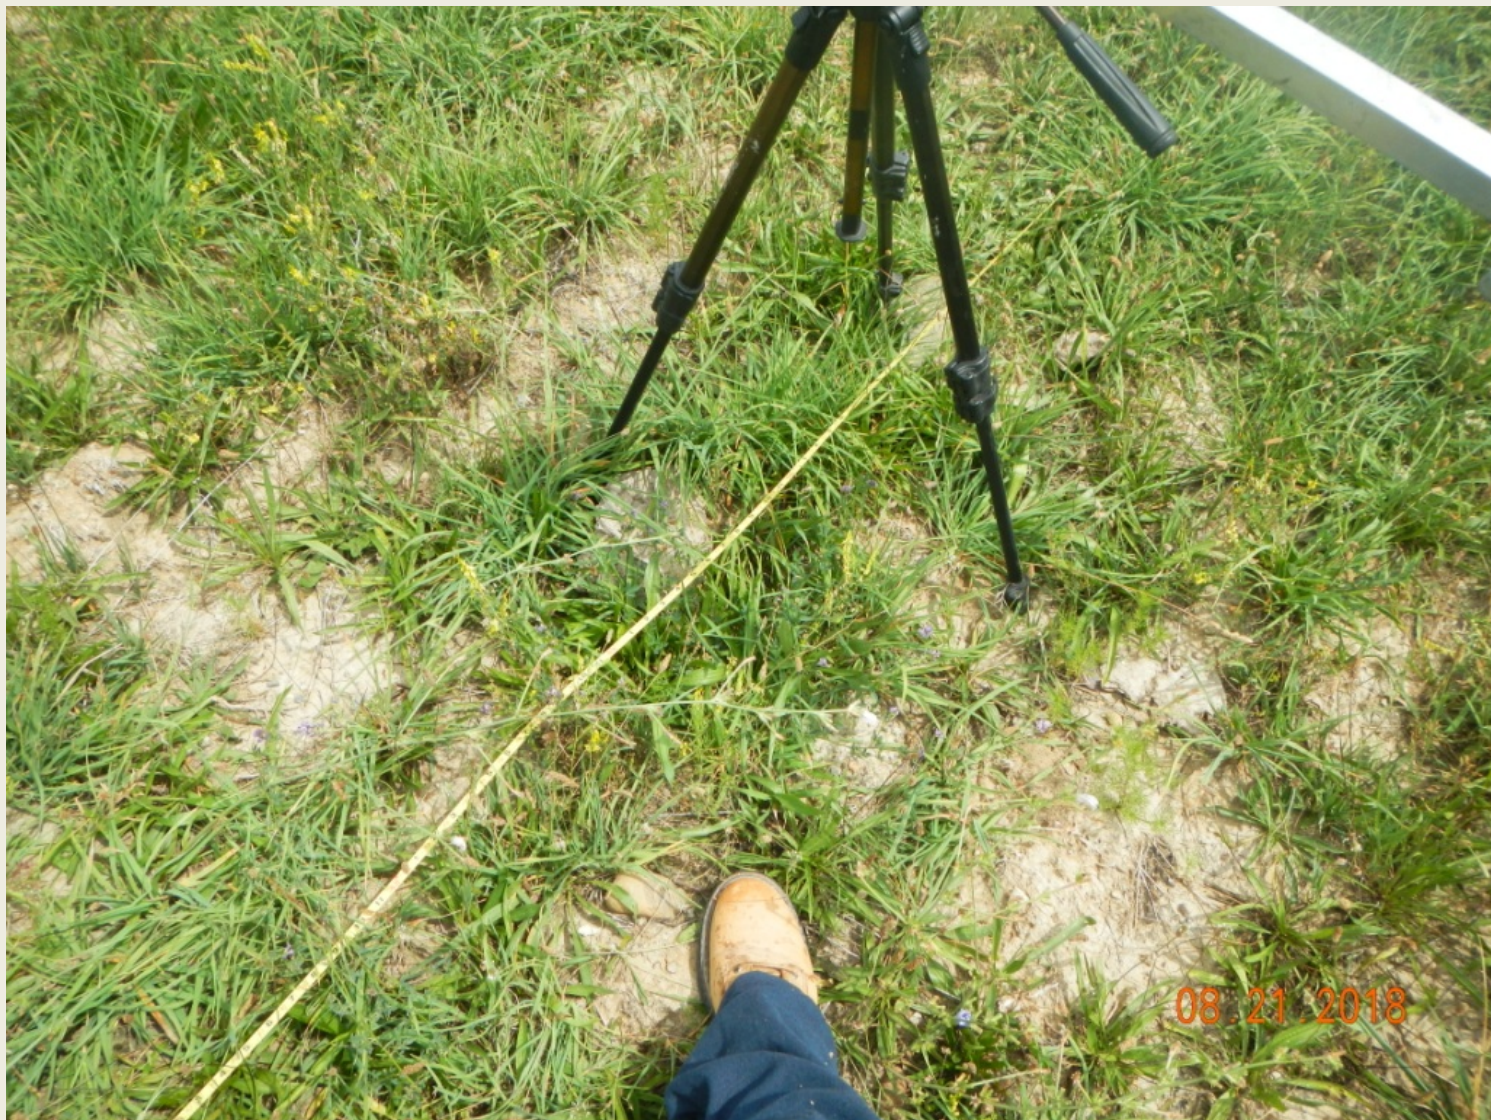
Photo 2. Birdseye view of vegetation at the midpoint of transect 1, within the project disturbance.

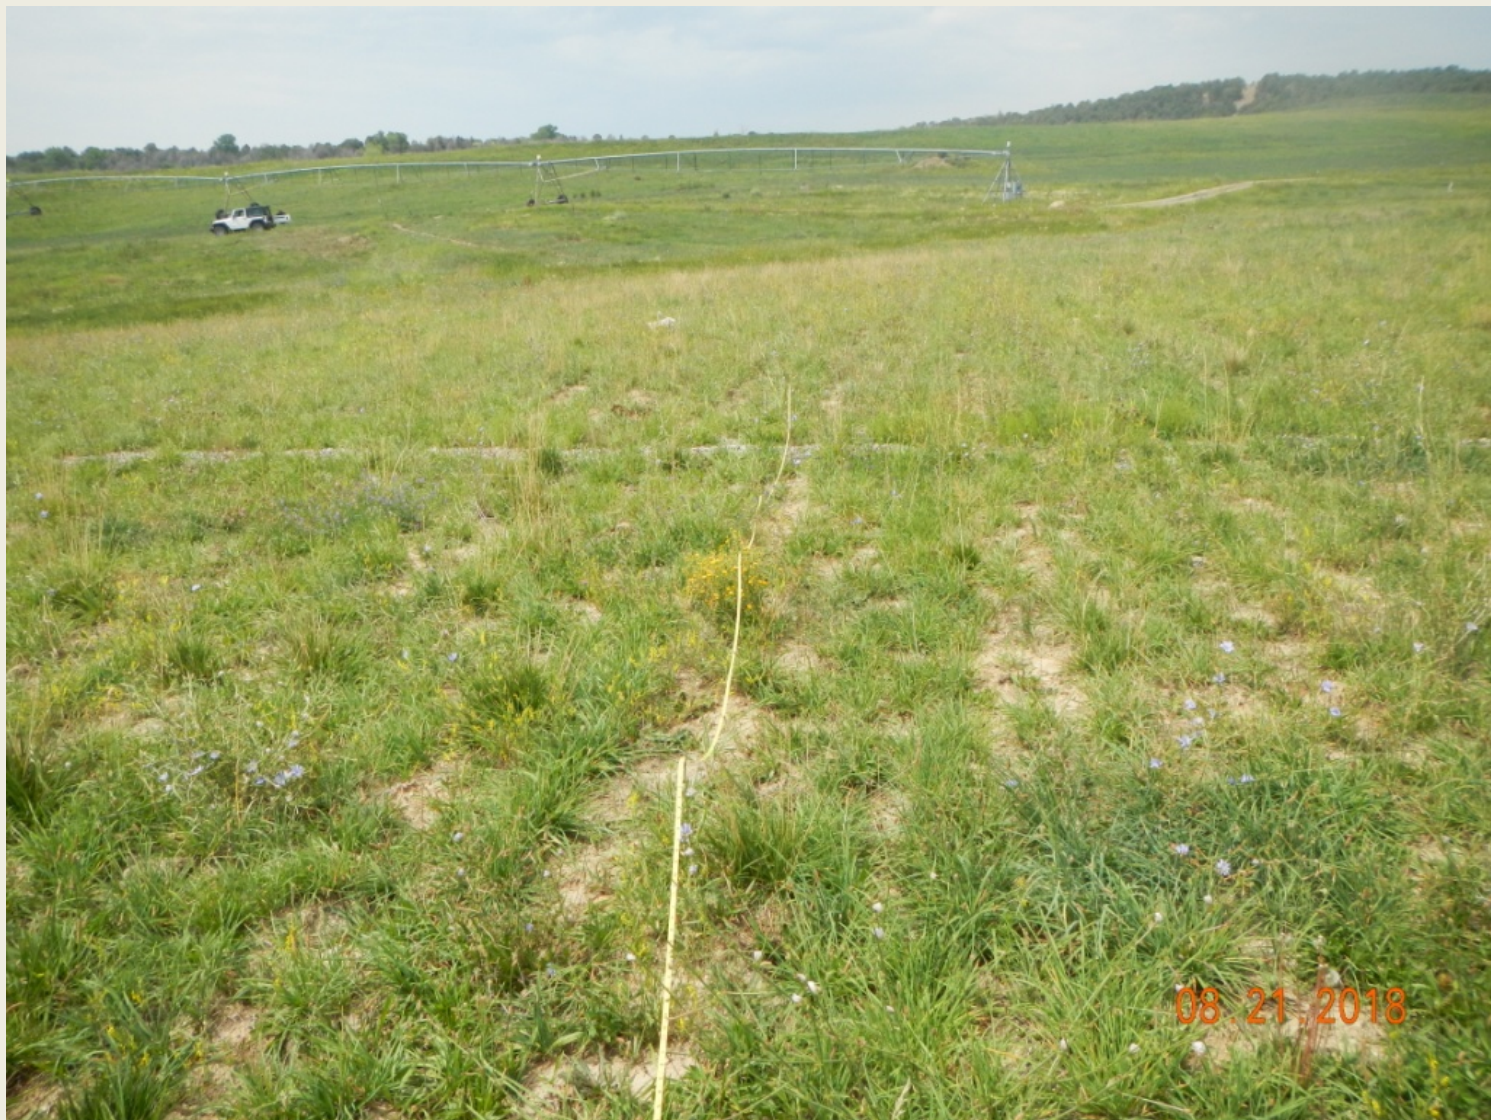
Photo 3. View of transect 1, within the project disturbance facing westward from the end of the transect.

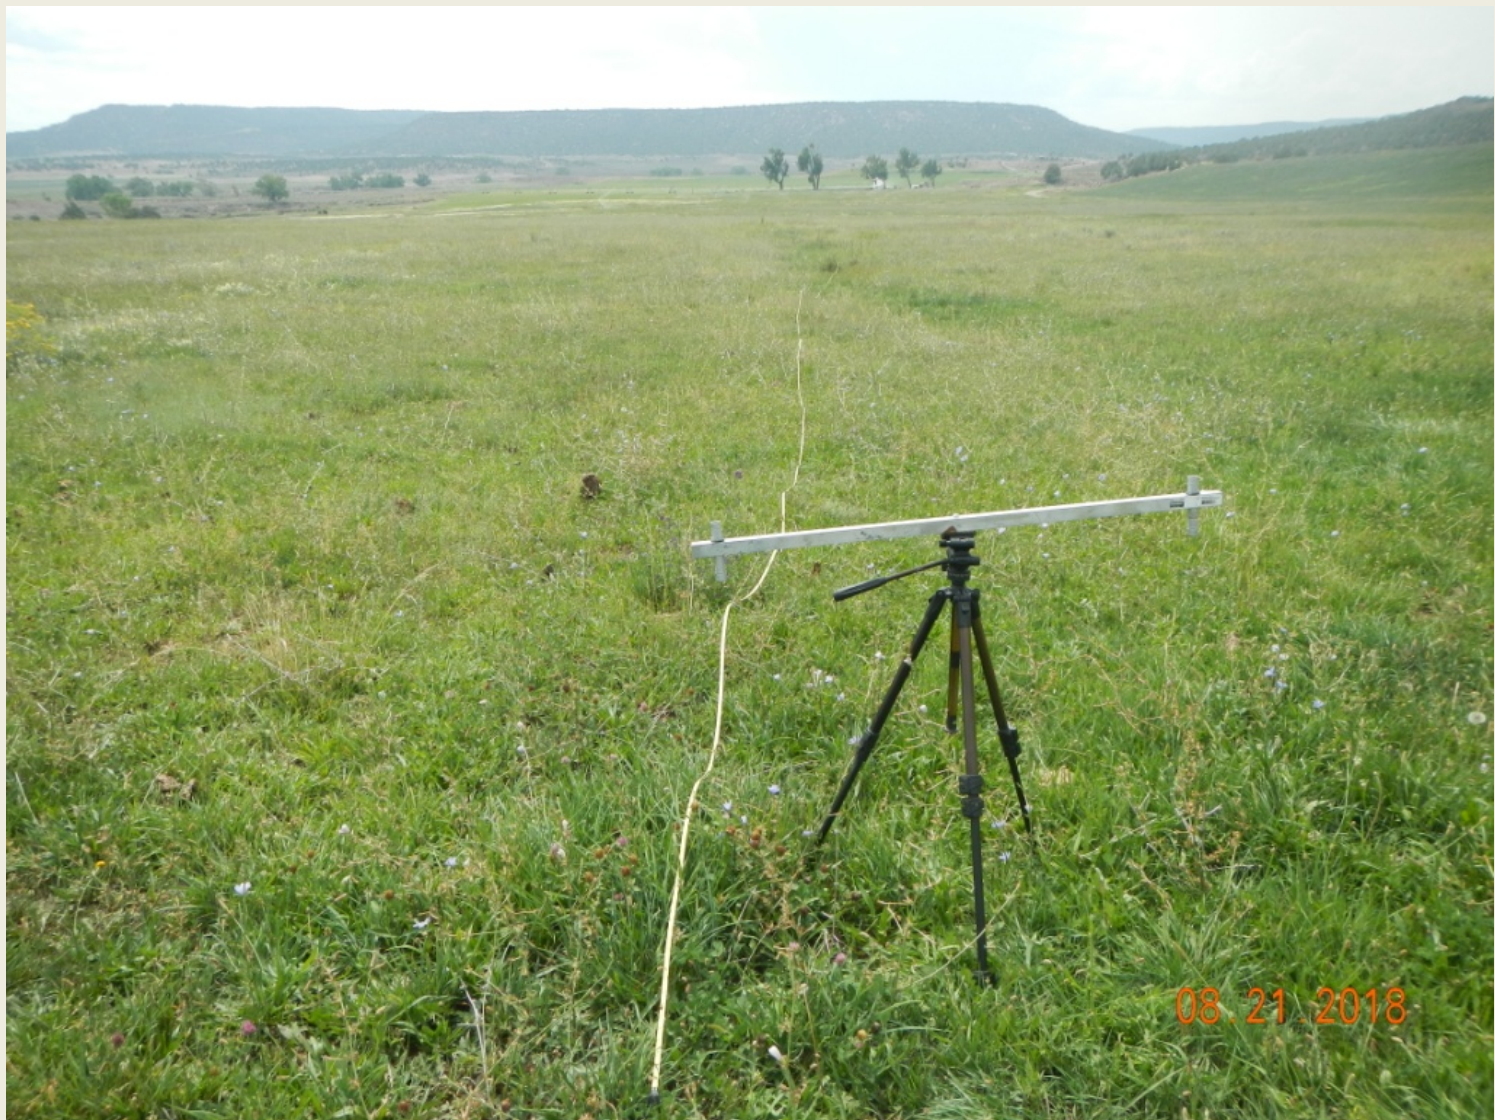
Photo 5. View of the beginning of transect 2, reference area, facing southward.

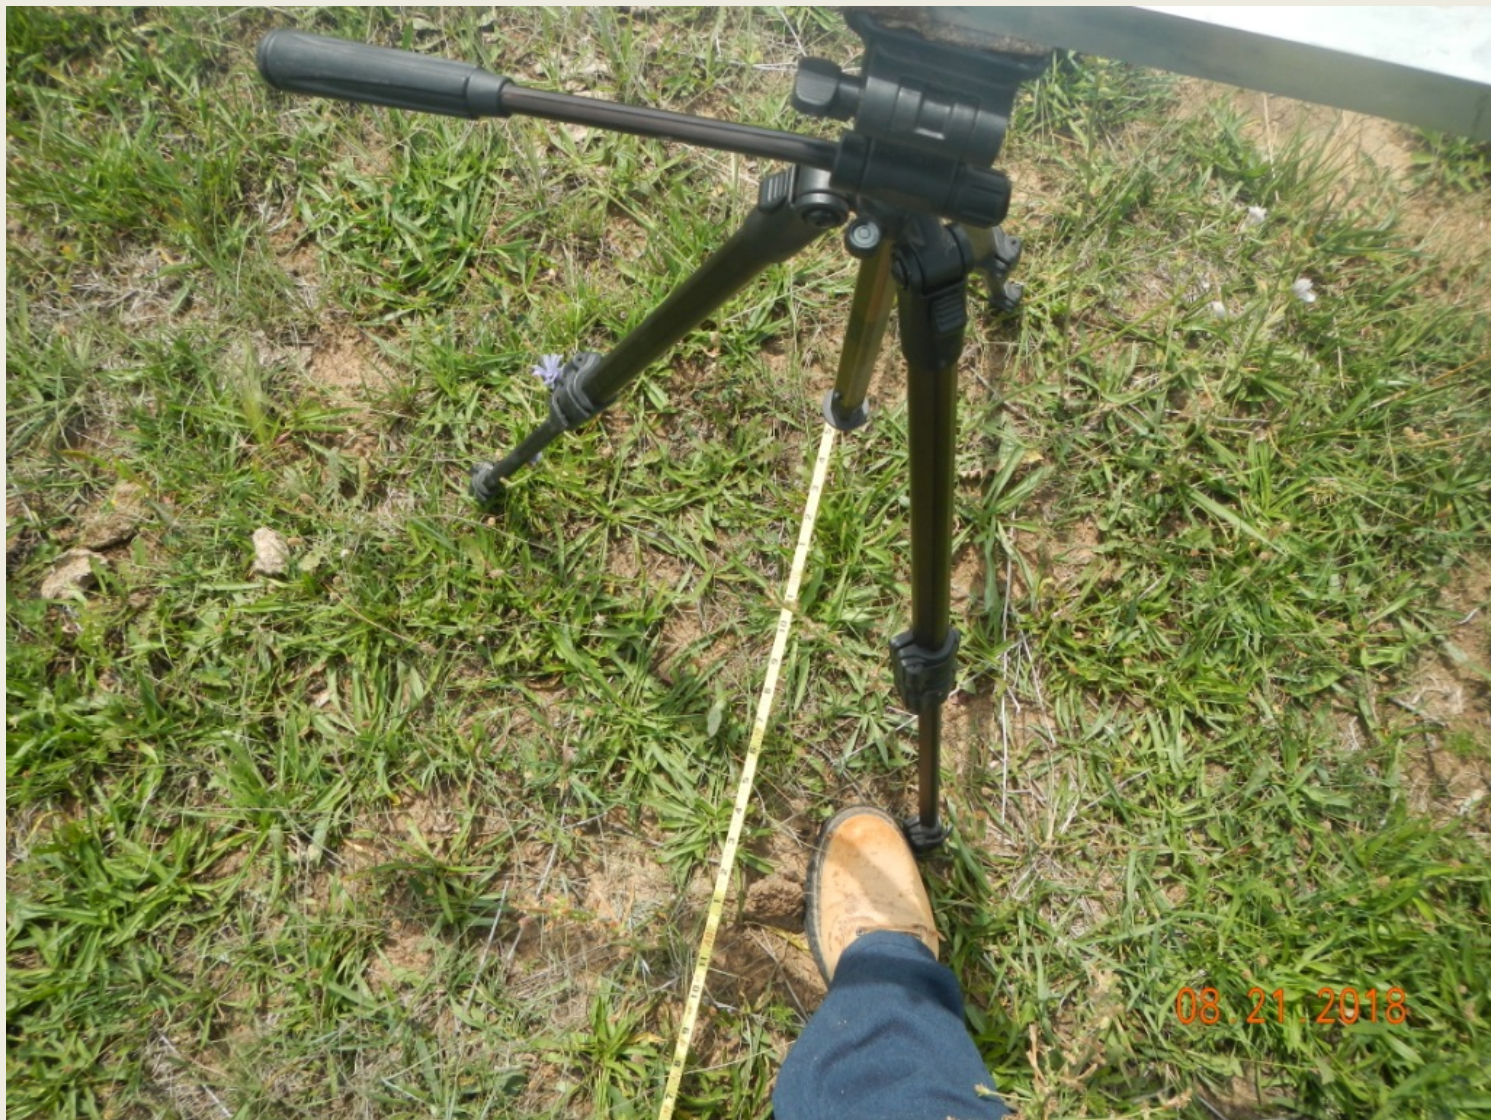
Photo 6. Birdseye view of vegetation at the midpoint of transect 2, within the reference area.
