Inspection Photos

Location Name: Cache - 66N63W / 8SWSE

Location #: 306312

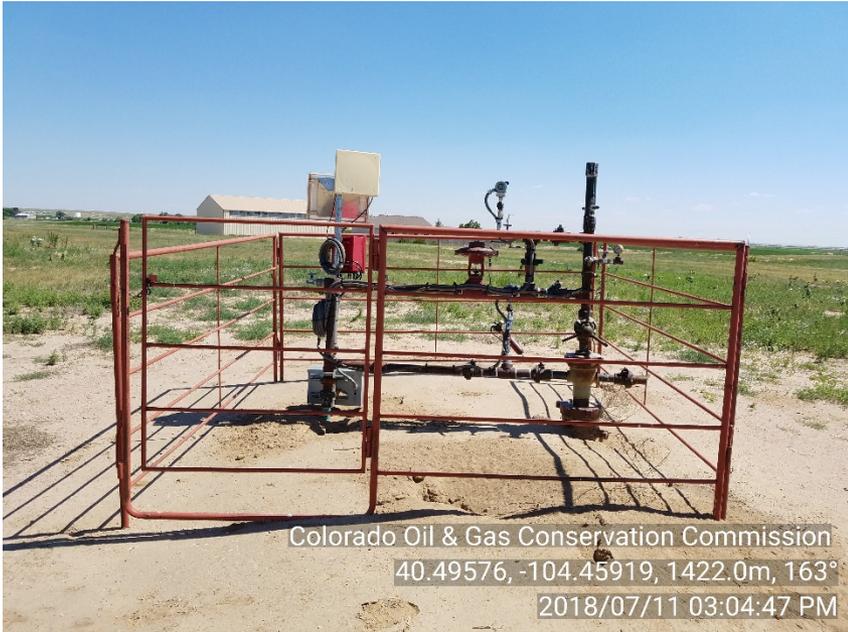
Photo #1

Cache 8-34 (API 05-123-24412) wellhead.

No sign or emergency contact information

From previous FIR

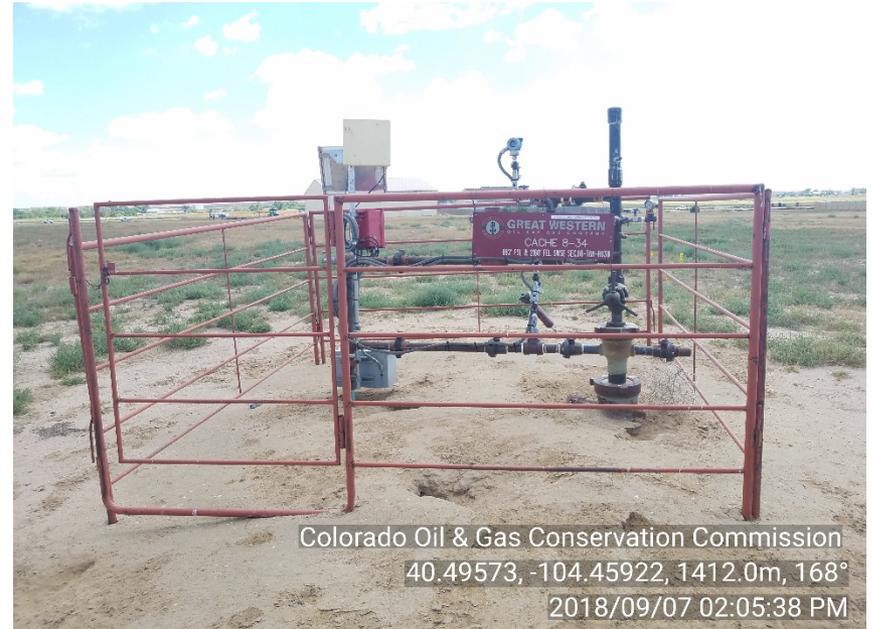
Photo #2

Cache 8-34 wellhead.

Sign & Emergency contact number now posted

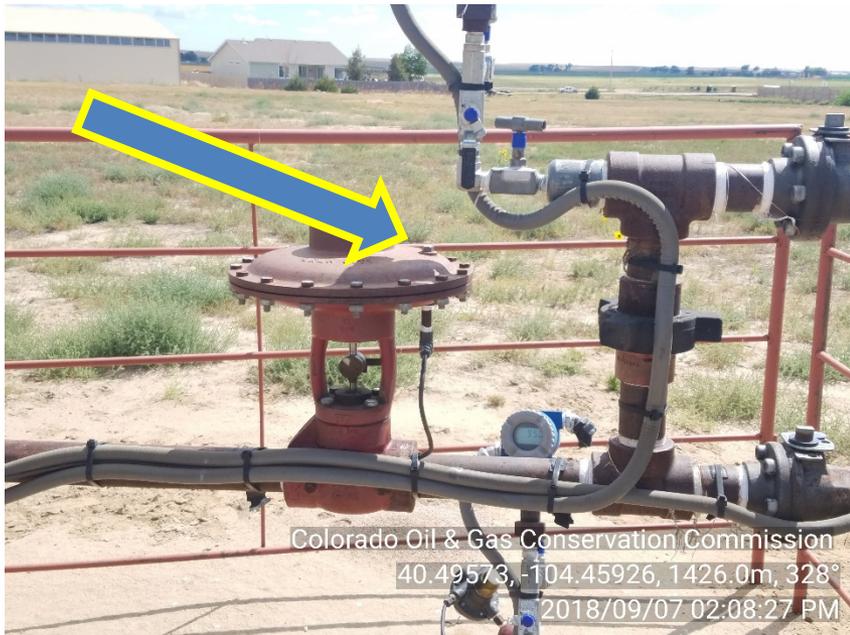
Photo #3

Cache 8-34 wellhead.

Observed motor valve hissing & venting gas
Crew on site repaired valve. Venting ceased.

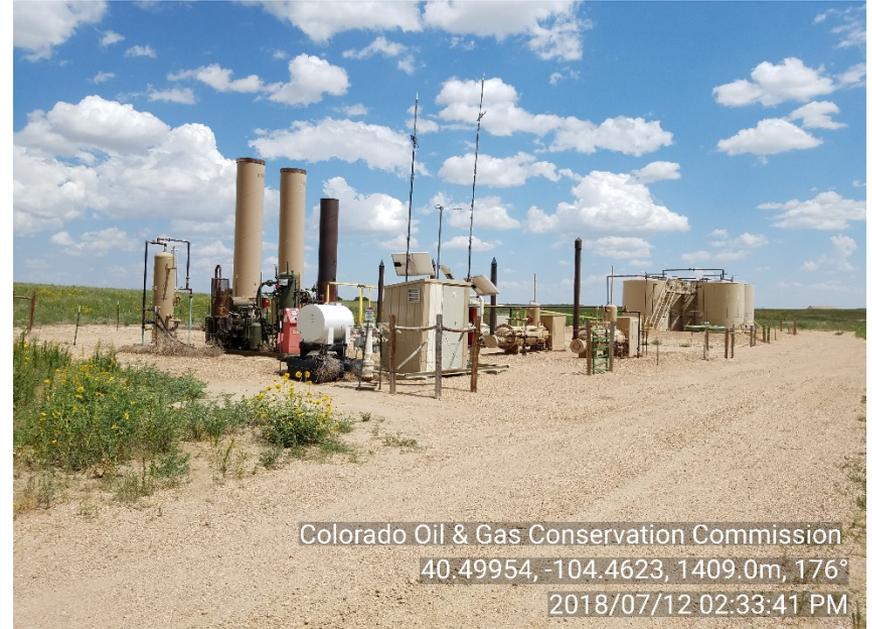
Photo #4

Cache 8-34, 8-13, 8-23, 8-24, 8-33,

Cornish 8-53 Battery

From previous FIR

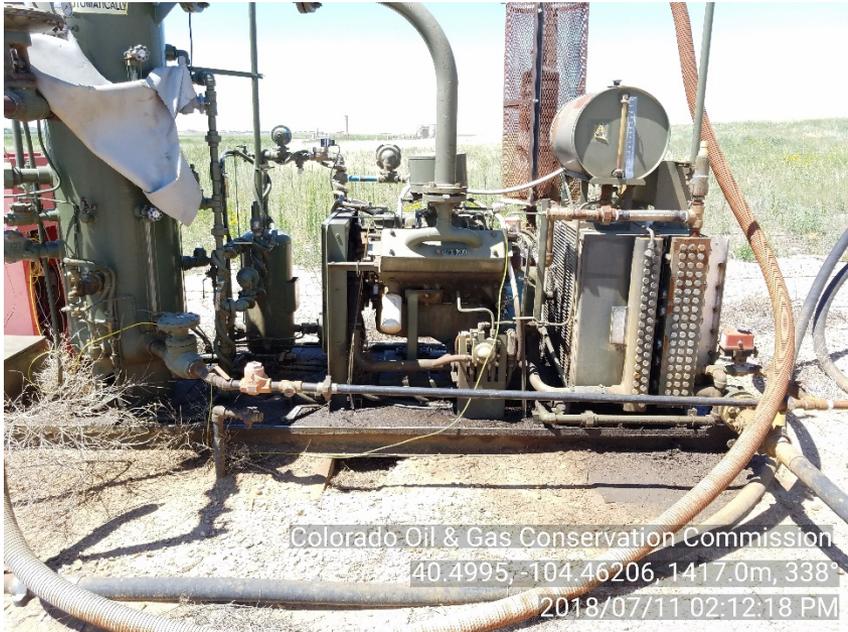
Photo #5

Compressor

Stained soil

From previous FIR

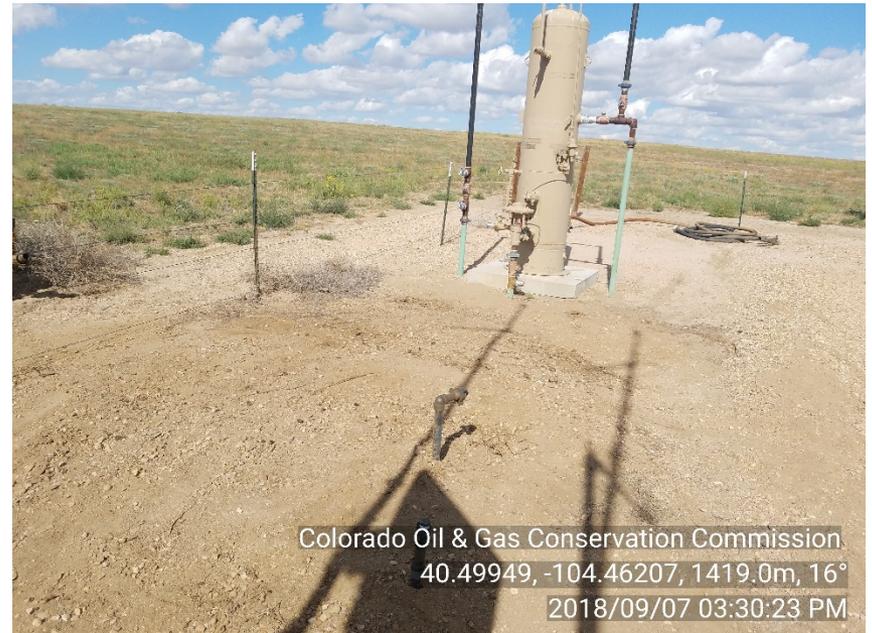
Photo #6

Compressor removed

Stained soil appears remediated

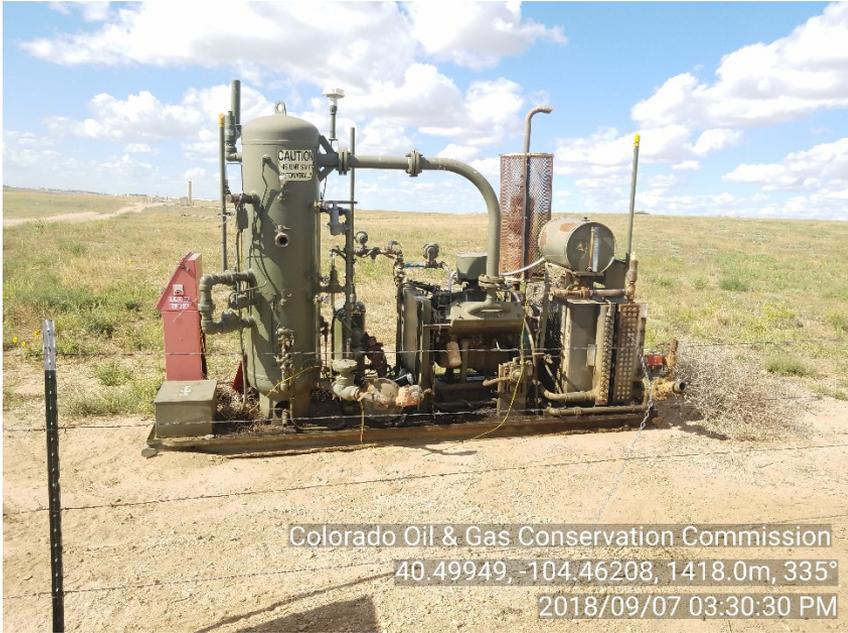
Photo #7

Compressor

Moved while soil remediated

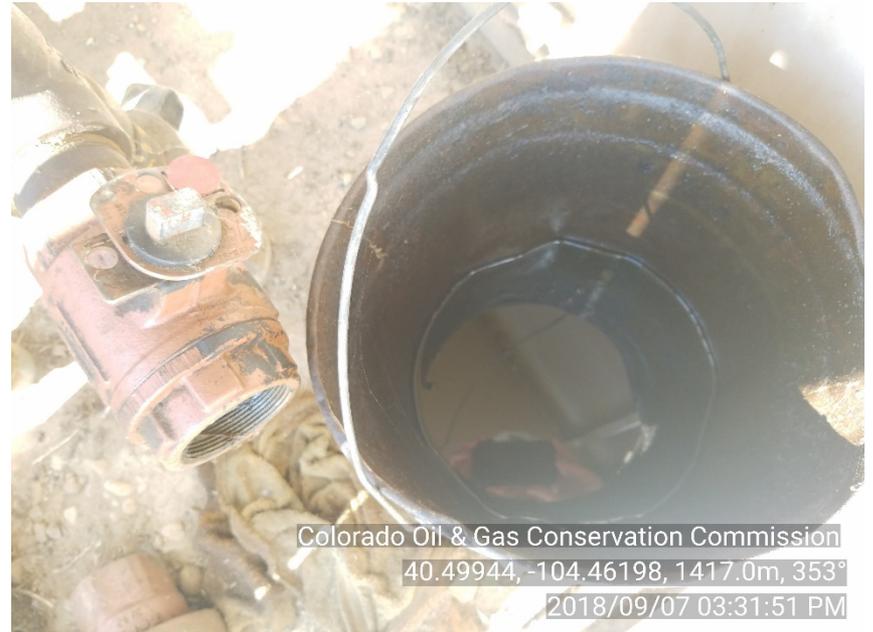
Photo #8

East separator doghouse.

Trash – oily bucket

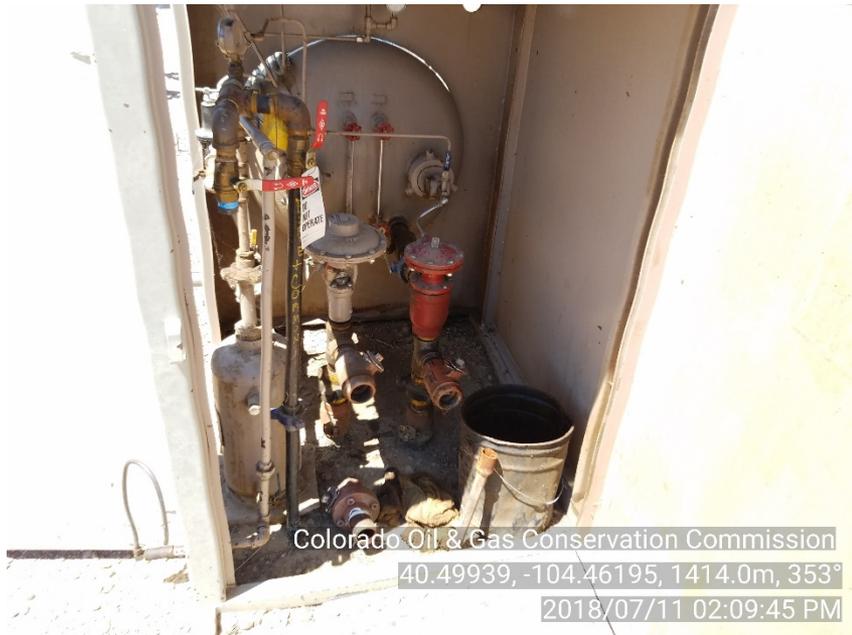
Photo #9

East separator doghouse.

Trash – oily rag, oily bucket, old valve

From previous FIR

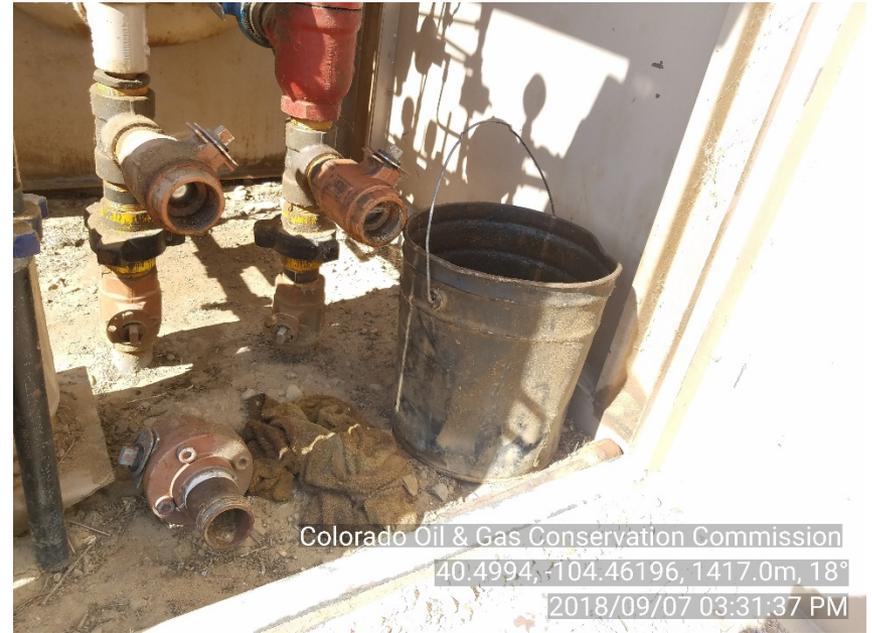
Photo #10

East separator doghouse.

Trash – oily rag, oily bucket, old valve
