Inspection Photos

Location Name: Federal Osprey- 68N60W / 35NENW

Location #: 331181

COLORADO
Oil & Gas Conservation
Commission
Department of Natural Resources

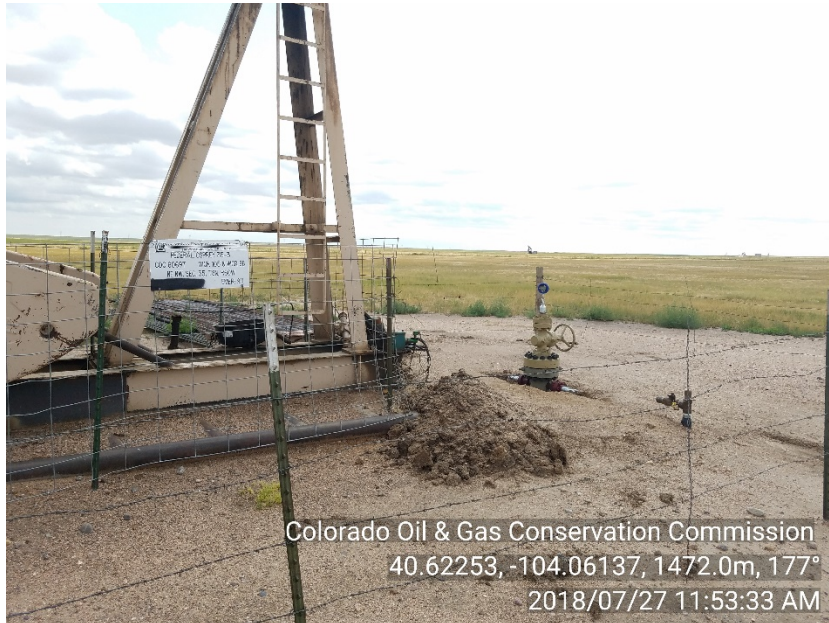
Photo #1

Federal Osprey 35-3 (API # 05-123-20272) wellhead

Bradenhead not plumbed to surface

From previous FIR

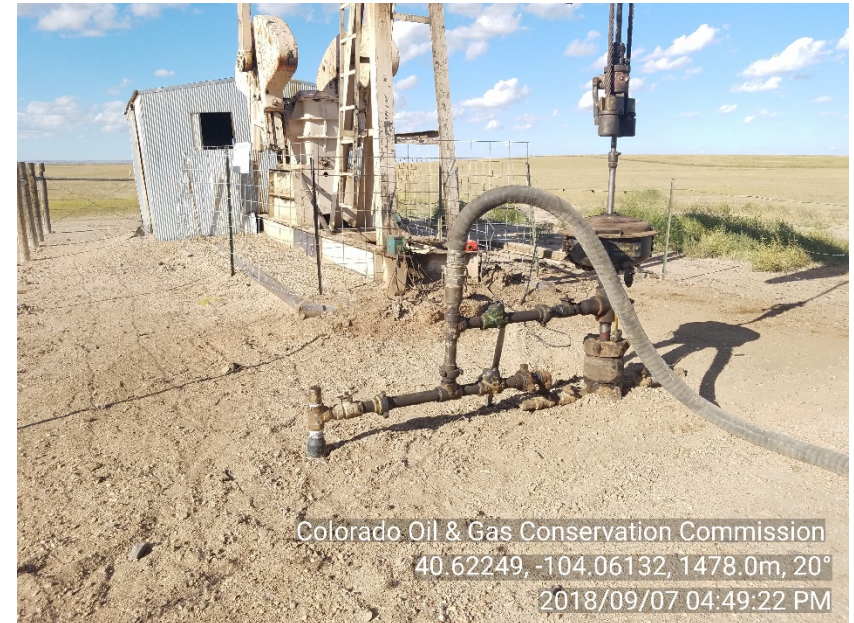
Photo #2

Federal Osprey 35-3 wellhead

Bradenhead not plumbed to surface

Vac-Truck clearing flowline leak downstream

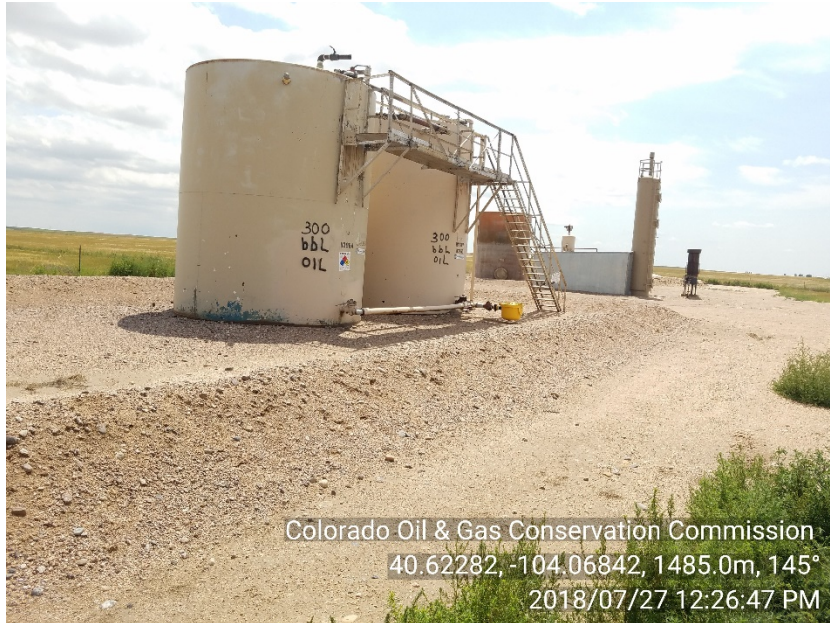
Photo #3

Federal Osprey 35-3 Battery

From previous FIR

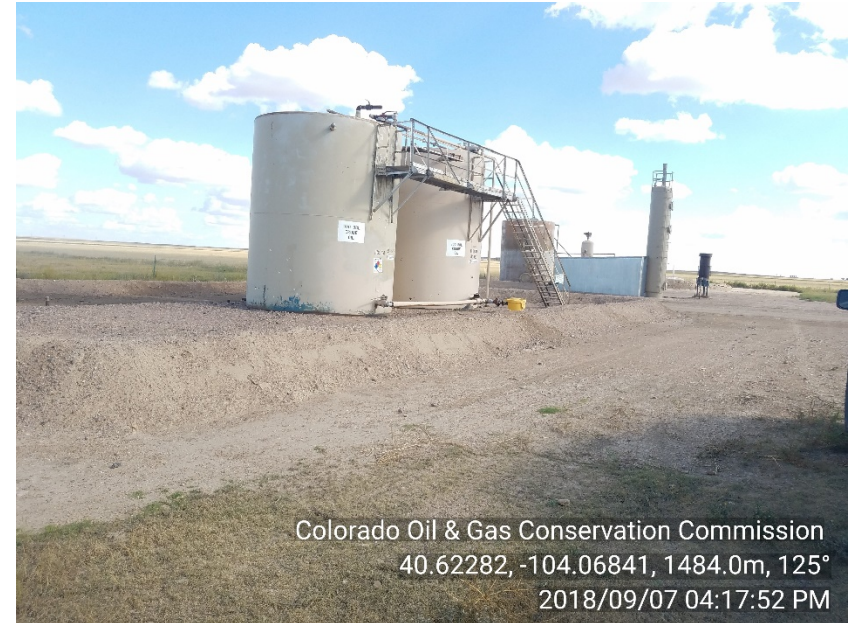
Photo #4

Federal Osprey 35-3 Battery

Current View

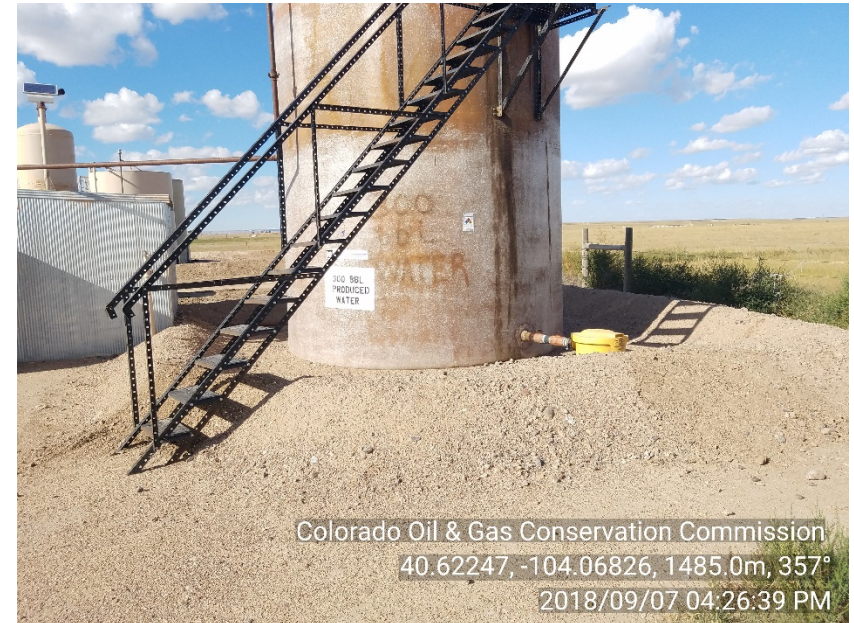
Photo #6

Federal Osprey 35-3 H2O tank

Berms dimensions now appear adequate

New capacity label & placard

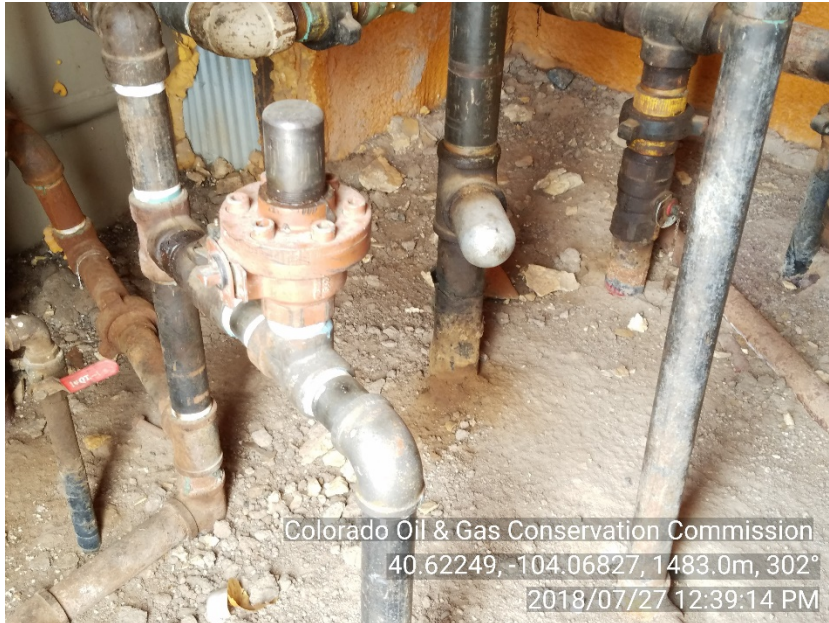
Photo #7

Federal Osprey 35-3 Oil treater

Stained soil from previous FIR
remains apparent

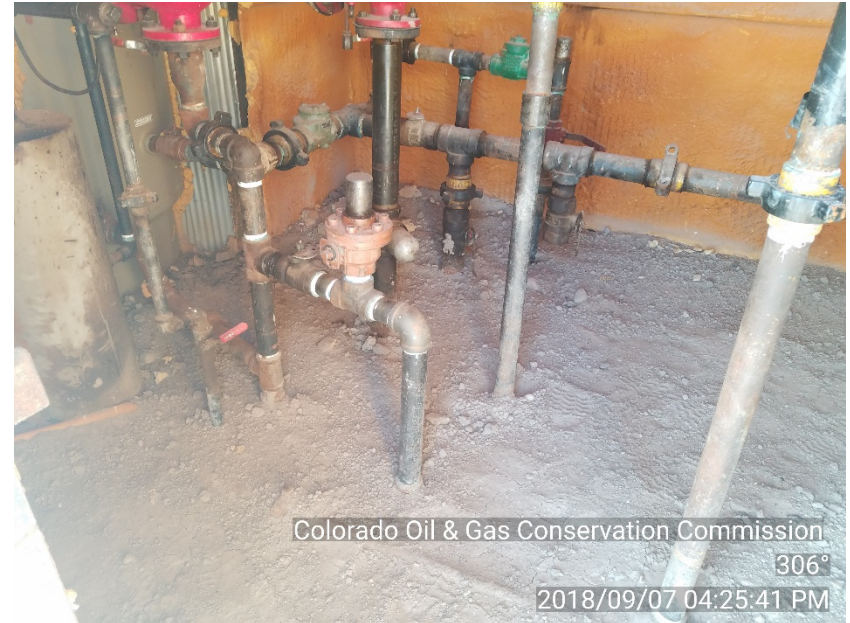
Photo #8

Federal Osprey 35-3 Oil treater

Stained soil appears to have been remediated

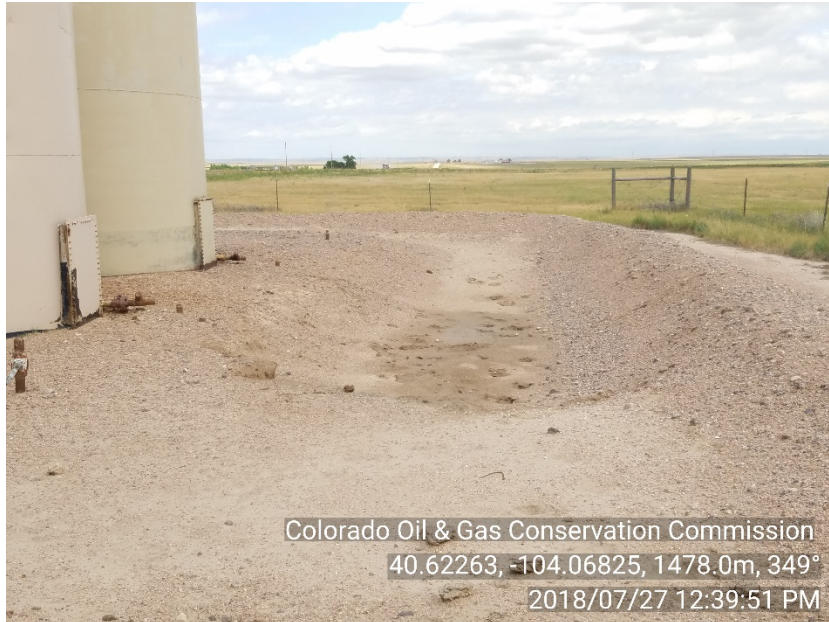
Photo #9

Federal Osprey 35-3 behind oil tanks

Un-permitted pit referenced from previous FIR

Remains apparent

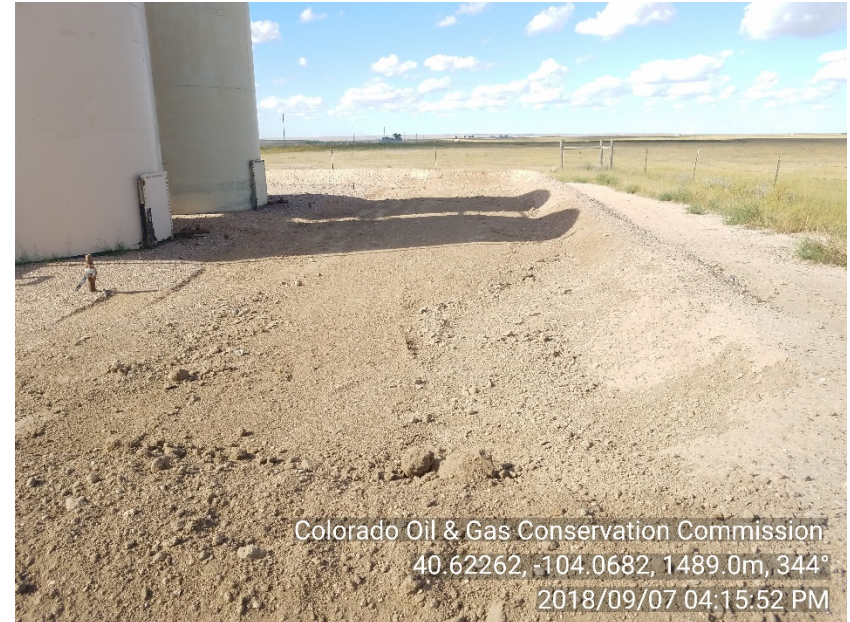
Photo #10

Federal Osprey 35-3 behind oil tanks

Un-permitted pit referenced from previous FIR

has been filled in

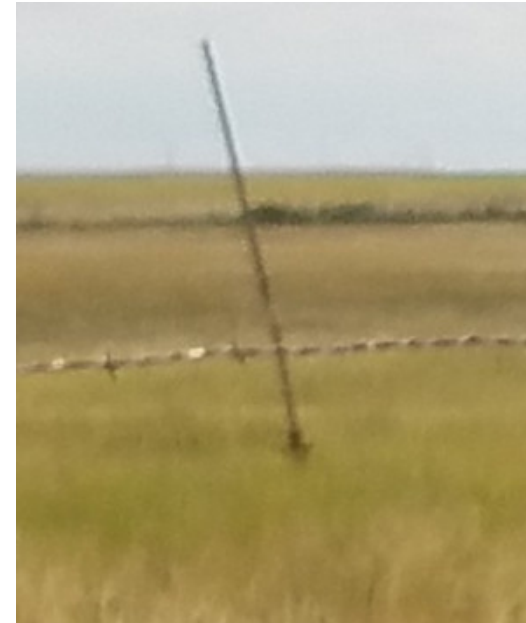
Photo #12

Federal Osprey 35-3 well anchors

4 - anchors are now marked

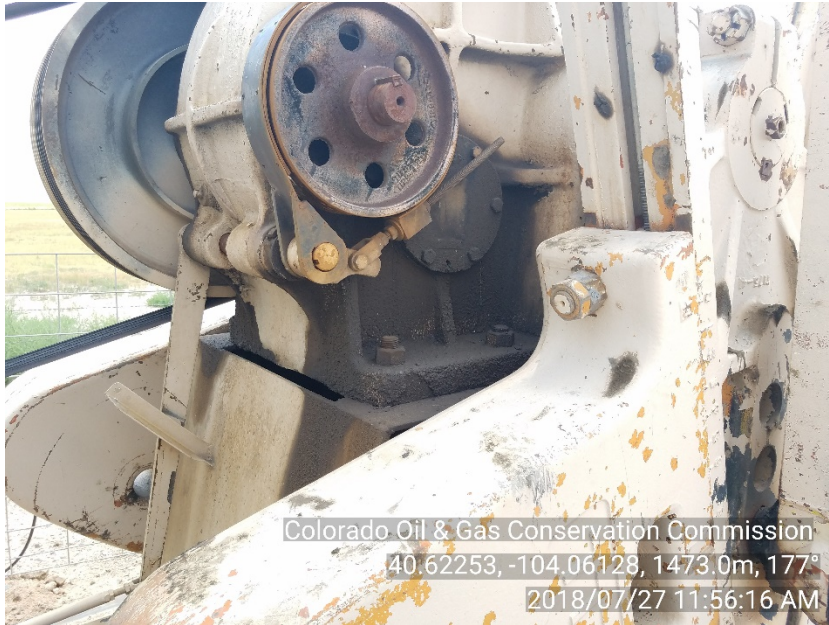
Photo #13

Federal Osprey 35-3 Pumping Unit
Stain on gearbox from previous FIR
remains apparent

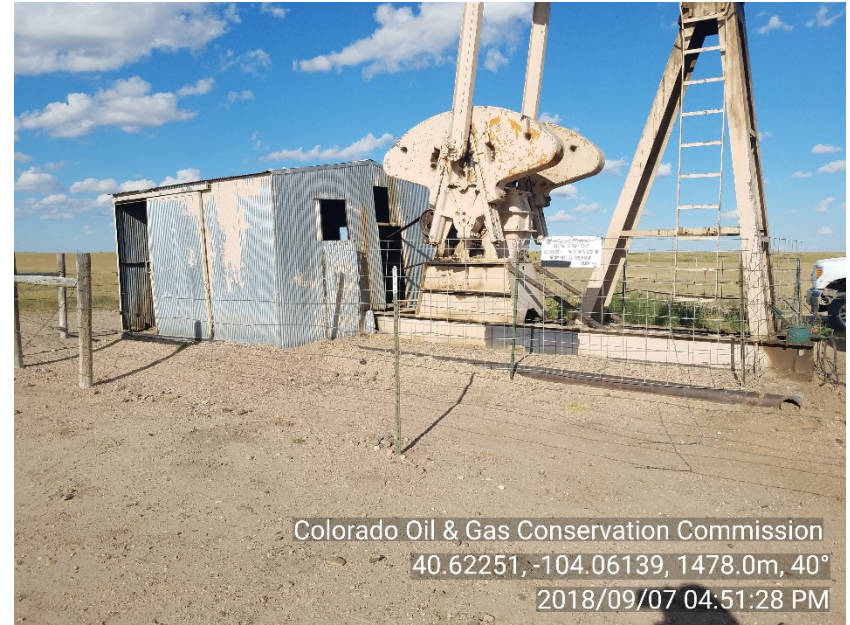
Photo #14

Federal Osprey 35-3 Pumping Unit
Stained gearbox & soil near pump jack base appear
to have been remediated

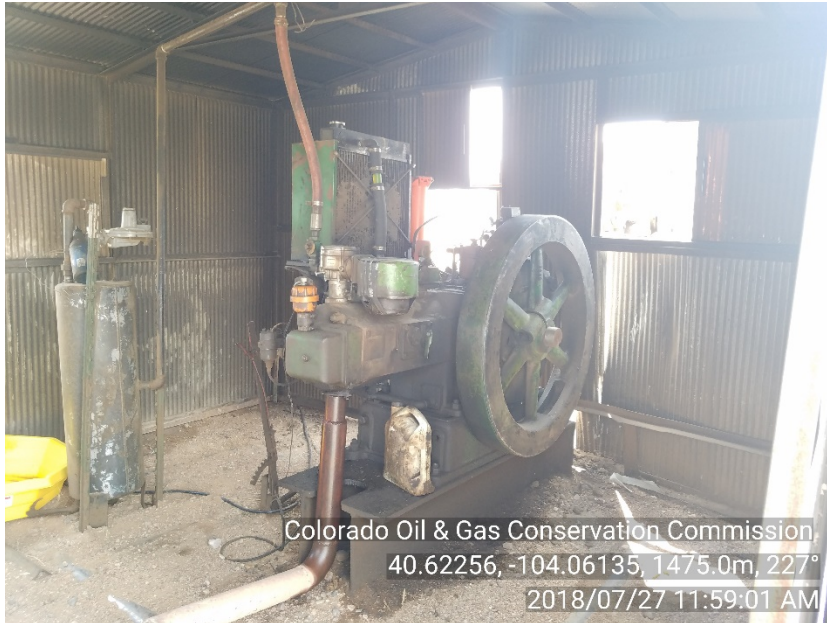
Photo #15

Federal Osprey 35-3 Gas Engine – Prime Mover
Stained soil near gas engine base referenced from
previous FIR remains apparent

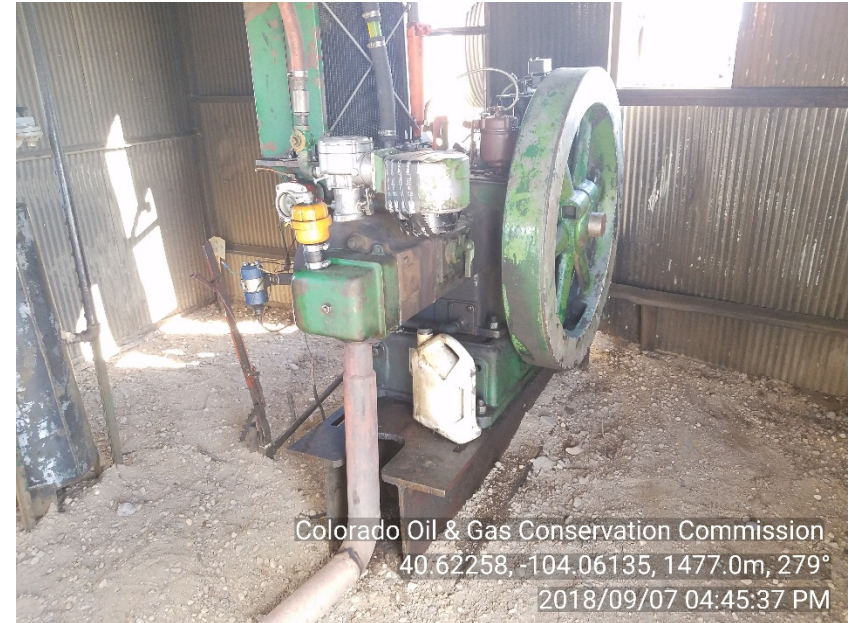
Photo #16

Federal Osprey 35-3 Gas Engine – Prime Mover
Stained soil near gas engine base appears to have
been remediated

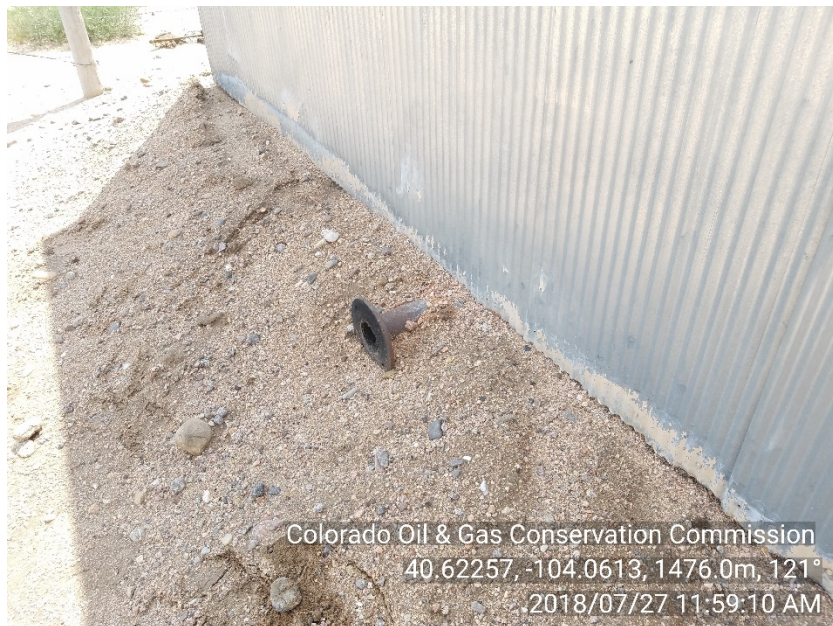
Photo #17

Federal Osprey 35-3 Gas Engine – Prime Mover

No engine muffler

referenced from previous FIR

Remains apparent

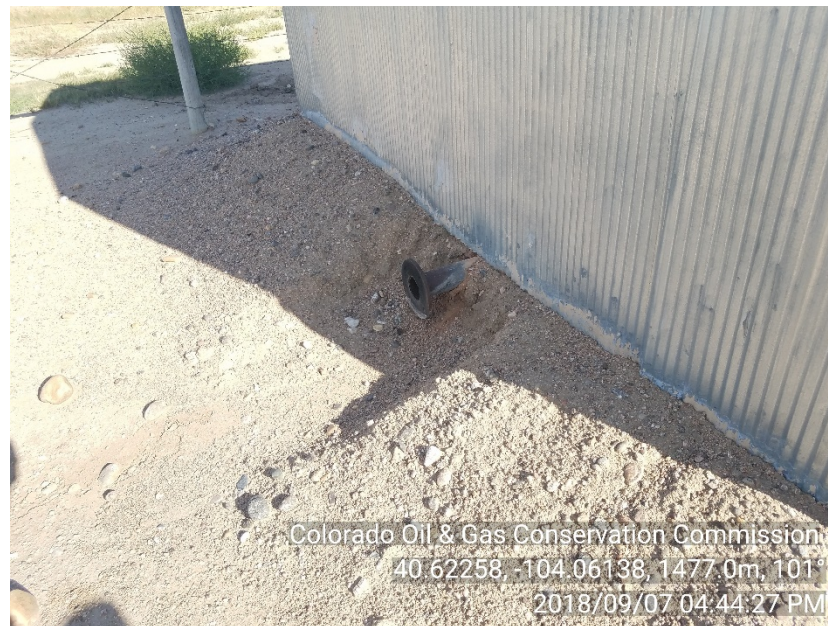
Photo #18

Federal Osprey 35-3 Gas Engine – Prime Mover

No engine muffler

Remains apparent

Stained soil - remediated

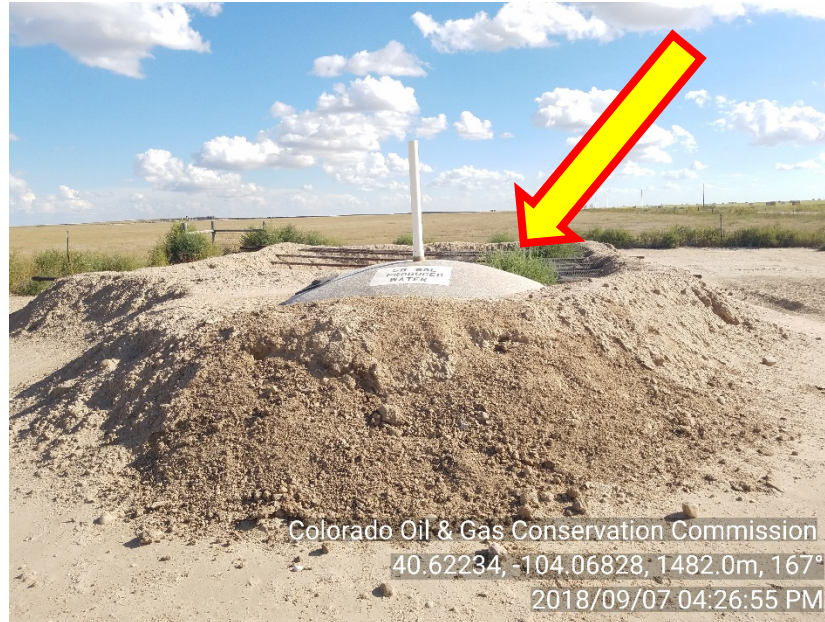
Photo #19

Federal Osprey 35-3 Pit

Weeds inside of pit netting
