Inspection Photos  
Location Name: Neva Dove A #2  
API: 05-067-08412

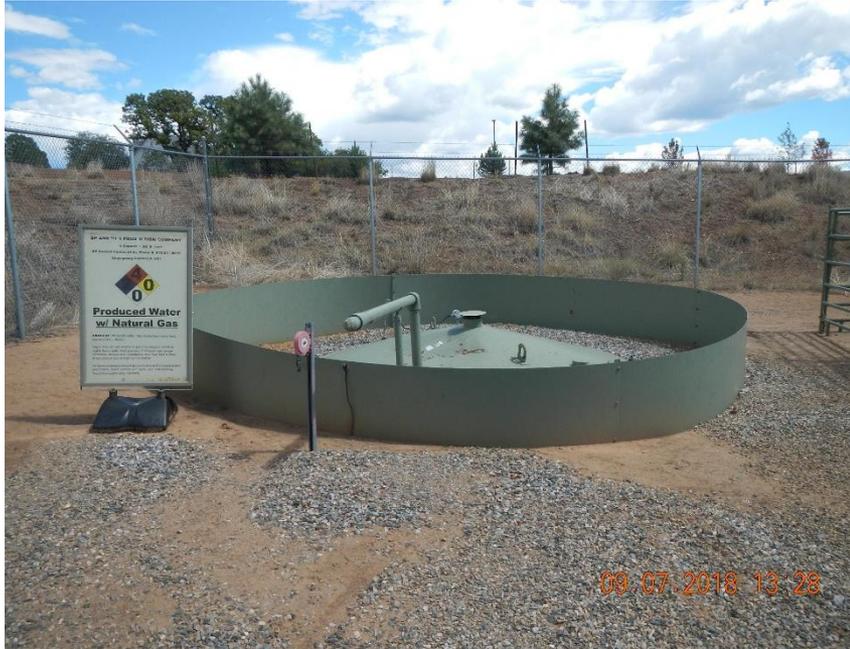
95 bbl. produced water PBV.

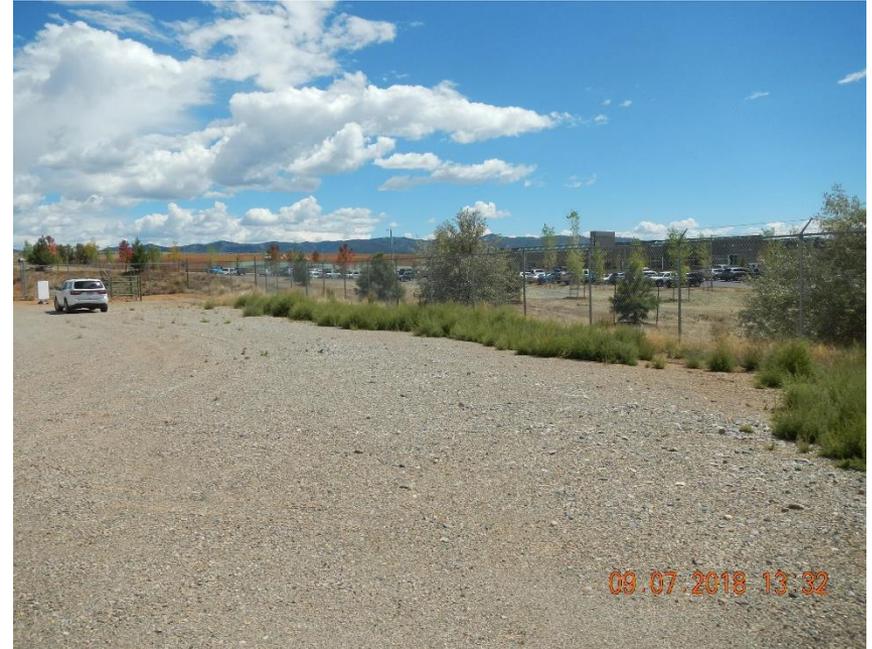
Weeds present along southern edge of location.

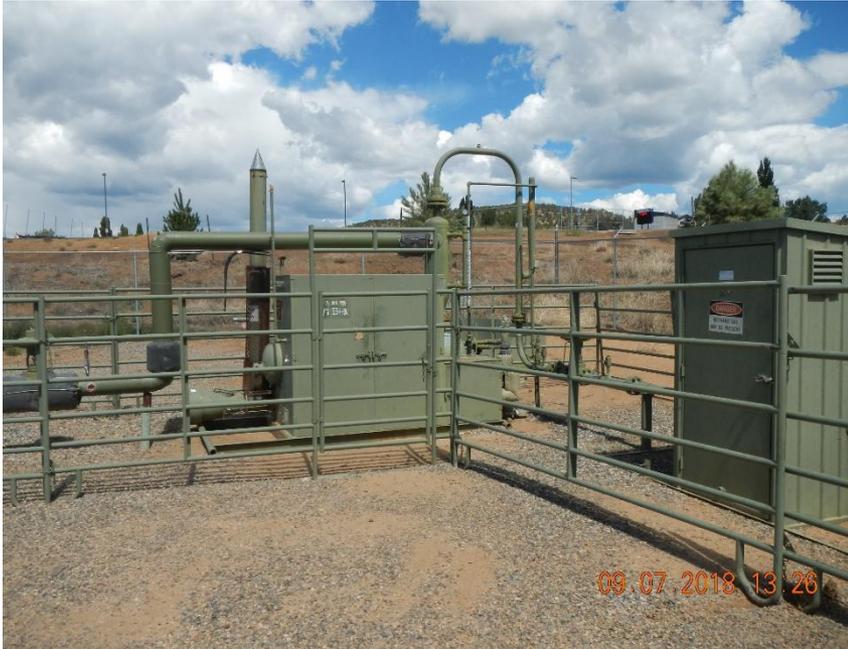
**Neva Dove A #2 production equipment.**

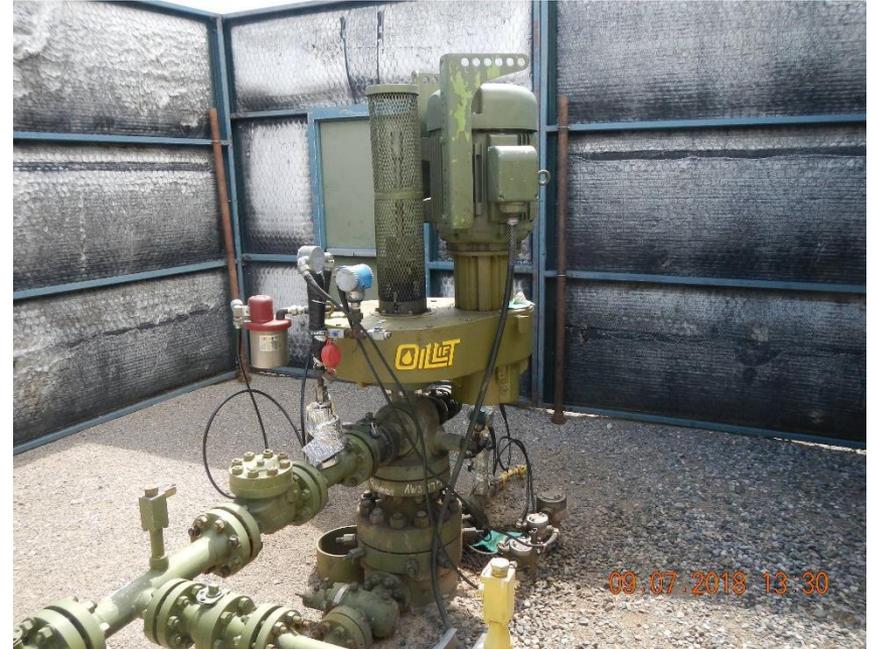
**Neva Dove A #2 well head and progressive cavity pump.  
Pump is leaking oil.**
