Inspection Photos

Location Name: Starkey 14-28-696 Centralized E&P Waste Management Facility

Location ID: #324069 Facility ID: #454686 Pit ID: #414554

Inspection Date: August 29, 2018

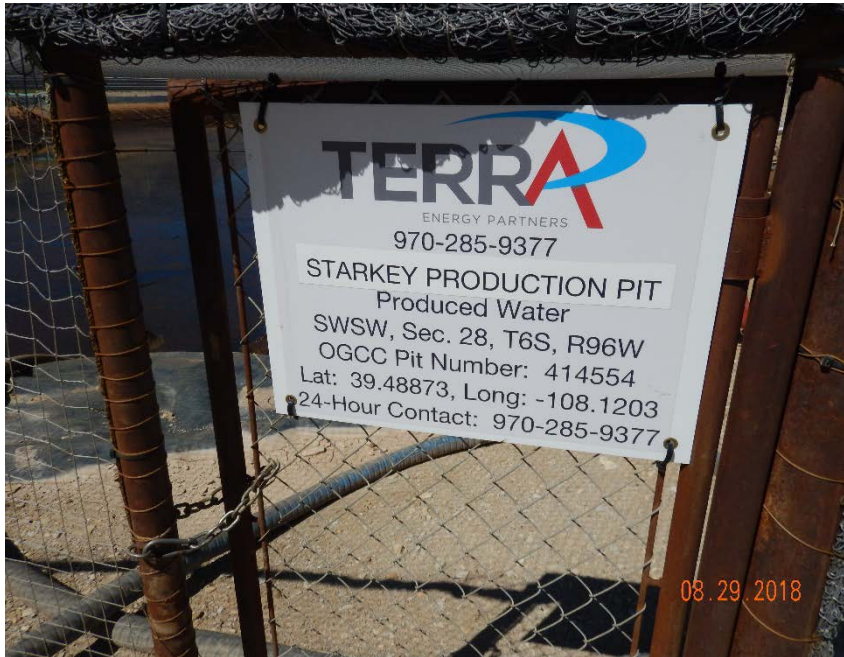
Photo #1 – Pit sign located on entry gate at SE corner of pit.

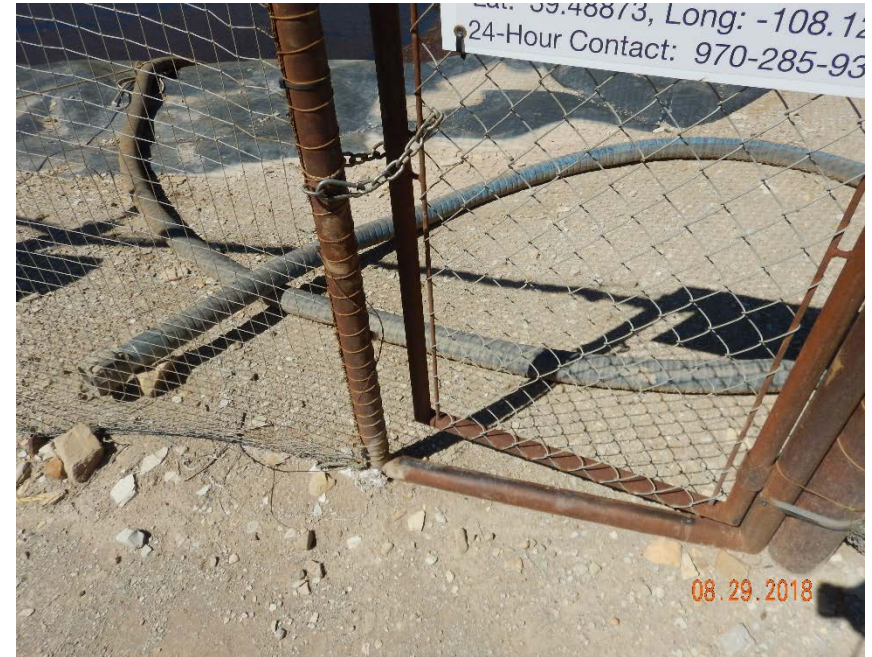
Photo #2 - Gap between gate and post is large enough to grant wildlife access.

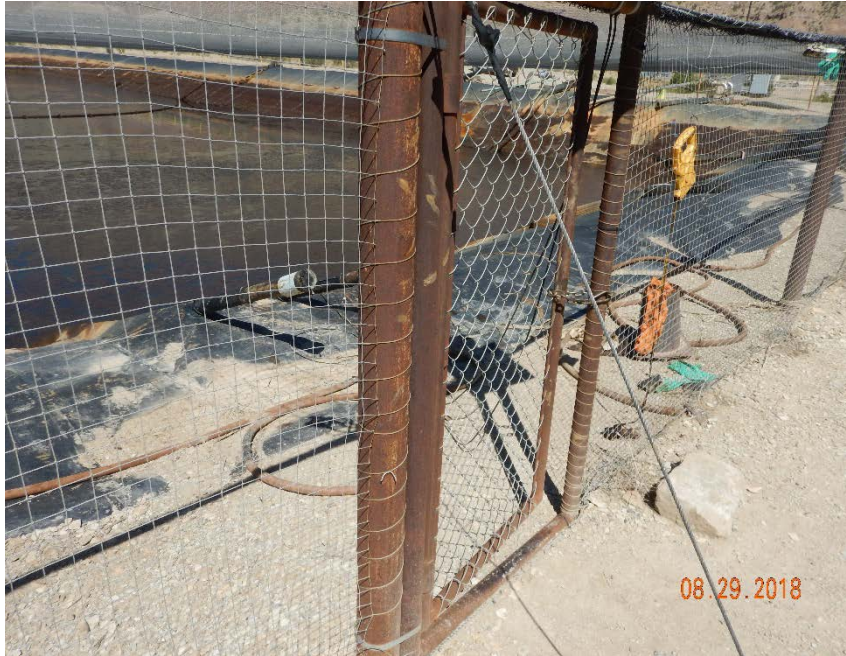
Photo #3 – Second gate located at SW corner of pit provides access to leak detection system. Note that gap between gate and post is big enough to provide wildlife access. Angular rocks encroaching upon pit liner.

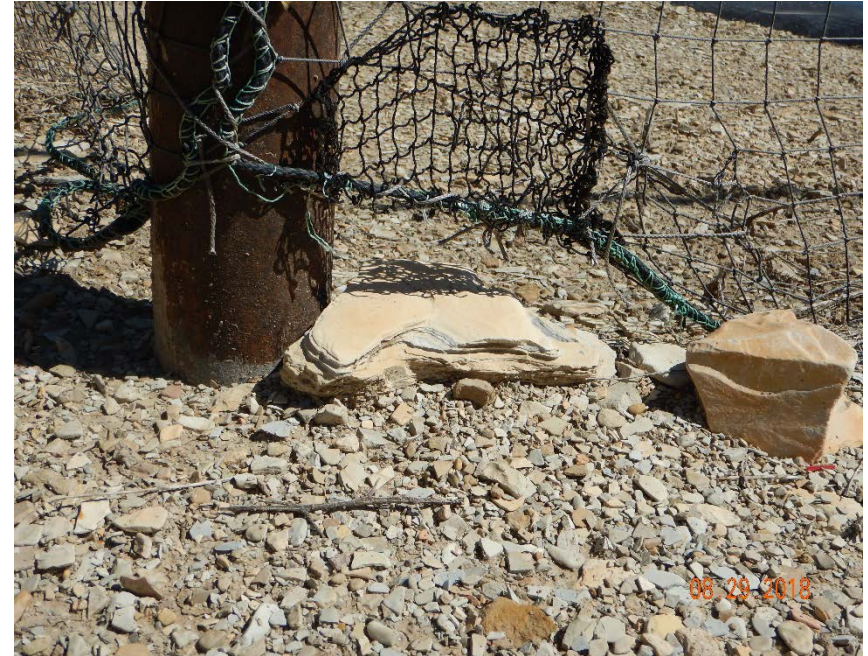
Photo #4 – Gap in base of mesh at NW corner of pit is large enough to provide wildlife access.

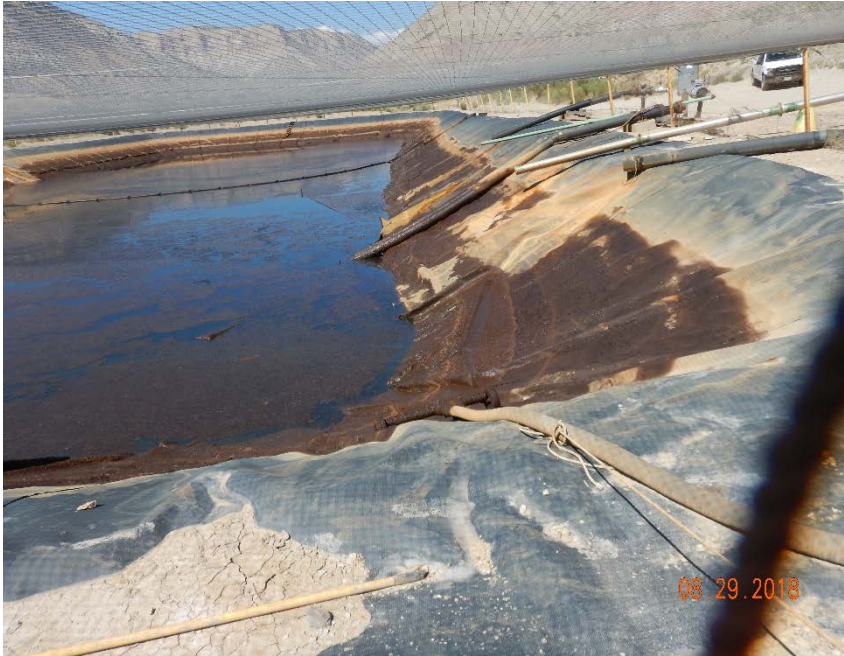
Photo #5 – Multiple discharge hoses and pipes along SE corner of pit are in direct contact with pit liner.

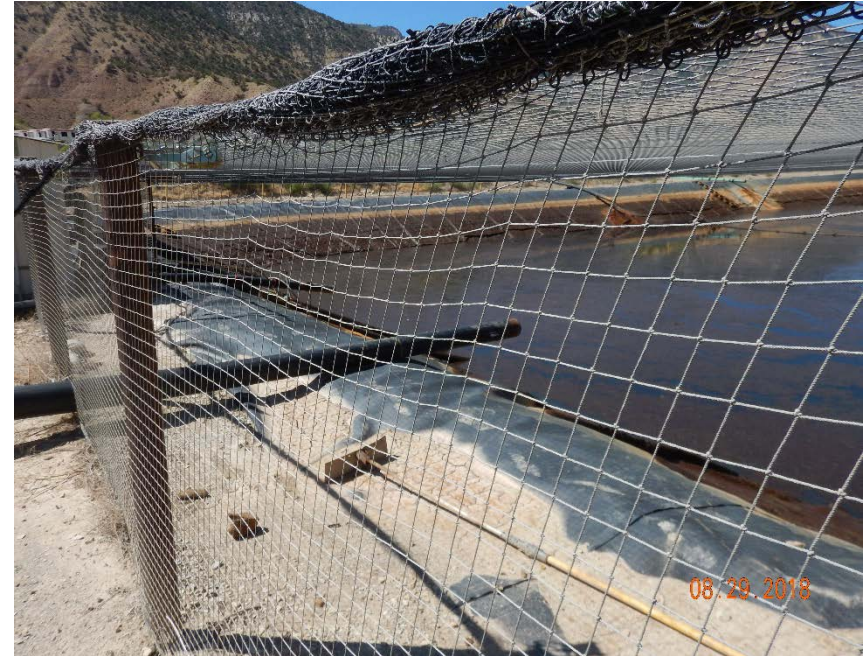
Photo #6 – Multiple discharge pipes along south end of pit are in direct contact with pit liner.

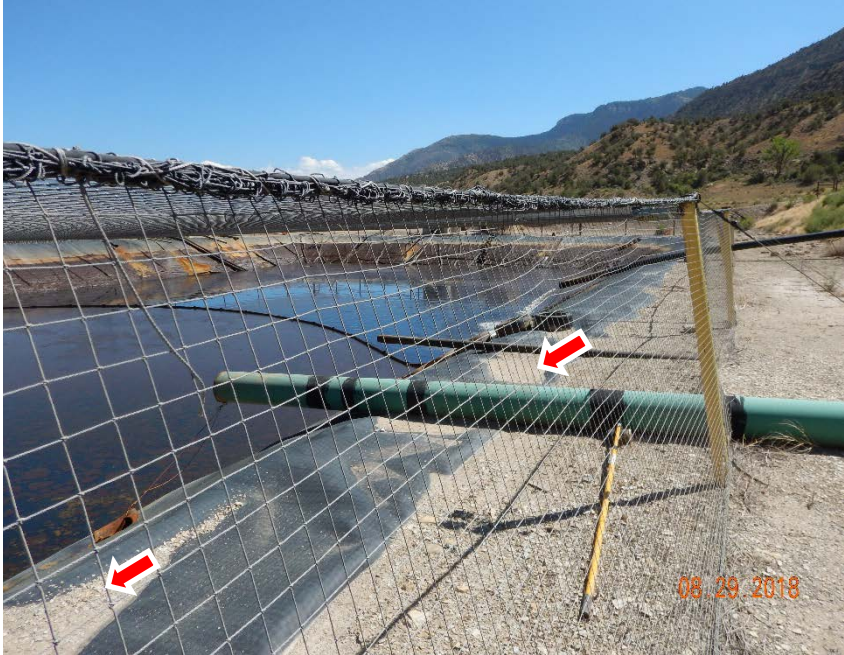
Photo #7 – Discharge pipelines from tank battery on west side of pit are in direct contact with pit liner. Note angular rocks encroaching on pit liner (red arrows).

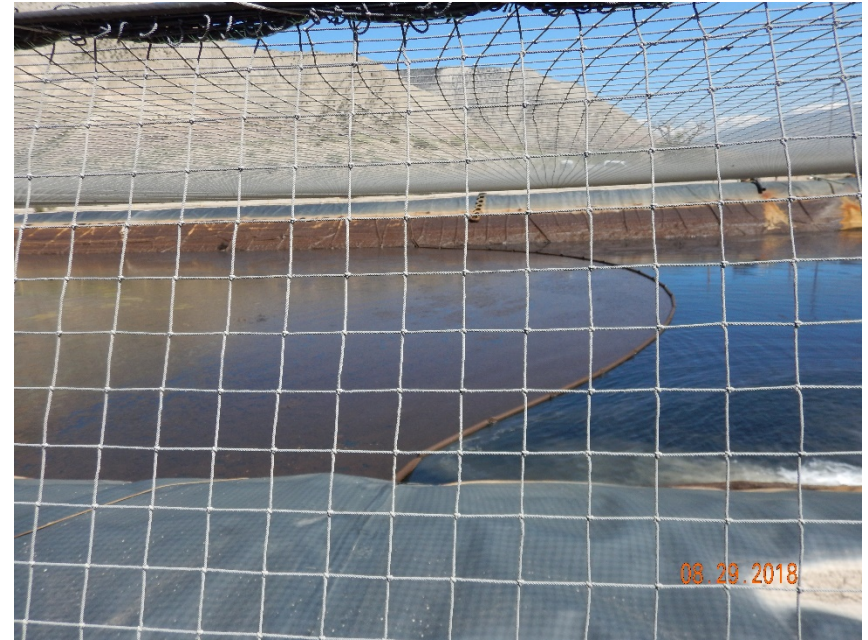
Photo #8 – Free product visible on fluid surface on both sides of boom, as well as liner.

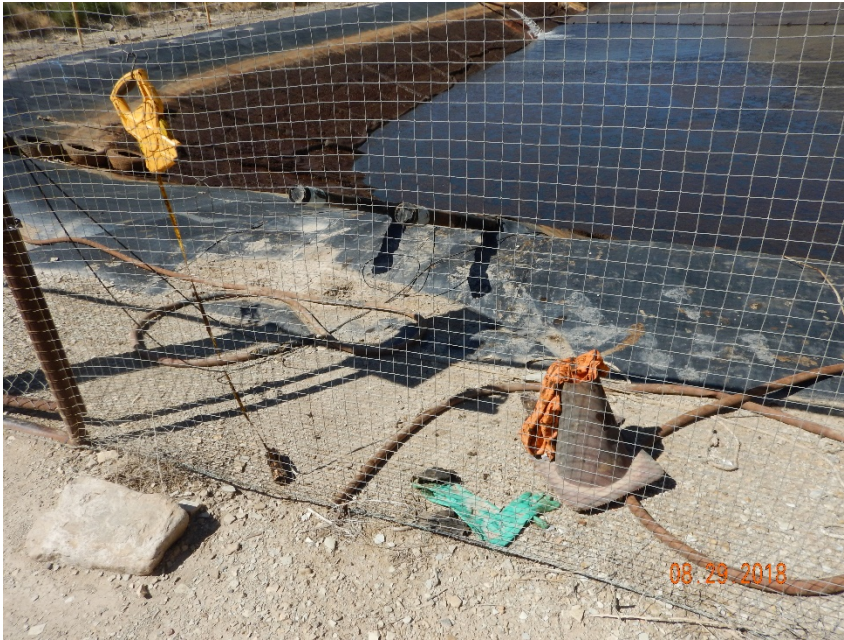
Photo #9 – Oily rag, gloves, hose, and cone stored inside of pit mesh. Note sediment encroaching on pit liner from south.

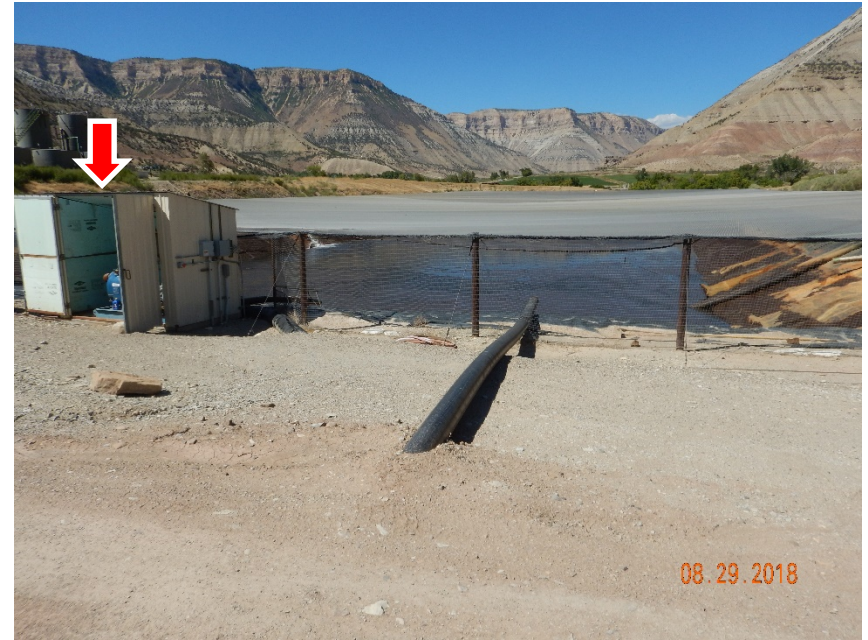
Photo #10 – Pump shed at SE corner of pit had been left open on inspection date.

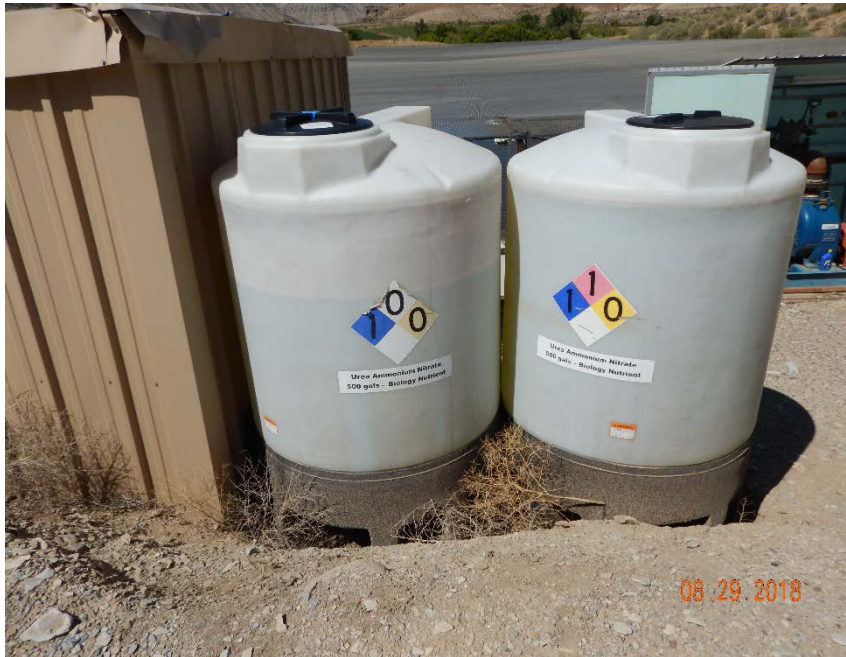
Photo #11 – Urea Ammonium Nitrate containers stored south of pit lack secondary containment device.

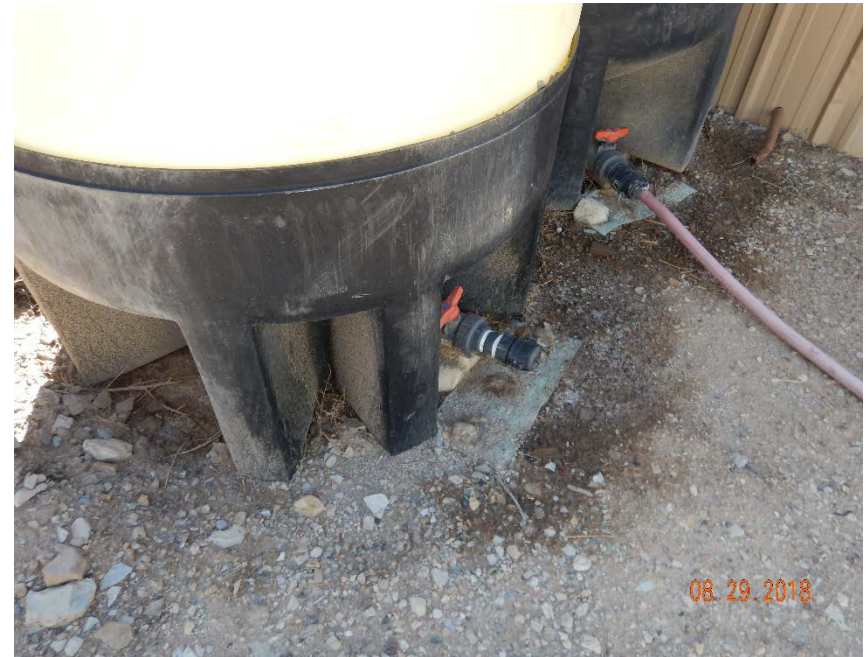
Photo #12 – Historical accumulation of impacted soil underlying chemical storage containers from previous photo.

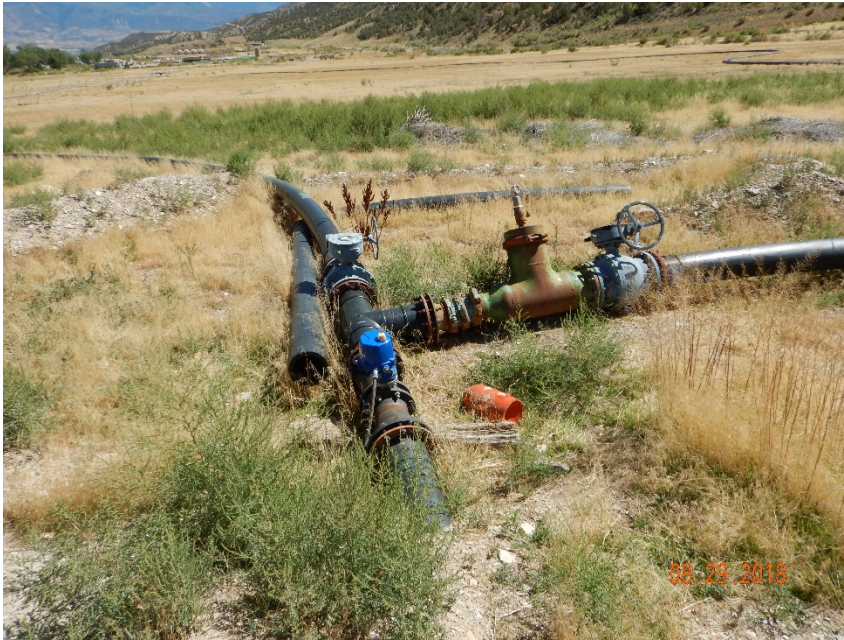
Photo #13 – T-intersection in surface pipeline located SE of pit.

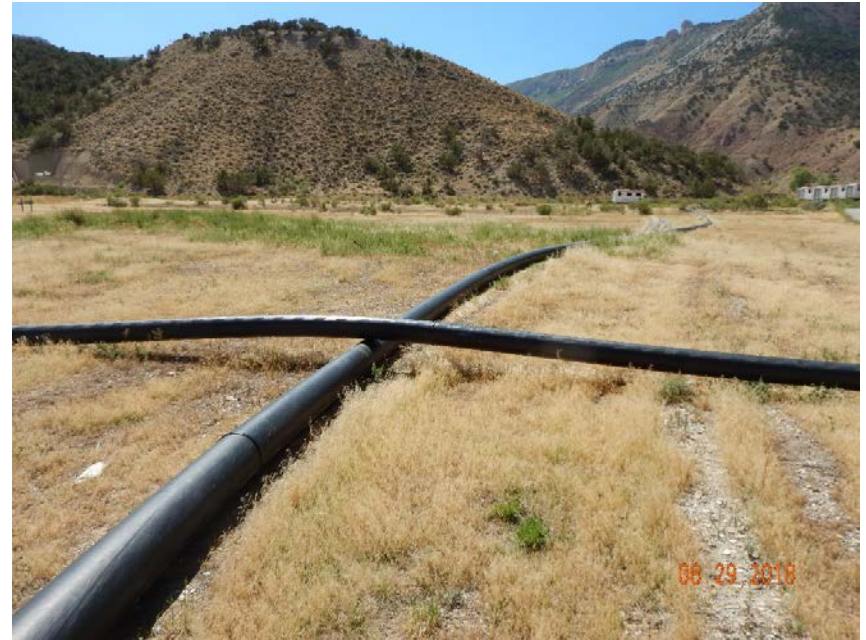
Photo #14 –View to south, along HDPE surface line that discharges into pit.

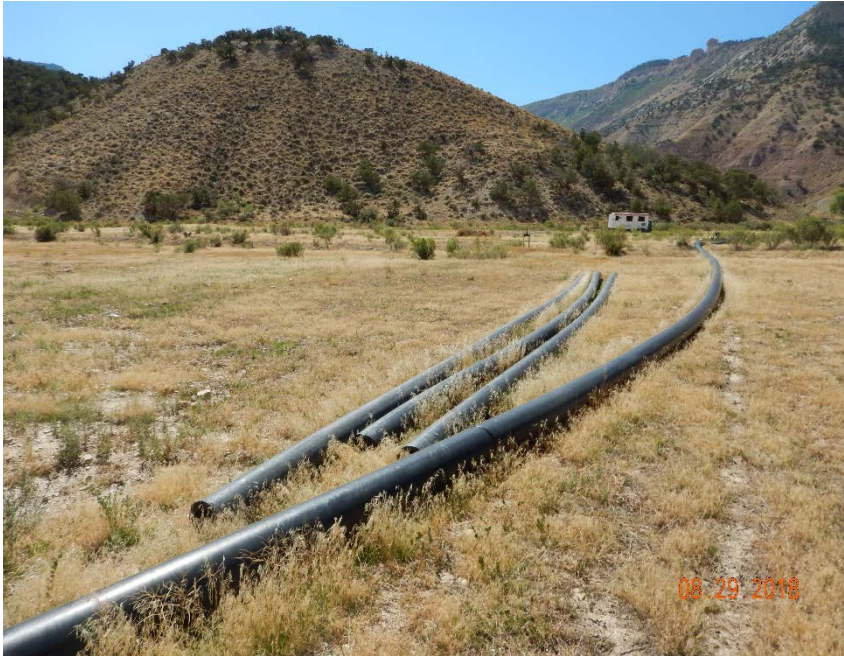
Photo #15 – Unused HDPE surface pipeline equipment stored SW of pit.

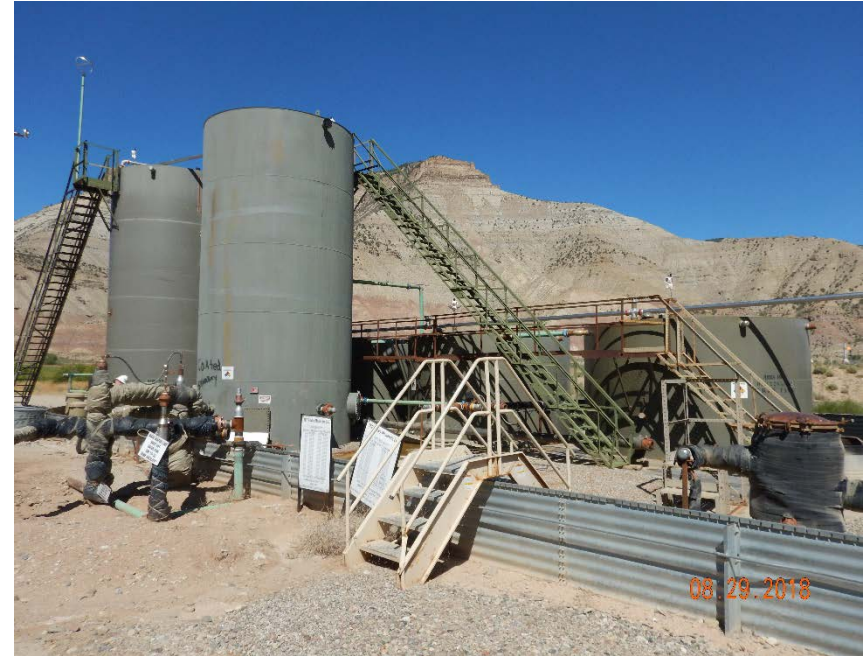
Photo #16 – Tank battery located west of pit.

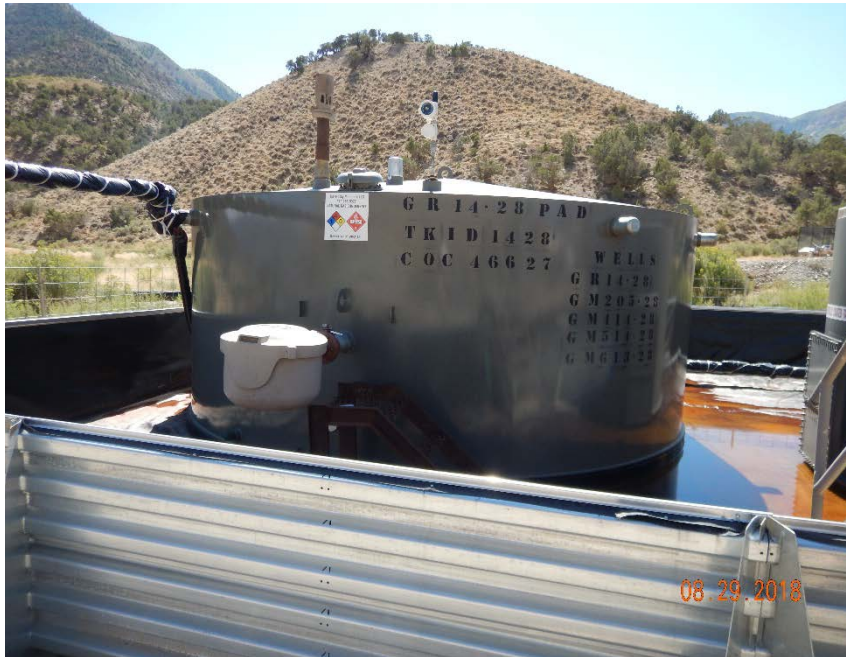
Photo #17 – 200 bbl condensate AST located southwest of pit.

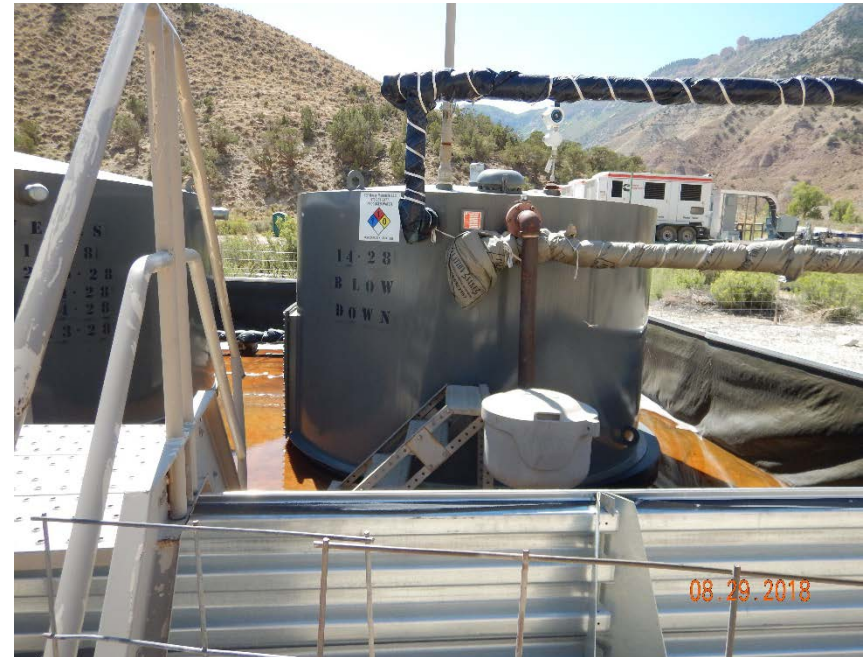
Photo #18 – 80 bbl produced water tank located southwest of pit.

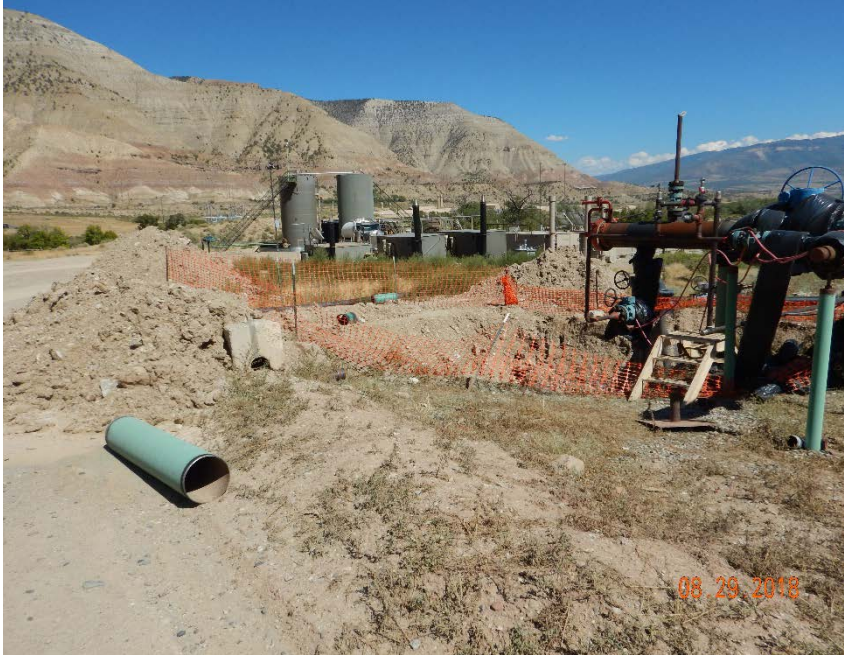
Photo #19 – Flowline excavation located at entrance to location.

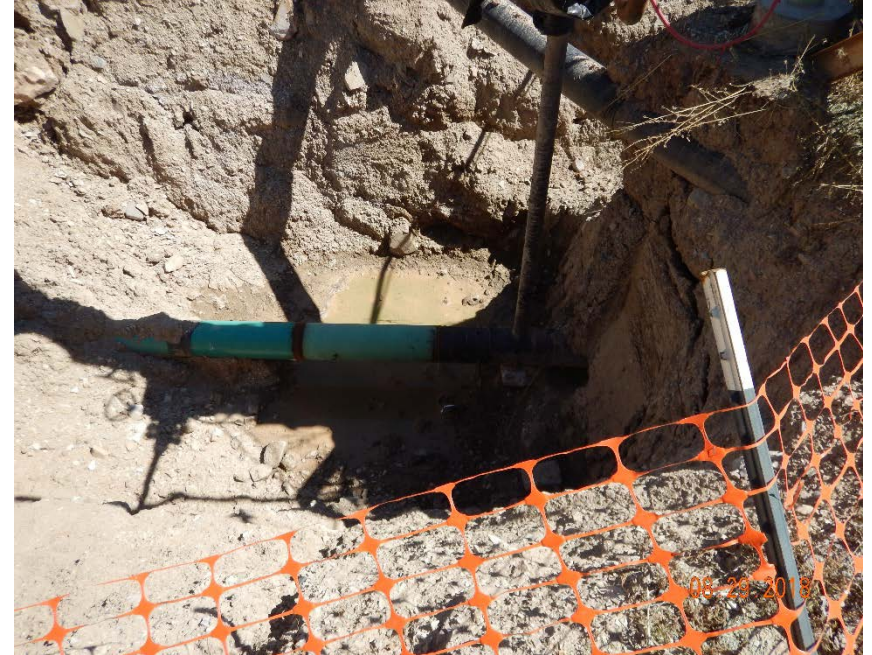
Photo #20 – View into the flowline excavation.

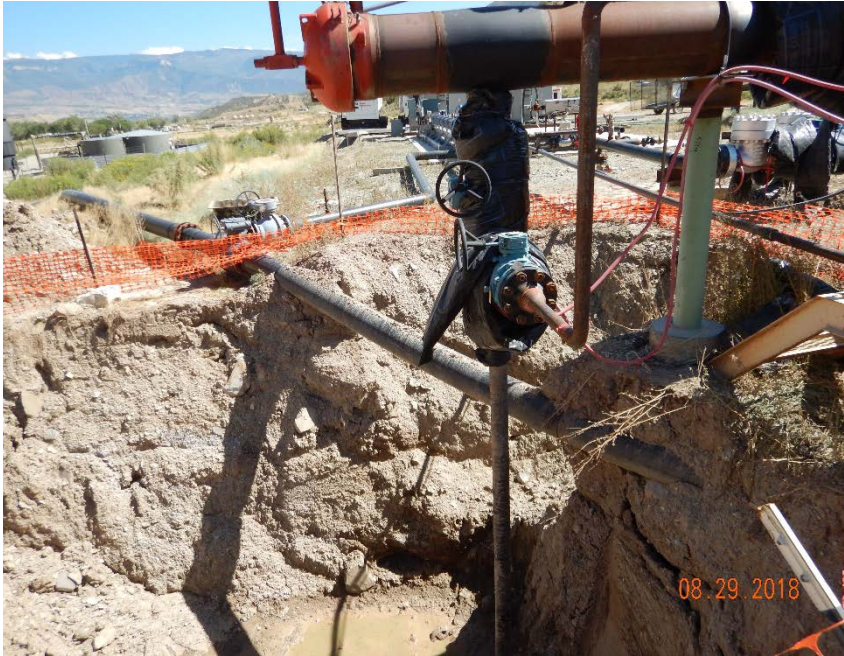
Photo #21 – Flowline suspended across flowline excavation.

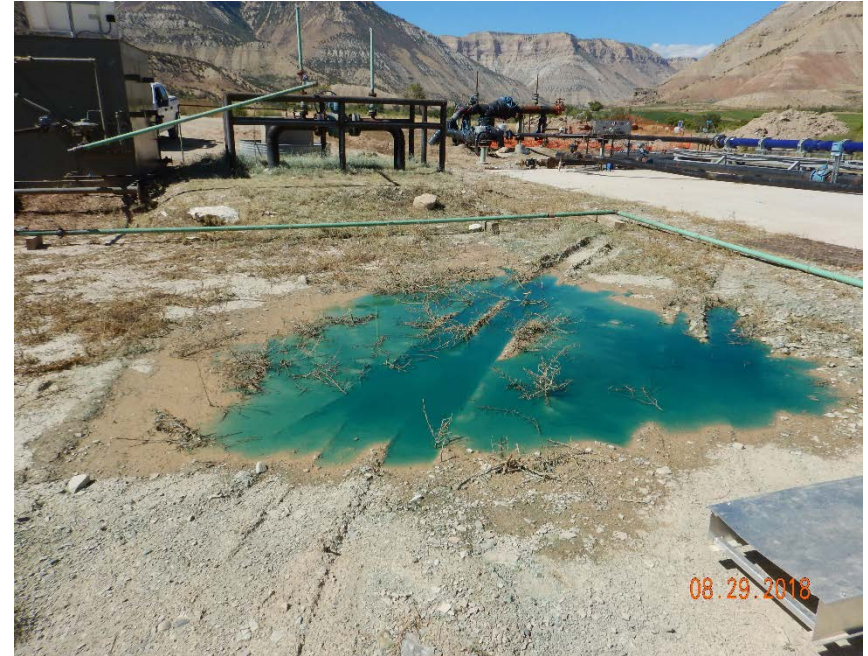
Photo #22 – Green puddle located on west end of location, near entrance, was the result of dye accumulating in recent precipitation. Operator was notified of puddle via phone on inspection date.
