Inspection Photos

Operator: FOUNDATION ENERGY
MANAGEMENT LLC - 10112

Location ID: 327361

Inspection Doc. Number: 682503860
Weld County, CO

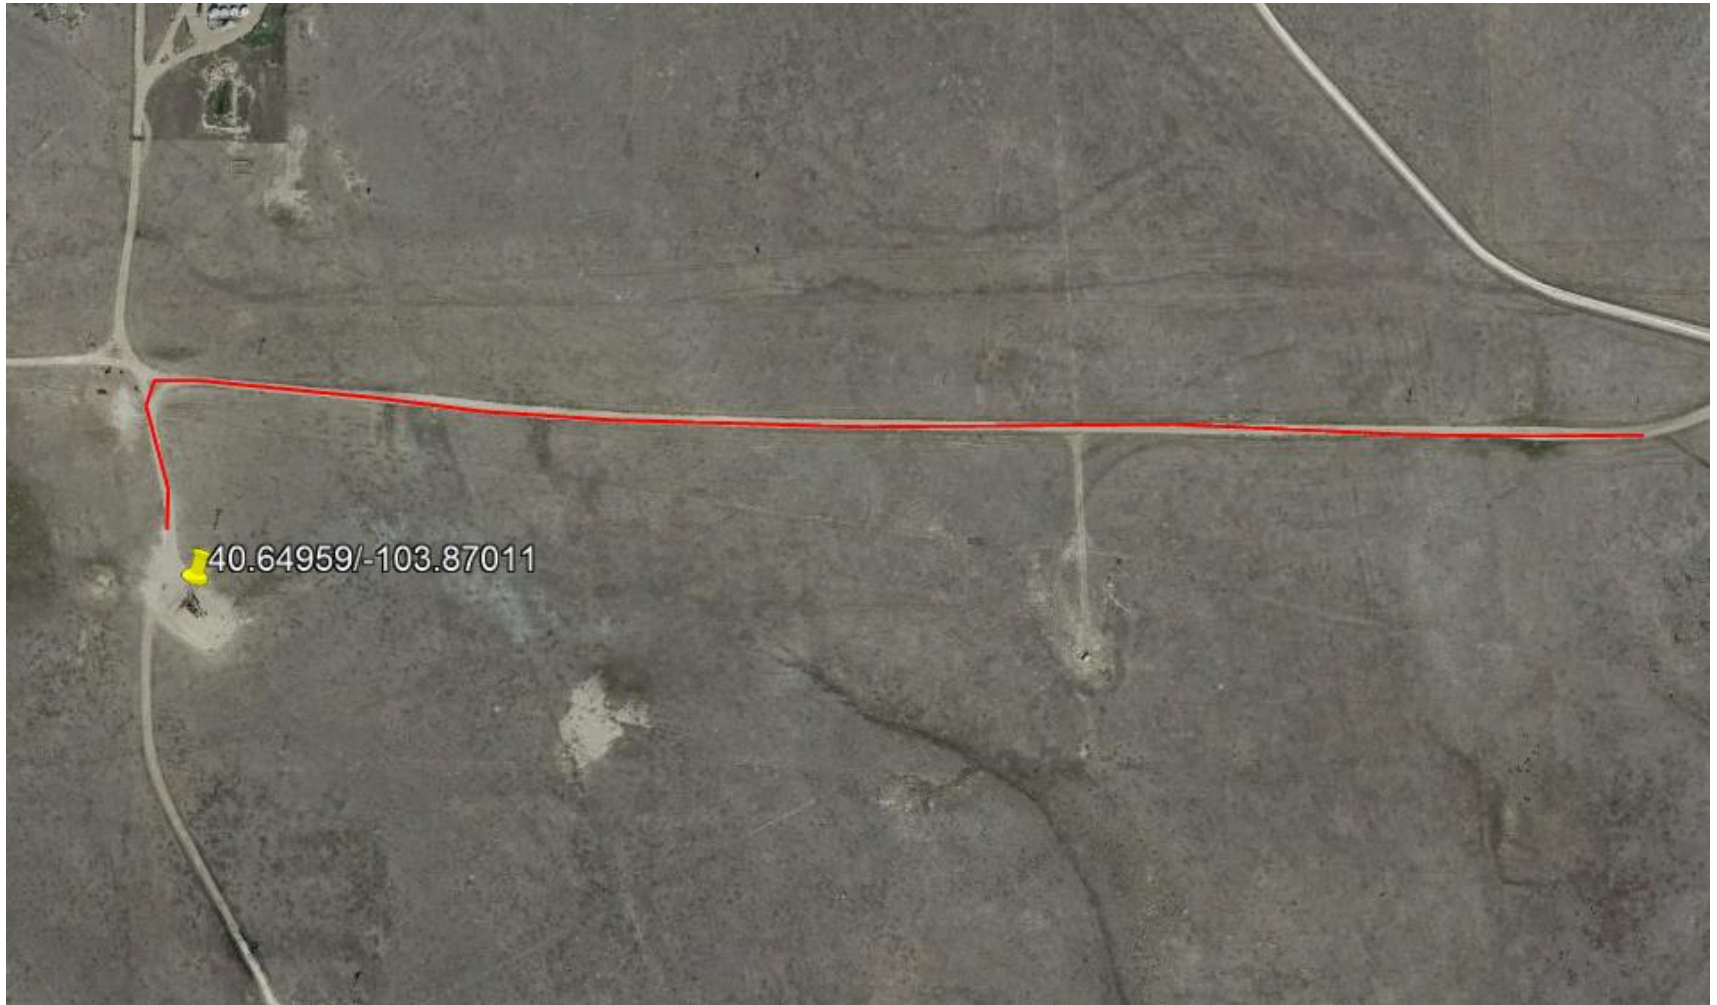
Photo 1: 2013 Aerial imagery. The following photos document Diffuse knapweed on the access road(s). For the purpose of this inspection report, this aerial image highlights the areas of the access road where weeds were observed.

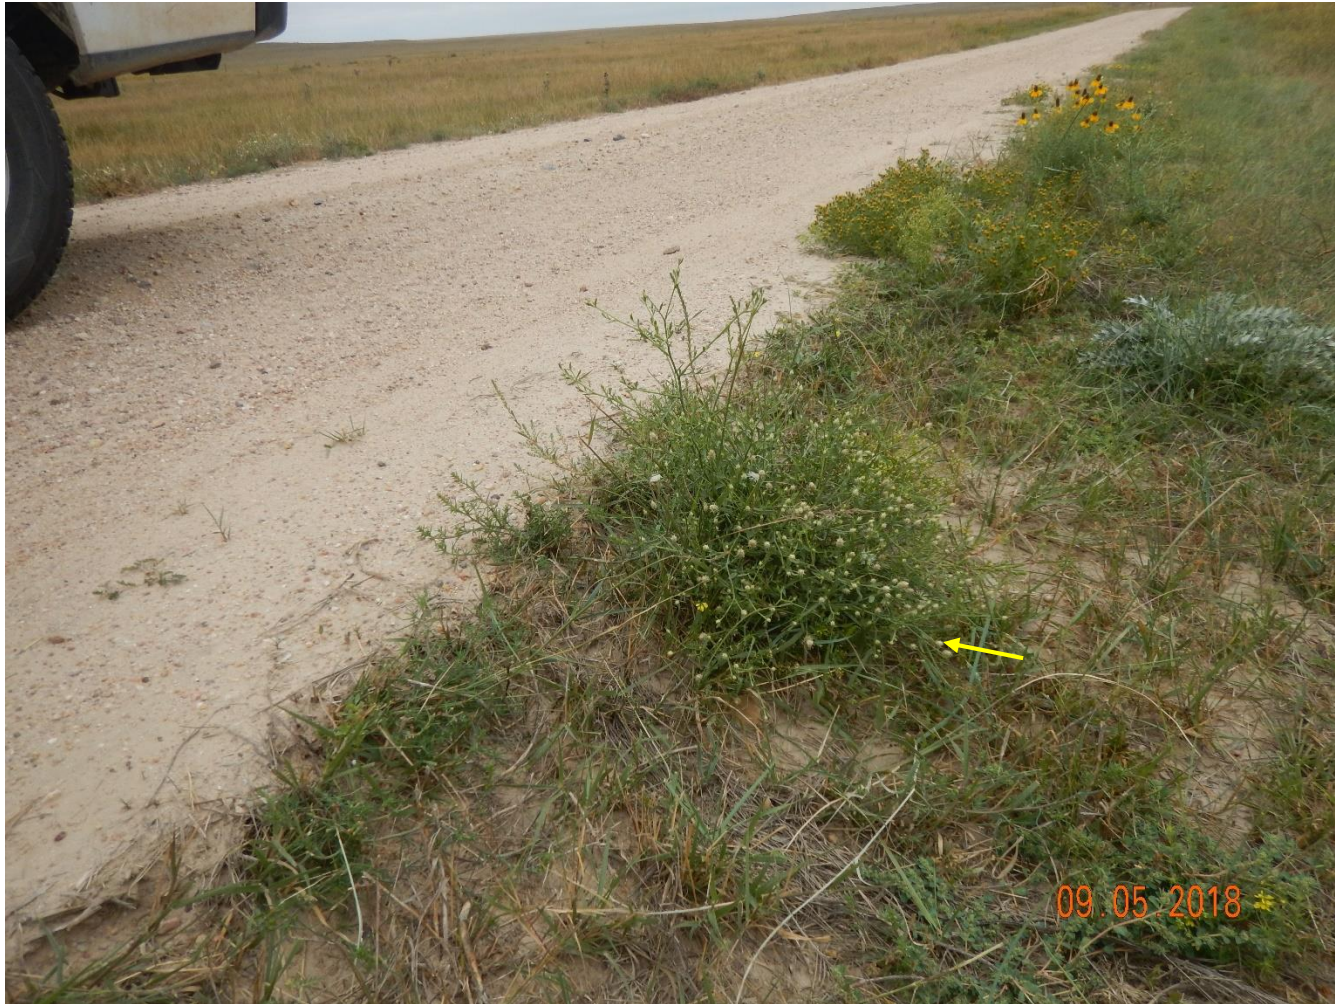
Photo 2: Photo taken from the access road. Photo shows Diffuse Knapweed has not been sufficiently managed or removed from access road.

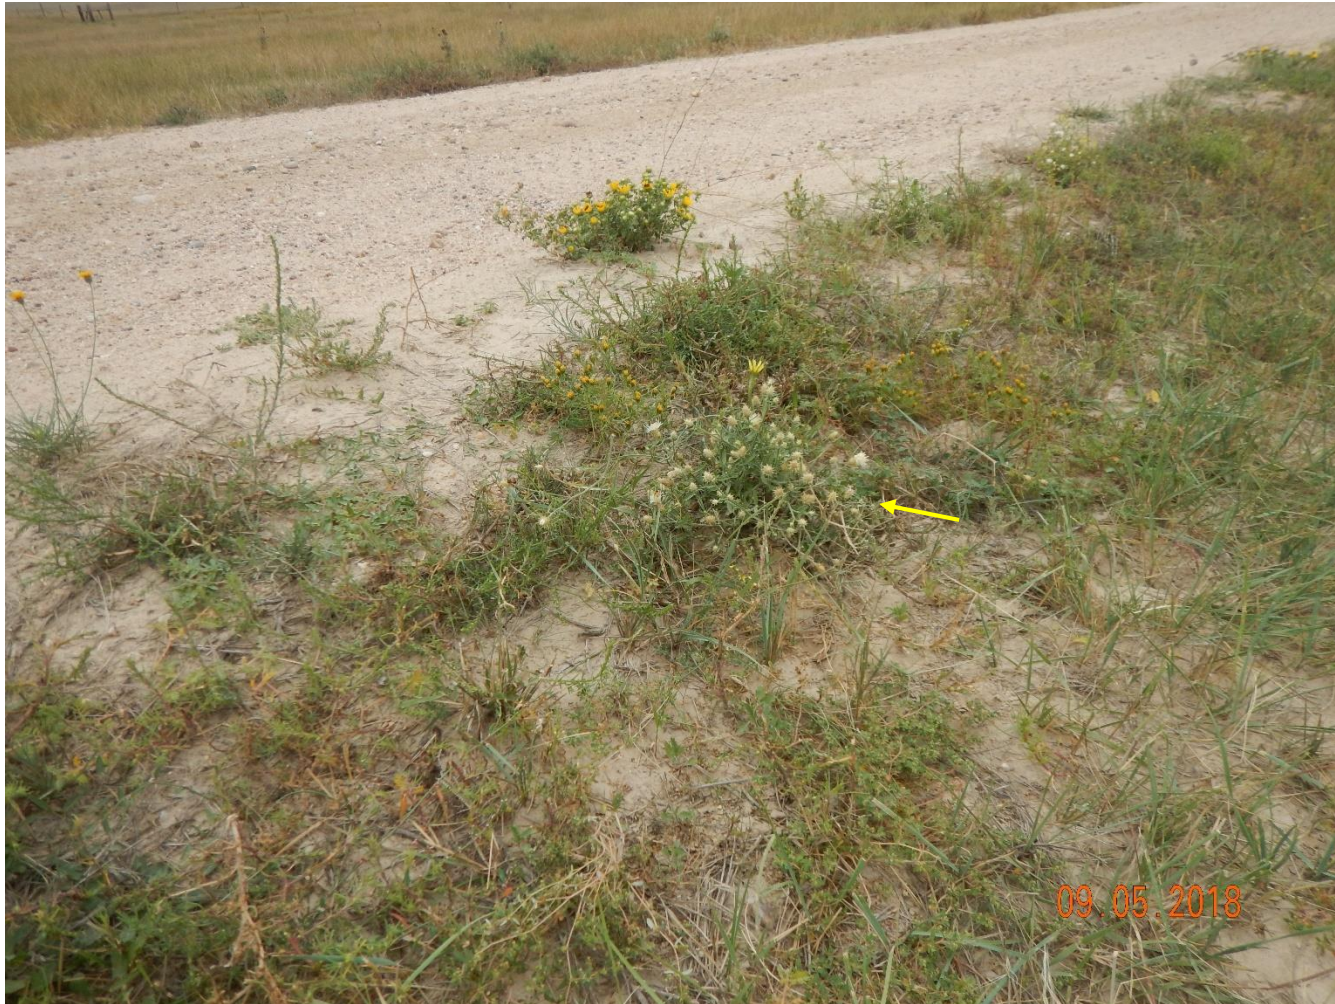
Photo 3: Photo taken from the access road. Photo shows Diffuse Knapweed has not been sufficiently managed or removed from access road.

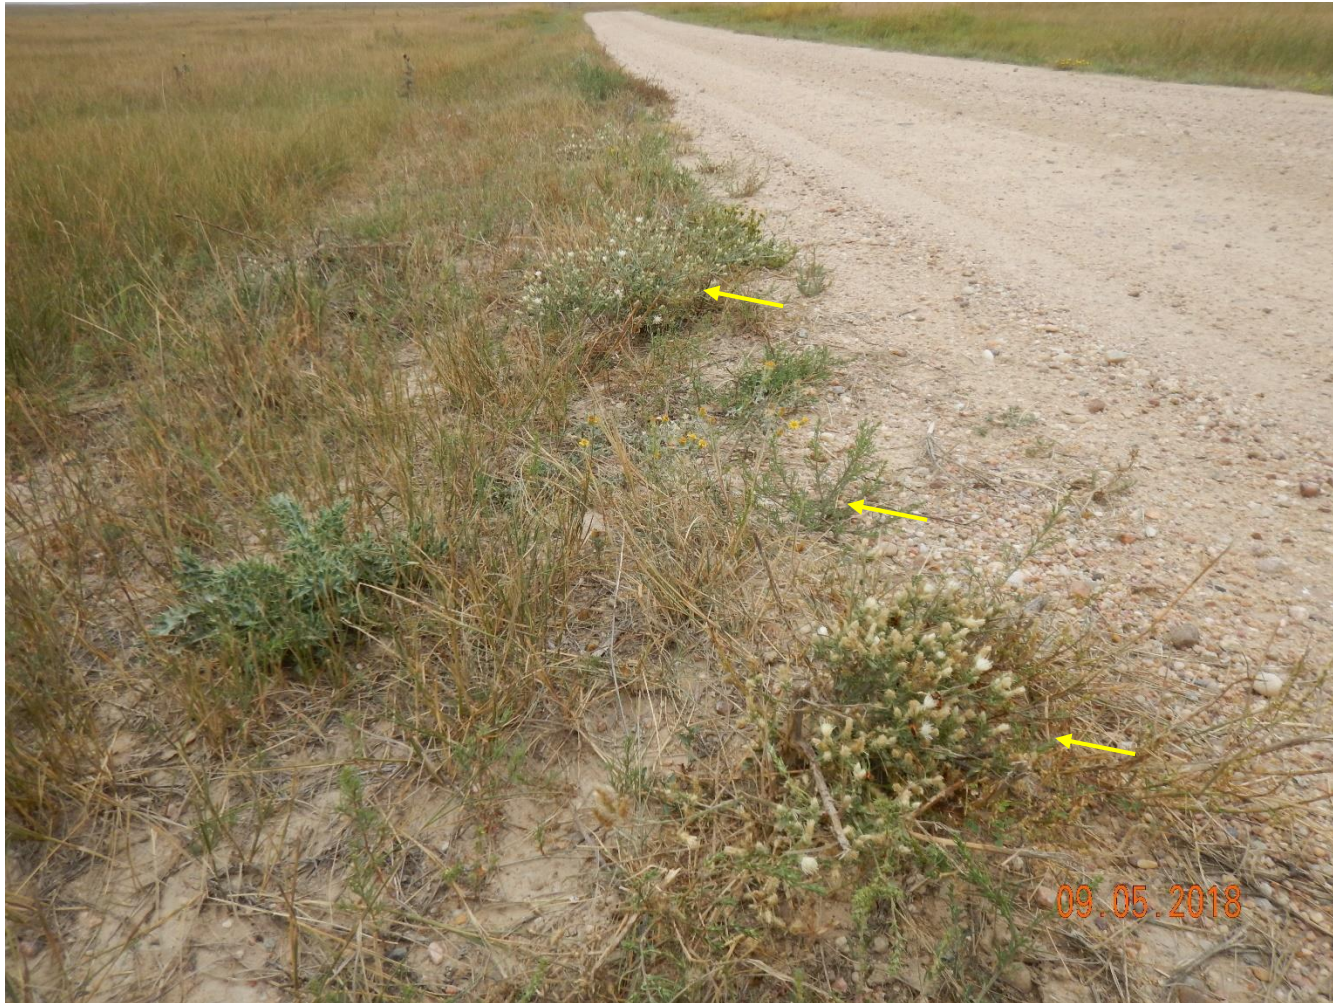
Photo 4: Photo taken from the access road. Photo shows Diffuse Knapweed has not been sufficiently managed or removed from access road.

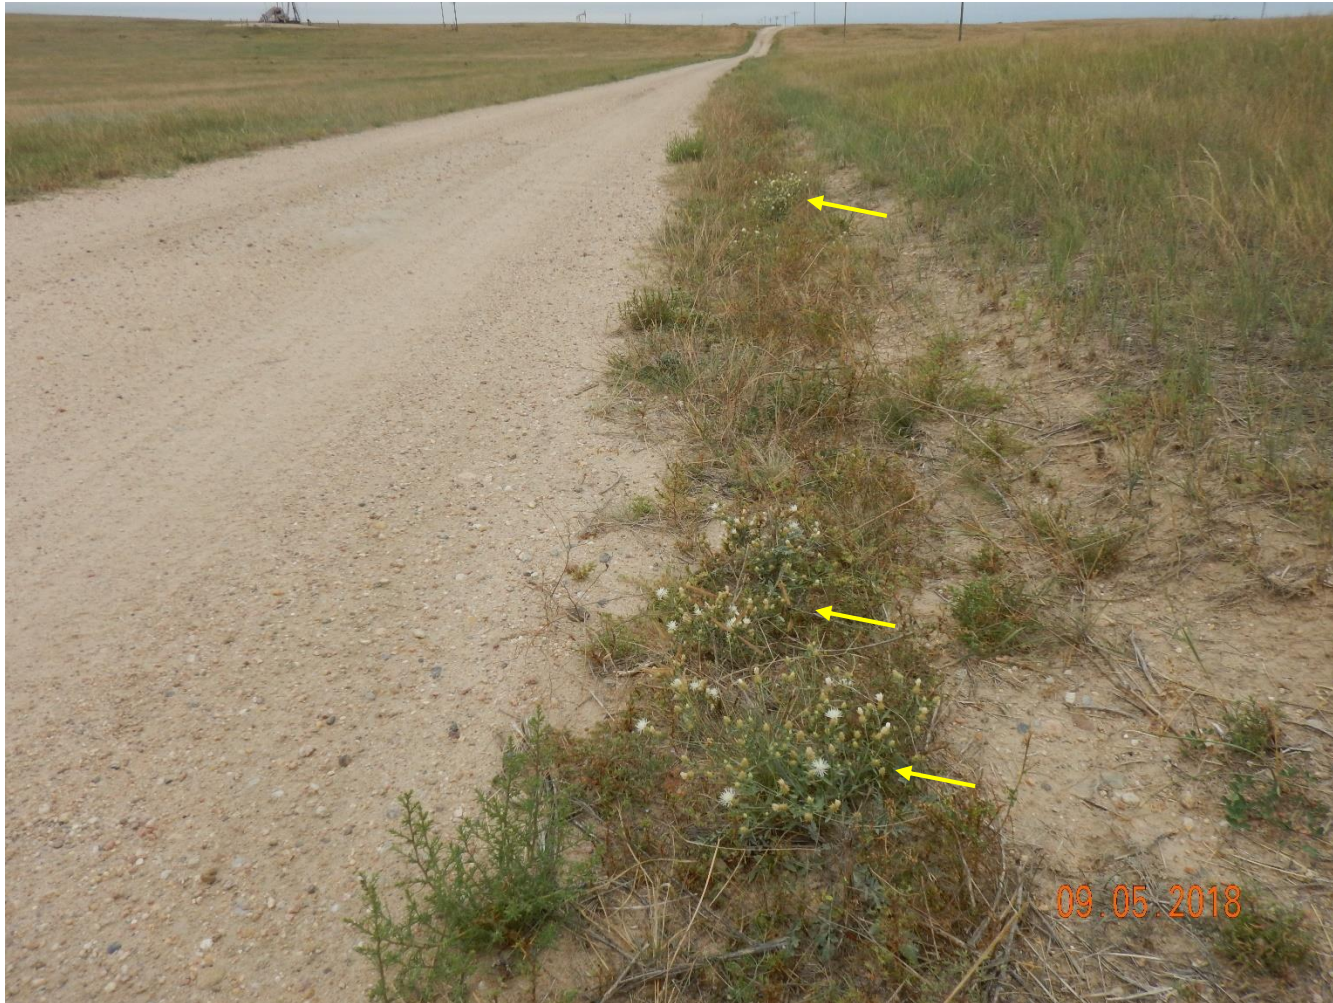
Photo 5: Photo taken from the access road, facing west. Photo shows Diffuse Knapweed has not been sufficiently managed or removed from access road.

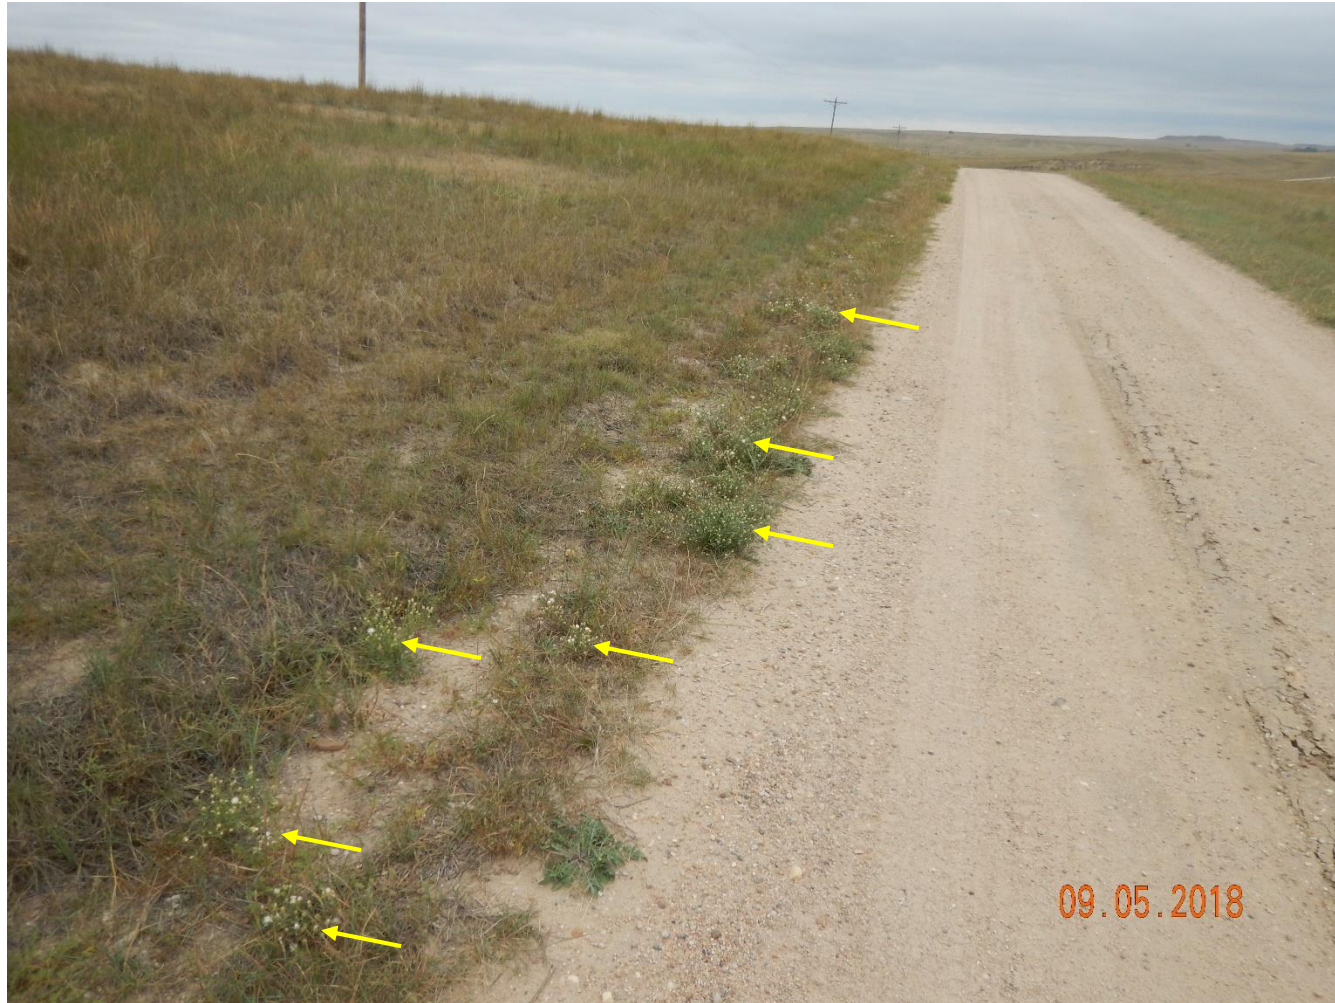
Photo 6: Photo taken from the access road facing east. Photo shows Diffuse Knapweed has not been sufficiently managed or removed from access road.

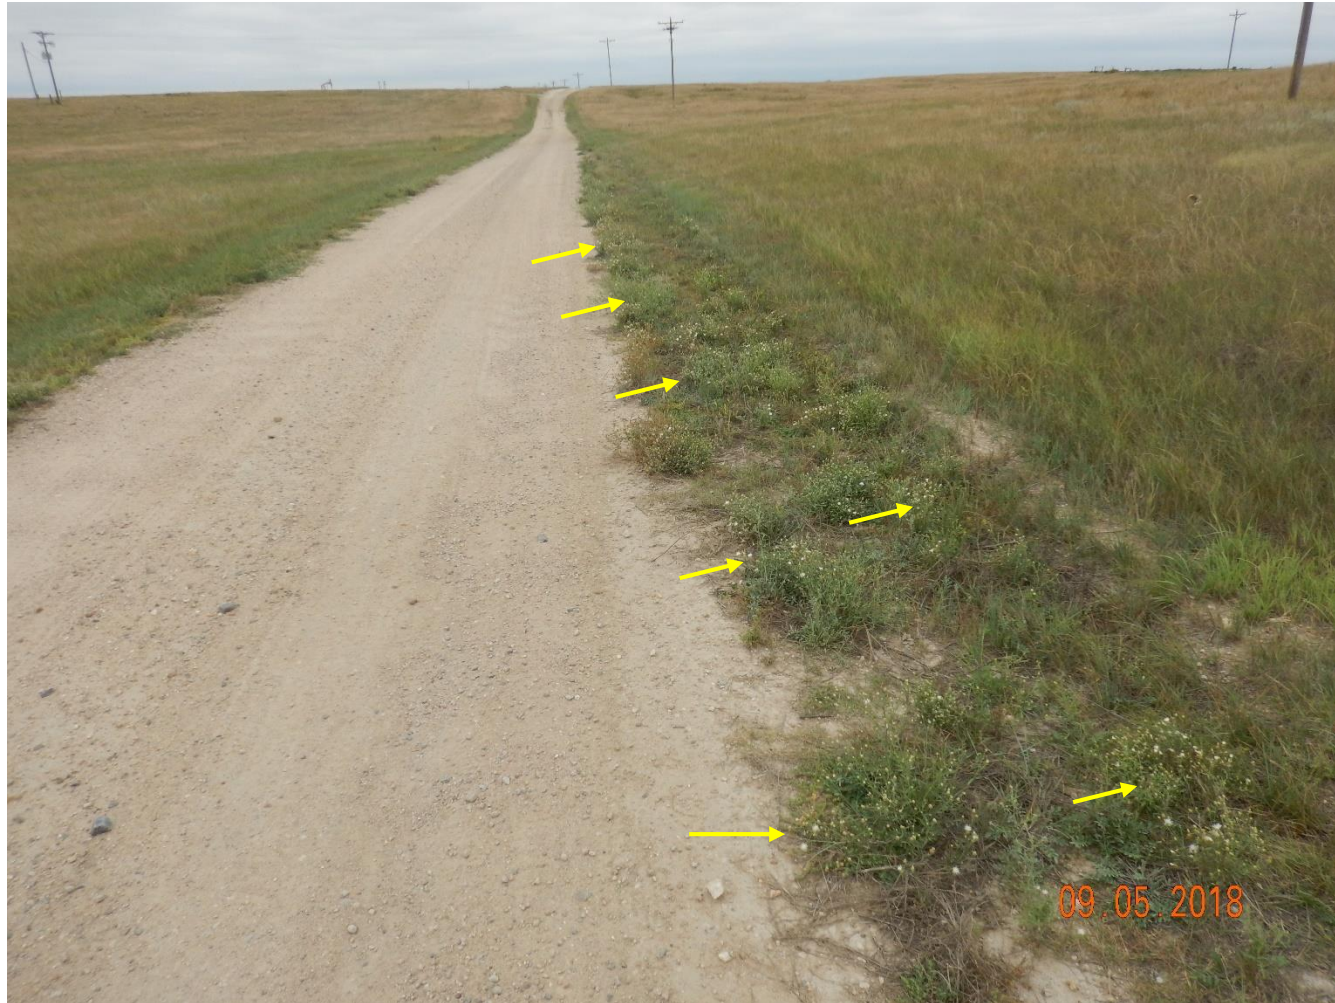
Photo 7: Photo taken from the access road facing west. Photo shows Diffuse Knapweed has not been sufficiently managed or removed from access road.

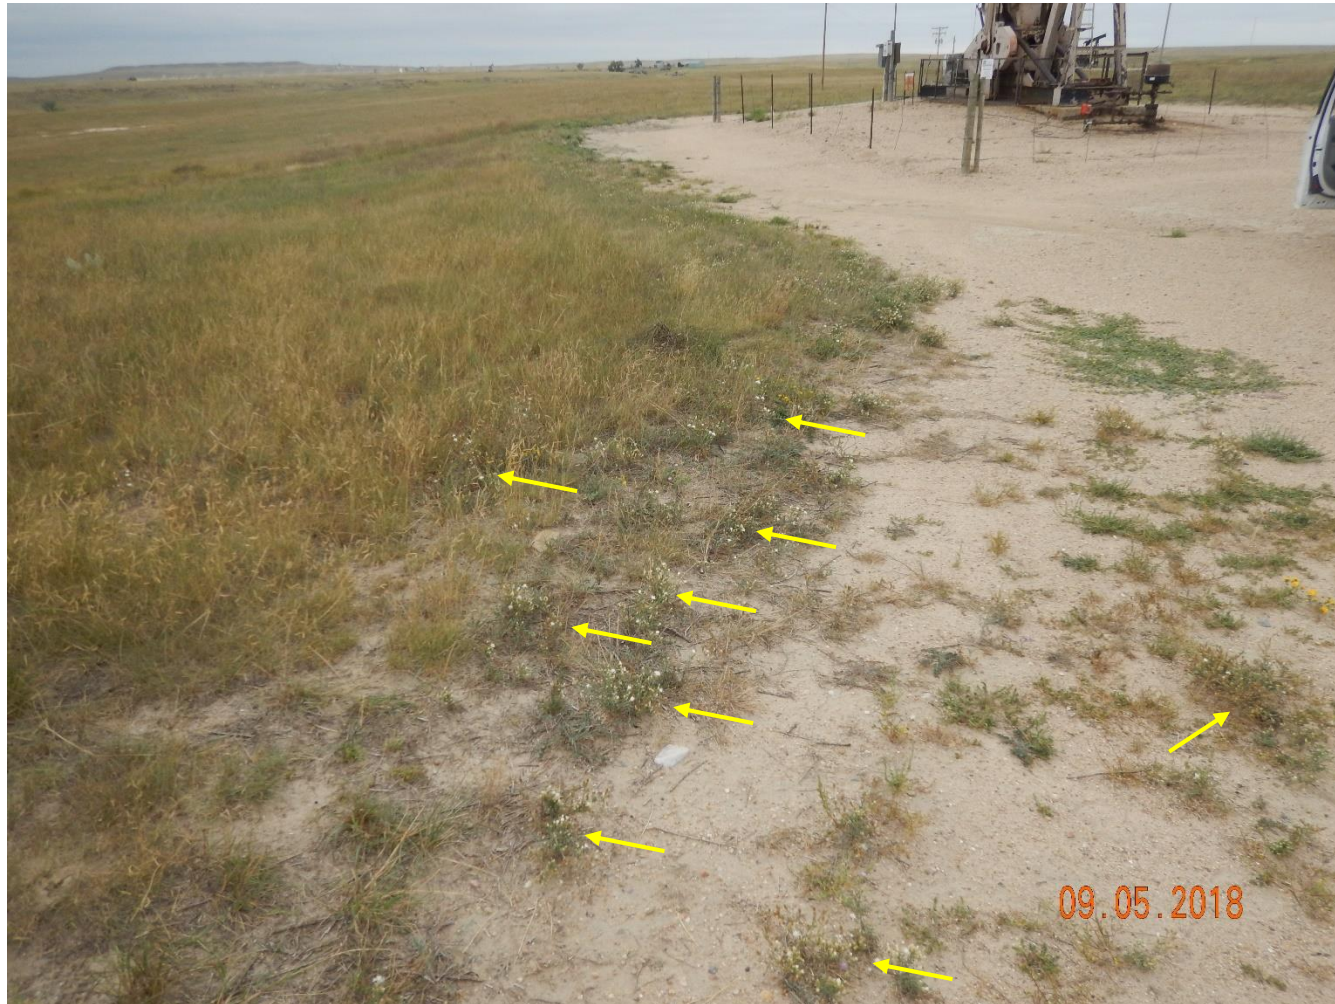
Photo 8: Photo taken from the north end of the location, facing southeast. Photo shows Diffuse Knapweed has not been sufficiently managed or removed from location.

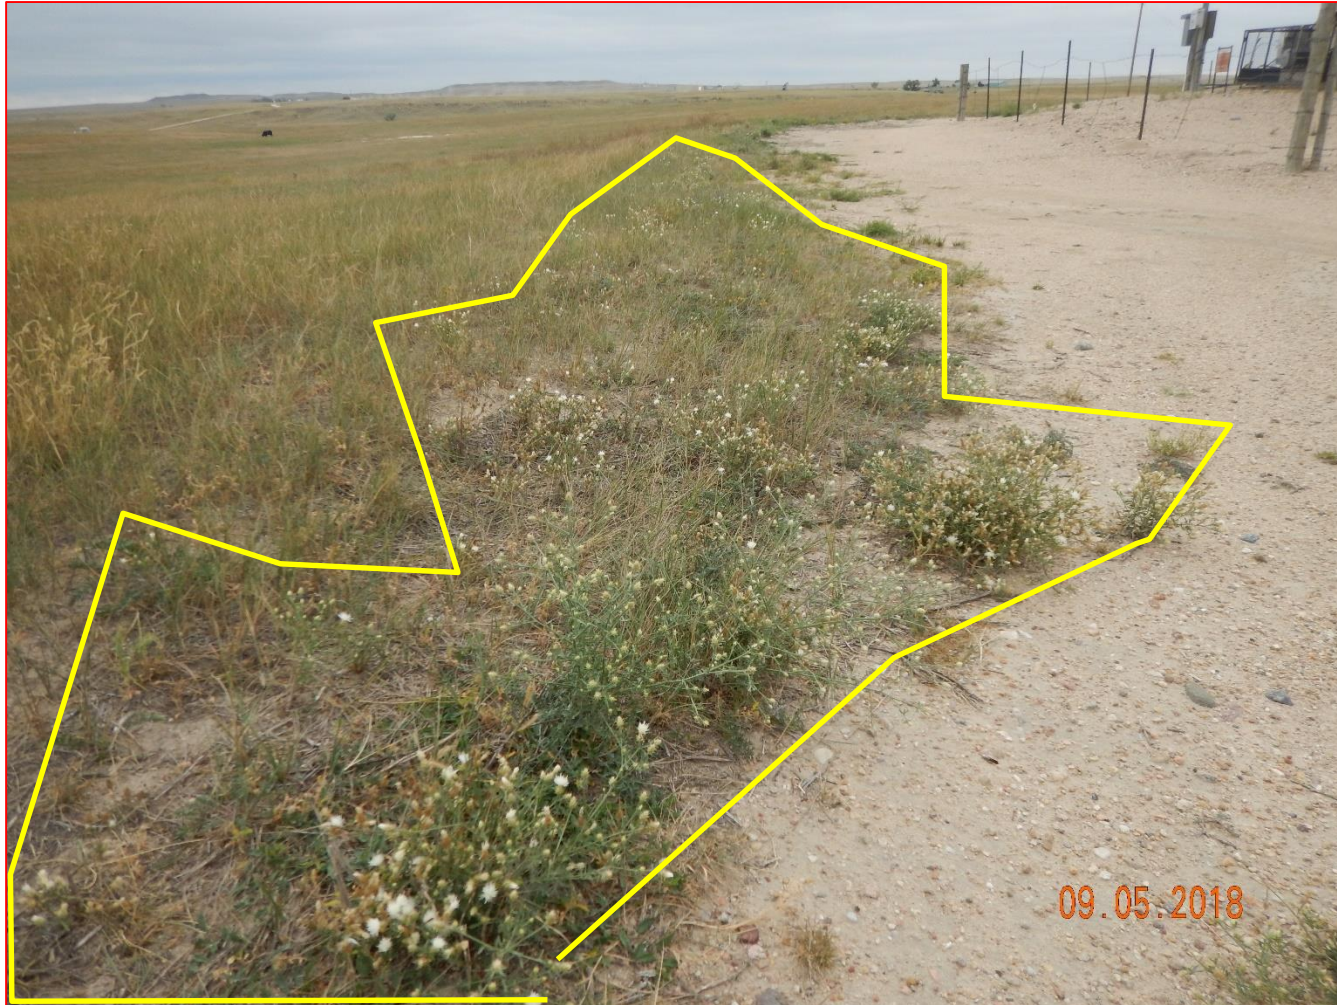
Photo 9: Photo taken from the north end of the location, facing southeast. Photo shows Diffuse Knapweed has not been sufficiently managed or removed from location.

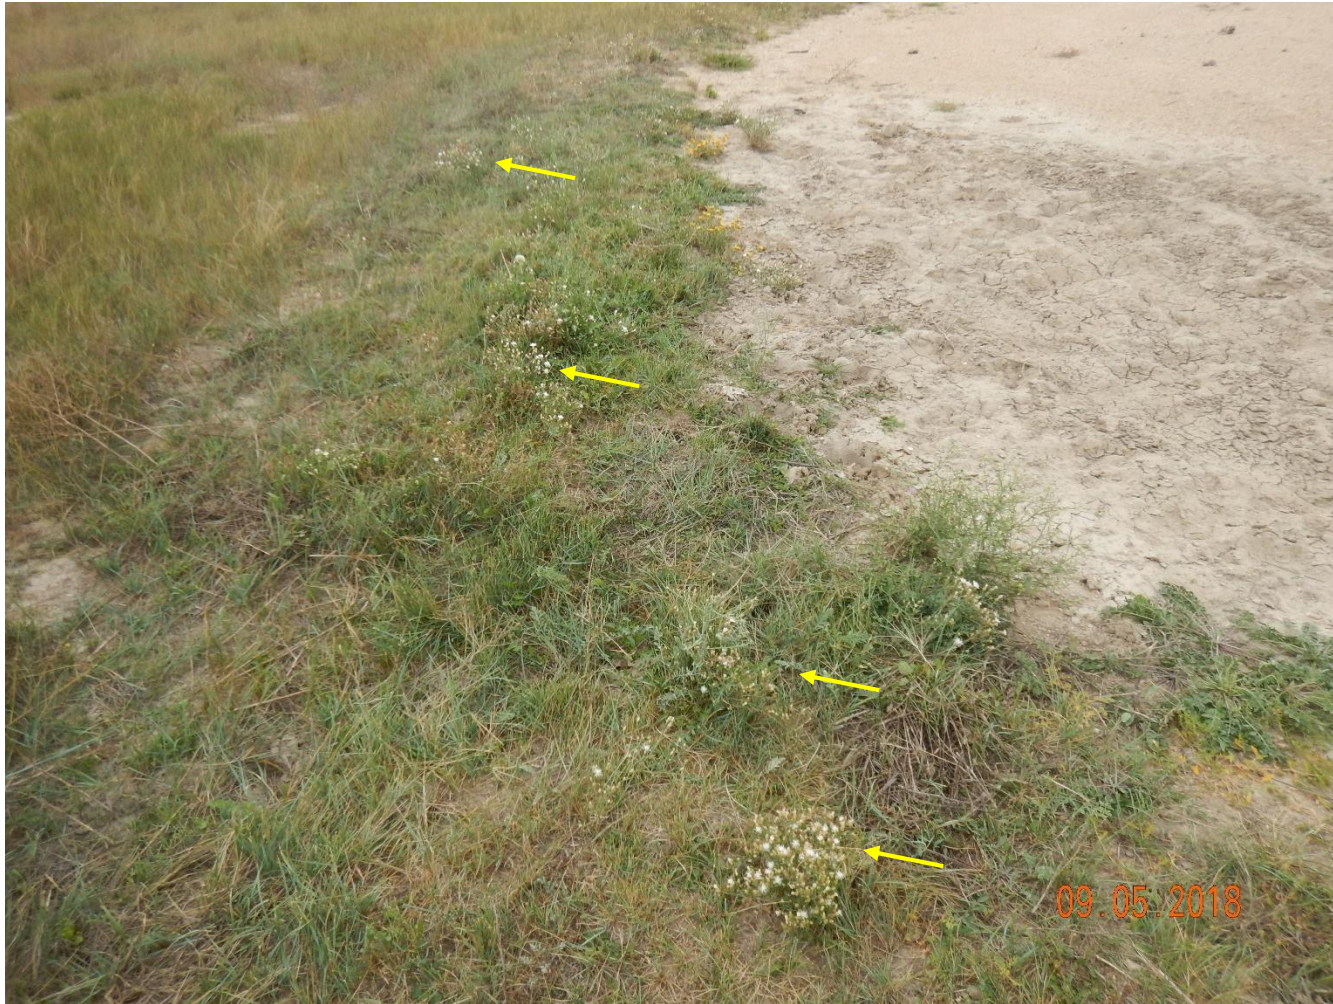
Photo 10: Photo taken from the south end of the location, facing southwest. Photo shows Diffuse Knapweed has not been sufficiently managed or removed from location.

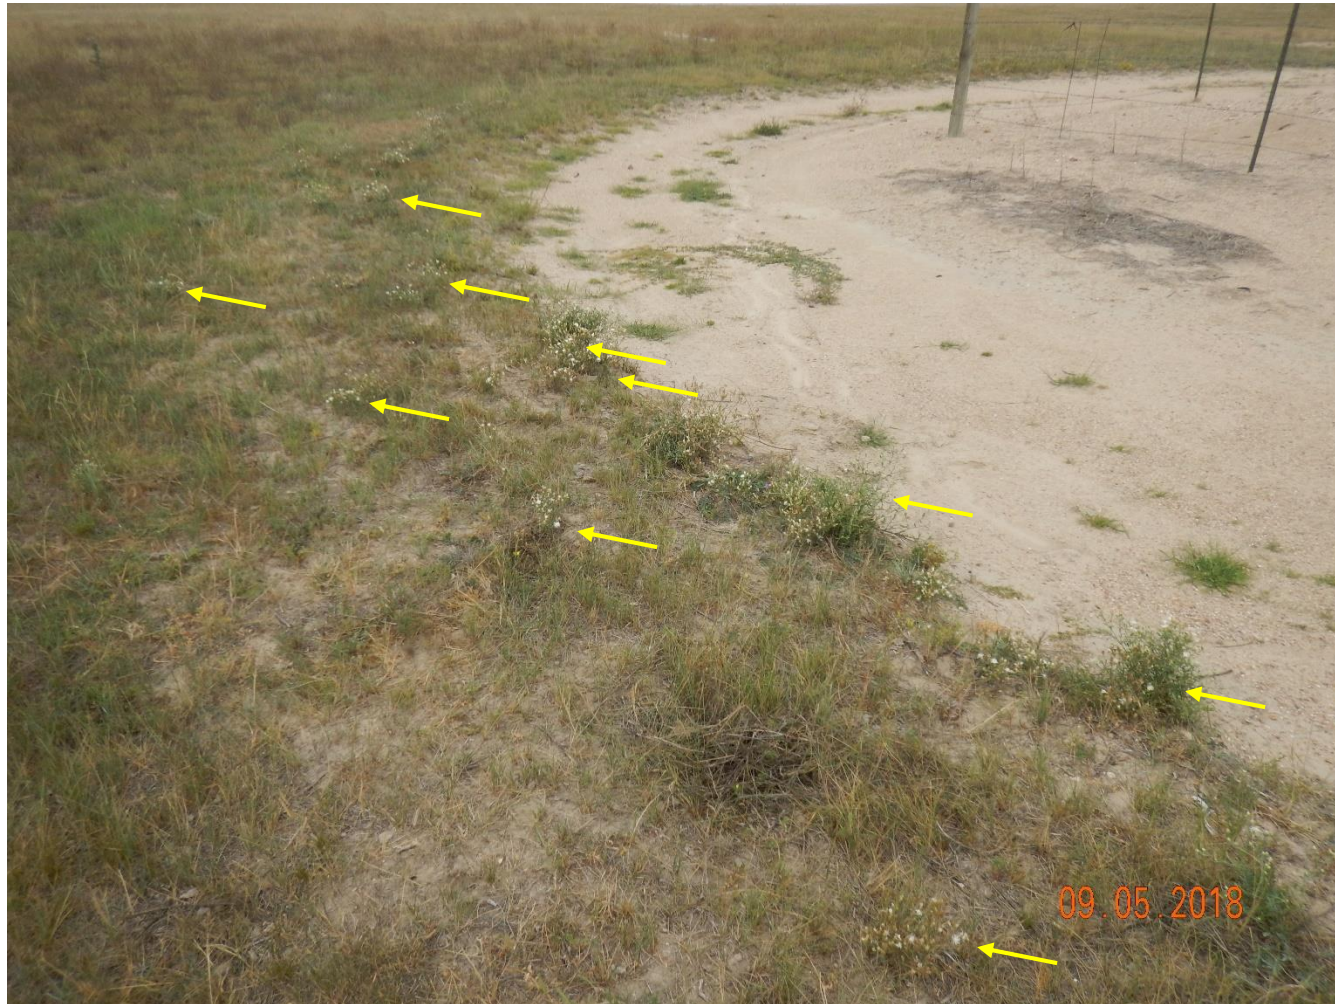
Photo 11: Photo taken from the southeast end of the location, facing southwest. Photo shows Diffuse Knapweed has not been sufficiently managed or removed from location.

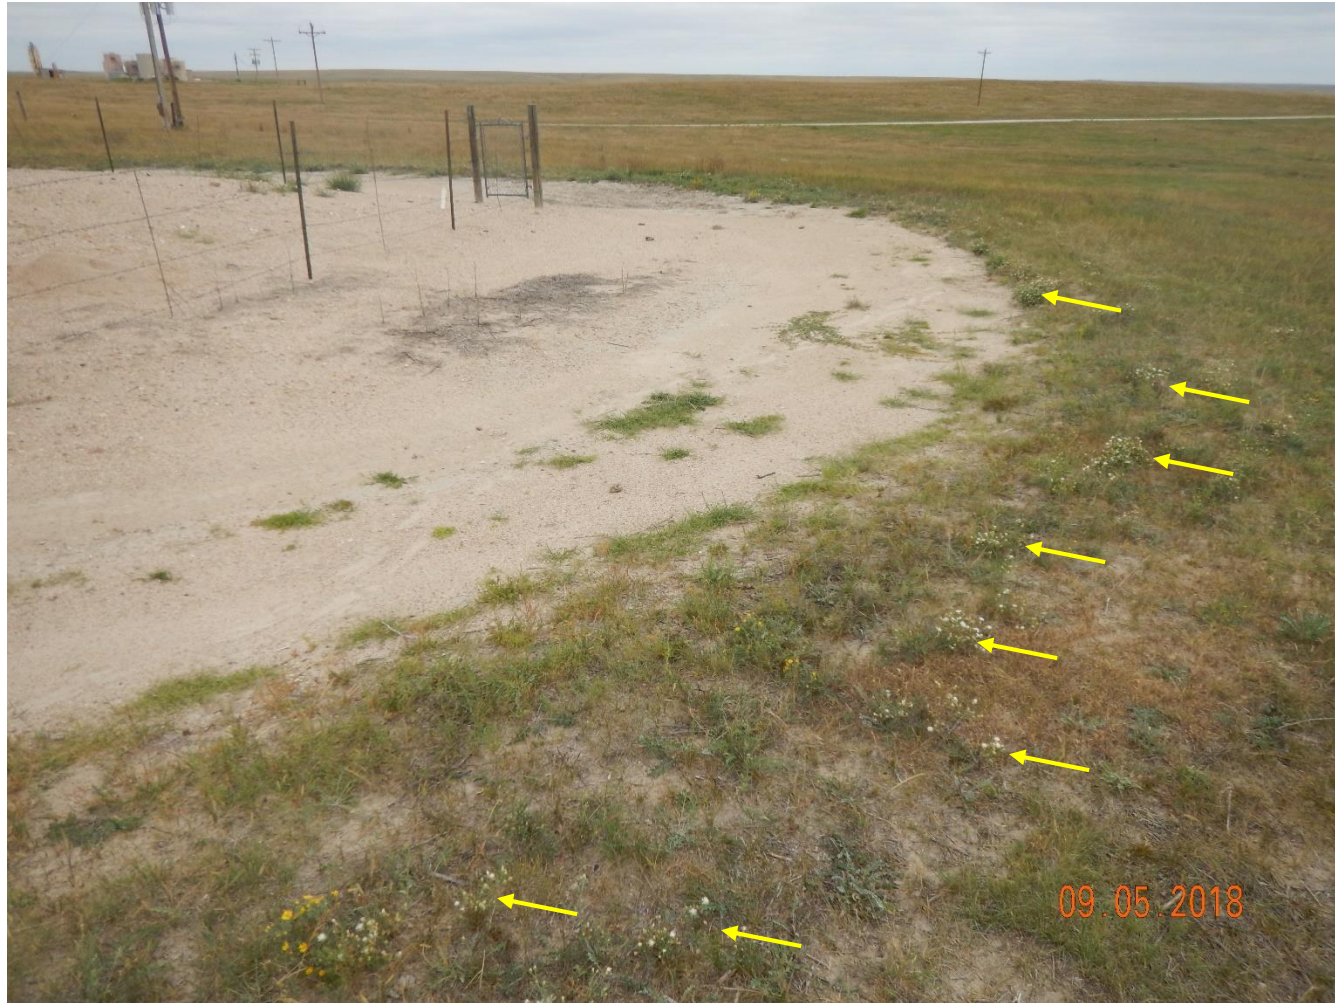
Photo 12: Photo taken from the south end of the location, facing northeast. Photo shows Diffuse Knapweed has not been sufficiently managed or removed from location.

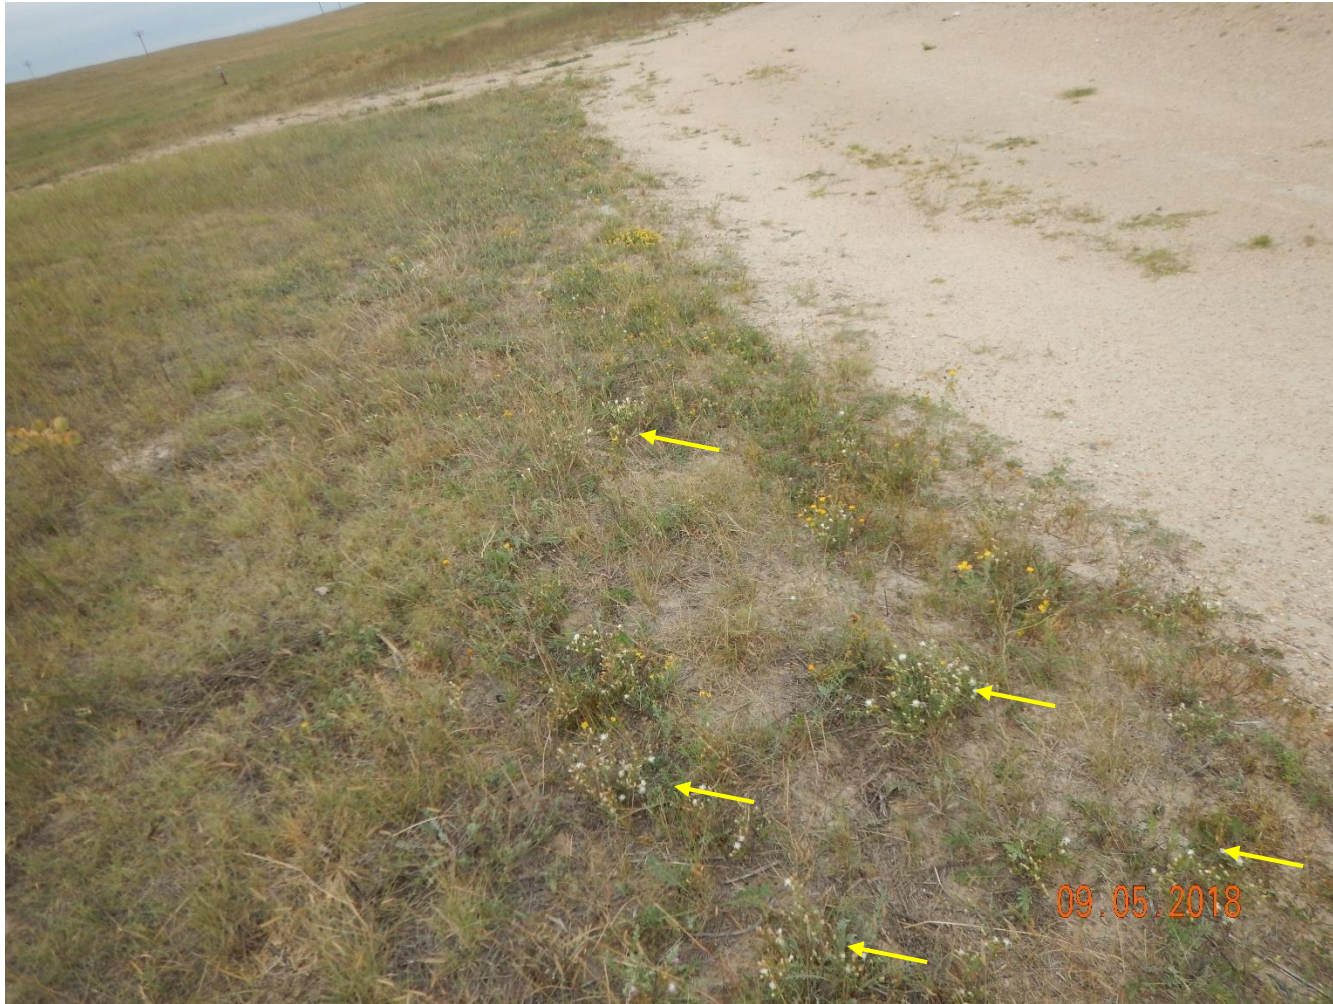
Photo 13: Photo taken from the west end of the location, facing northeast. Photo shows Diffuse Knapweed has not been sufficiently managed or removed from location.

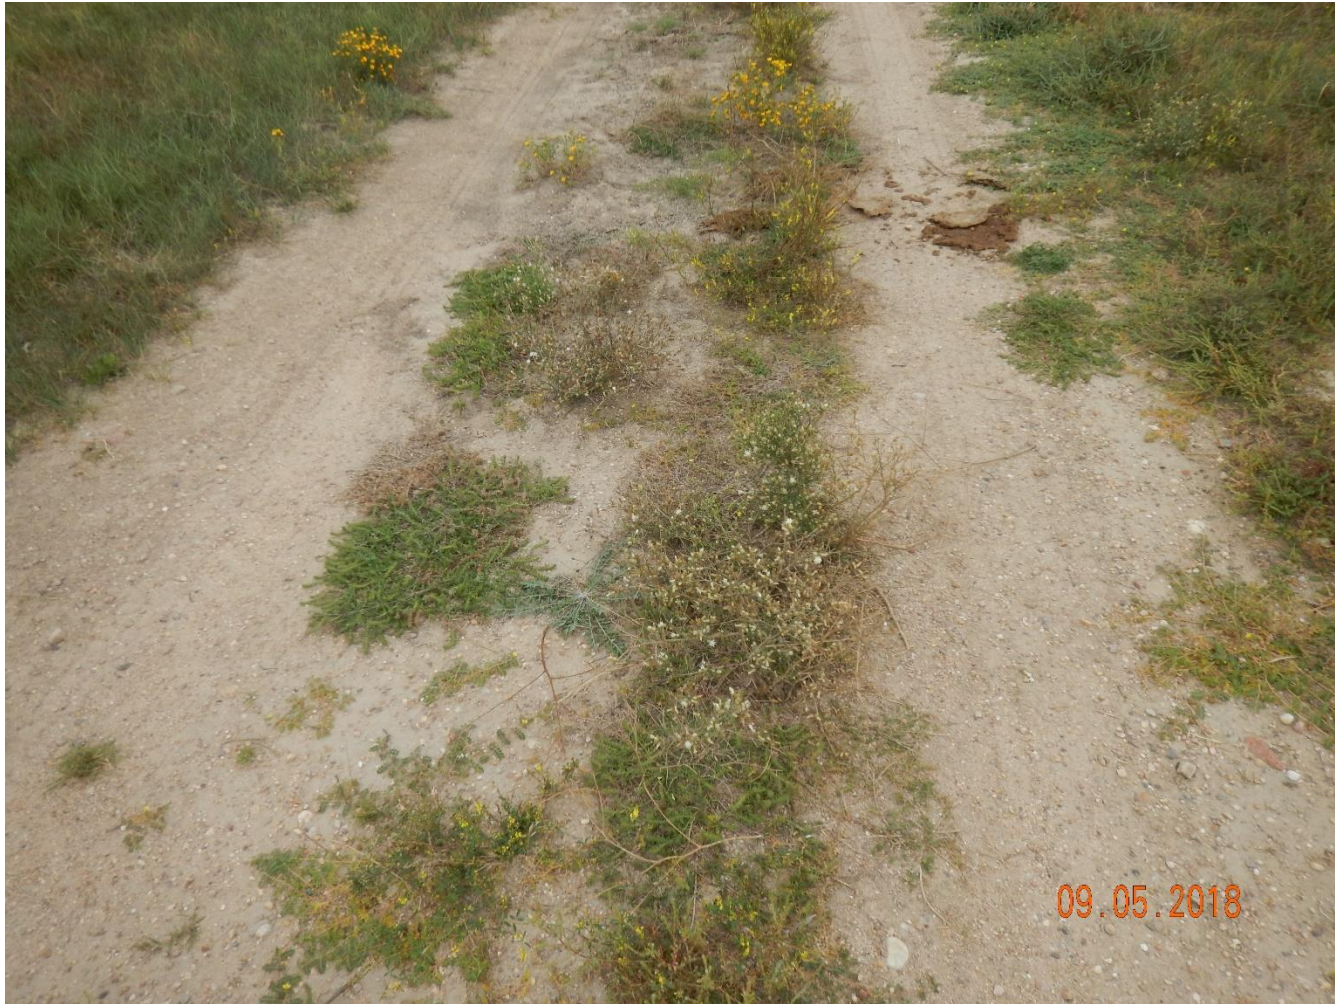
Photo 14: Photo taken from the north end of the location. Photo shows Diffuse Knapweed has not been sufficiently managed or removed from access road.
