Inspection Photos

Operator: BP Production

API: 05-067-08507

Date: 9/10/2018

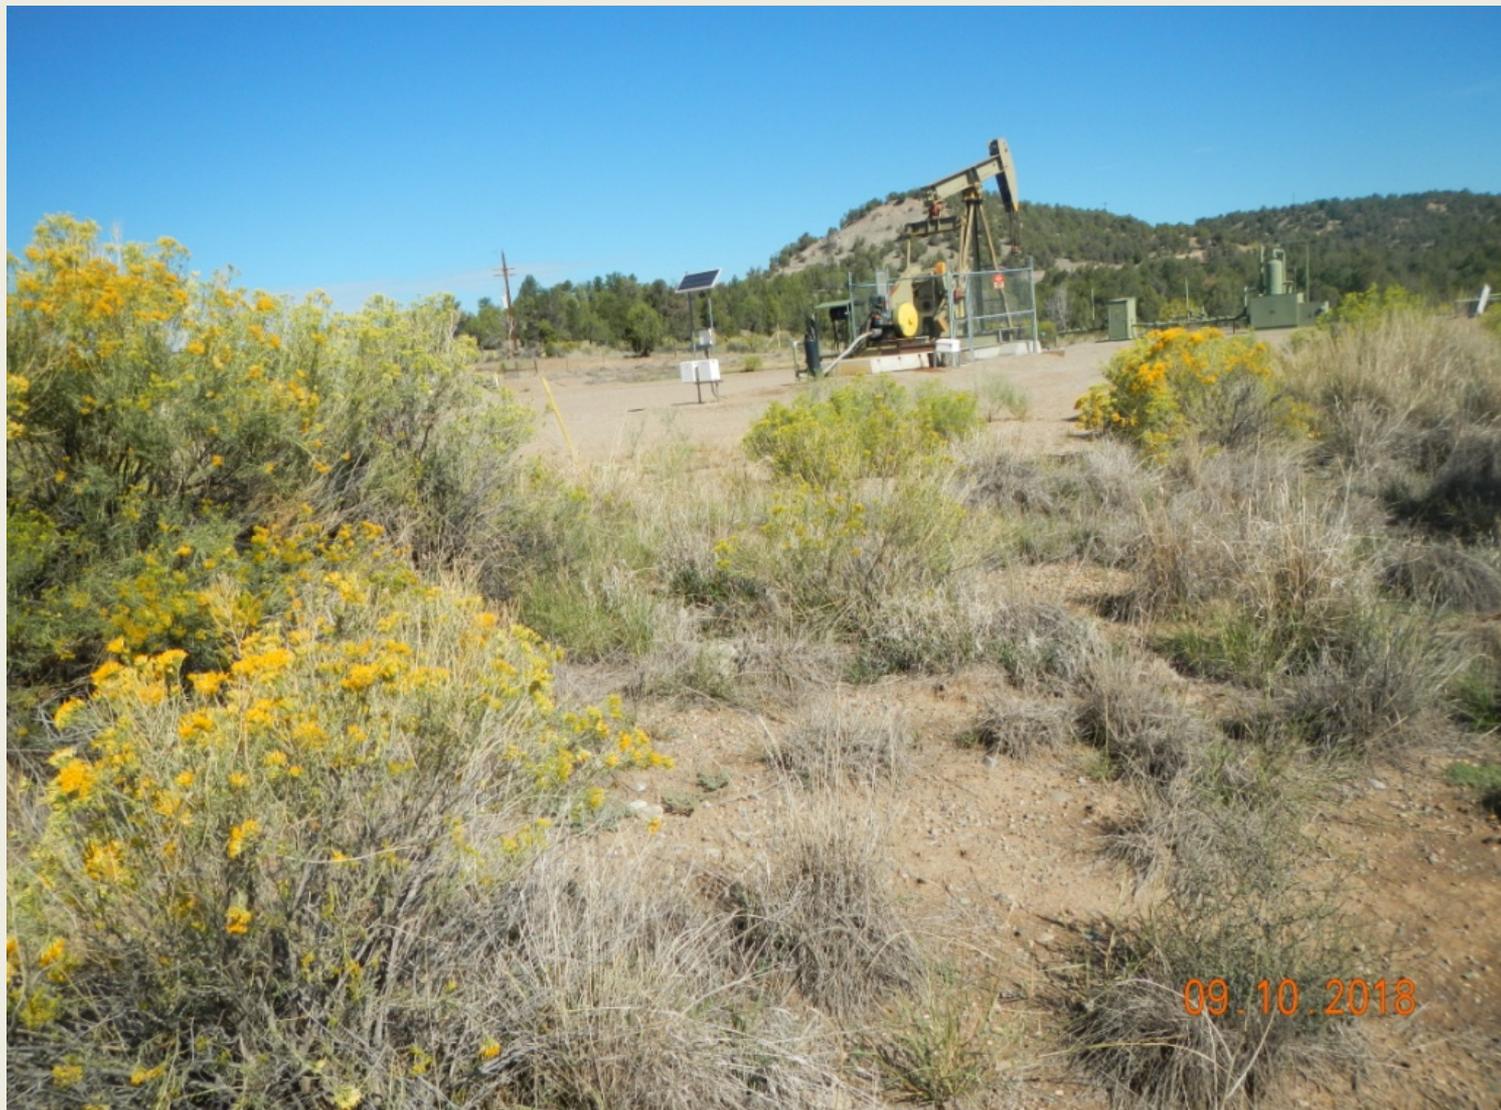
Photo 1. View of the project area from the southwestern corner facing center.

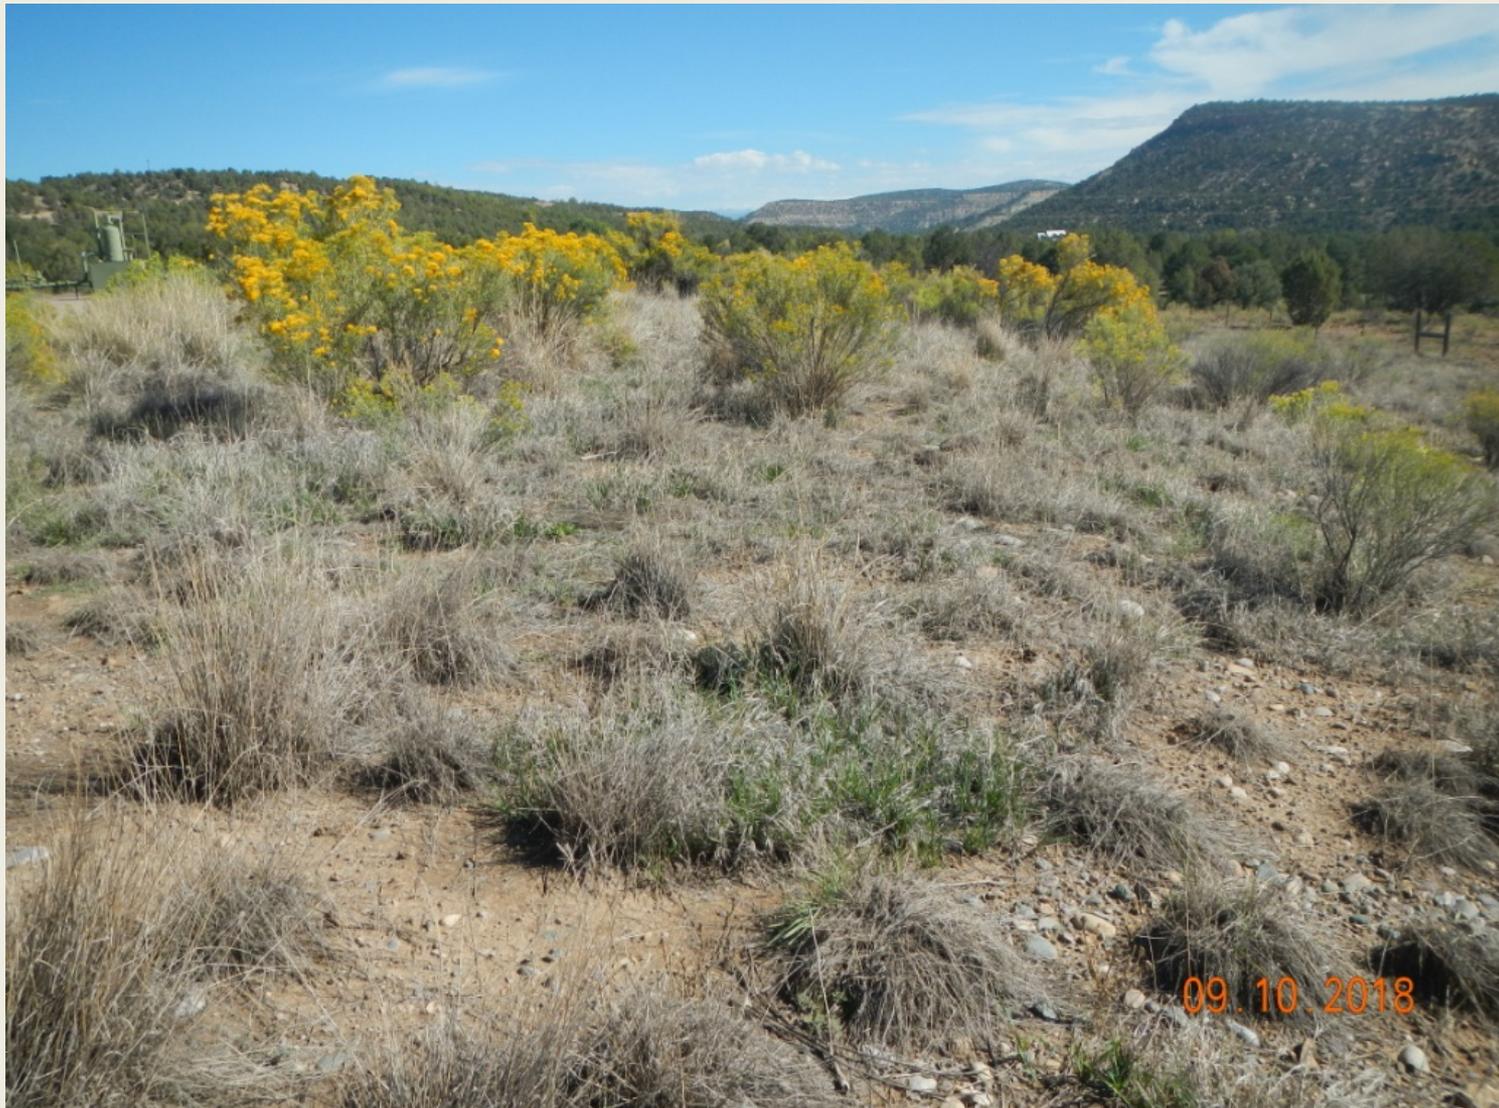
Photo 2. View of the southern portion of the project area from the southwestern corner facing eastward. Revegetation is progressing with grasses and shrubs such as crested wheatgrass (*Agropyron cristatum*), smooth brome (*Bromus inermis*), and rubber rabbitbrush (*Chrysothamnus nauseosus*).

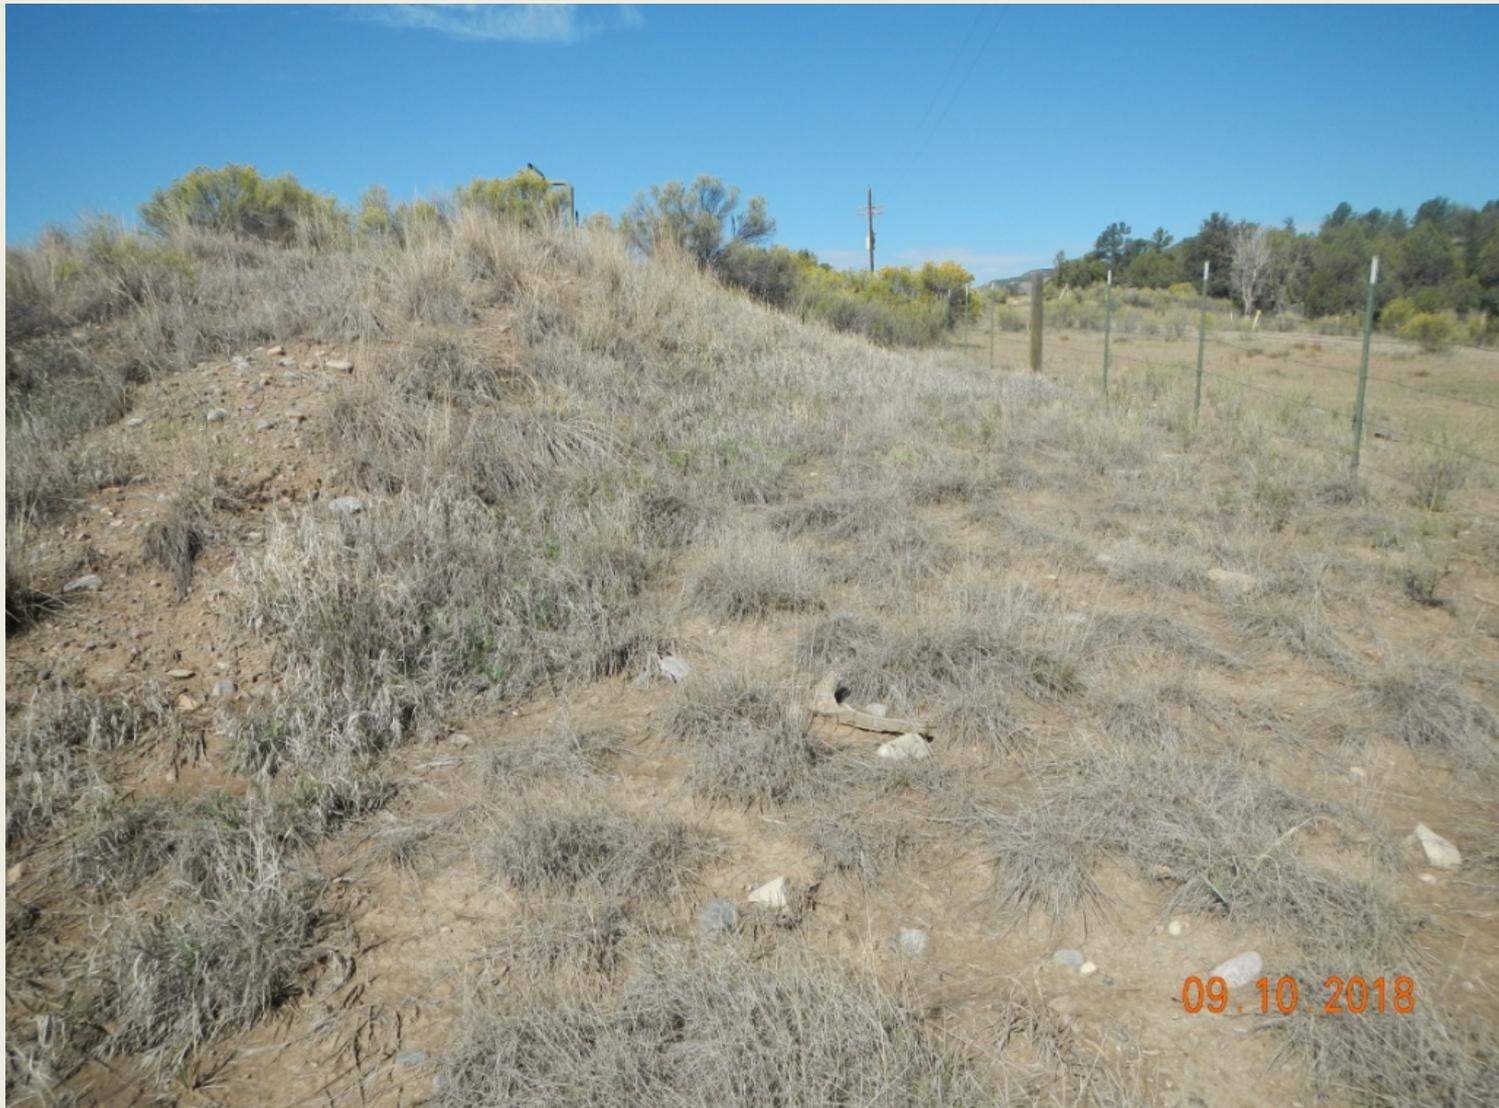
Photo 3. View of the northern portion of the project area from the northeastern corner facing westward.

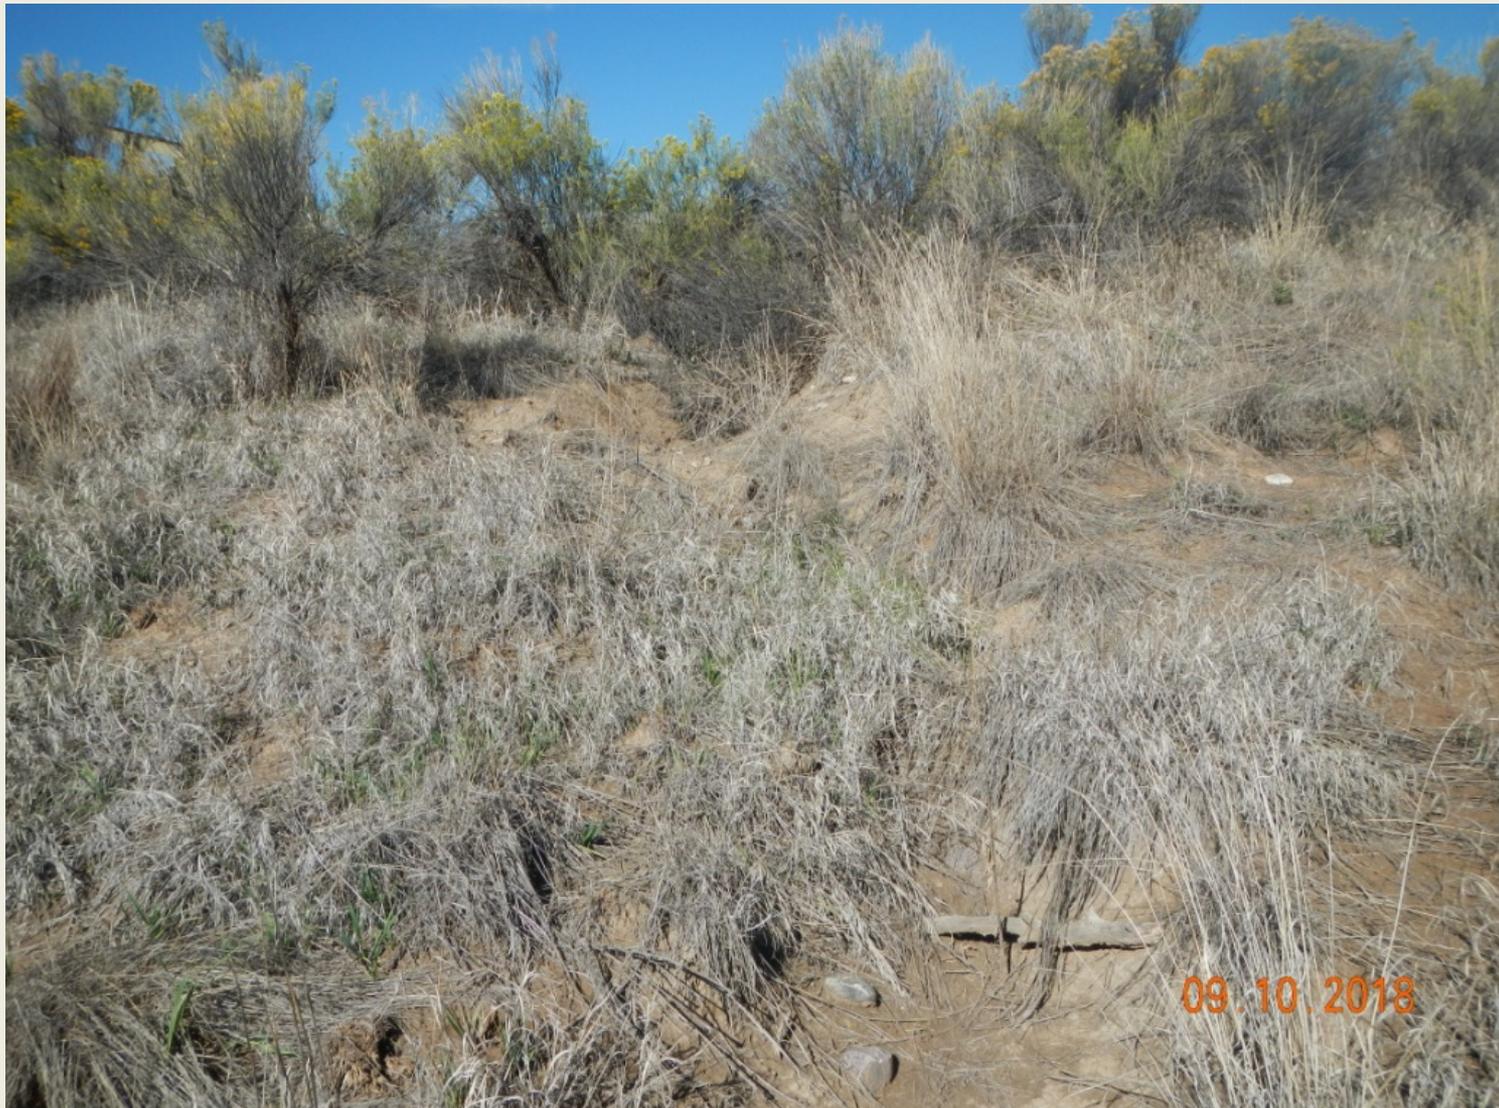
Photo 4. View of erosional channel forming within the eastern project area.
