**Inspection Photos**  
**Location Name: RUSSELL, TOM E. UNIT D 2**  
**Facility ID: 241030**

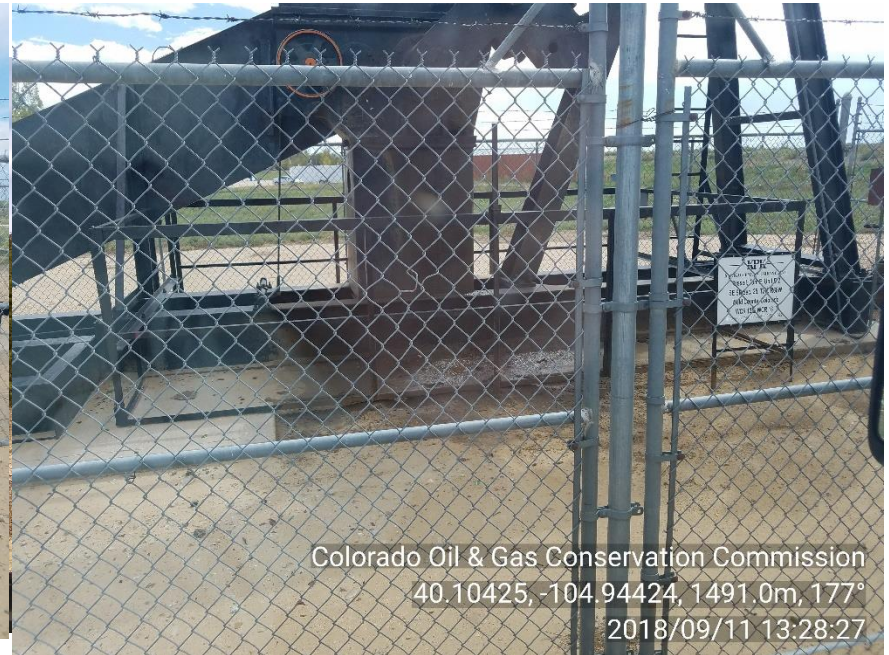
**Photo 2. Fluid leaking from pumpjack gear box**
