Inspection Photos
Location Name: Federal Sandwash 2-1
API: 05-081-06792

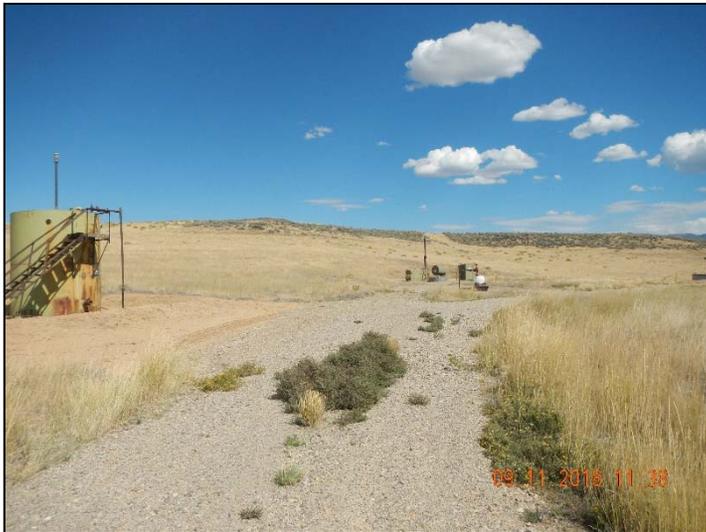
Photo 1. Overview of location taken at entrance facing east.

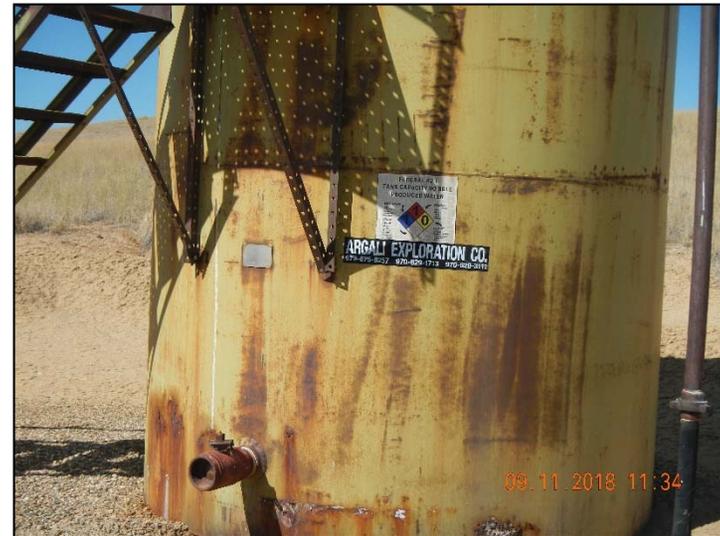
Photo 2. Incorrect emergency contact information on location signs.

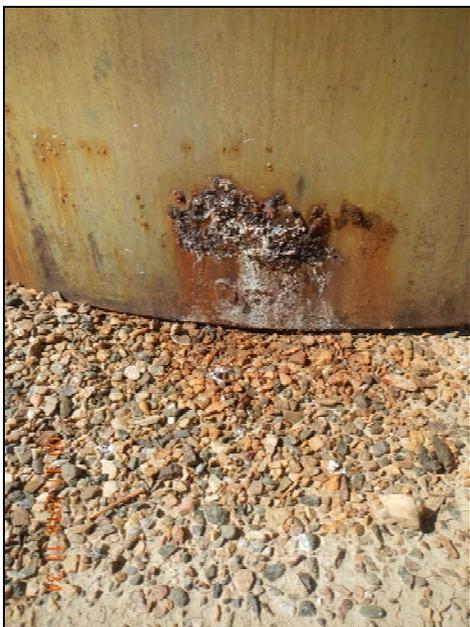
Photo 3. Corrosion on tank.

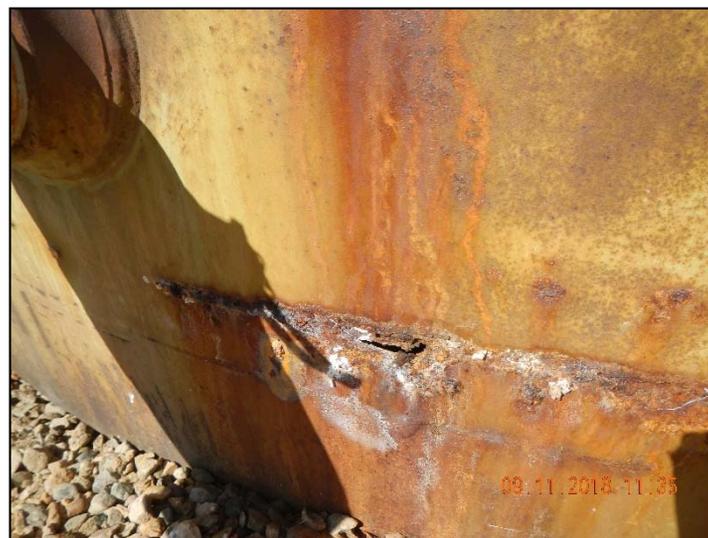
Photo 4. Hole in tank from corrosion.

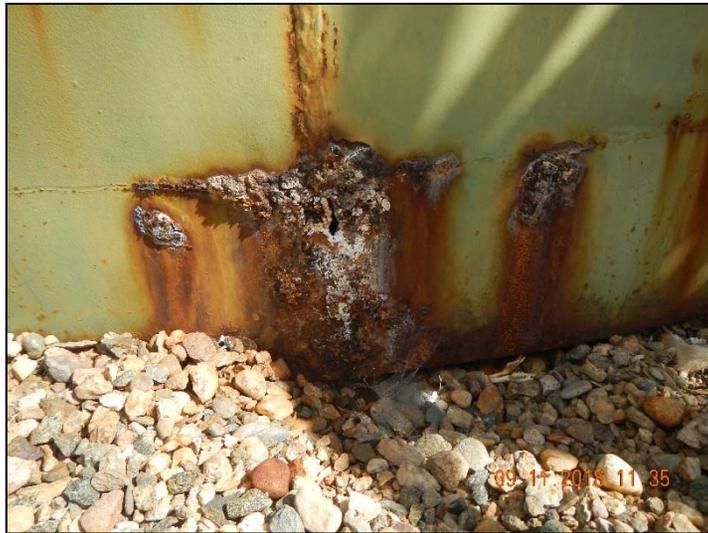
Photo 5. Hole in tank from erosion.

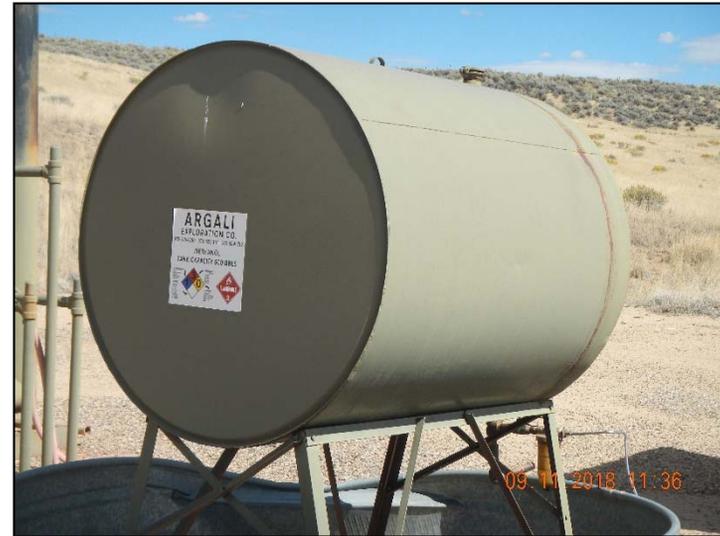
Photo 6. Methanol container labeled as 500 BBL capacity.

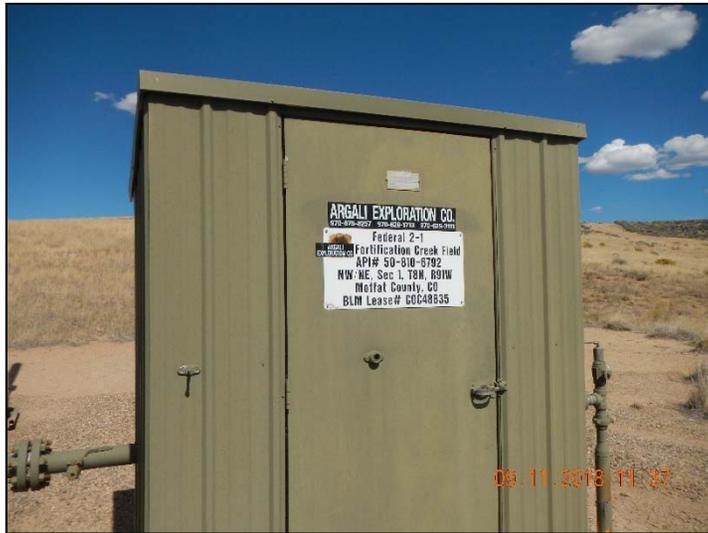
Photo 7. Incorrect emergency contact information on location signs.

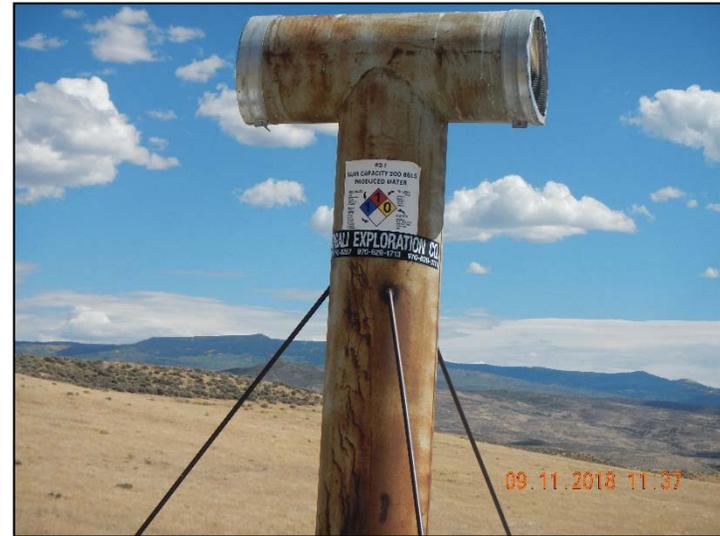
Photo 8. Incorrect emergency contact information on location signs.
