Inspection Photo
Miller 42A-36-692
API # 045-17621
Inspection # 689301896

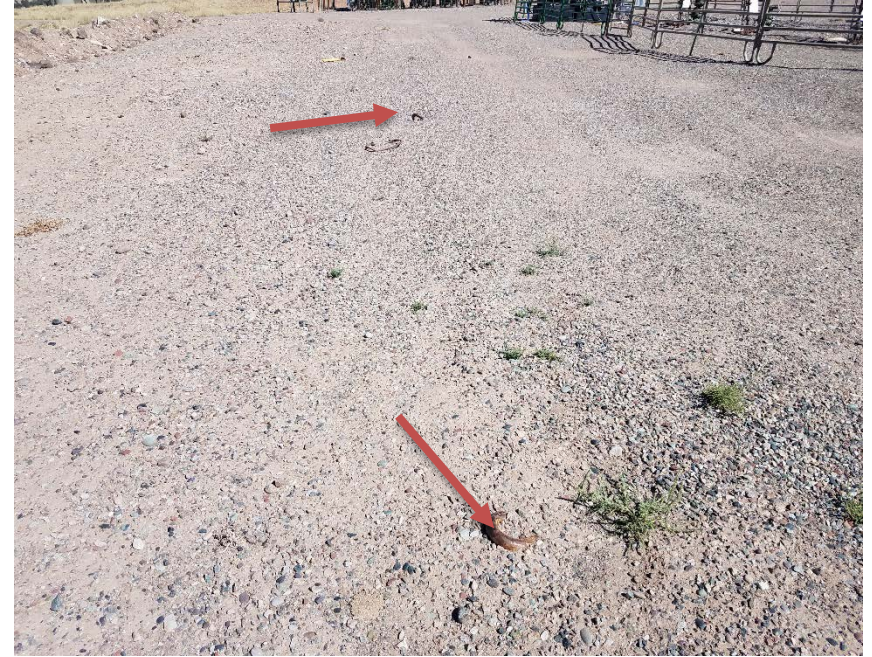
**Location Photo #4, unmarked anchors on
west side of wellheads**

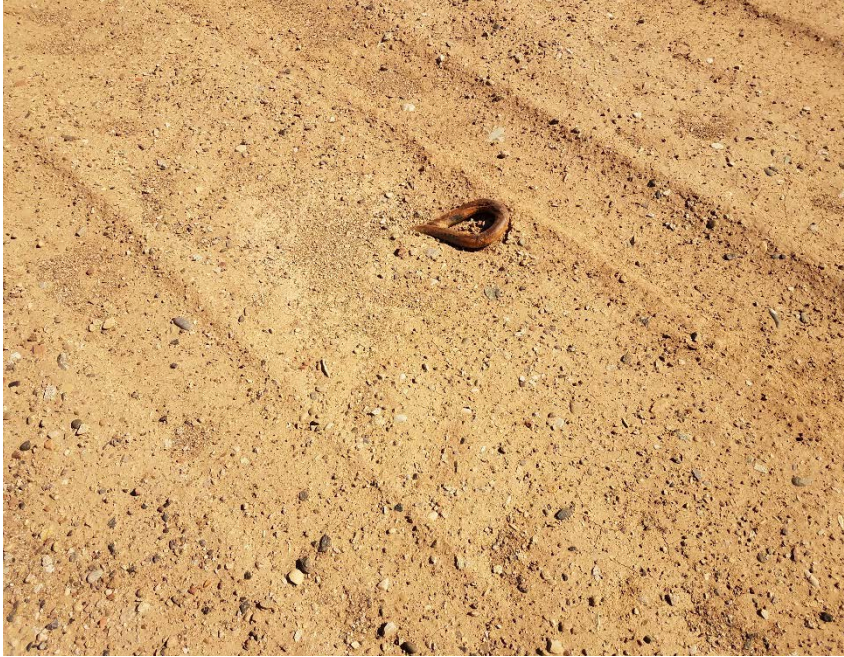
Location Photo #5, unmarked anchors on west side of wellheads

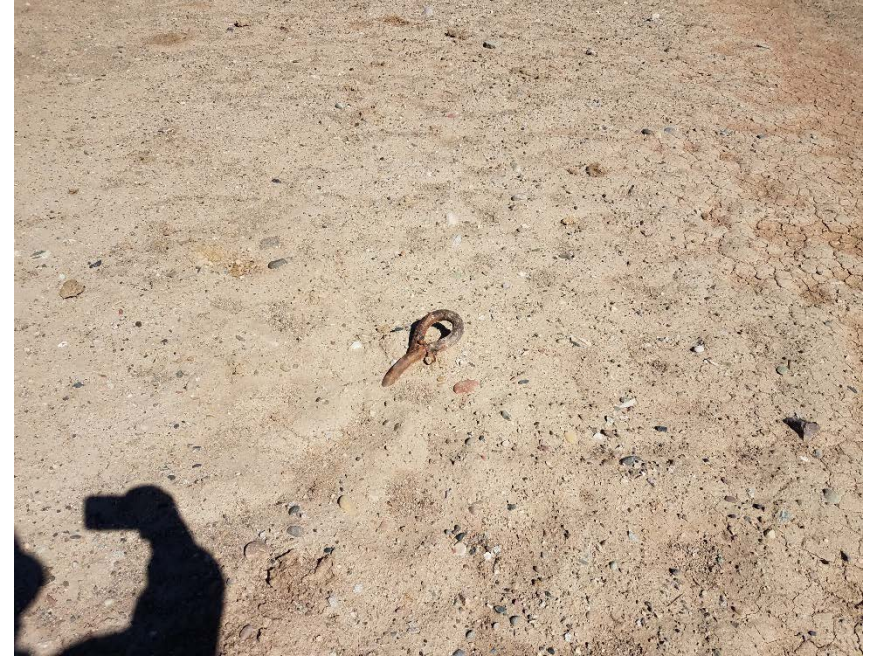
Location Photo #6, unmarked anchors on east side of wellheads.

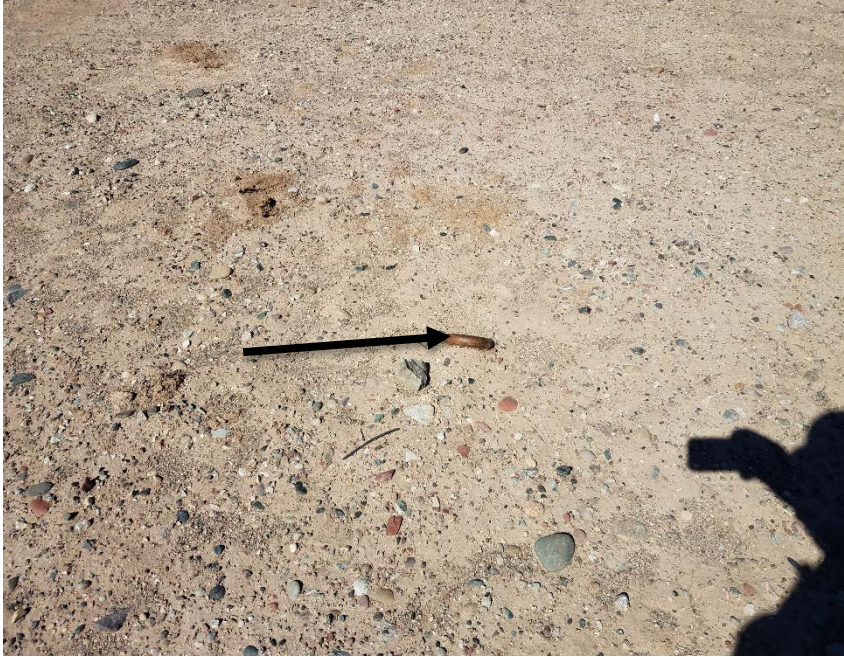
Location Photo #7, unmarked anchors on east side of wellheads.

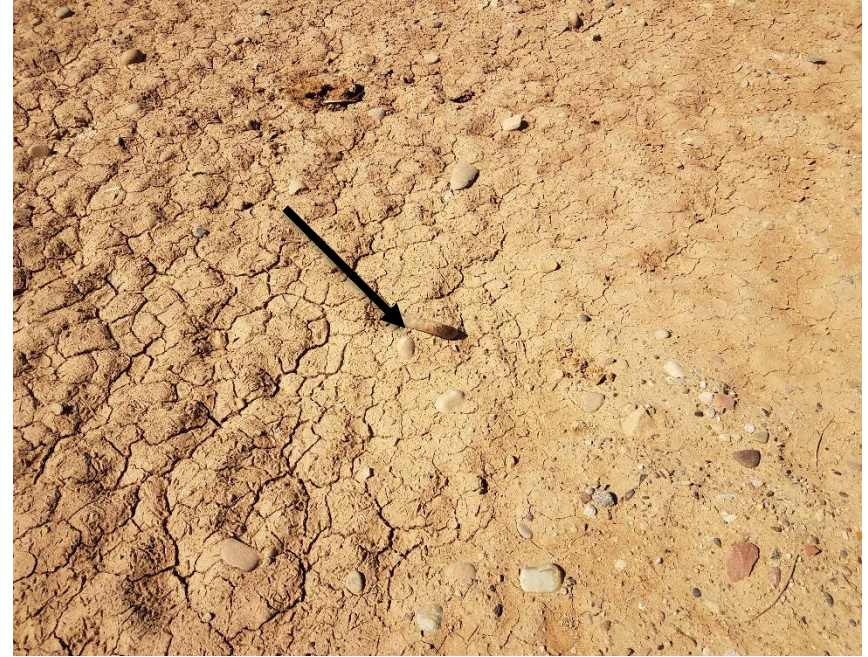
Location Photo #8, unmarked anchors on east side of wellheads.

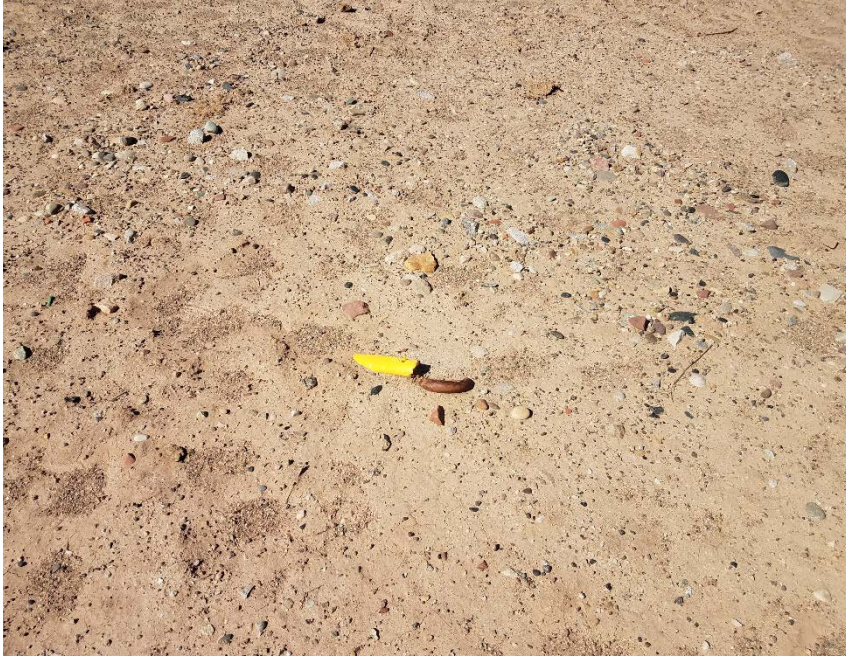
Location Photo #9, unmarked anchors on east side of wellheads.
