Inspection Photos
Location Name: MSSU Location
Location ID: 333083

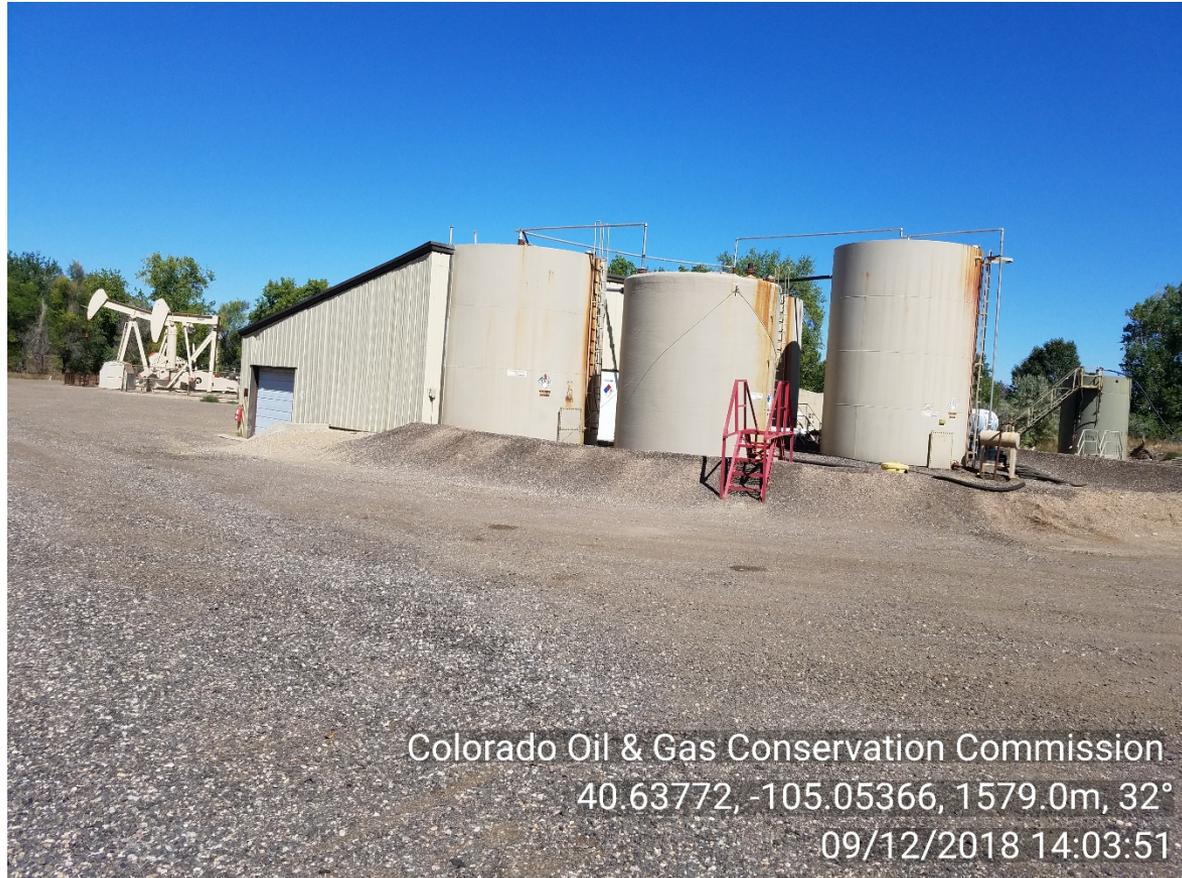
Secondary recovery water storage tanks and facility.
