Inspection Photos

09/12/2018

Operator: BISON OIL & GAS II LLC - 10661

Location ID: 457131

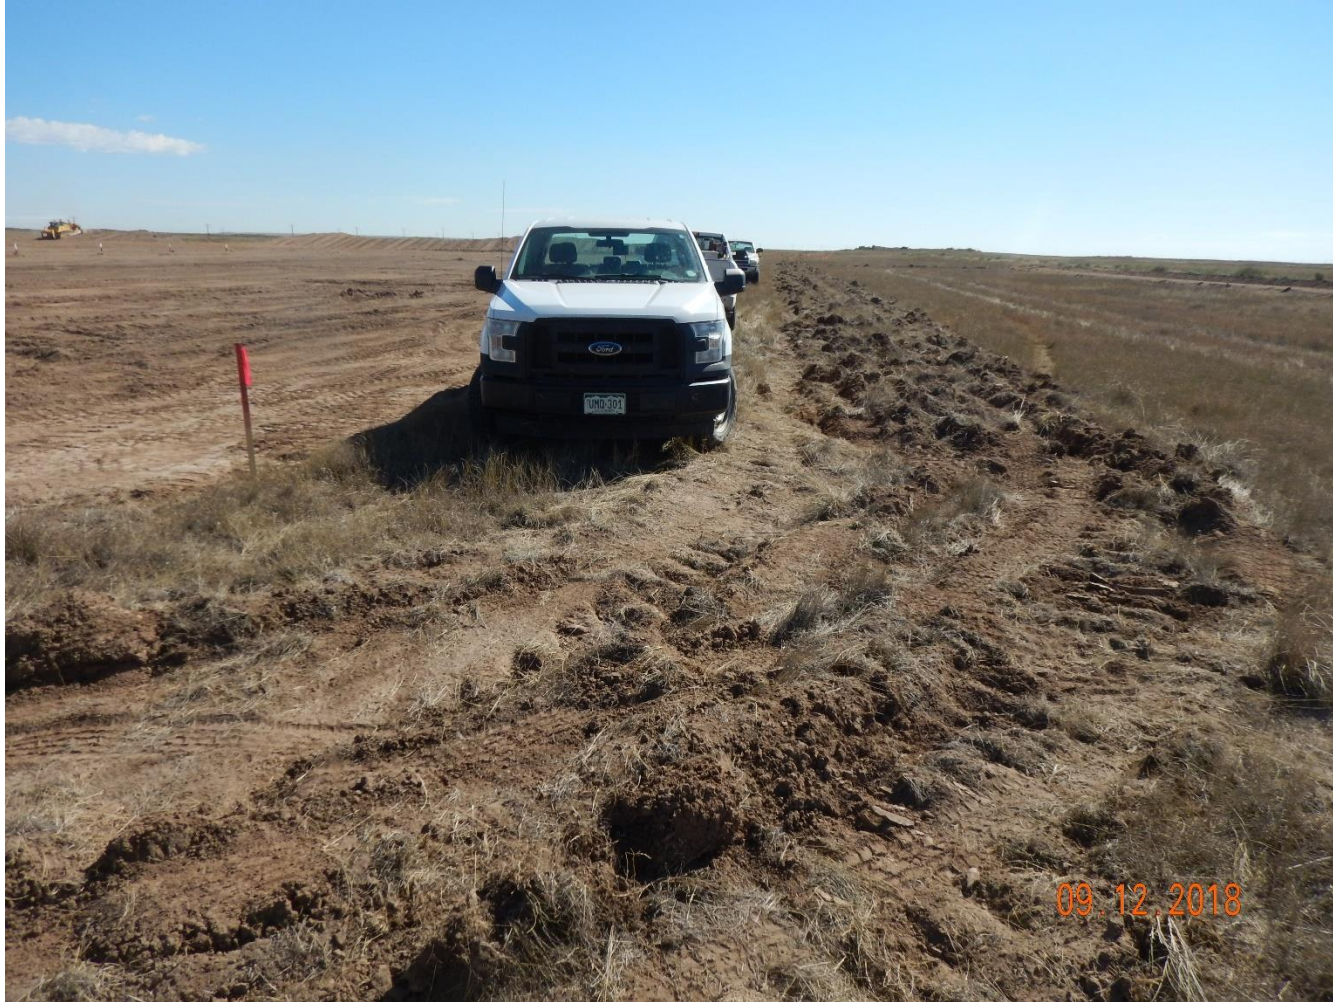
Photo 1: Photo taken from the southwest corner of the location, facing east. Photos 1-3 provide overview of the construction in process. Photo also shows operator implemented surface roughening along perimeter of the location. Surface roughening is a temporary erosion control BMP that needs to be used in conjunction with other BMPs.

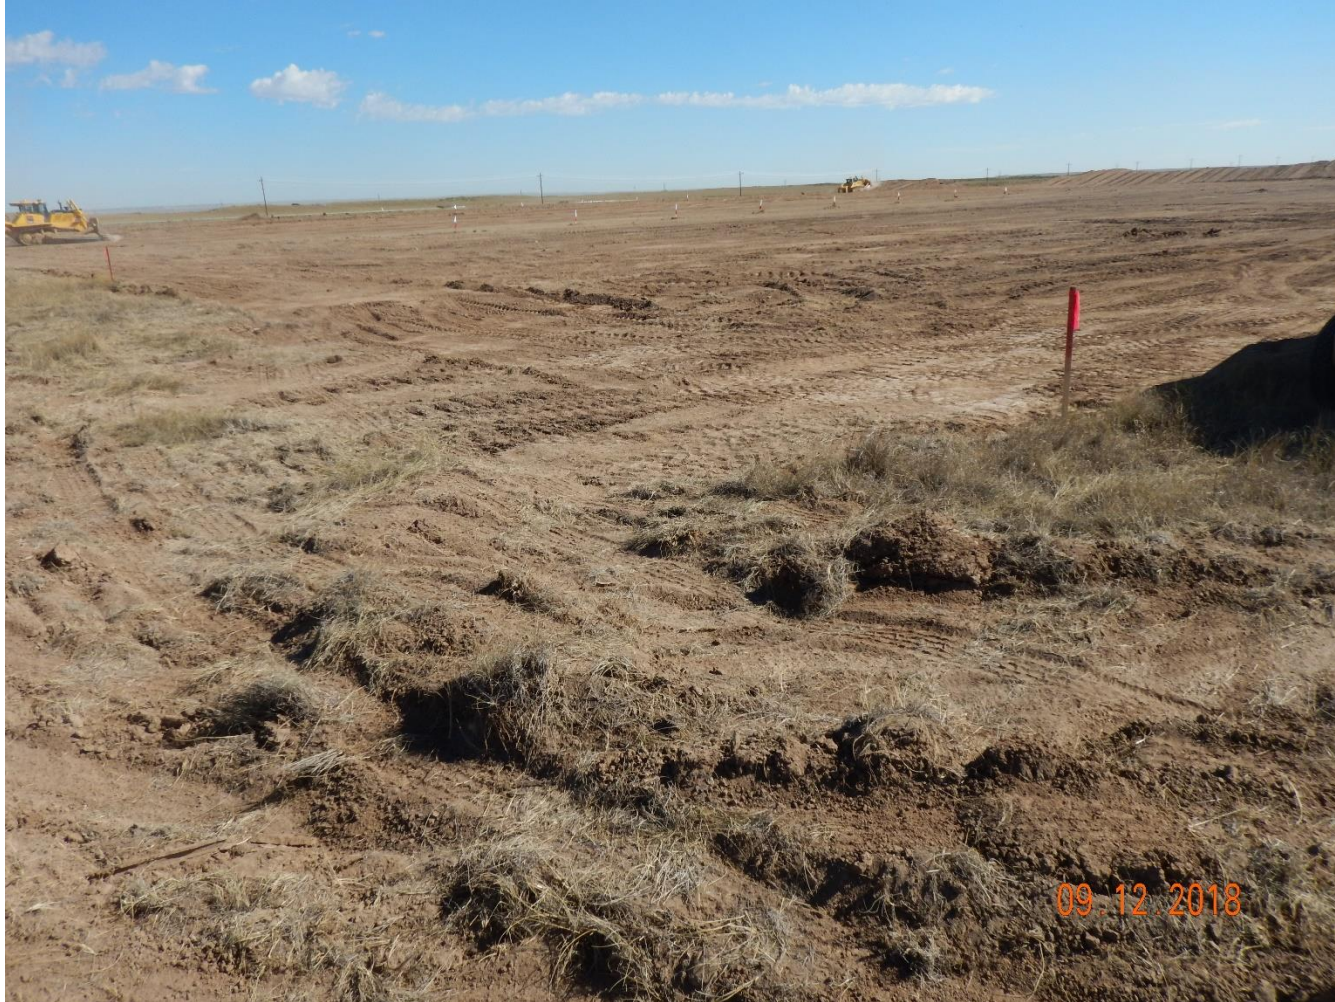
Photo 2: : Photo taken from the southwest corner of the location, facing northeast. Photos 1-3 provide overview of the construction in process.

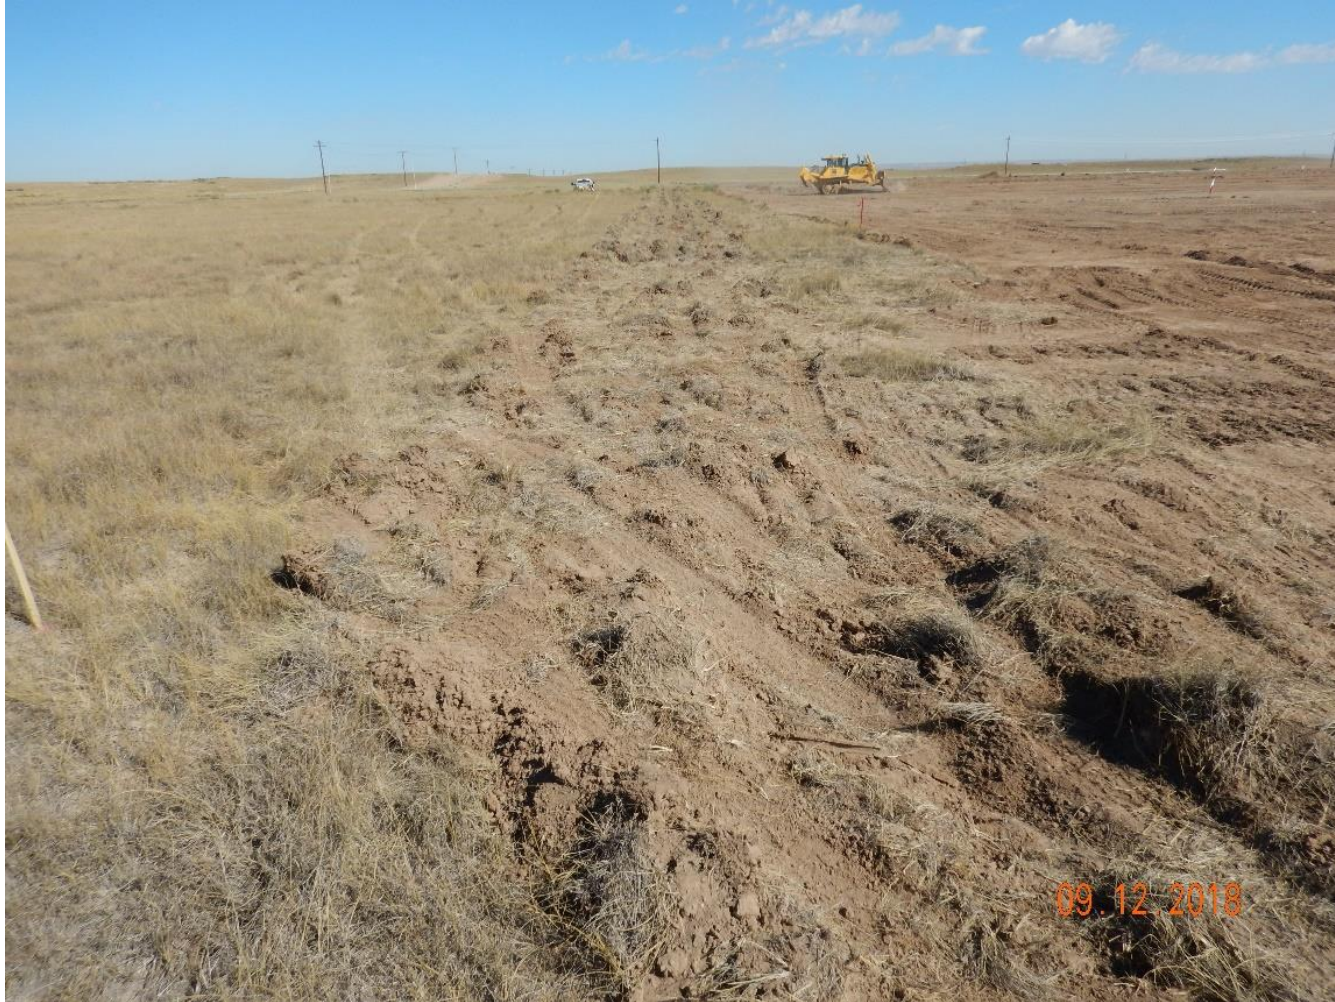
Photo 3: : Photo taken from the southwest corner of the location, facing north. Photos 1-3 provide overview of the construction in process. Photo also shows operator implemented surface roughening along perimeter of the location. Surface roughening is a temporary erosion control BMP that needs to be used in conjunction with other BMPs.

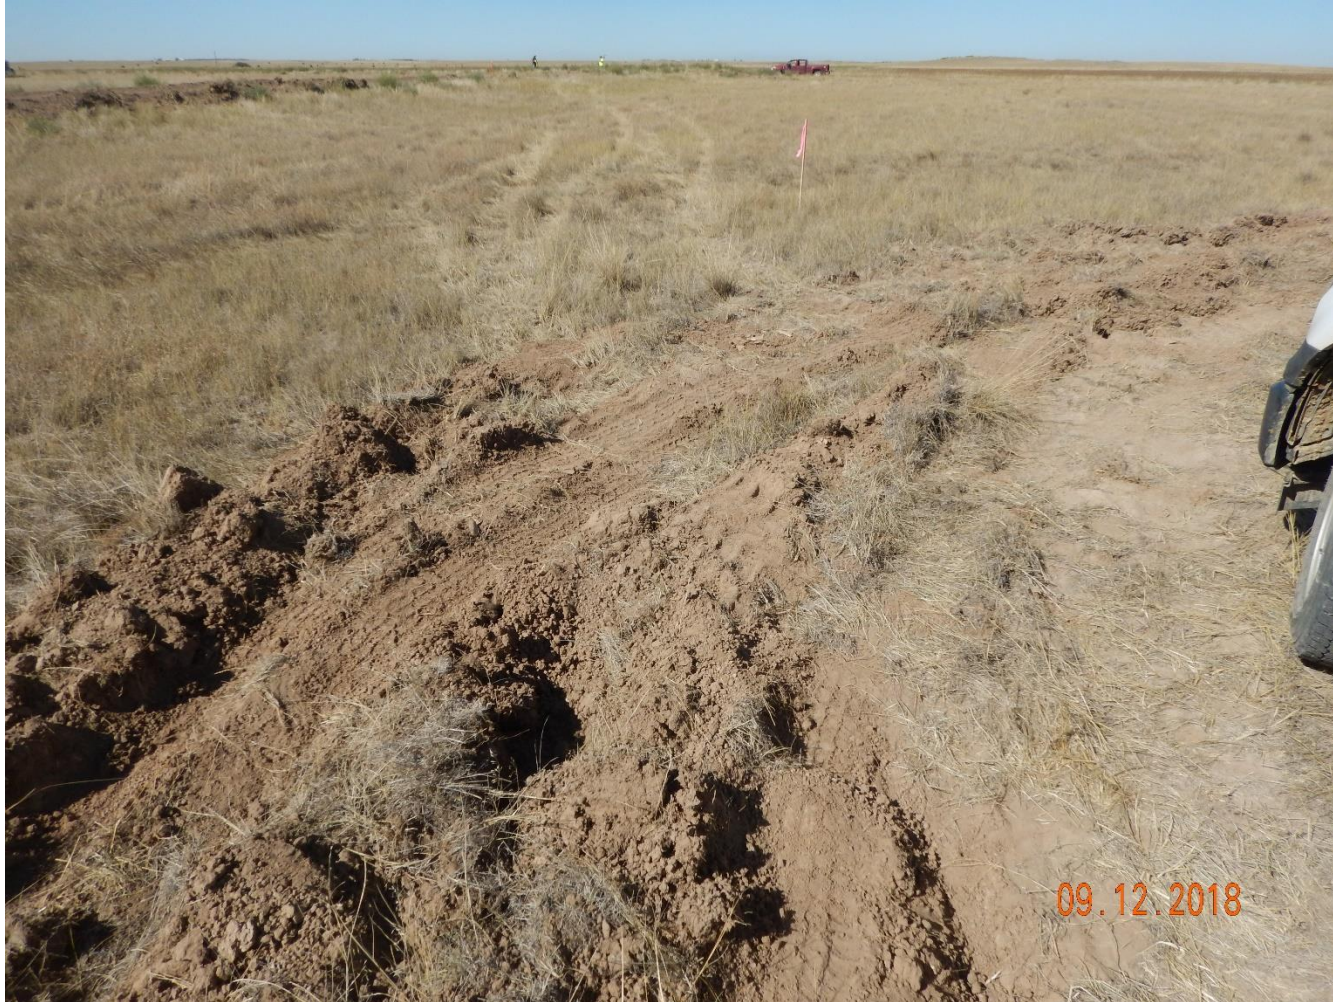
Photo 4: Photo taken from the southwest corner of the location, facing west. Photo shows surface roughening appears to have been traveled over by vehicle traffic rendering the control to no longer be in proper functioning condition.

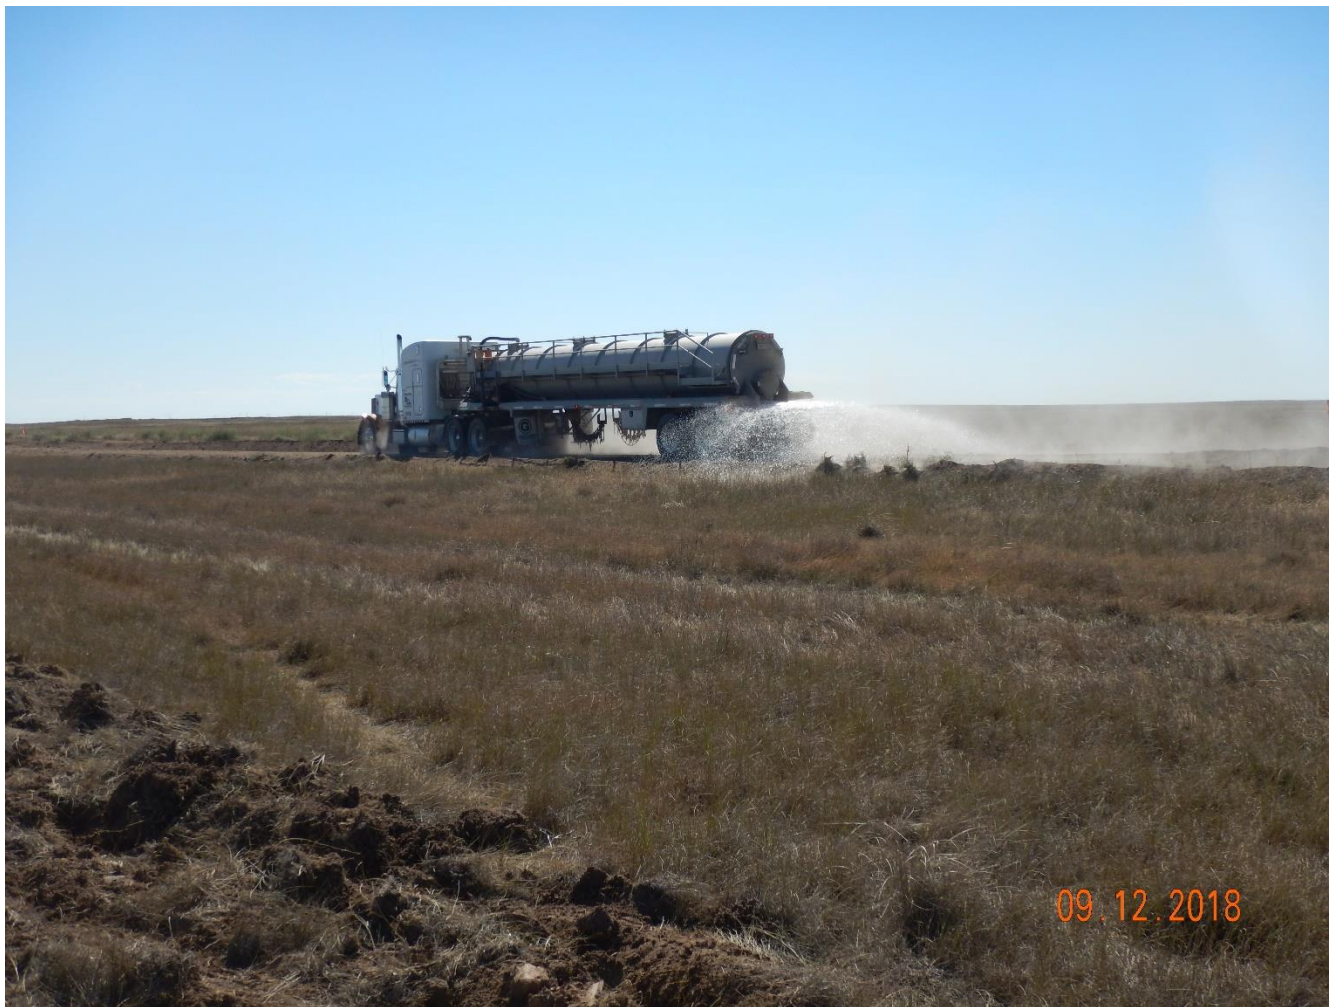
Photo 5: Photo showing actively spraying road with water to mitigate dust

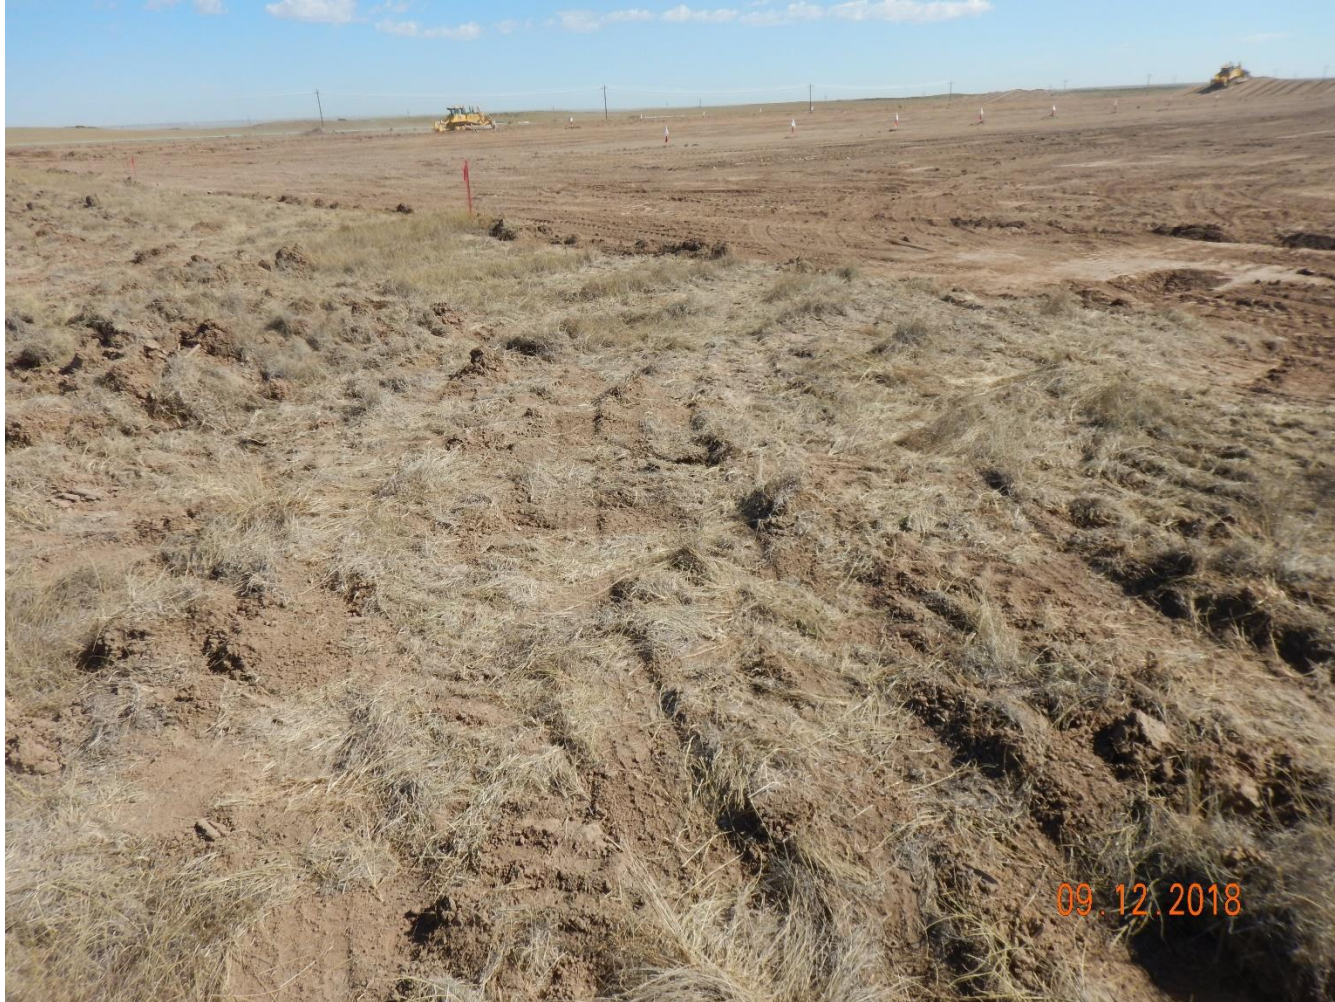
Photo 6: Photo taken from the west end of the location, facing northeast. Photo shows surface roughening appears to have been traveled over by vehicle traffic rendering the control to no longer be in proper functioning condition.

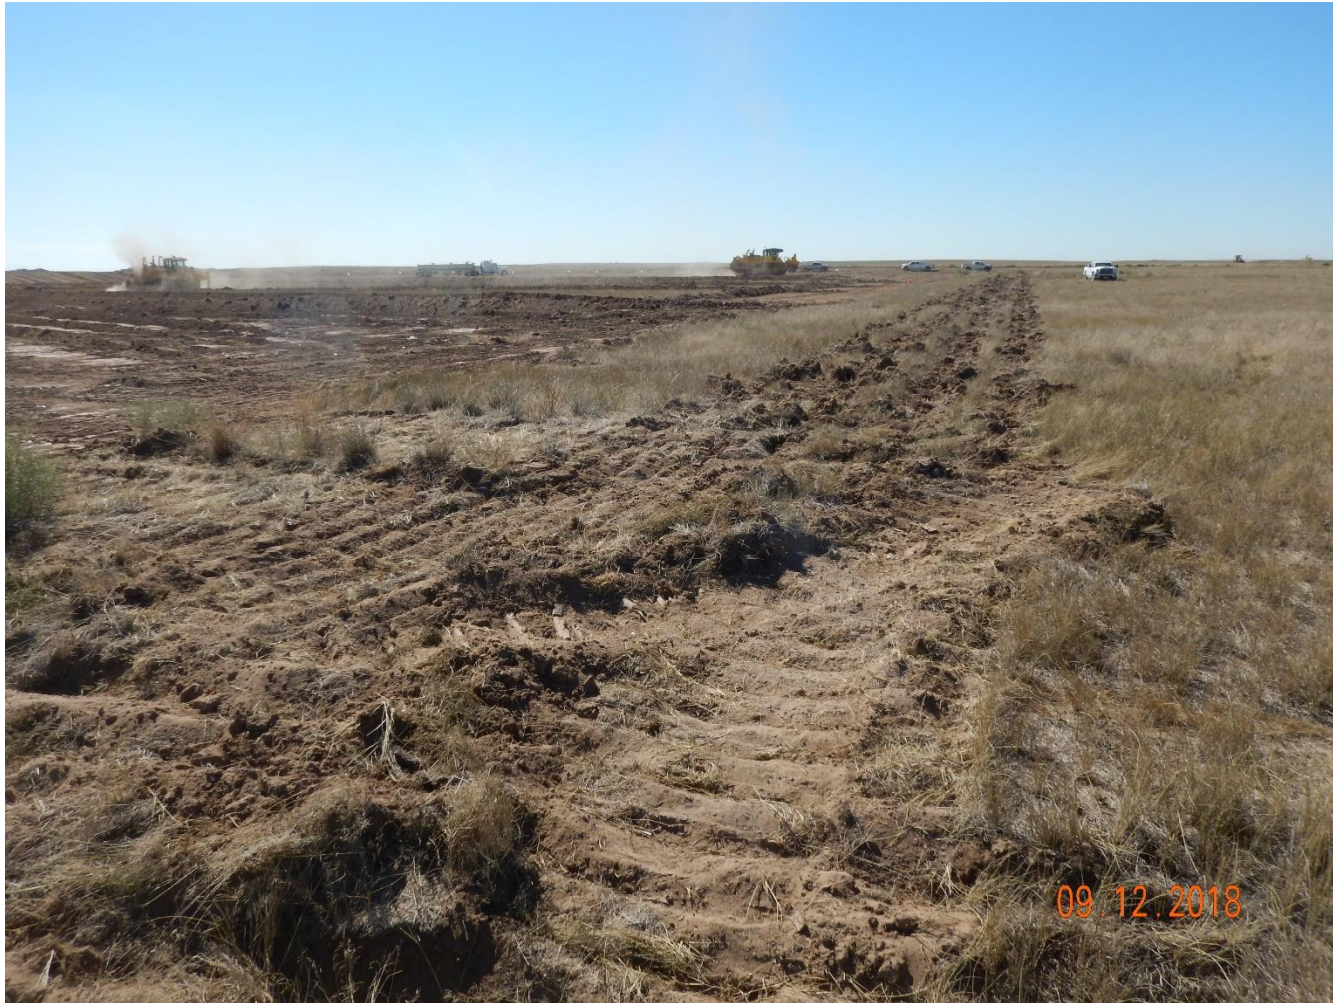
Photo 7: Photo taken from the northwest corner of the location, facing south. Photo also shows operator implemented surface roughening along perimeter of the location. Surface roughening is a temporary erosion control BMP that needs to be used in conjunction with other BMPs.

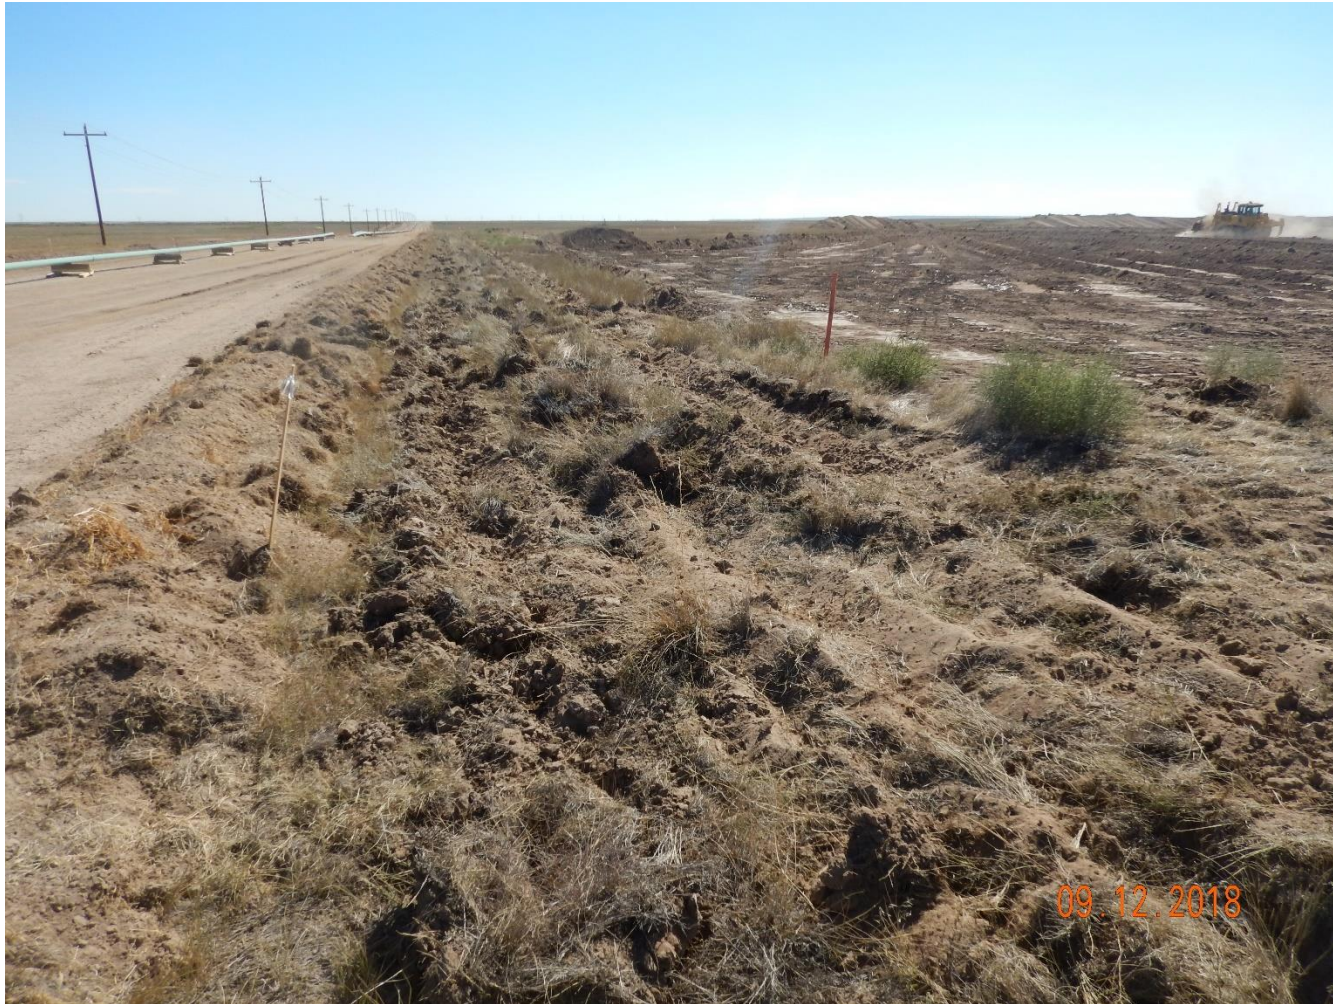
Photo 8: Photo taken from the northwest corner of the location, facing east. Photo also shows operator implemented surface roughening along perimeter of the location. Surface roughening is a temporary erosion control BMP that needs to be used in conjunction with other BMPs.

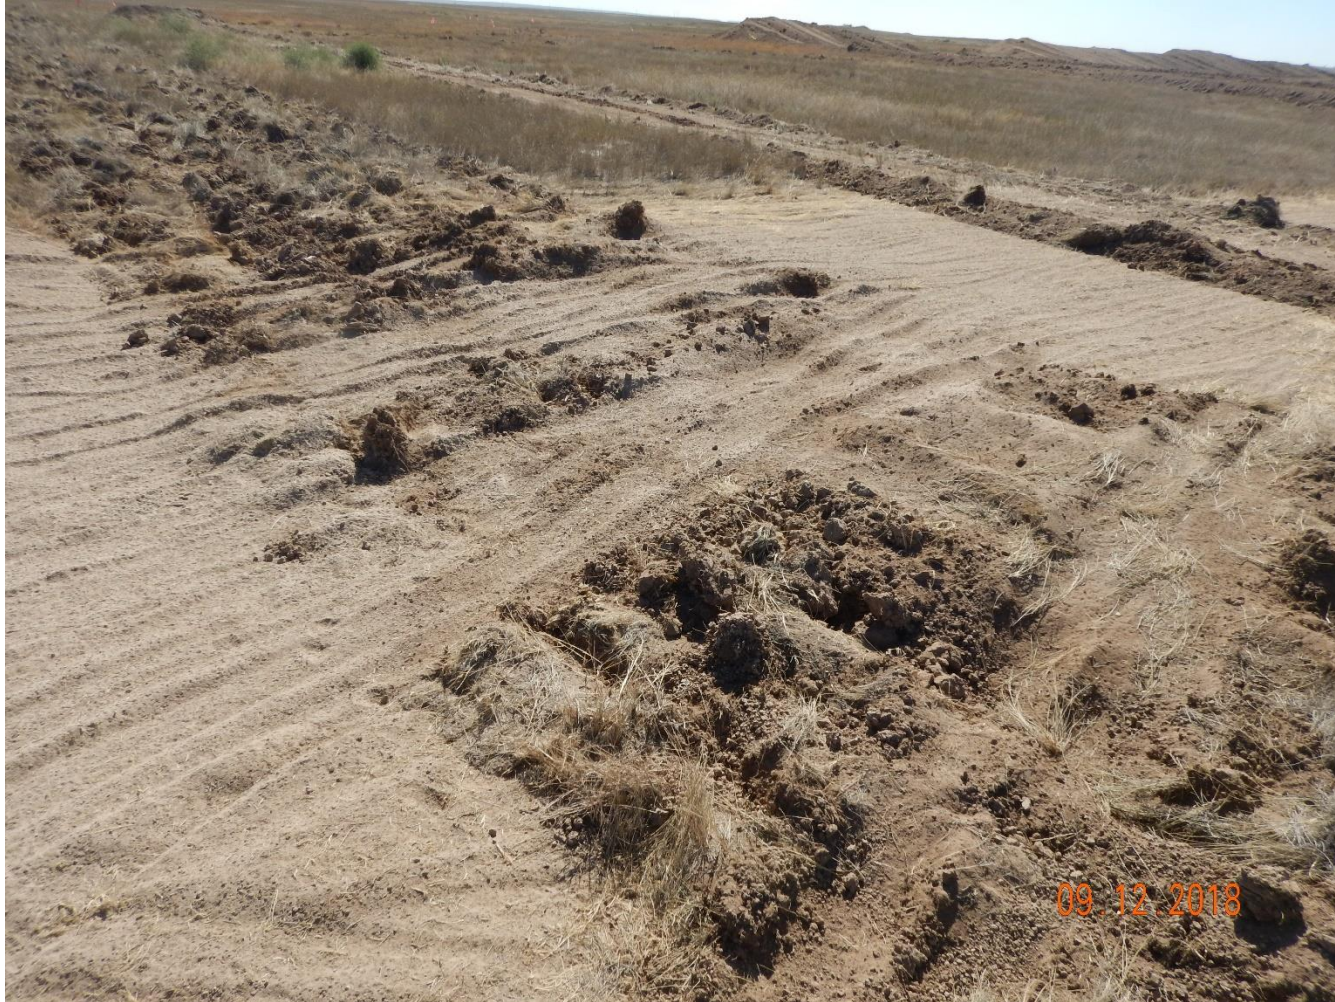
Photo 9: Photo taken from the north end of the location, facing southeast. Photo shows surface roughening appears to have been traveled over by vehicle traffic rendering the control to no longer be in proper functioning condition.

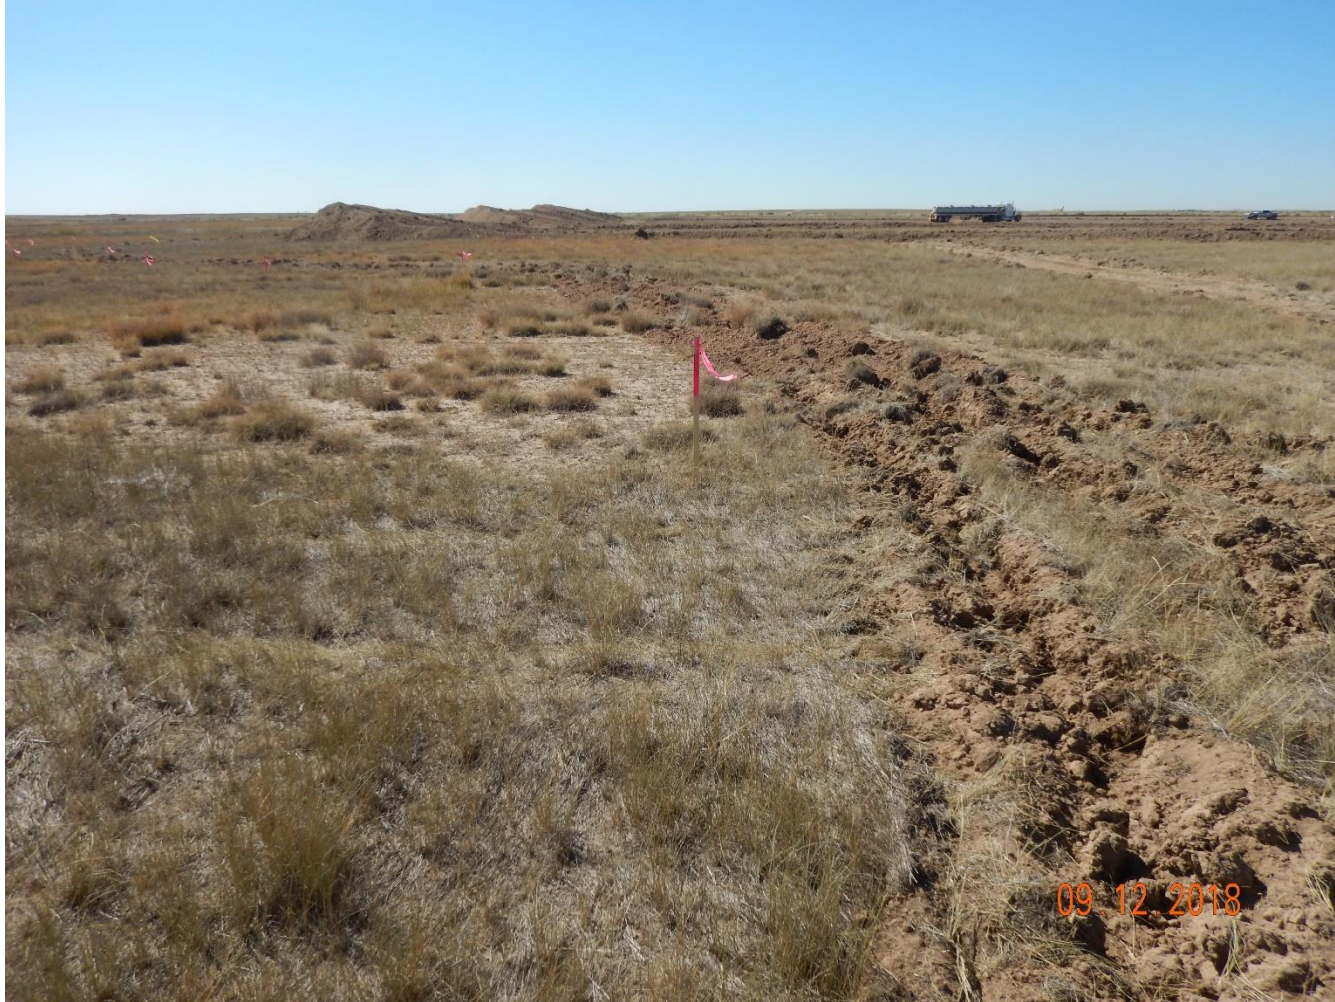
Photo 10: Photo taken from the northeast corner of the location, facing south. Photo also shows operator implemented surface roughening along perimeter of the location. Surface roughening is a temporary erosion control BMP that needs to be used in conjunction with other BMPs.

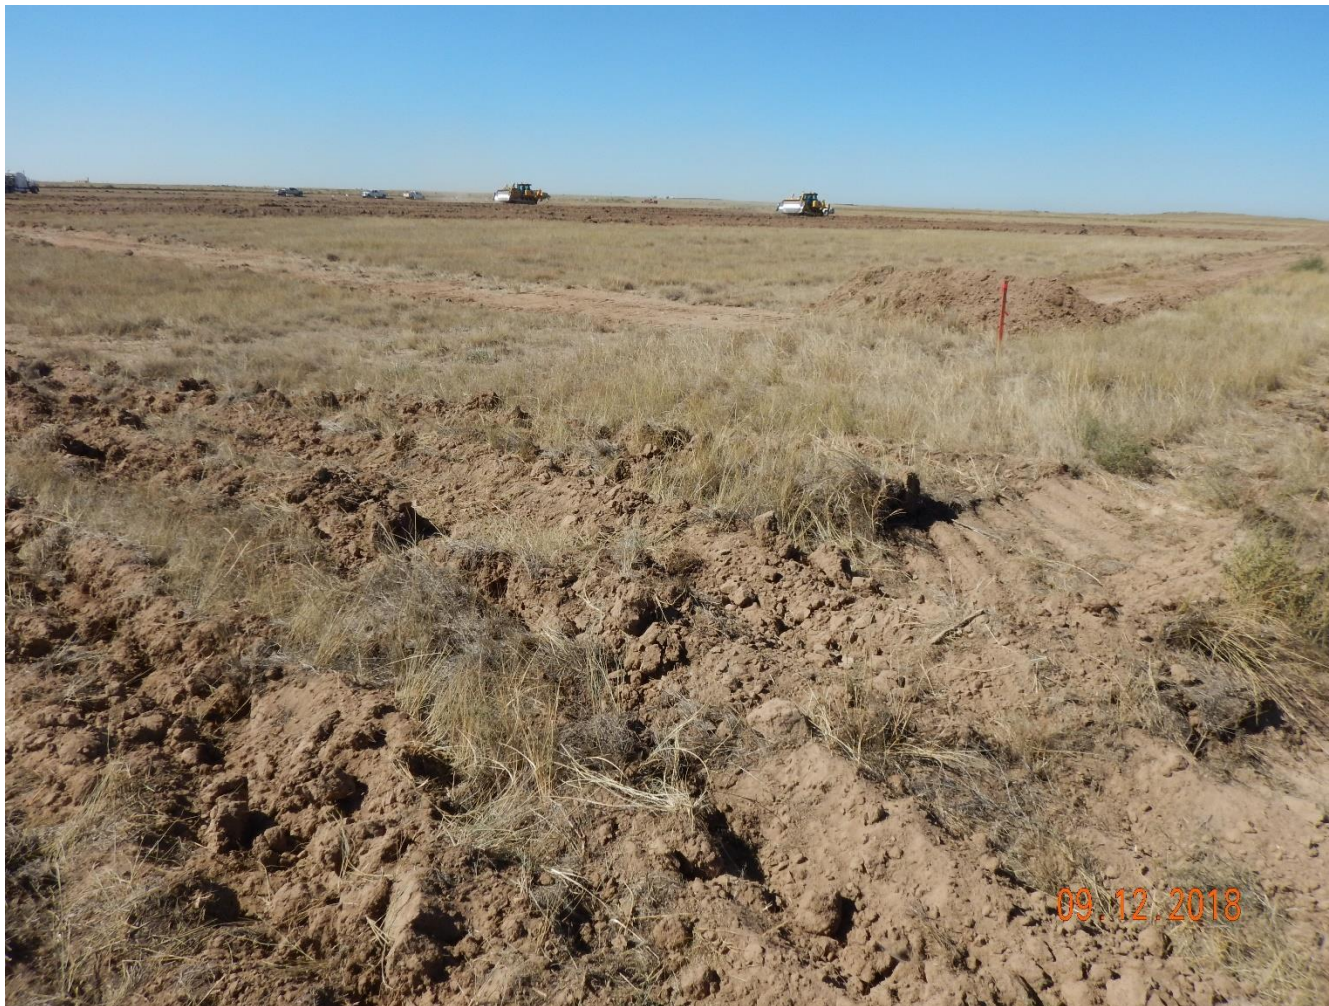
Photo 11: Photo taken from the northeast corner of the location, facing southwest

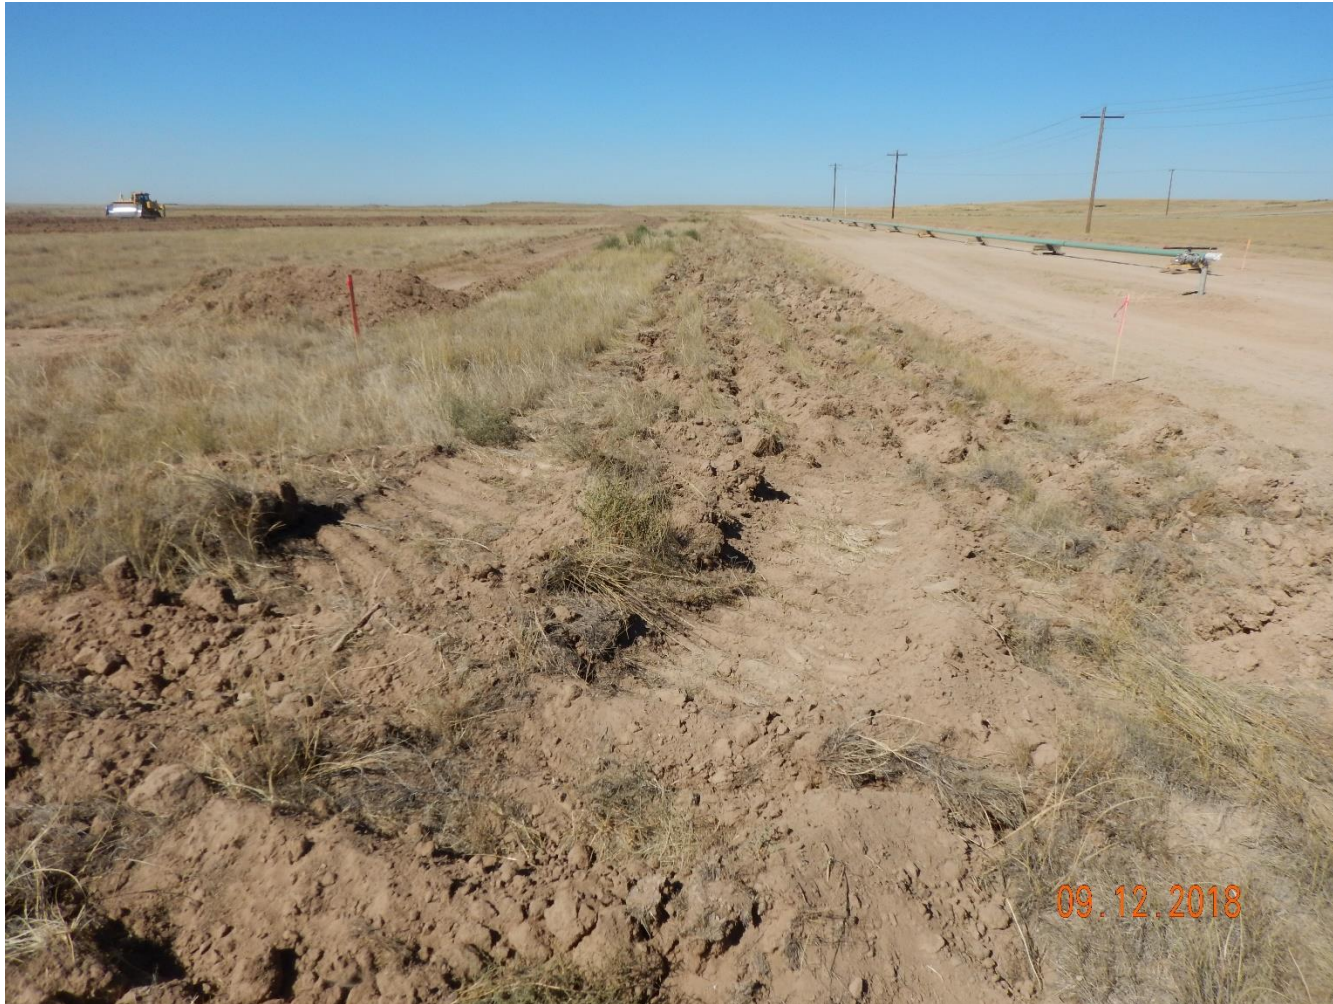
Photo 12: Photo taken from the northeast corner of the location, facing west. Photo also shows operator implemented surface roughening along perimeter of the location. Surface roughening is a temporary erosion control BMP that needs to be used in conjunction with other BMPs.

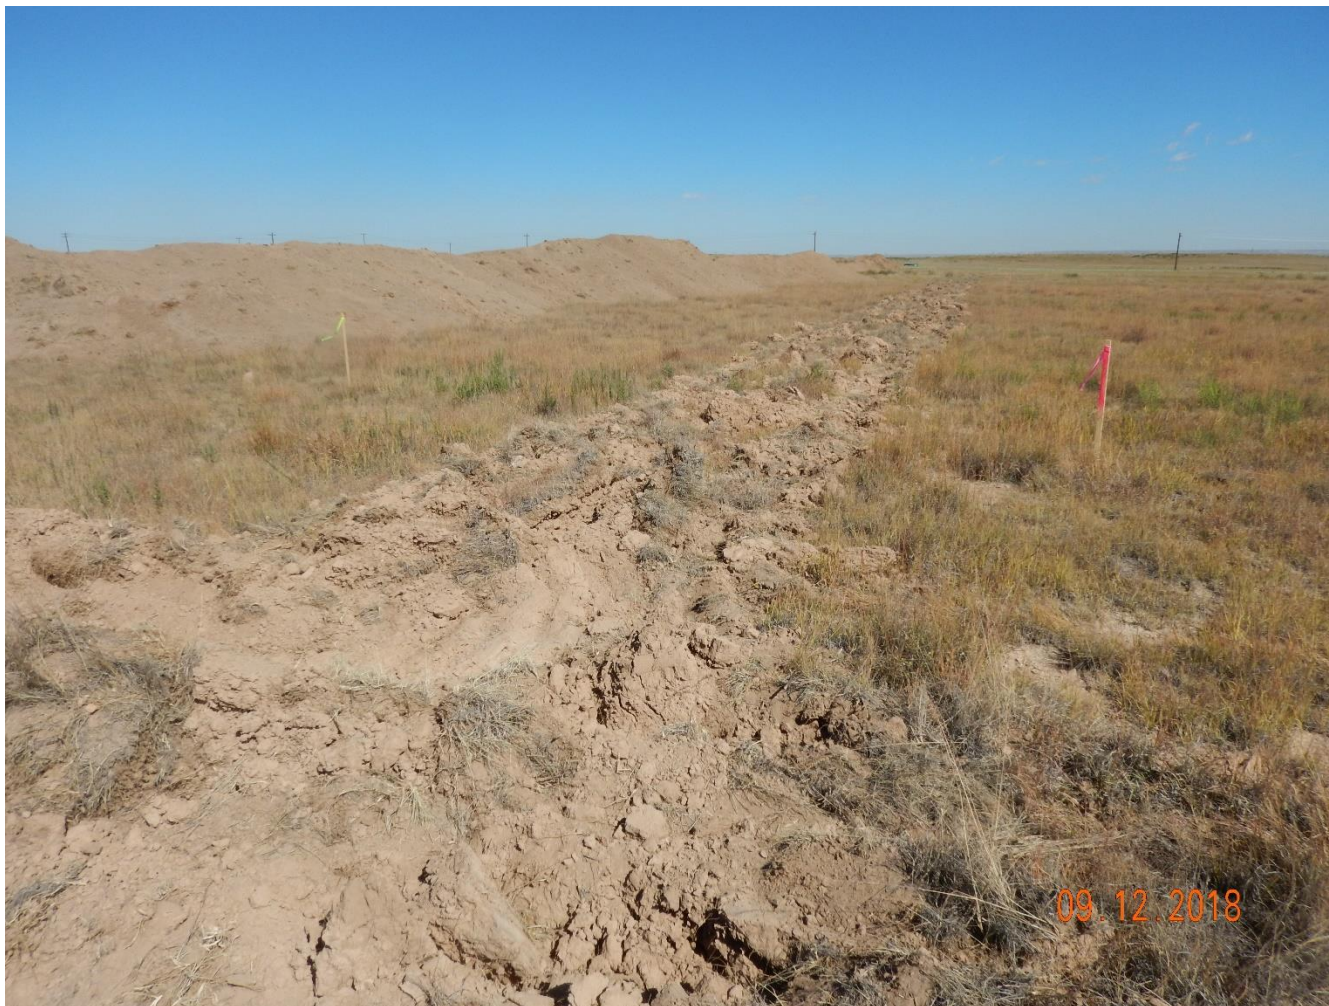
Photo 13: Photo taken from the southeast corner of the location, facing north. Photo also shows operator implemented surface roughening along perimeter of the location. Surface roughening is a temporary erosion control BMP that needs to be used in conjunction with other BMPs.

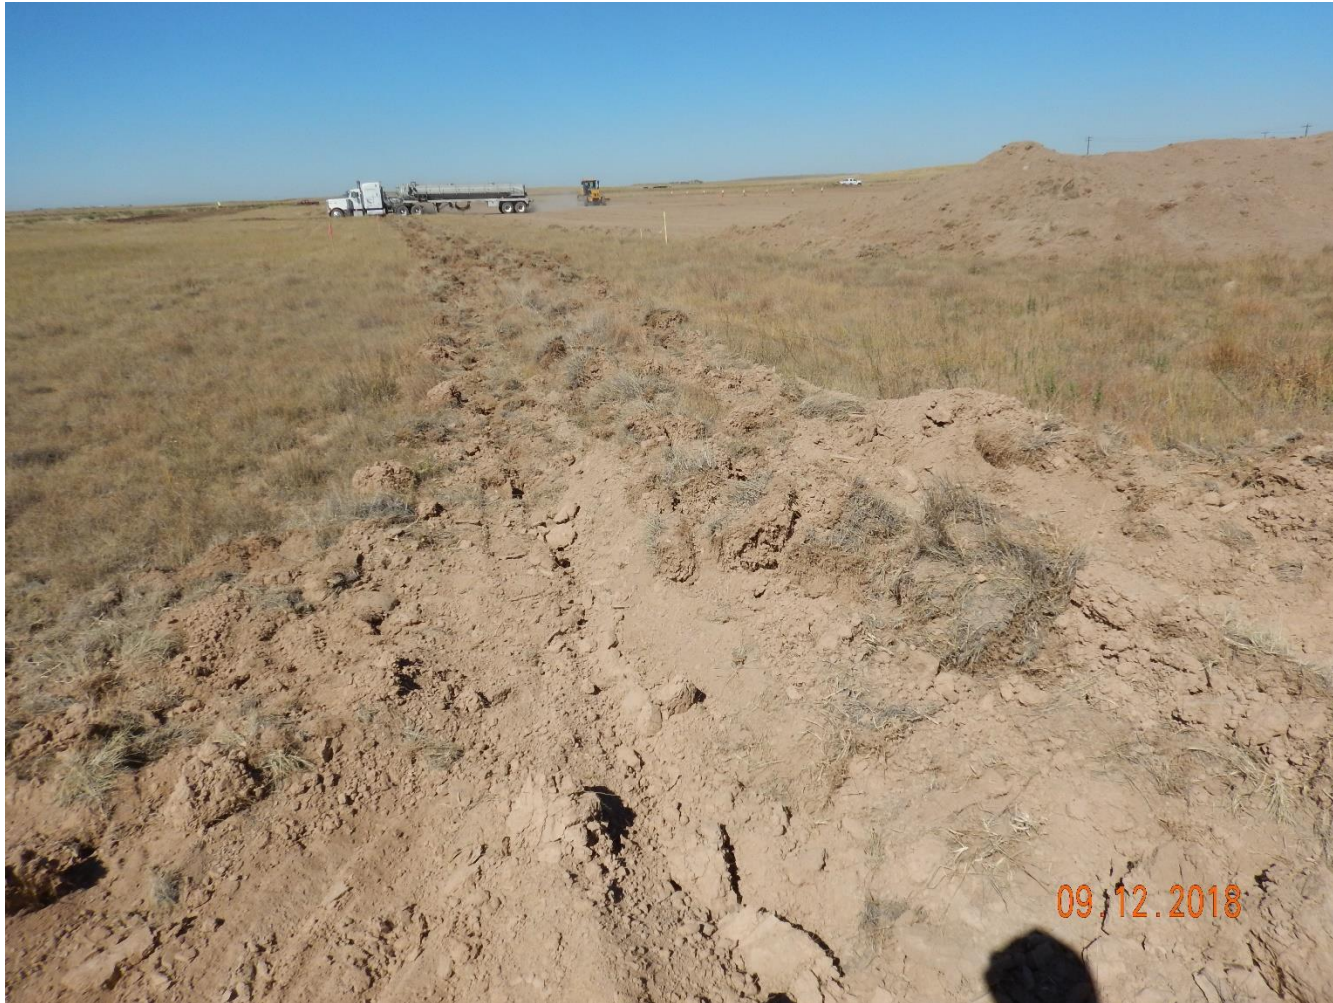
Photo 14: Photo taken from the southeast corner of the location, facing west. Photo also shows operator implemented surface roughening along perimeter of the location. Surface roughening is a temporary erosion control BMP that needs to be used in conjunction with other BMPs.

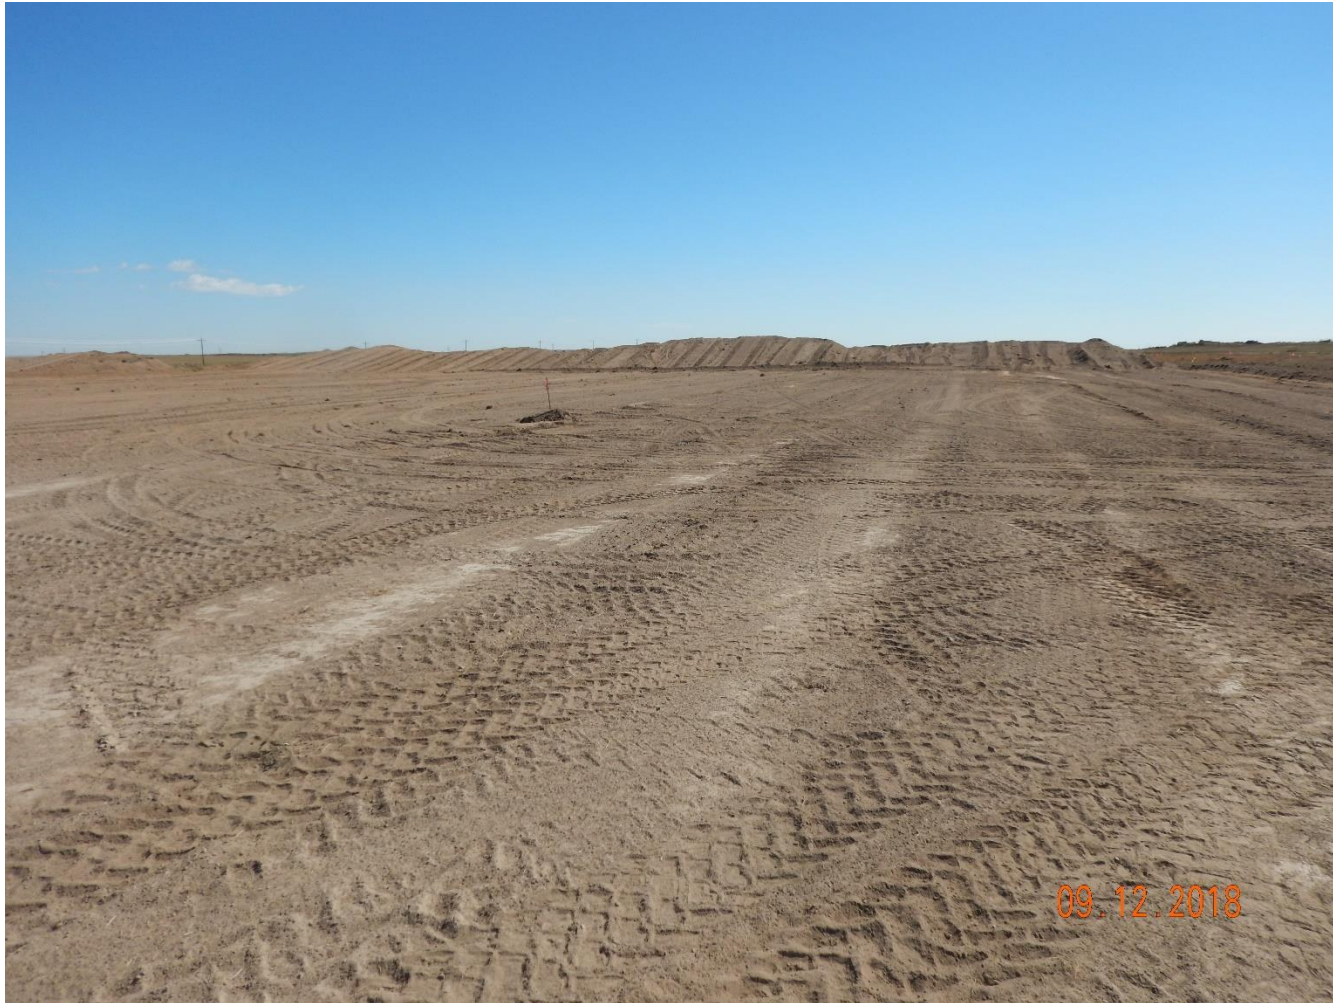
Photo 15: Photo taken from the pad, facing east. Photo shows what appears to be the topsoil stockpile on the location. Soil salvage currently in process, however, there are areas where topsoil remains evident that the contractor has indicated to be “at grade”.

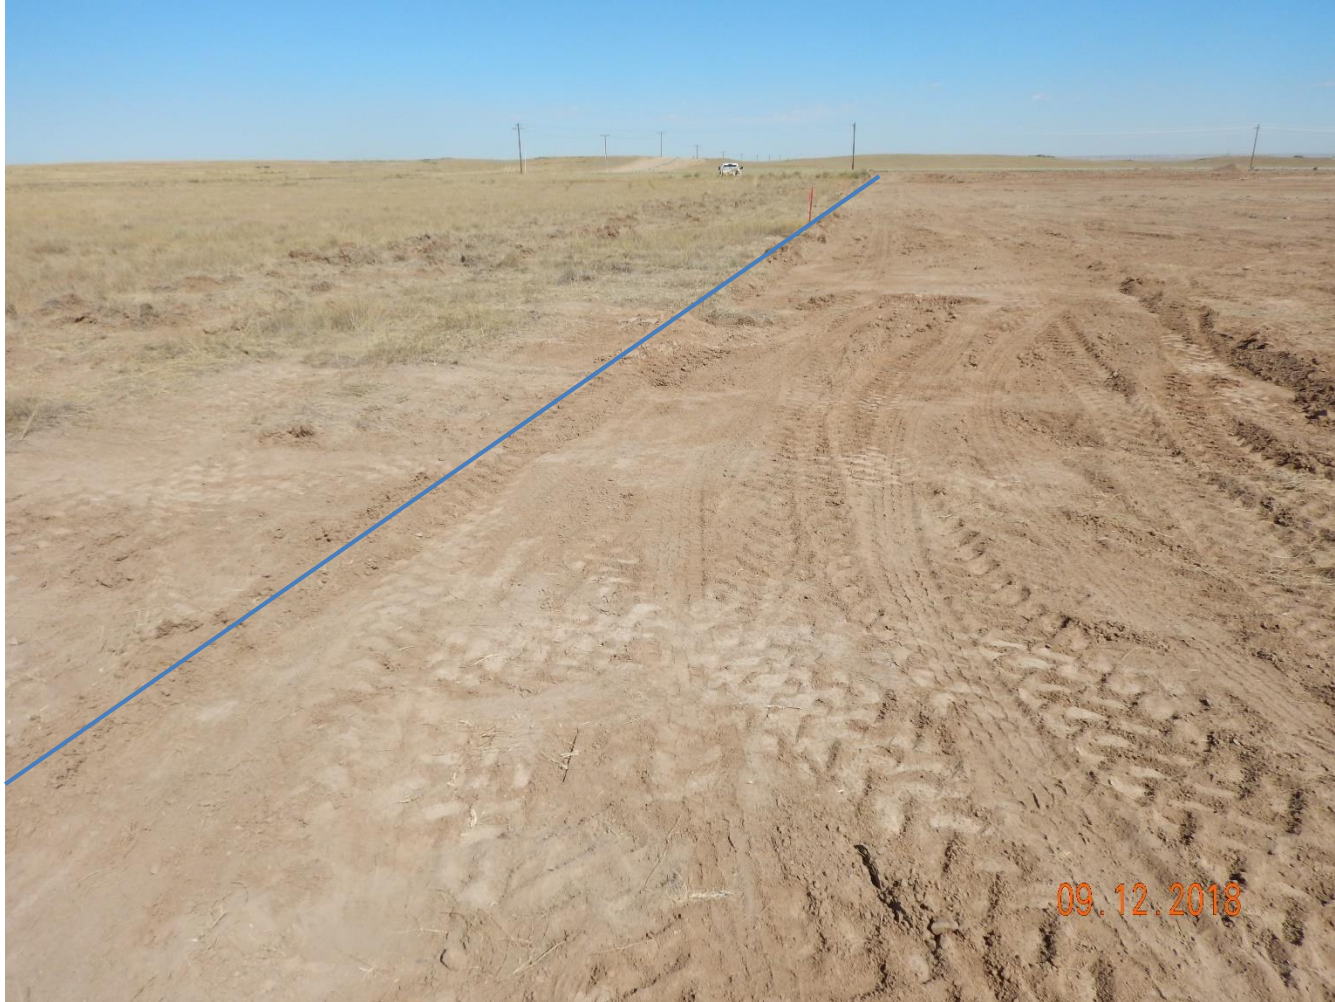
Photo 16: Photo taken from the west end of the location, facing north. Photo shows the pad and the adjacent lands. It does not appear as though sufficient topsoil salvage has been conducted on this area of the pad.

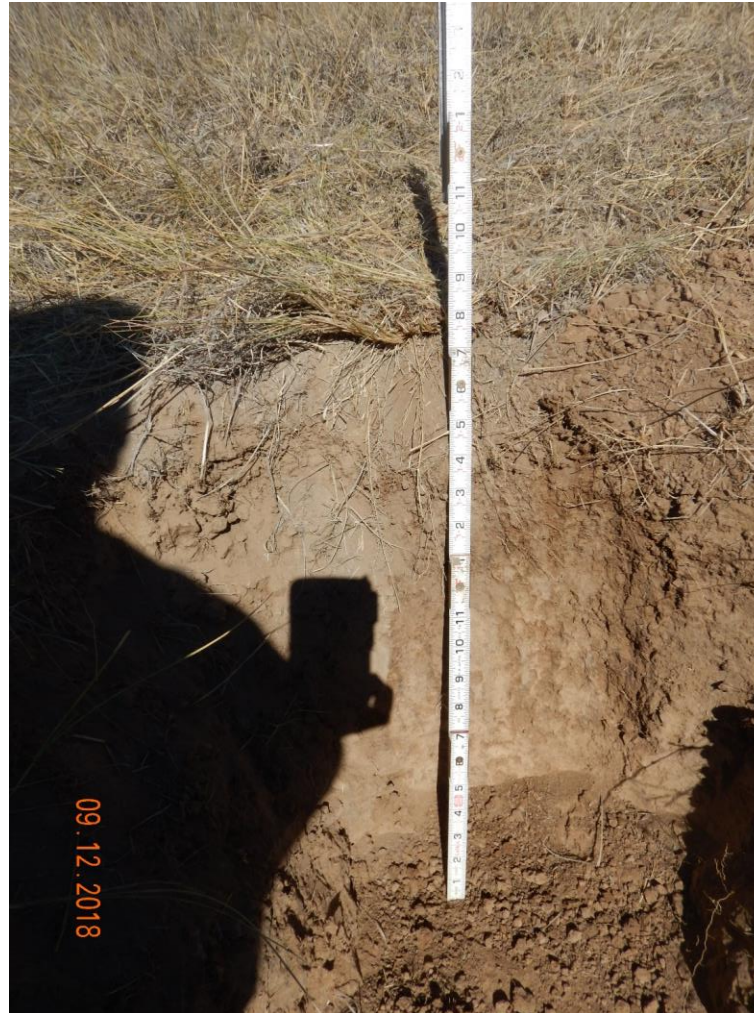
Photo 17: Photo taken from the west of the pad on adjacent to the disturbance. Contractor on site indicated that "~8 inches of topsoil" is being salvaged and stored on the east end of the location". Contractor indicated that he was unaware of the actual depth of the topsoil horizon. Photo shows that it appears that the topsoil horizon exceeds 8 inches in depth.
