# Inspection Photos

Operator: FOUNDATION ENERGY  
MANAGEMENT LLC - 10112

Location ID: 447523

Inspection Doc. Number: 682503847  
Weld County, CO

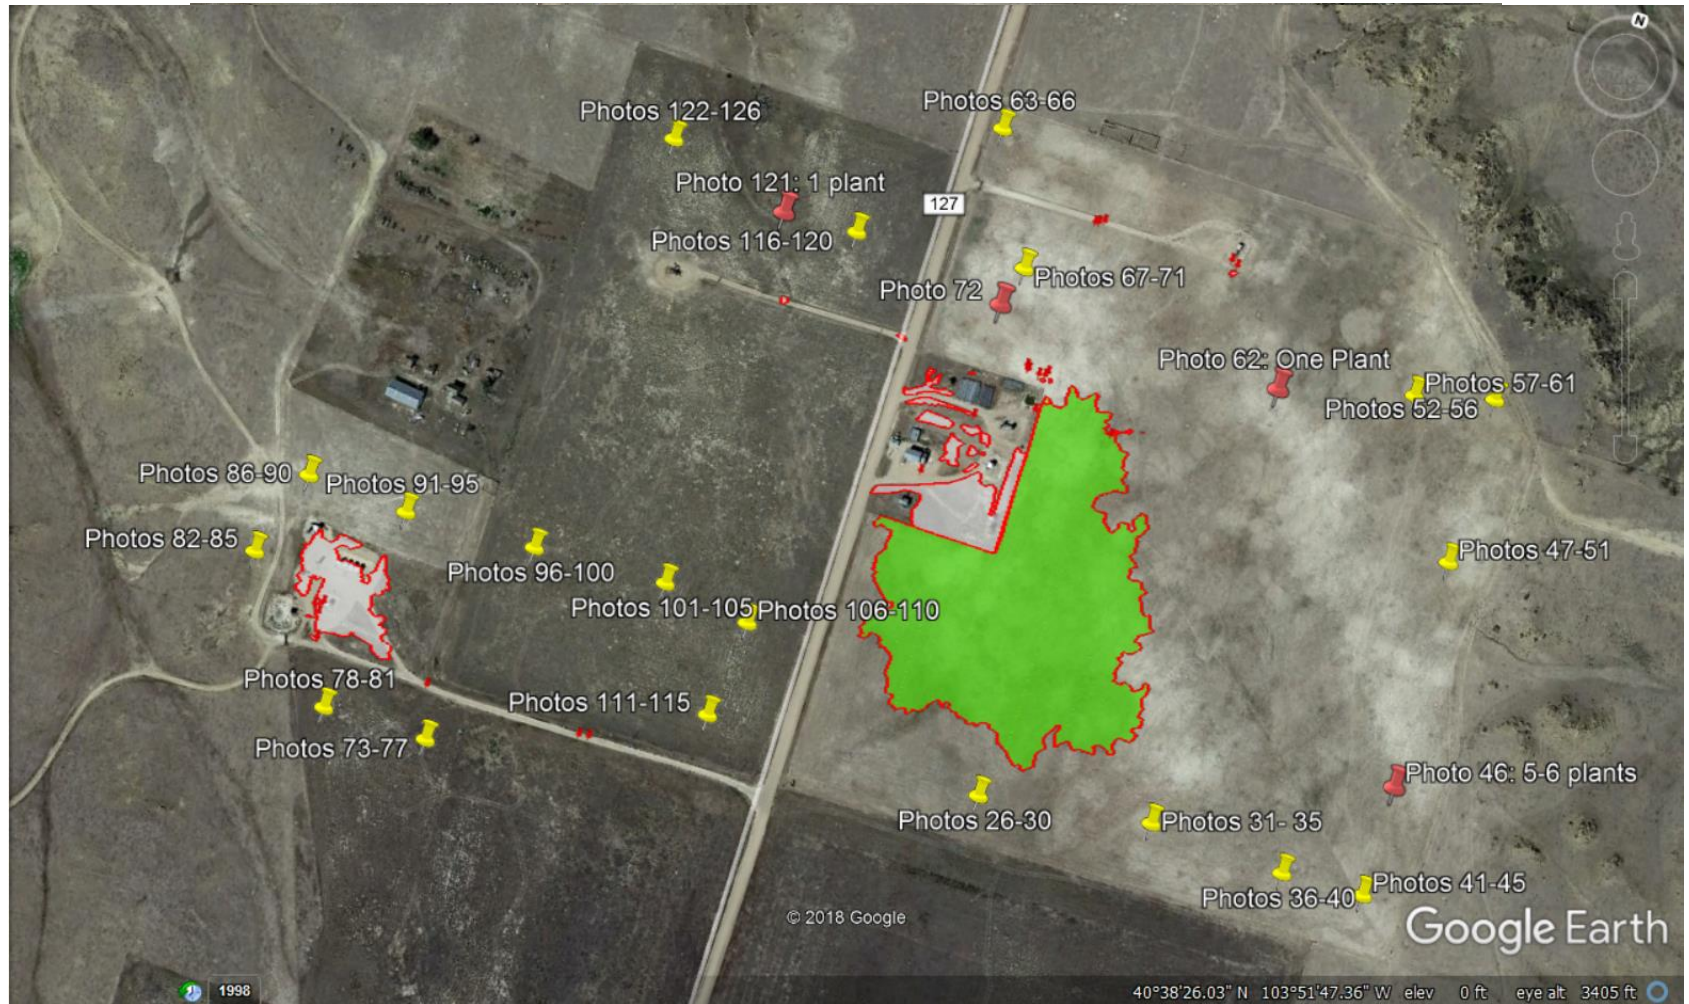
Aerial imagery of photos that have been taken for documentation purposes. Not all photo documents are included within this report. Red polygons (green/white fill) where Noxious weeds were mapped on and off location using a GPS during the 6/15/2018 inspection; White polygon is diffuse knapweed concentration on location, green is the high density knapweed off the location. Point ("thumb-tacs") represent GPS points and the related photos within this documentation. Photo shows adjacent lands do not have the population densities of noxious weeds compared to areas within the locations and its immediate surrounding; noxious weed population densities decrease as the distance away from the locations increase.

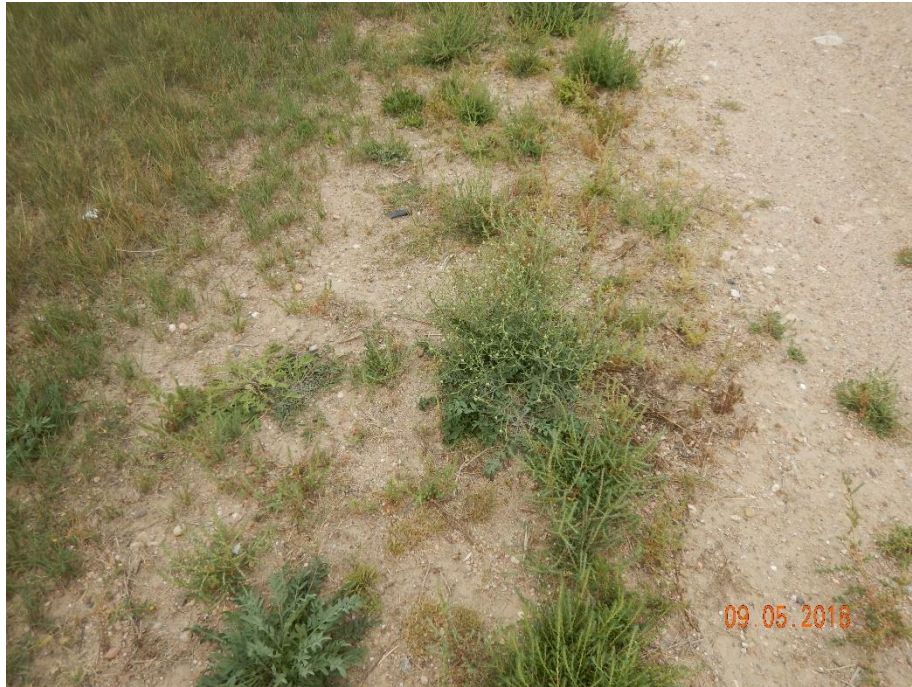
**Photo 1:** Photo taken from the southwest end of the location.  
Photo shows Diffuse Knapweed remains on location.

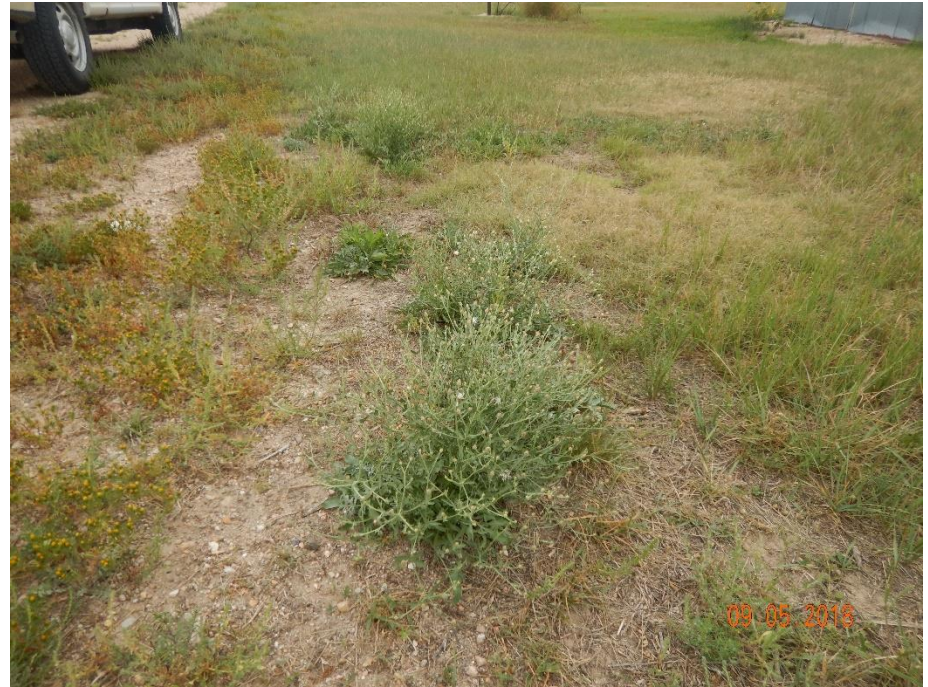
**Photo 2:** Photo taken from the southwest end of the location.  
Photo shows Diffuse Knapweed remains on location.

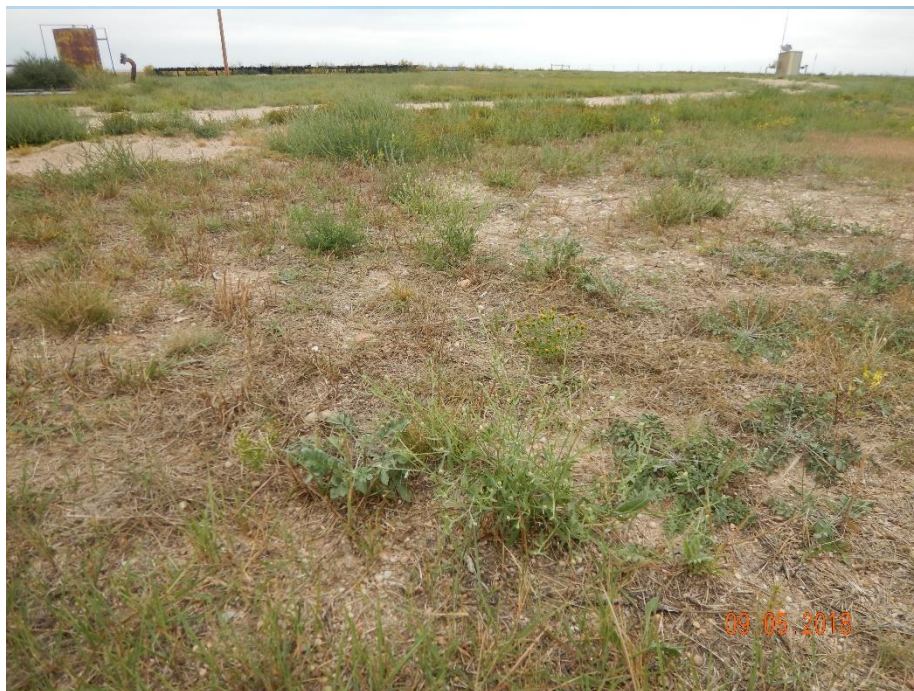
**Photo 3:** Photo taken from the southwest end of the location, facing northeast. Photo shows Diffuse Knapweed remains on location.

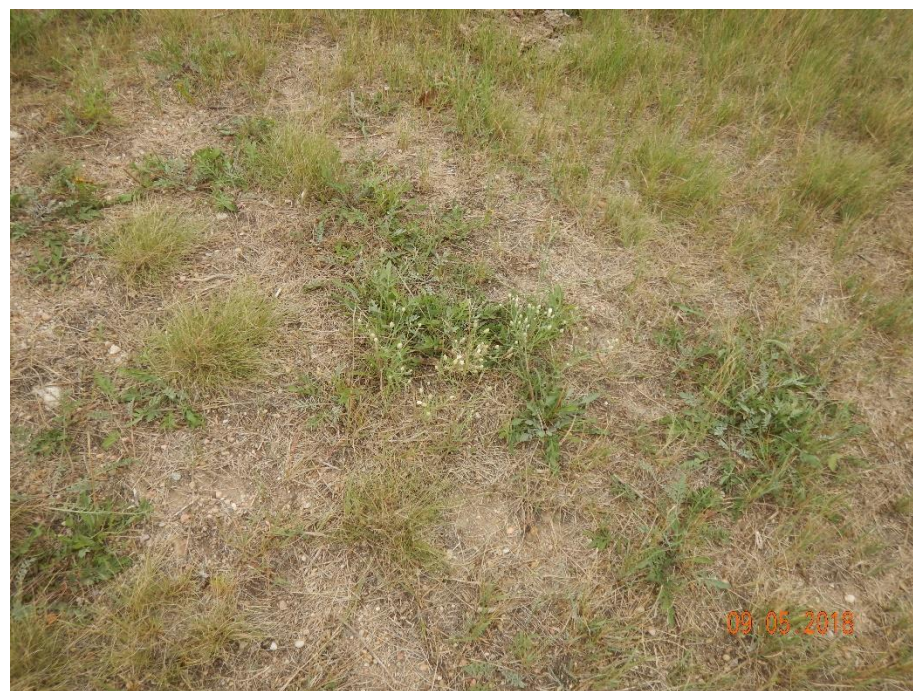
**Photo 4:** Photo taken from the south end of the location. Photo shows Diffuse Knapweed remains on location.

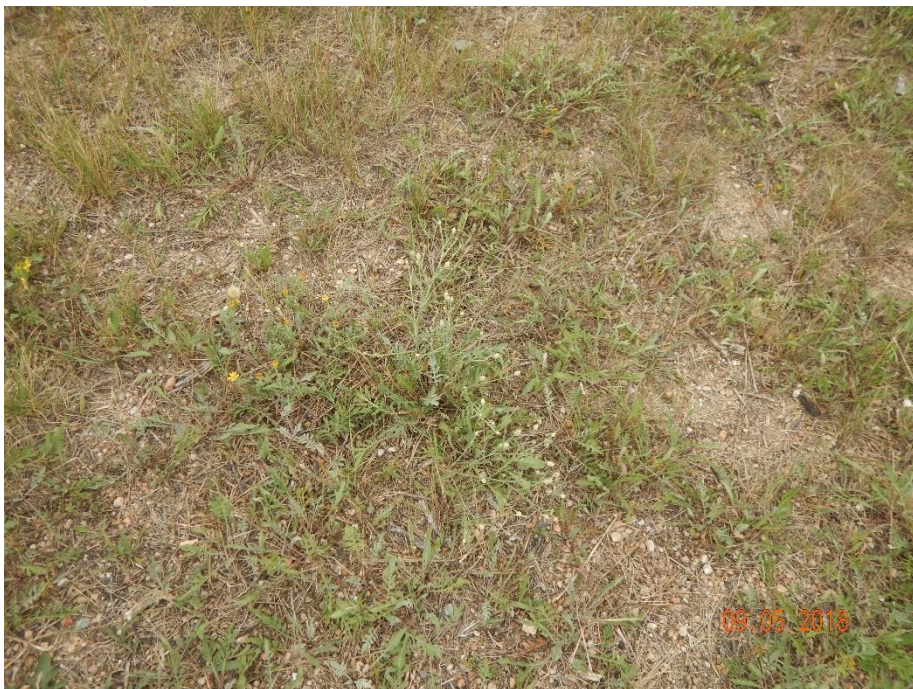
**Photo 5:** Photo taken from the south end of the location. Photo shows Diffuse Knapweed remains on location.

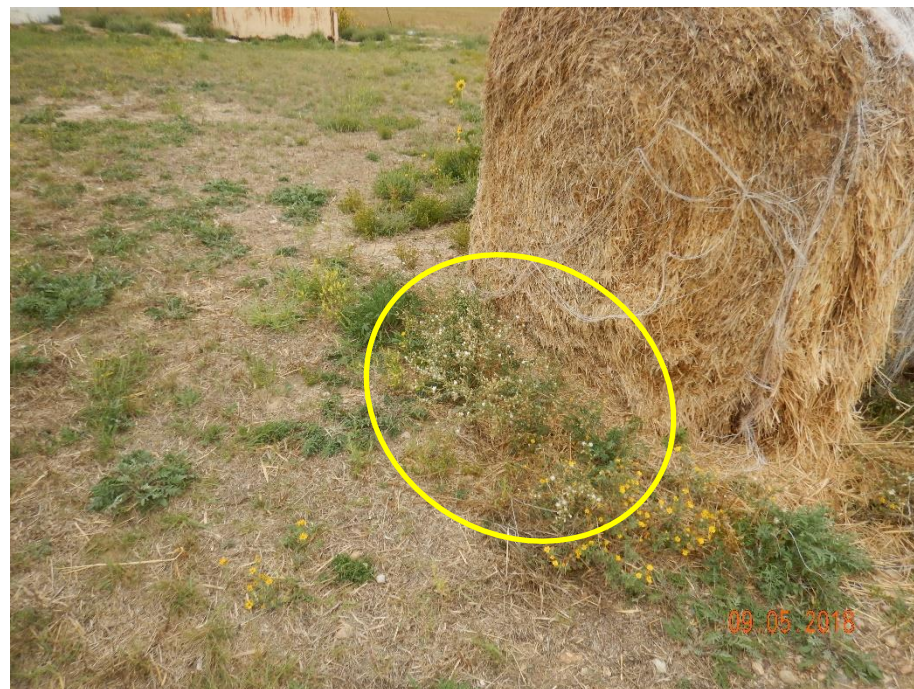
**Photo 6:** Photo taken from the south end of the location, facing east. Photo shows Diffuse Knapweed remains on location.

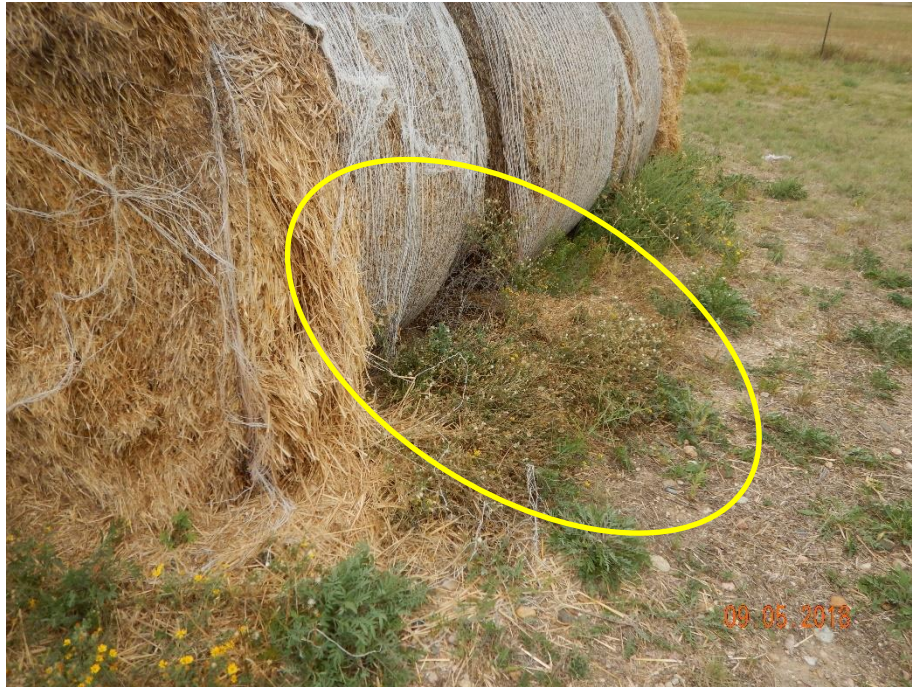
**Photo 7:** Photo taken from the south end of the location, facing south. Photo shows Diffuse Knapweed remains on location.

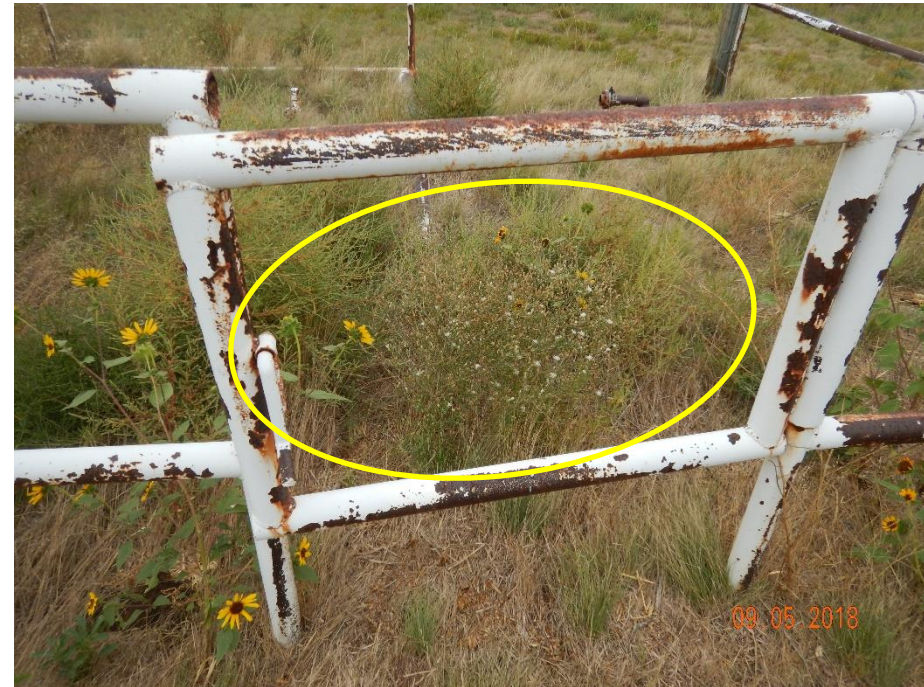
**Photo 8:** Photo taken from the south end of the location, facing south. Photo shows Diffuse Knapweed remains on location.

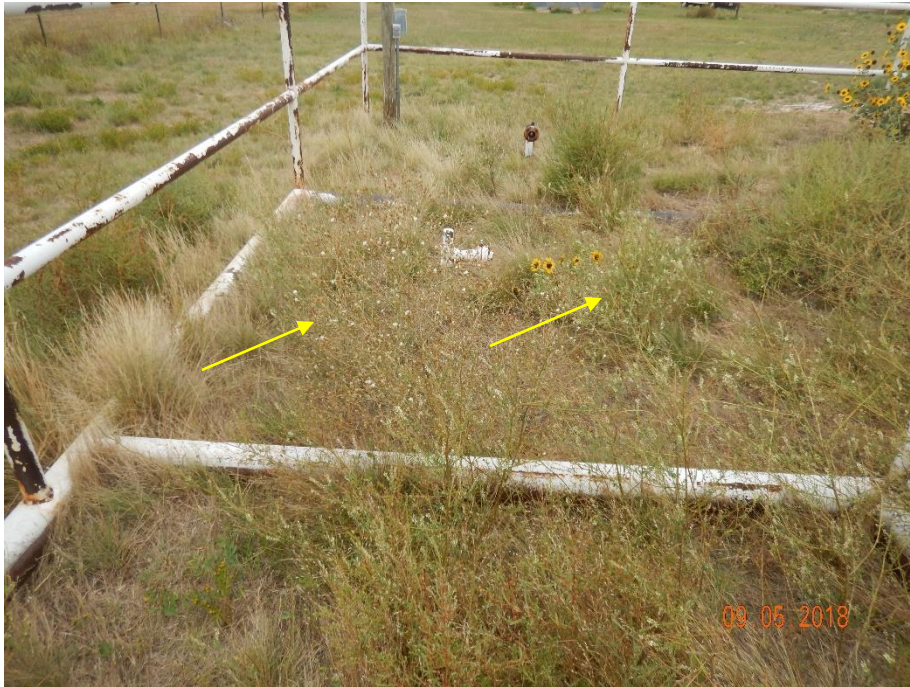
**Photo 9:** Photo taken from the south end of the location, facing west. Photo shows Diffuse Knapweed remains on location.

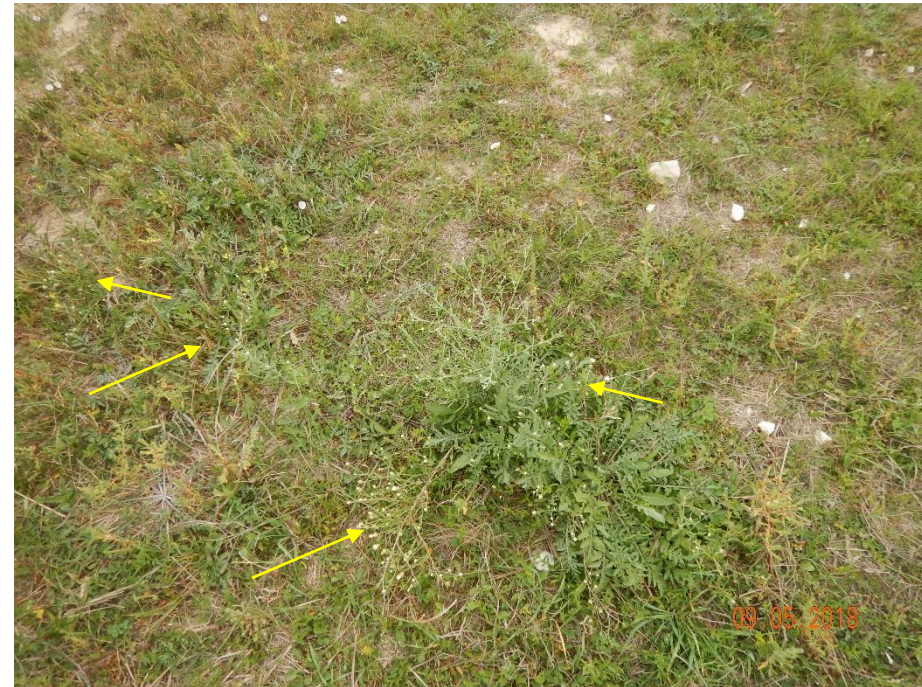
**Photo 10:** Photo taken from the south end of the location. Photo shows Diffuse Knapweed remains on location.

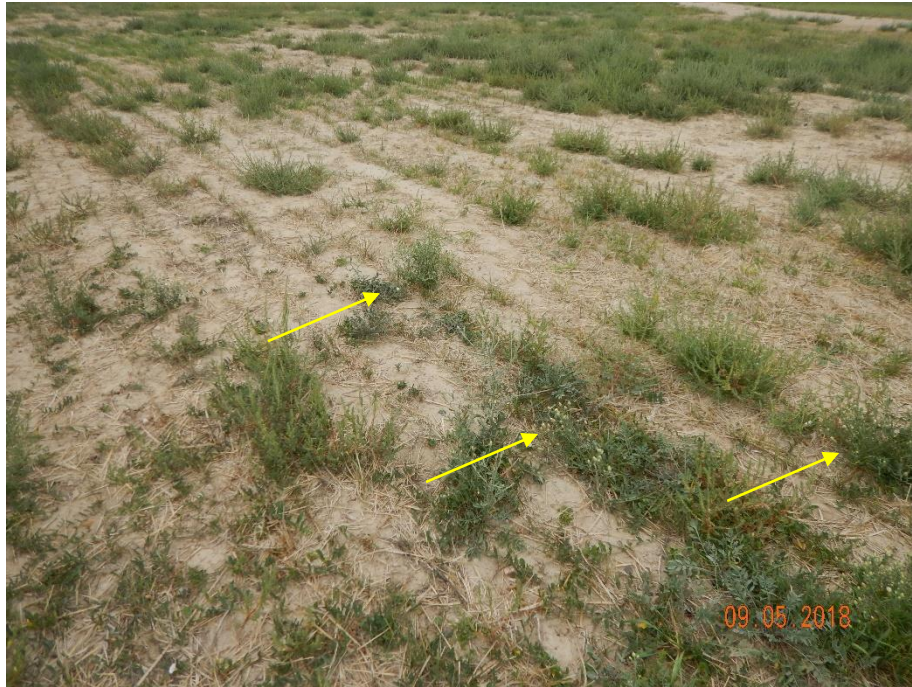
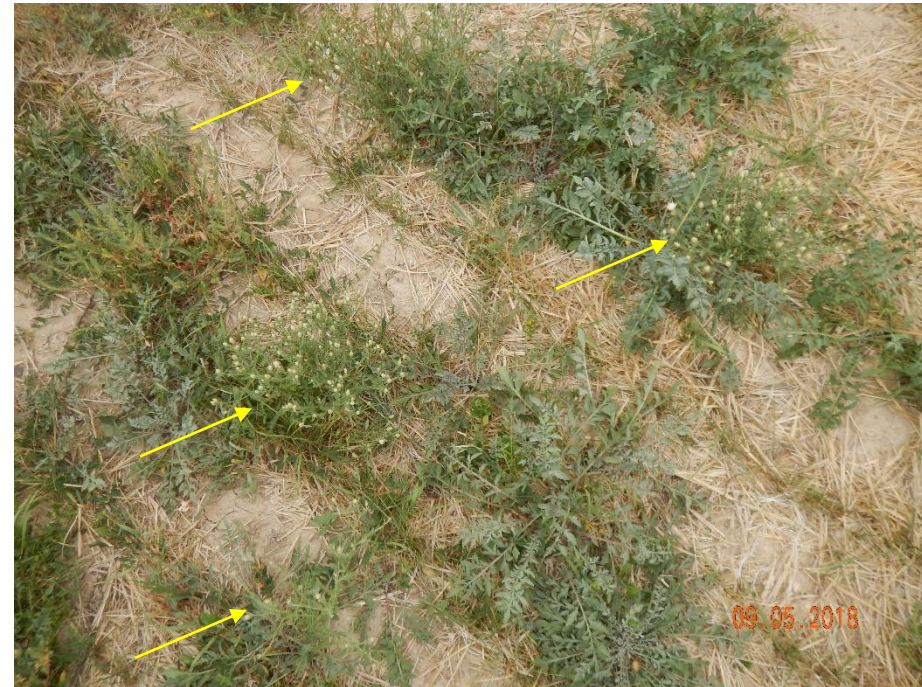
**Photo 11:** Photo taken from the east end of the location. Photo shows Diffuse Knapweed remains on location.

**Photo 12:** Continued from photo 11

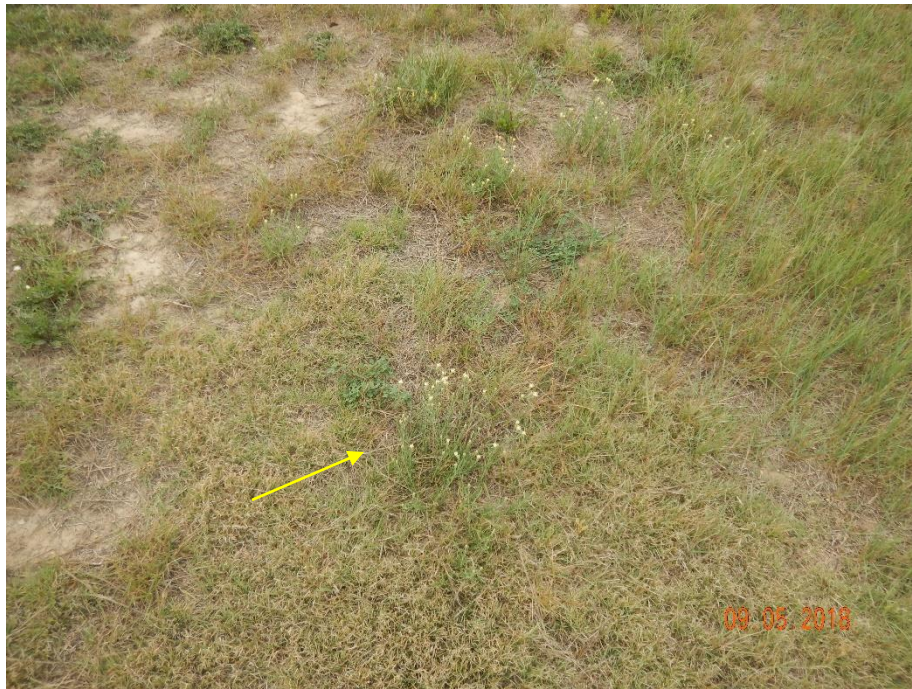
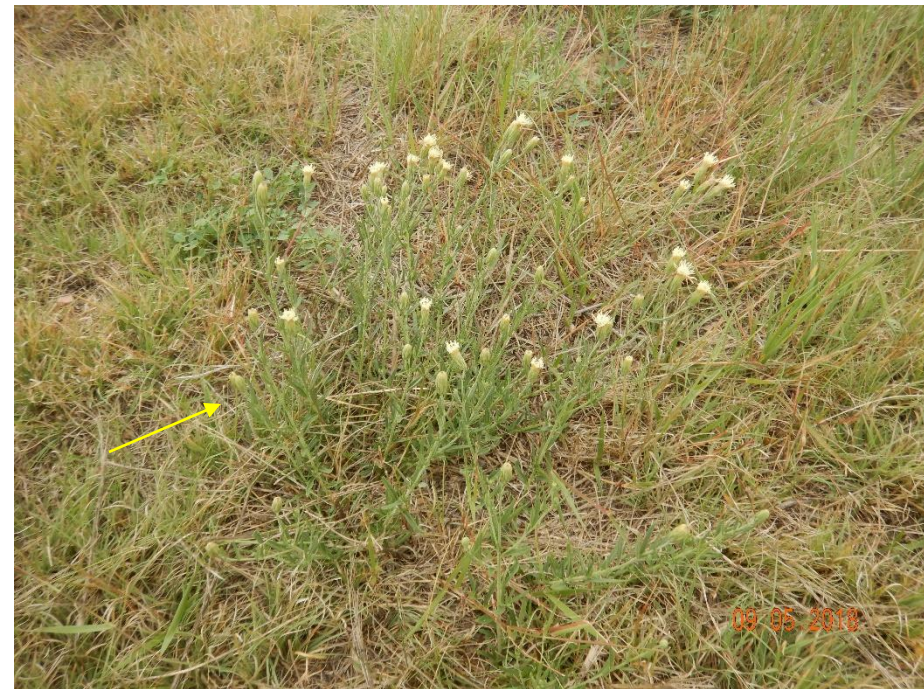
**Photo 13:** Photo taken from the northwest end of the location.  
Photo shows Diffuse Knapweed remains on location

**Photo 14:** Continued from photo 13

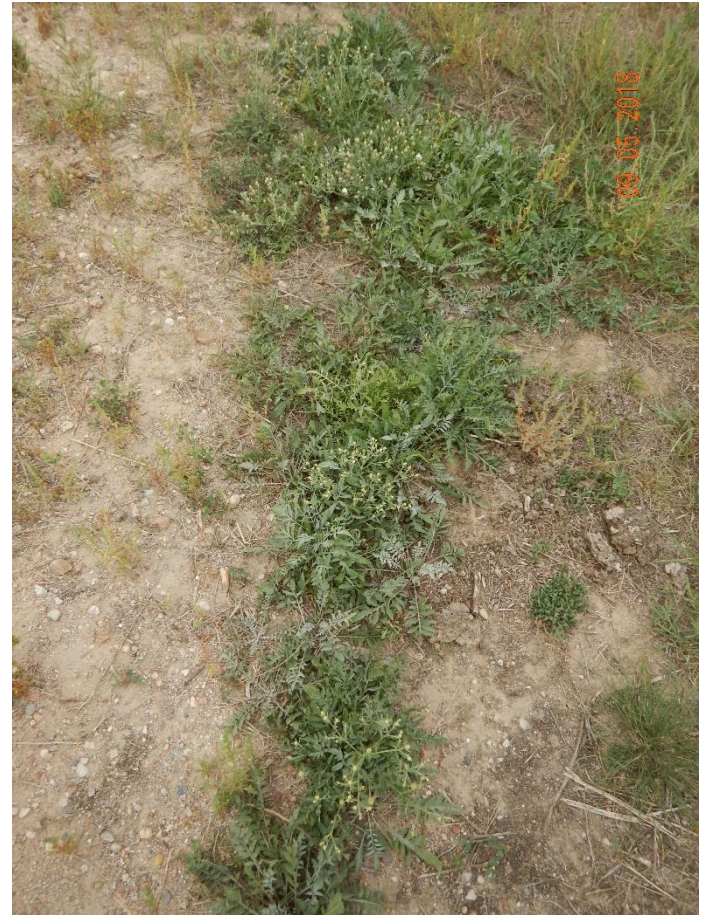
**Photo 15:** Photo taken from the northwest end of the location, facing west. Photo shows Diffuse Knapweed remains on location

**Photo 16:** Continued from photo 15

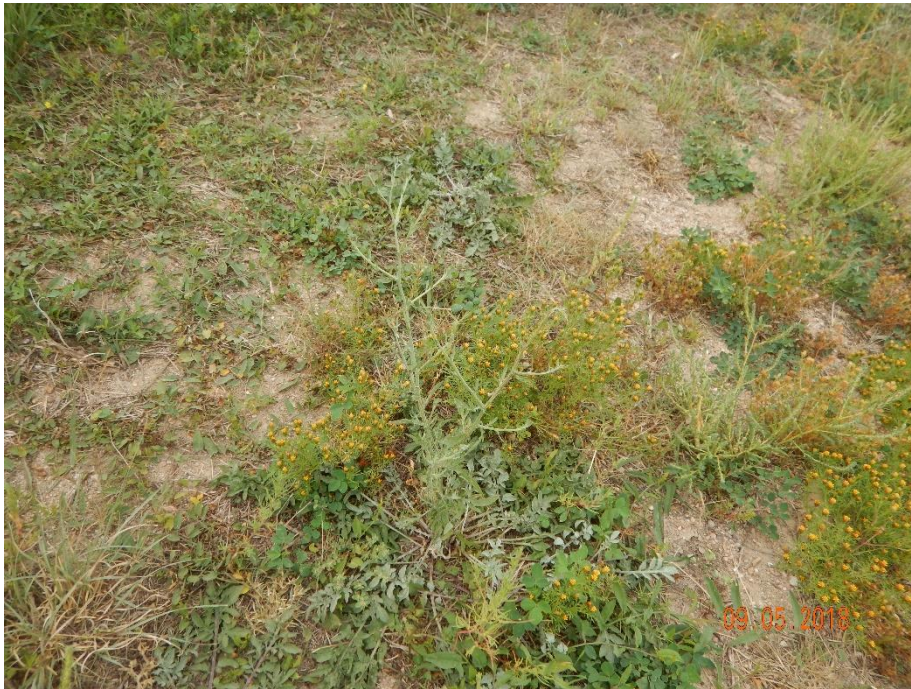
**Photo 17:** Photo taken from the northwest end of the location.  
Photo shows Diffuse Knapweed remains

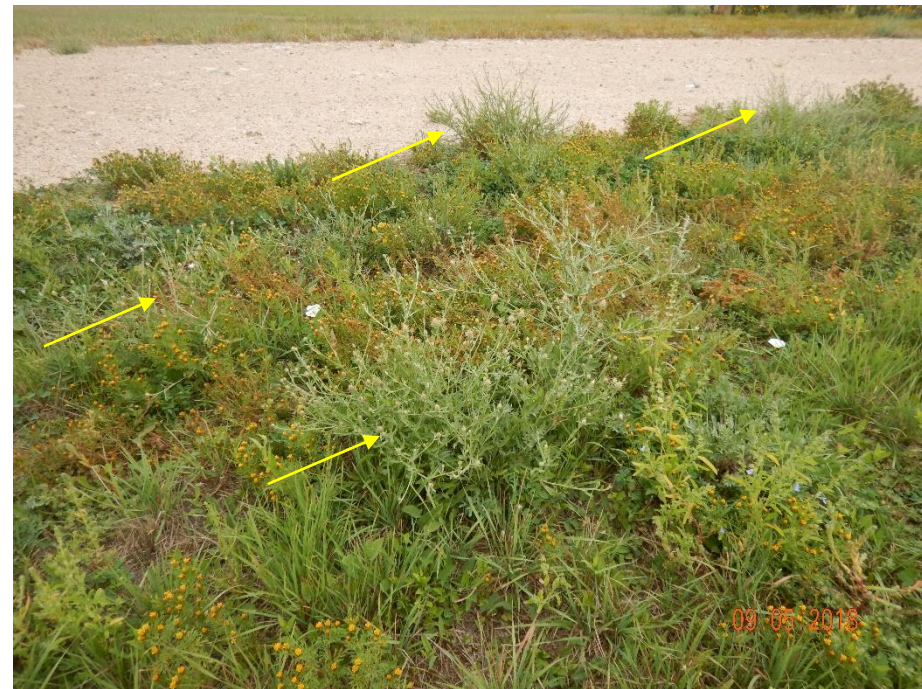
**Photo 18:** Photo taken from the northwest end of the location,  
facing north. Photo shows Diffuse Knapweed remains

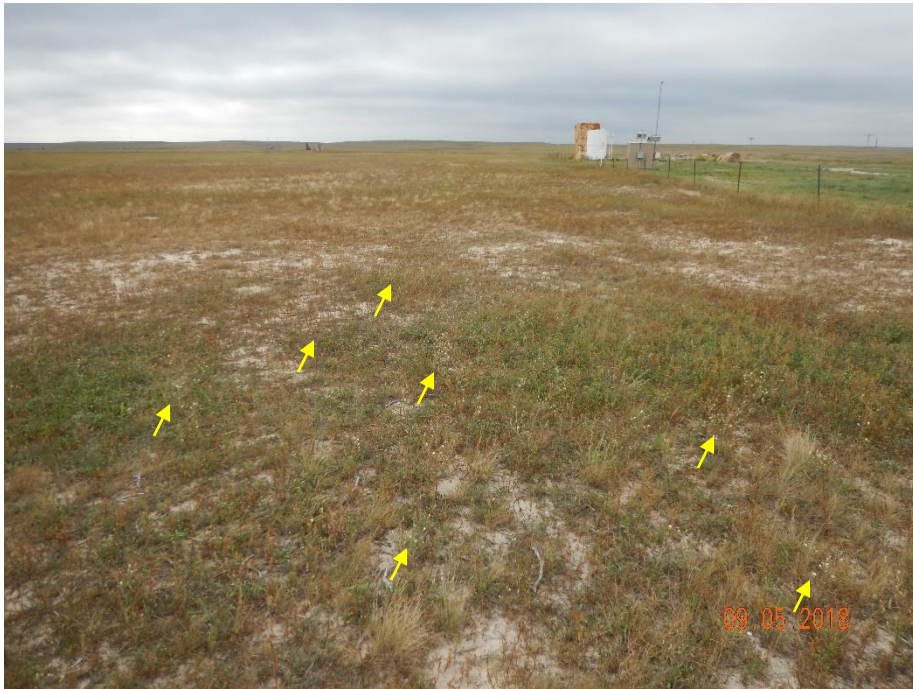
**Photo 19:** Photo taken from the east of the location, facing south. Previous inspection required operator to conduct weed management in these area due to noxious weeds spreading from the location onto the adjacent lands. Hundreds of individual Diffuse Knapweed remain evident and dense in these areas. White flowers observed in the photo Diffuse Knapweed. Unable to find evidence that sufficient weed management has been conducted. Diffuse knapweed evident in all areas of the foreground in this photo

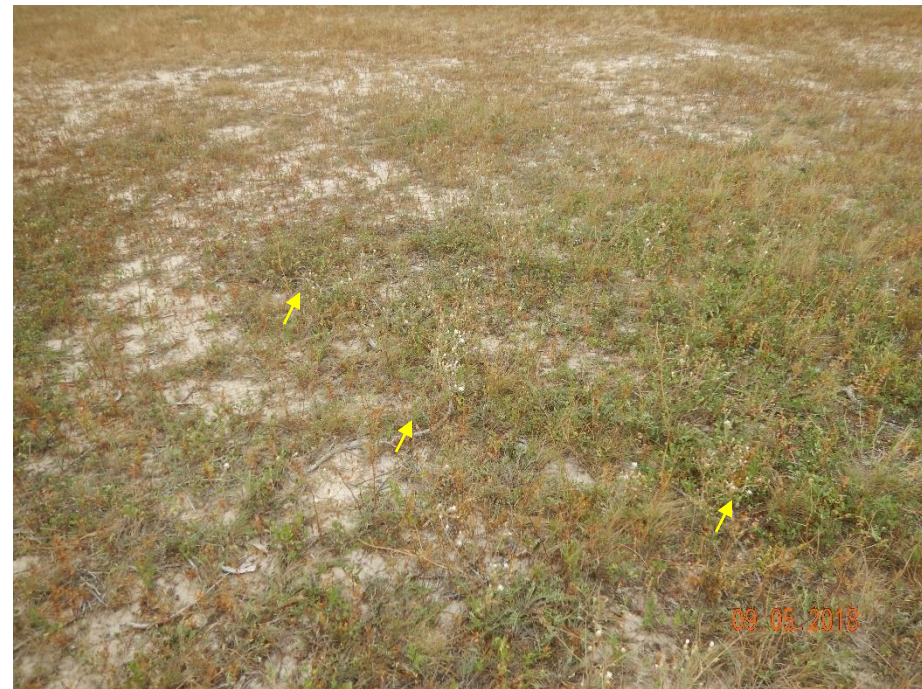
**Photo 20:** See comments under photo 19

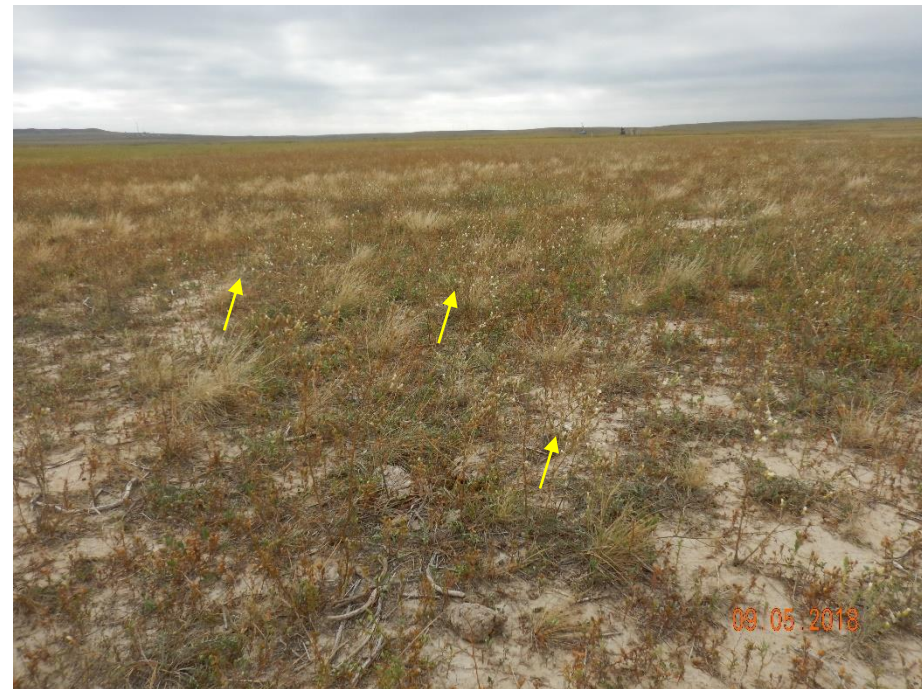
**Photo 22:** See comments under photo 19. White flowers observed in the photo Diffuse Knapweed.

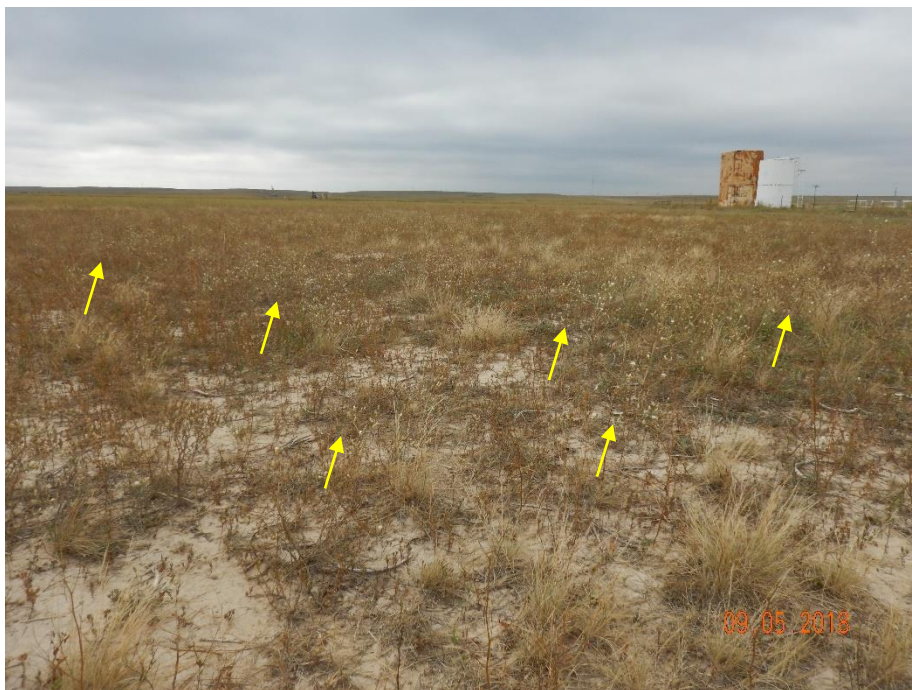
**Photo 23:** Photo taken from the east of the location, facing south. See comments under photo 19. White flowers observed in the photo Diffuse Knapweed.

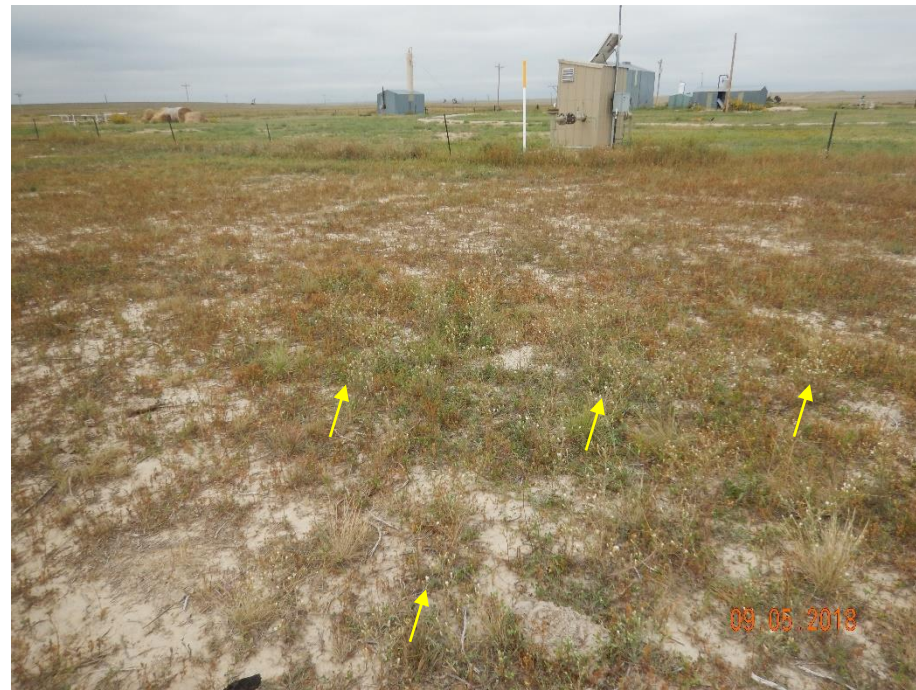
**Photo 24:** Photo taken from the east of the location, facing west. See comments under photo 19. White flowers observed in the photo Diffuse Knapweed.

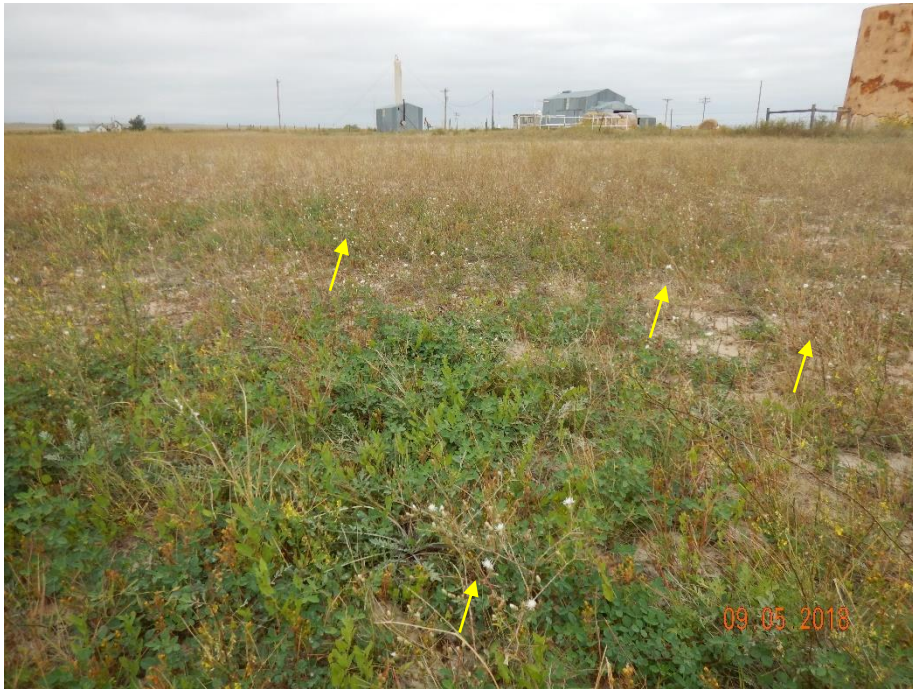
**Photo 25:** Photo taken from the southeast of the location, facing northwest. See comments under photo 19. White flowers observed in the photo Diffuse Knapweed.

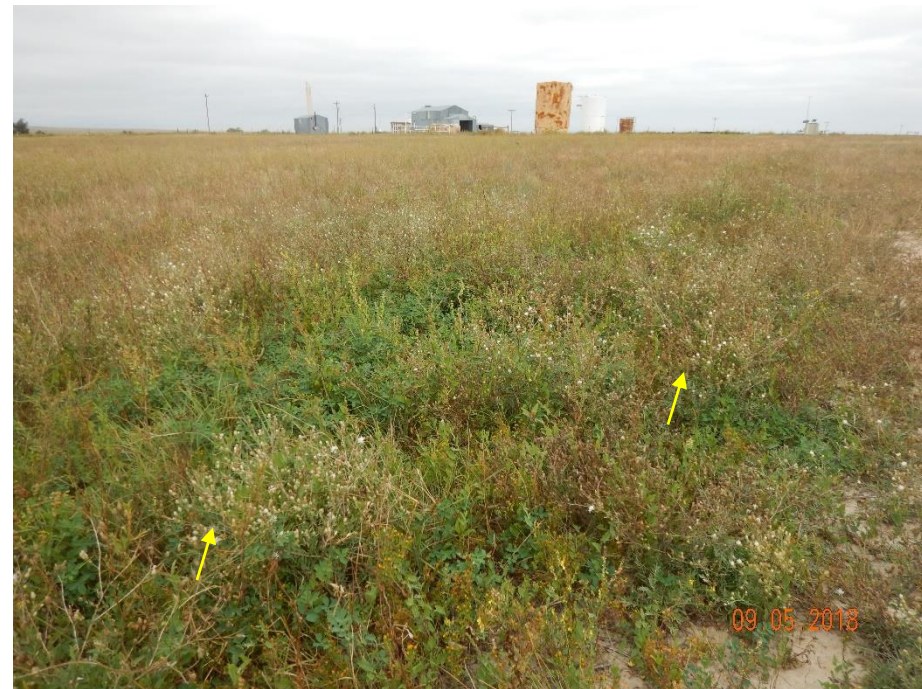
**Photo 26:** Photo taken from the southeast of the location, facing northwest. See comments under photo 19. White flowers observed in the photo Diffuse Knapweed.

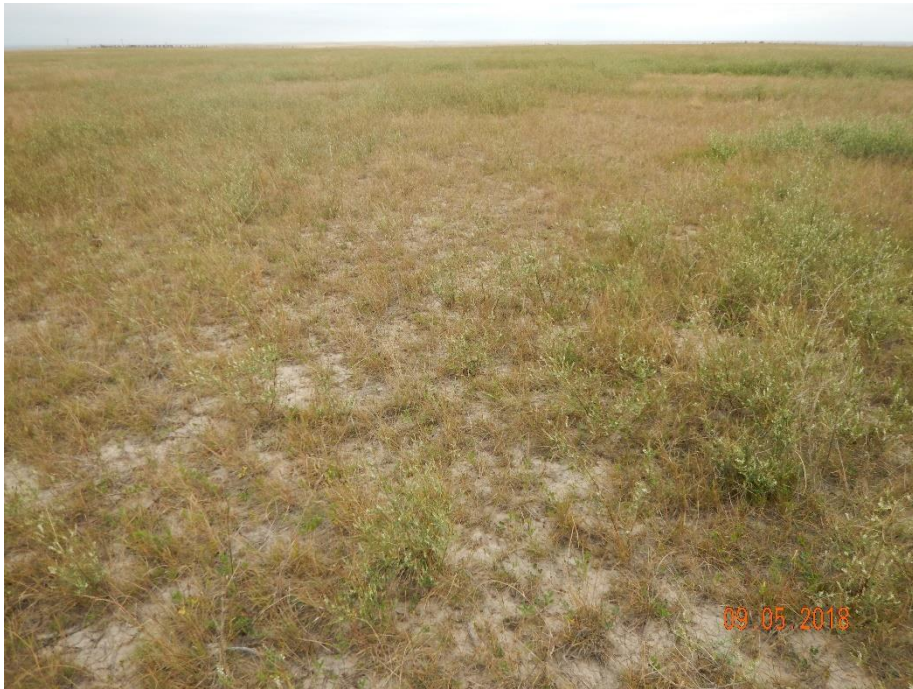
**Photo 26:** Photo taken from the adjacent lands, facing north. See photo 127 for additional details. Individual Diffuse Knapweed was observed in this area. Photo shows adjacent lands do not have the population densities of noxious weeds compared to areas within the locations and its immediate surrounding; noxious weed population densities decrease as the distance away from the locations increase.

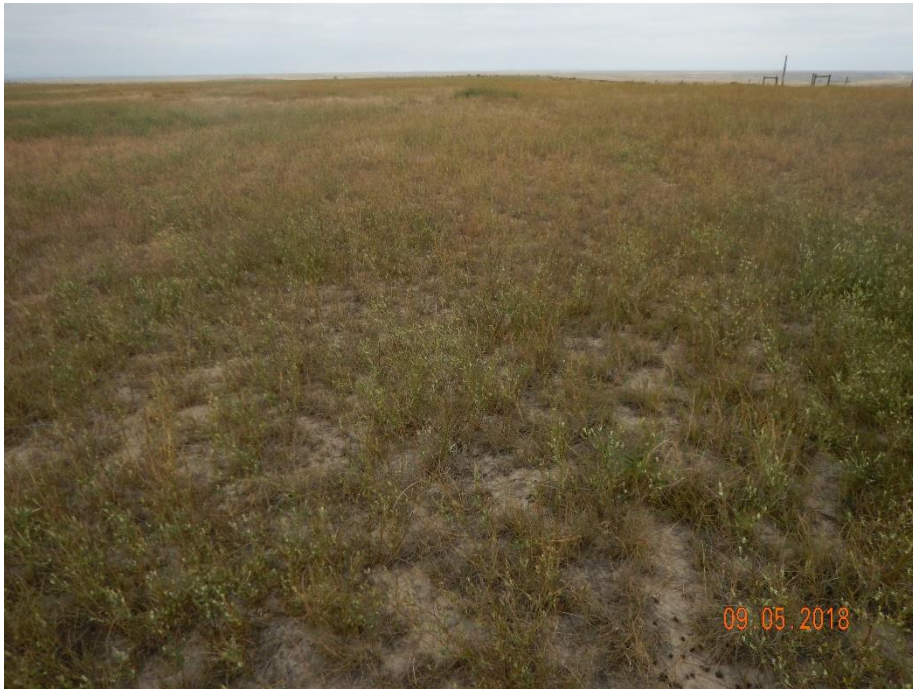
**Photo 41:** Photo taken from the adjacent lands, facing north. See photo 127 for additional details. An individual Diffuse Knapweed was observed in this area. Photo shows adjacent lands do not have the population densities of noxious weeds compared to areas within the locations and its immediate surrounding; noxious weed population densities decrease as the distance away from the locations increase.

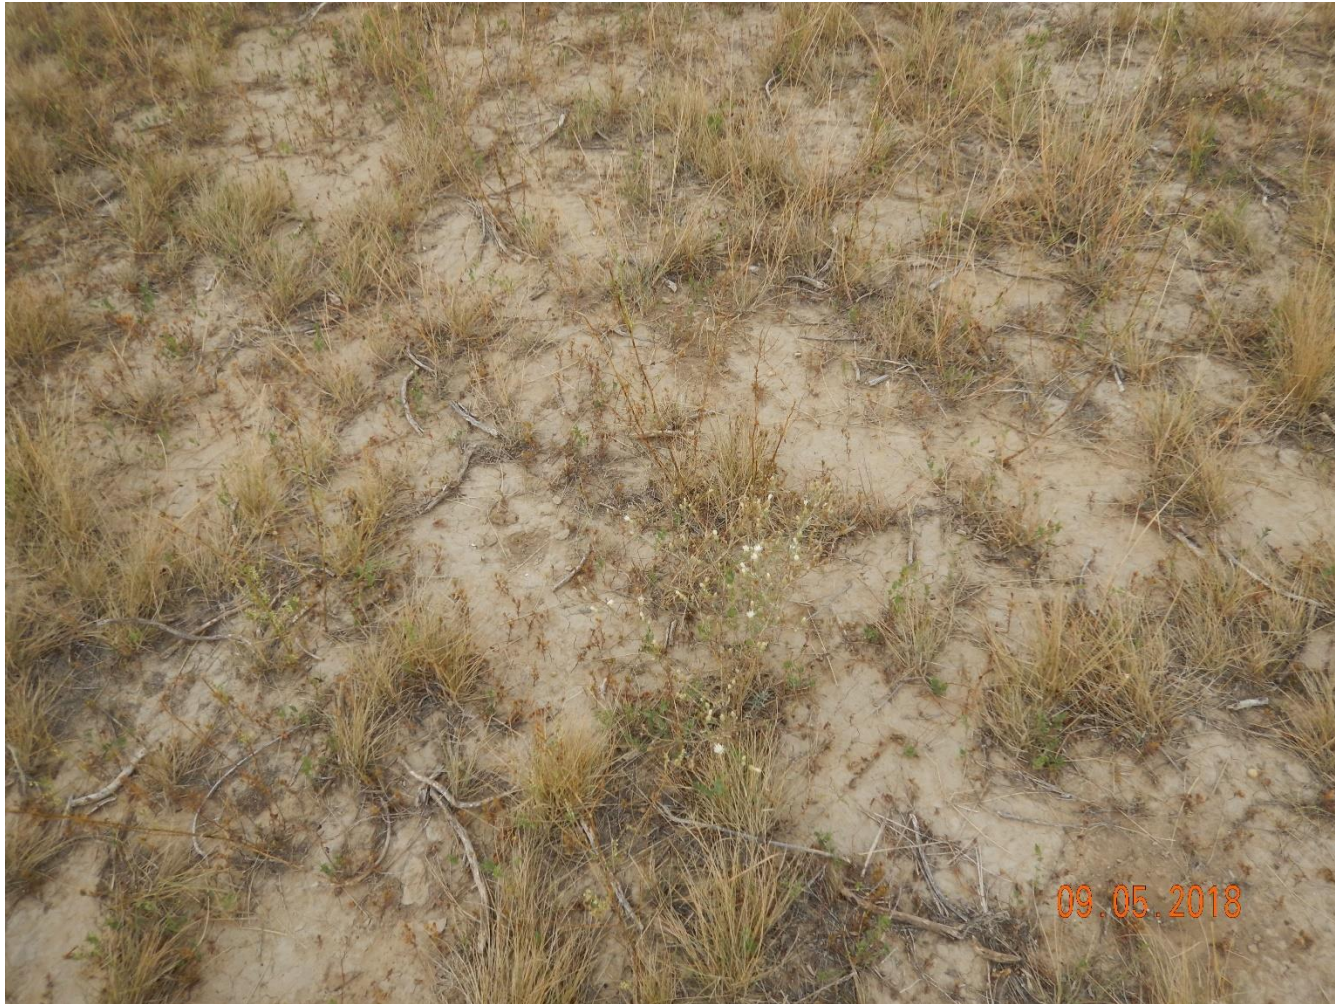
**Photo 46:** Photo taken from the adjacent lands to the east of the location. See photo 127. Photo shows Diffuse Knapweed observed in the reference. ~5-6 individuals were observed within this area. Photo shows adjacent lands do not have the population densities of noxious weeds compared to areas within the locations and its immediate surrounding; noxious weed population densities decrease as the distance away from the locations increase.

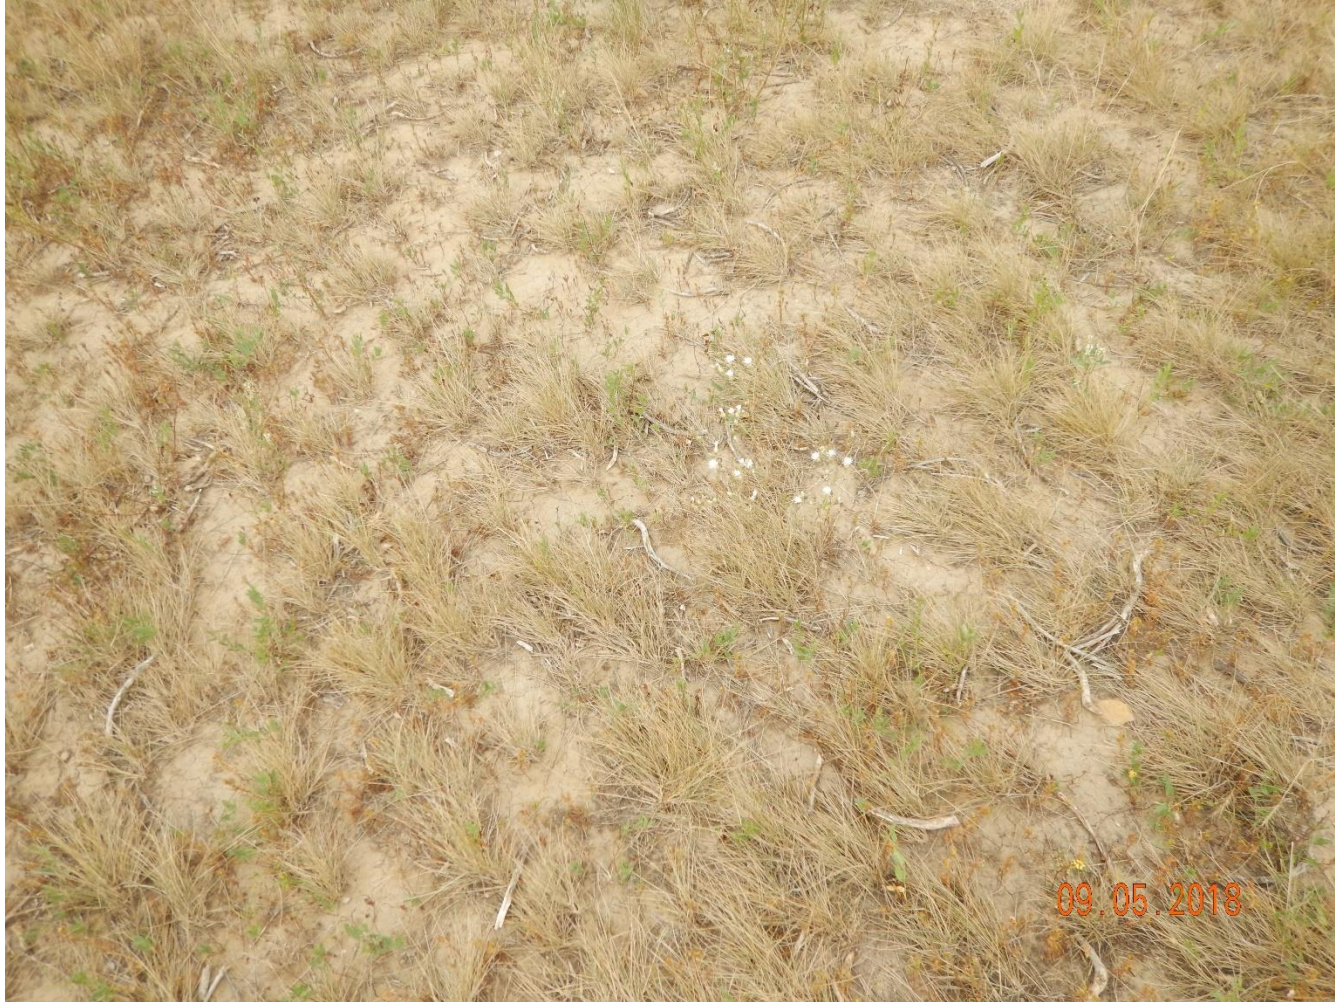
**Photo 62:** Photo taken from the adjacent lands to the northeast of the location. See photo 127. Photo shows Diffuse Knapweed observed in the reference. Only 1 individuals was observed within this area. Photo shows adjacent lands do not have the population densities of noxious weeds compared to areas within the locations and its immediate surrounding; noxious weed population densities decrease as the distance away from the locations increase.
