# Inspection Photos

Operator: FOUNDATION ENERGY  
MANAGEMENT LLC - 10112

Location ID: 447523

Inspection Doc. Number: 682503847  
Weld County, CO

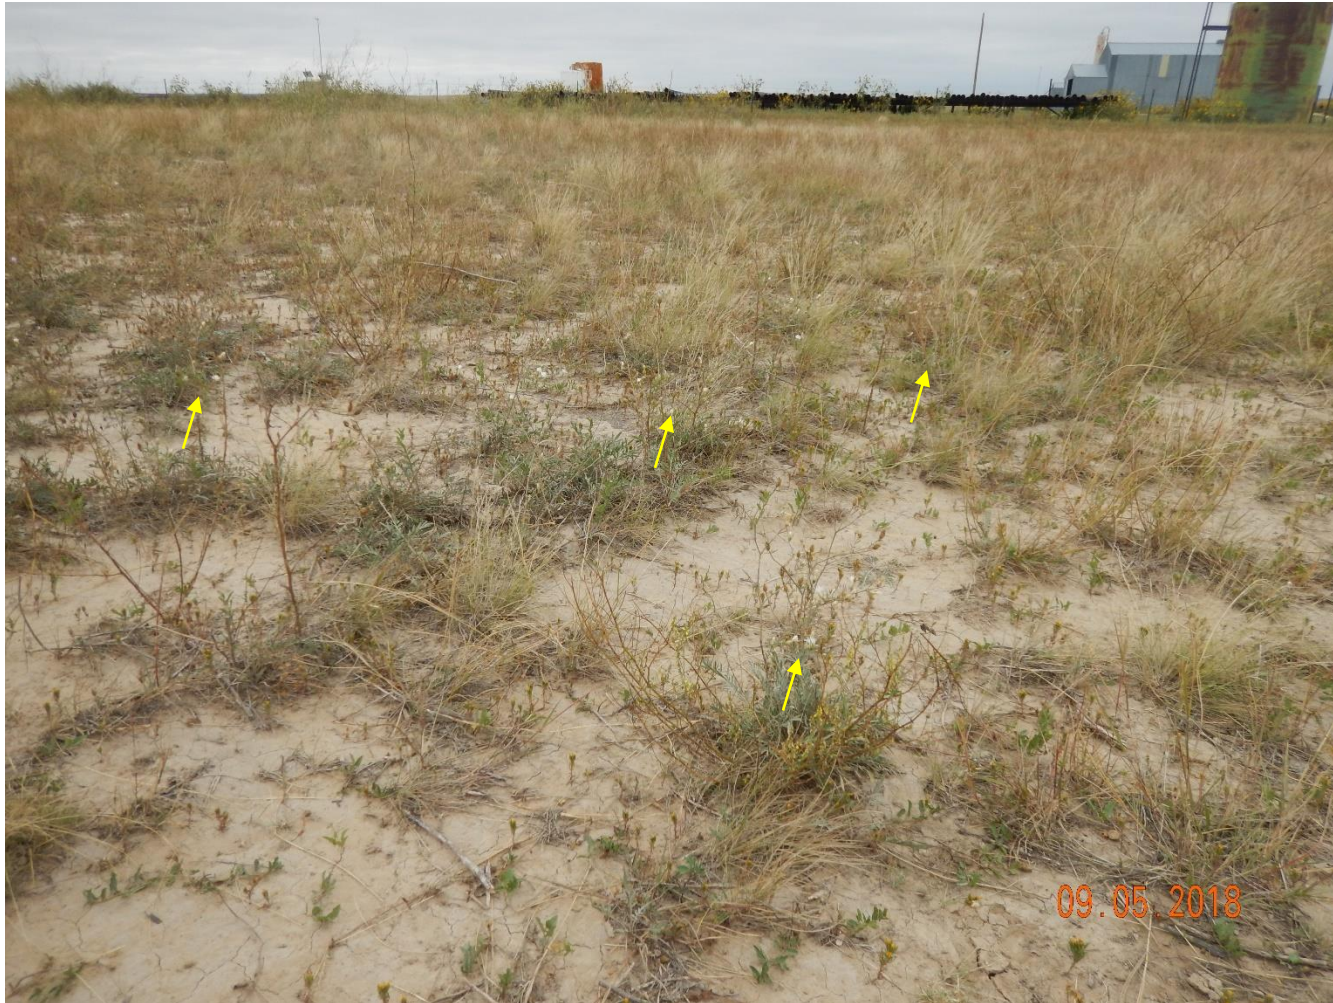
**Photo 72:** Photo taken from the adjacent lands to the northeast of the location. See photo 127. Photo shows Diffuse Knapweed observed in the reference. Multiple individuals was observed within this area. Photo shows adjacent lands do not have the population densities of noxious weeds compared to areas within the locations and its immediate surrounding; noxious weed population densities decrease as the distance away from the locations increase.
